WSRC-TR-2001-00163

**Degradation and
Failure Characteristics
of NPP Containment
Protective Coating Systems**

Preliminary Evaluation of Plant Coating Specimens

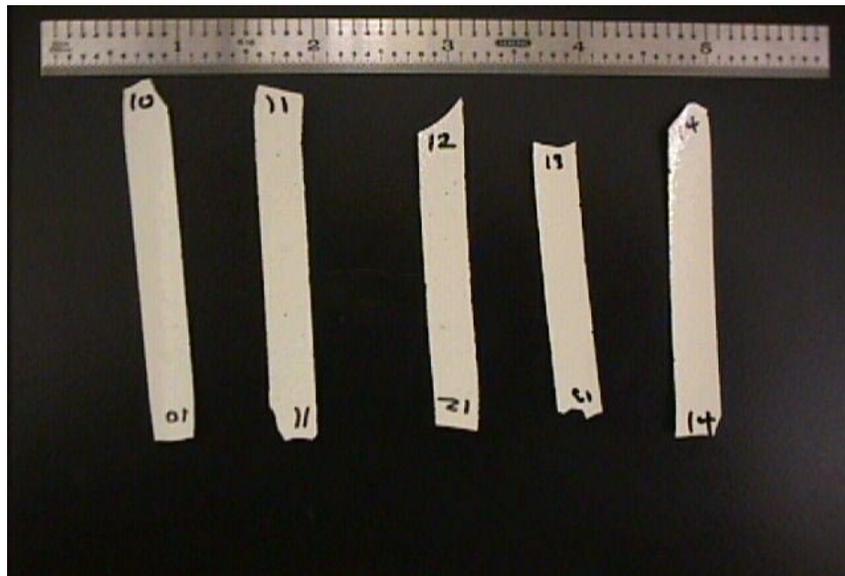
Free-film tensile tests were developed using fragments or chips of an epoxy-phenolic/IOZ coating system which failed in service. The strip specimens were die-cut in widths of 0.35 in. (Figure 2-11). Specimens were tested (Figure 2-12) in an Instron model 4507 mechanical testing machine at a crosshead speed of 0.05 inches per minute, using knurled, spring-loaded grips. Failure occurred outside the grips (Figure 2-13) in only one successful test, at 100°F. The maximum load was 2.7 lb and the resulting tensile strength 710 psi. Other tests resulted in failure within a grip. The 710-psi tensile strength is lower than that measured in an unirradiated, freshly applied epoxy phenolic coating (without any primer layer), but is within the range seen in the same coating irradiated to 10^9 rad.

Figure 2-11. Tensile strip specimens cut from chips

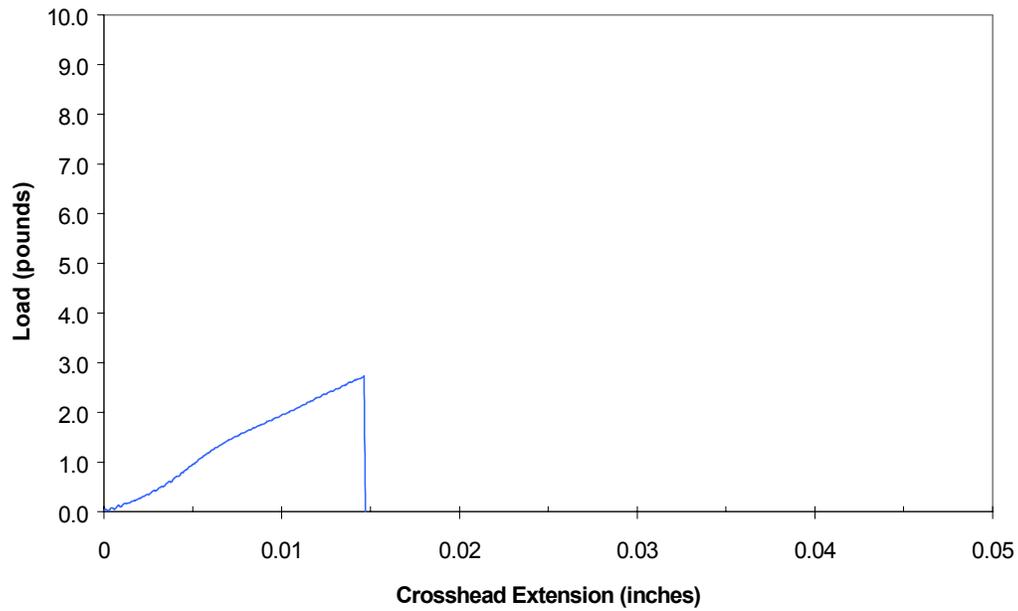
Plant Chip Tensile Test, Specimen 10 @ 38 deg C
failed outside grips

Figure 2-12. Tensile test of plant chip at 100°F (38°C)

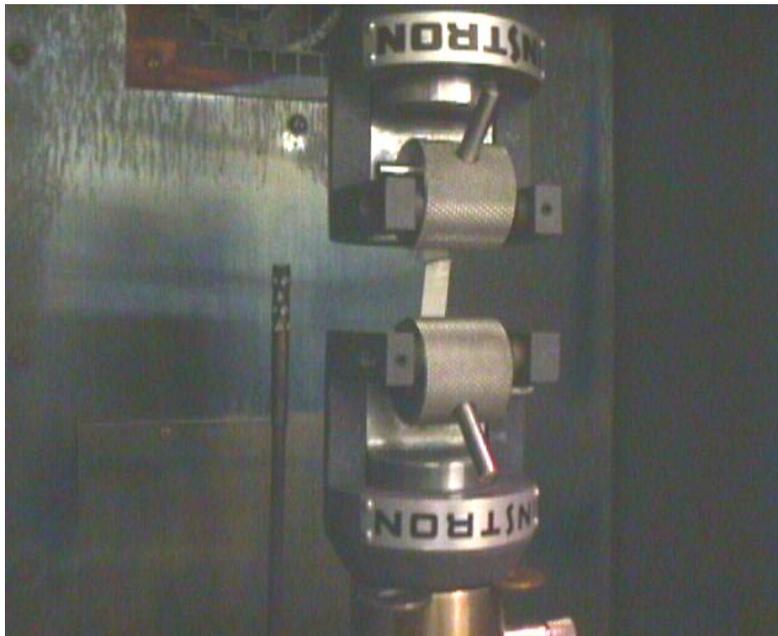
Figure 2-13. Tensile test of free-film specimen

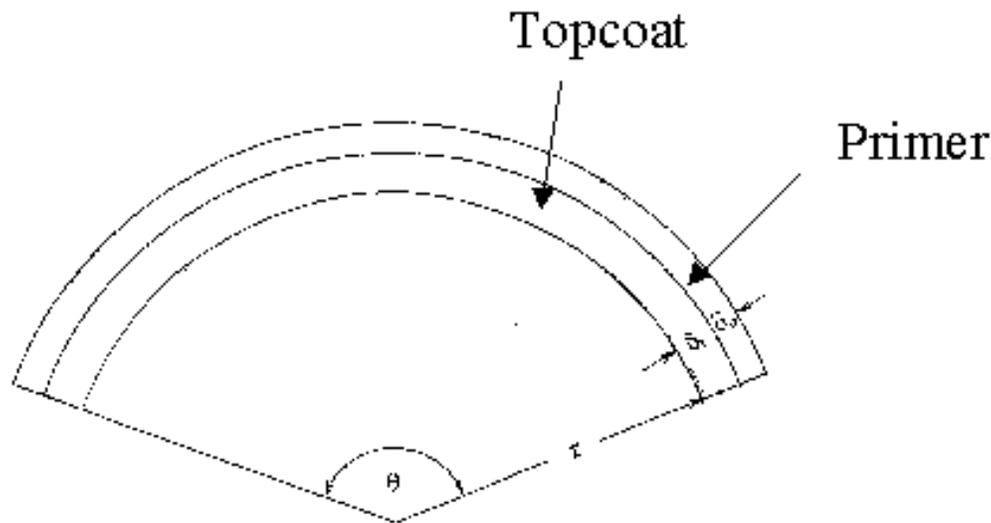
Figure 2-17. Analytical model of the radius of curvature of a two-layer chip

This model shows that, whatever the mechanisms causing the differential expansion or contraction, a difference in expansion/contraction must occur if the chips curl. The as-received chips had an initial radius of curvature of approximately 1 cm, consistent with a differential expansion/contraction of approximately one percent.

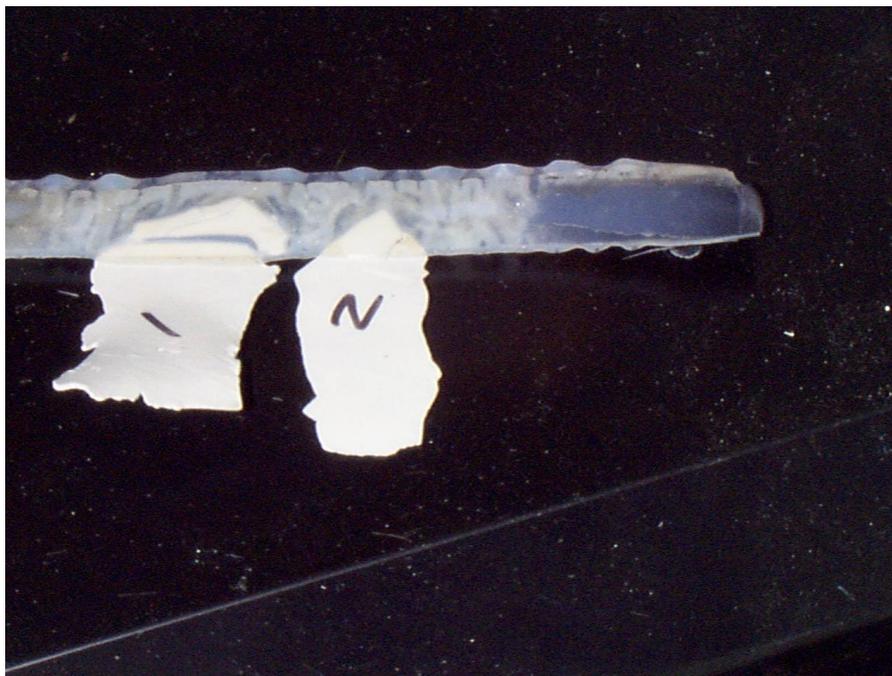
To test the hypothesis that a single-layer system should not be subject to the high degree of curling because differential expansion/contraction could not occur (unless the single-layer was not uniform), tests were run with single-layer coats. First, specimens of “artificial” debris chips, prepared by LANL for transport tests, were exposed to 300°F steam for 1 hour. The artificial chips exhibited only minor deformation compared to the plant-provided chips (Figure 2-18). Next, single-layer specimens were prepared by carefully grinding off the 0.005" IOZ layer on the chips using 1200 grit paper. Some residual IOZ remained at the edges of the chips, since it was difficult to remove this layer without breaking the chips.

Figure 2-18. Photograph of the artificial chips following steam exposure

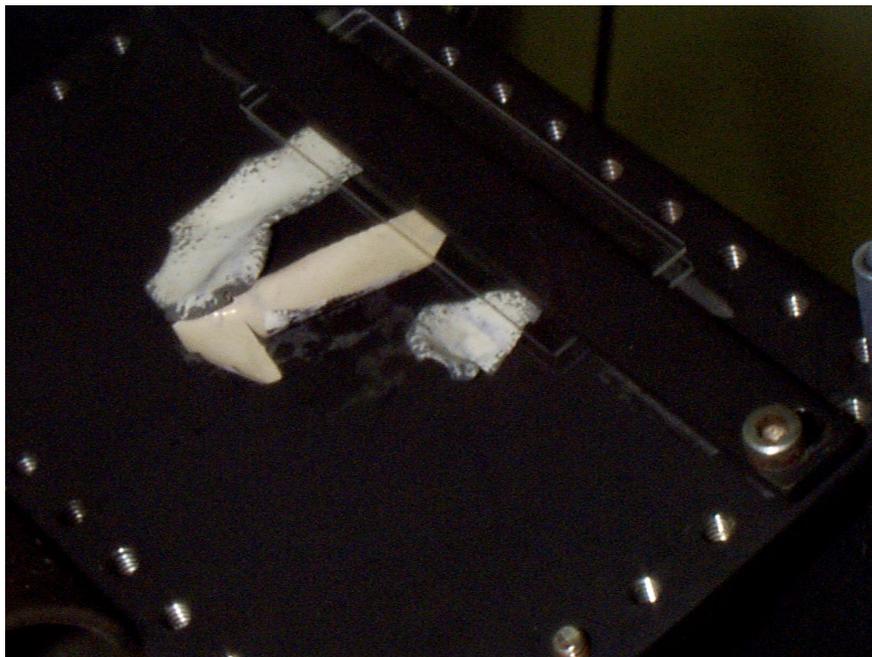
The single-layer chips were exposed to 300°F steam for 1 hour and the results (Figure 2-19) showed only minor

curling of the chips compared to the results from the two-layer chips.

Figure 2-19. Photograph of the single-layer chips following steam exposure

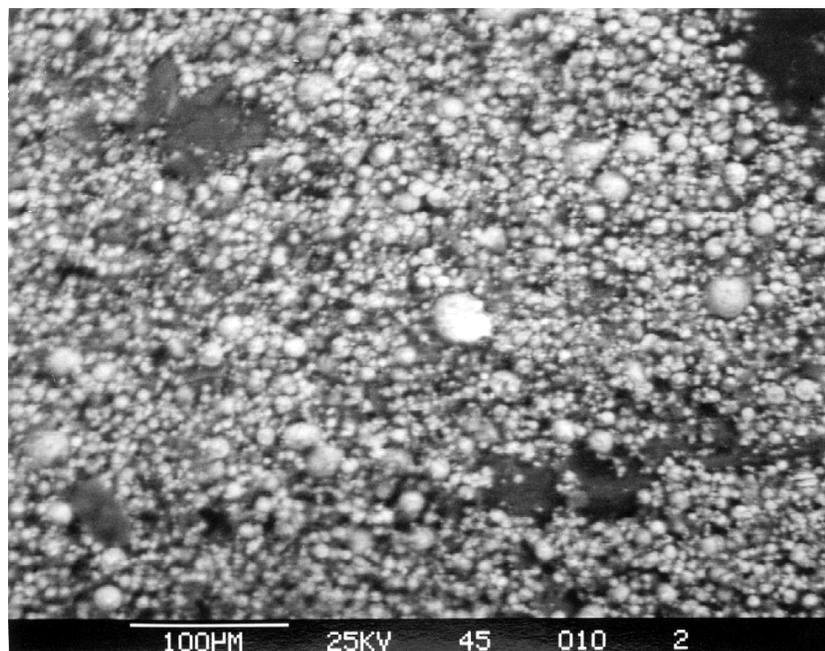
A backscattered electron image of the same area shown in Figure 3-5 is provided in Figure 3-6 to show the relative difference between the two imaging techniques. In the backscattered image, the conductive areas are shown in white with the non-conductive areas being darker. The relevant fact to note from these images is that although the inorganic zinc primer was assumed to be polymerized/oxidized, it was still relatively conductive even in the uncoated condition (uncoated with either gold or carbon typically used for imaging of non-conductive materials).

**Figure 3-6. Backscattered image of inorganic zinc primer – header steel location (200X)
(same area as Figure 3-5)**

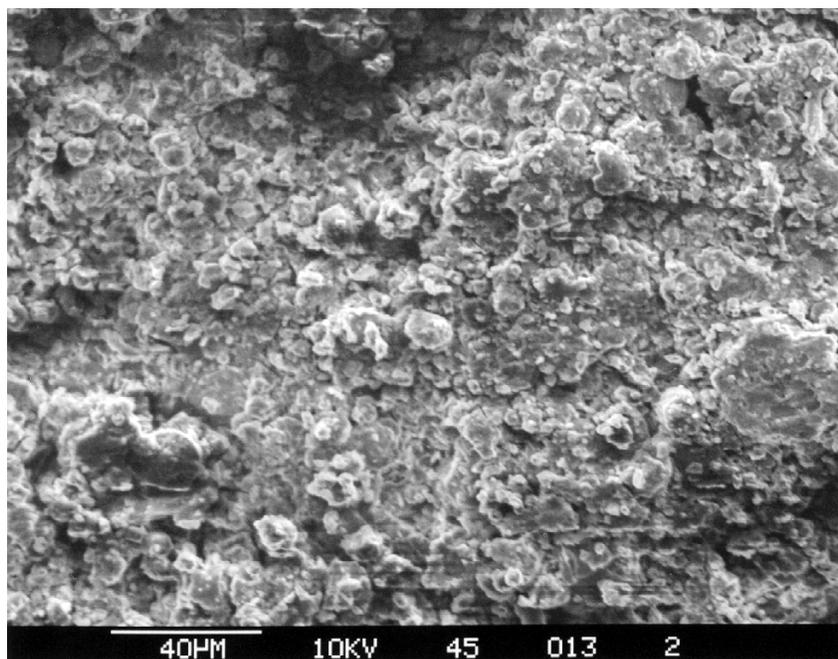
Secondary electron images of the same general area and features are shown from 500 to 5000X in figures 3-7 to 3-10, with the majority of zinc oxide particles observed to be less than 20 μm in diameter. At the higher magnifications, cleavage planes (splitting of the particulates) were observed. Cleavage of particles may have occurred during coating failure or may be an artifact of the coating curing process.

Figure 3-7. Secondary electron image of inorganic zinc primer (500X)

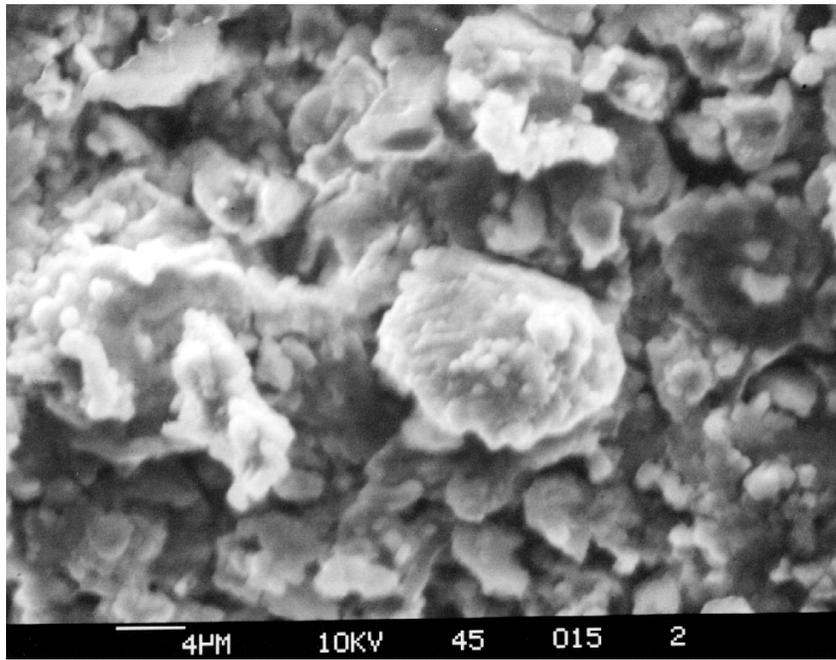
Figure 3-9. Secondary electron image of larger particle (from center of Figure 20), 2500X

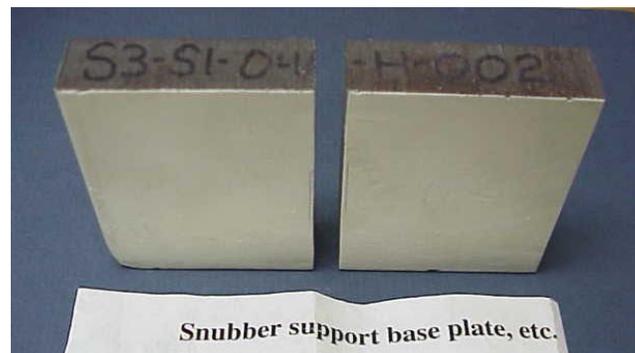
Figure 4-6. Overall view of the coated steel specimen provided from an operating nuclear power plant. The specimen was coated on the two main surfaces with two coats of Mobil 78-W-300.

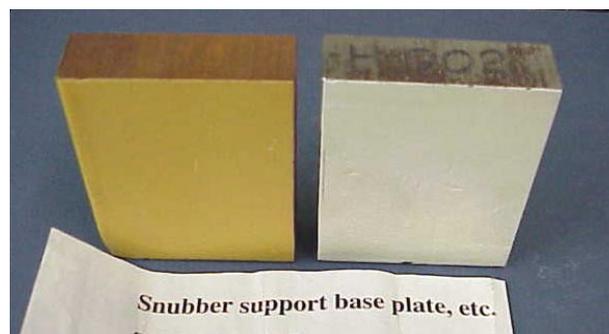
Figure 4-7. Overall view of the snubber support specimen following irradiation aging of the left half to 1×10^9 rads at 1×10^6 rad/hr and 120°F in the SRTC gamma cell.

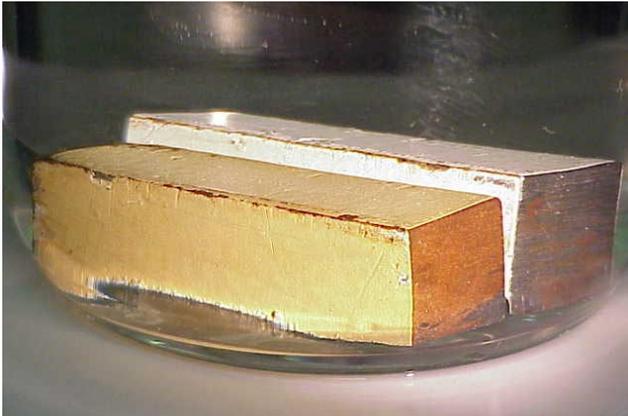
Portions of the aged and non-aged coating specimens were immersed in room temperature water, which was then heated to 200°F (Figure 4-11). As the water was heated, gas bubbles appeared on the coated surfaces of the irradiated specimen, accompanied by the formation of blisters in the coating as the temperature approached 200°F (Figure 4-12).

Figure 4-11. Overall view of the irradiation-aged (yellow, front) and non-aged (white, back) specimens in room temperature water at the beginning of immersion testing

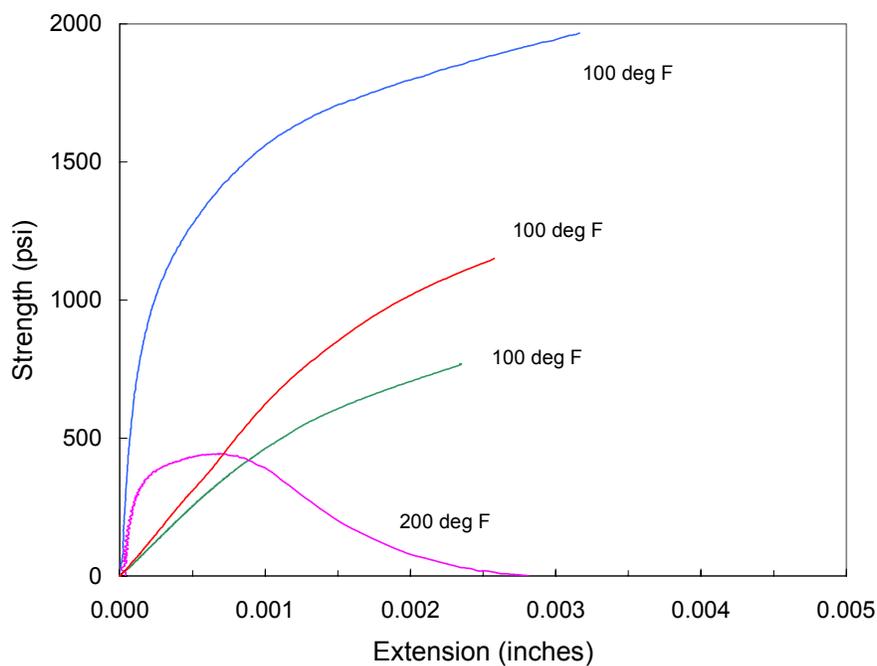
Figure 4-15 shows the load-extension results from an as-received plate in the dry condition. The highest strength was 1970 psi at 100°F, in which test failure, or separation of the puller from the substrate, occurred at what appeared to be the topcoat/primer coat interface. In the lower strength failures at 100°F, failure occurred at the topcoat/primer interface as well as at the primer coat/substrate interface. In the instances of separation at the substrate, there appeared to be spots of rust on the steel substrate, which probably accounts for the lower strengths. The relatively lower strength and more ductile failure observed in the 200°F test compared with the 100°F tests are consistent with observations in the epoxy phenolic/inorganic zinc coating on steel (the SRTC System 1 coating).

Figure 4-15. Adhesion pull test results from the as-received snubber plate at 100°F and 200°F in the dry condition

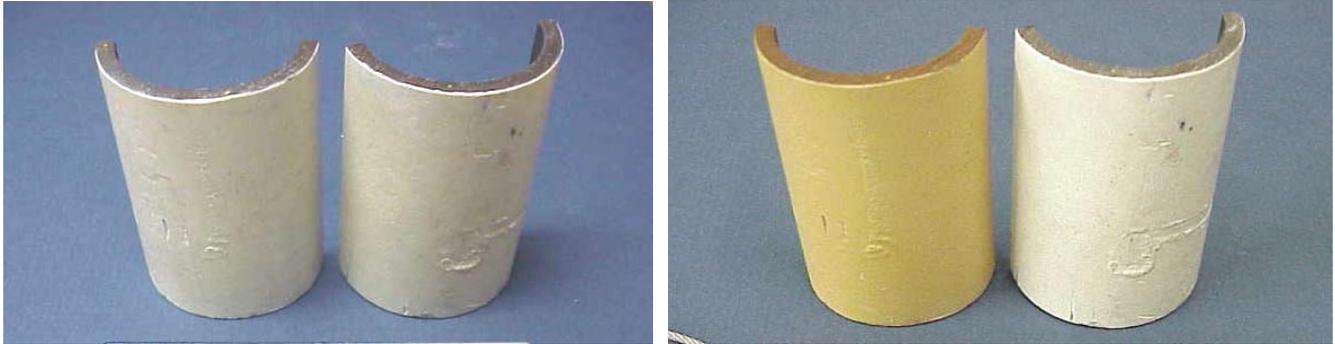
Figure 4-16. Overall views of the handrail specimen as it appeared as-received and after dividing in half (left), and after irradiation-aging of half of the specimen (right)

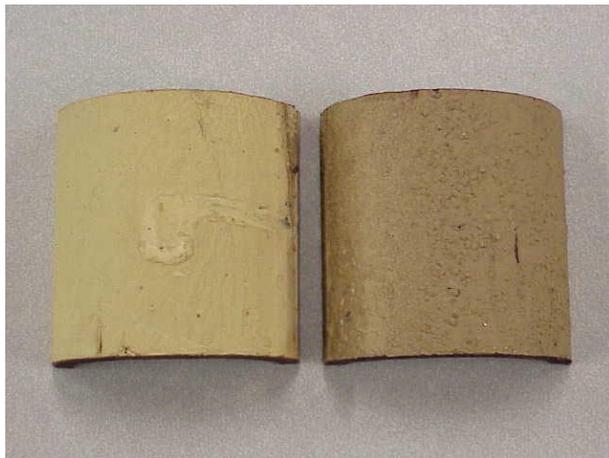
The coating did not fail, according to the acceptance criteria of the ASTM specification (Figures 4-17 and 4-18). However, under microscopic examination, there was evidence of failure of the coating in the irradiated specimen, similar to what has been observed in other irradiated specimens – by release of fine particles (Figure 4-19).

Figure 4-17. Overall view of the handrail specimens, after DBA-LOCA testing. The as-received specimen is on the left; the irradiation-aged specimen on the right.

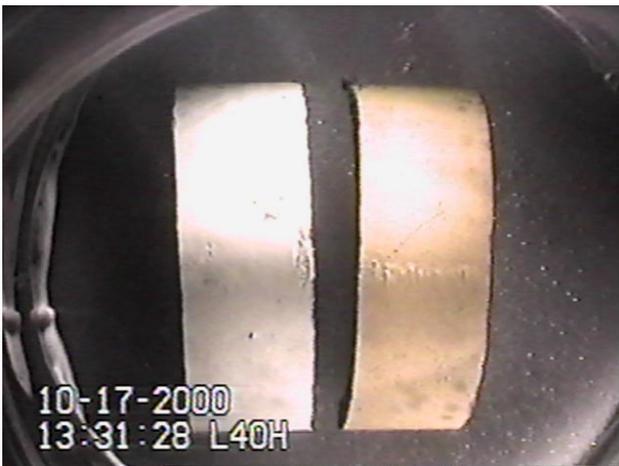
The first image (Figure 4-20) illustrates the condition of the specimens immediately after immersing them into water, preheated to 200° F. The next image (Figure 4-21) illustrates the appearance of the specimens after 10 minutes. Note the formation of a uniform layer of bubbles and blisters on the surface of the irradiated specimen. The rapid formation and release of bubbles is consistent with the hypothesis of gas formation within an epoxy topcoat during the irradiation of the specimen.

Figure 4-20. Handrail specimens immediately after immersion in water preheated to 200°F

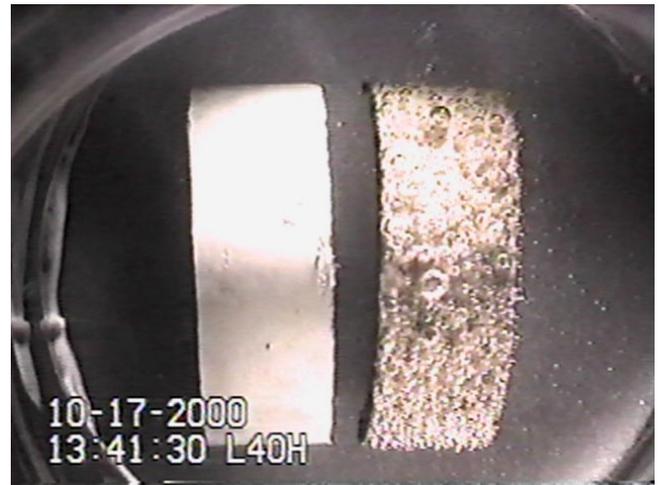
Figure 4-21. Handrail specimens 10 minutes after immersion in water preheated to 200°F

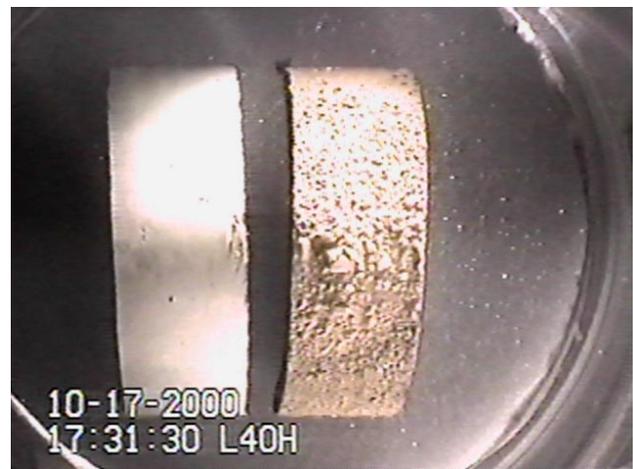
The addition of heat was terminated after approximately 2.5 hours and the specimens were allowed to cool under water. Figure 4-22 shows the appearance of the specimens after cooling for approximately 1.5 hours.

Figure 4-22. Handrail specimens at the end of the immersion tests

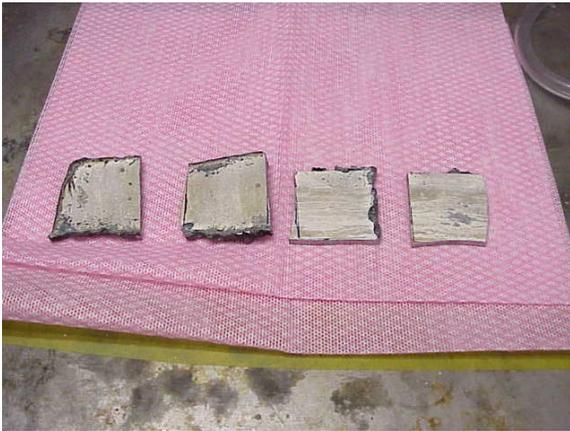
Figure 5-1. Overall view of coated steel plate specimens. The specimens are approximately 2 inches square, each, and were saw-cut from a plate which appeared to have been removed from service with a cutting torch.

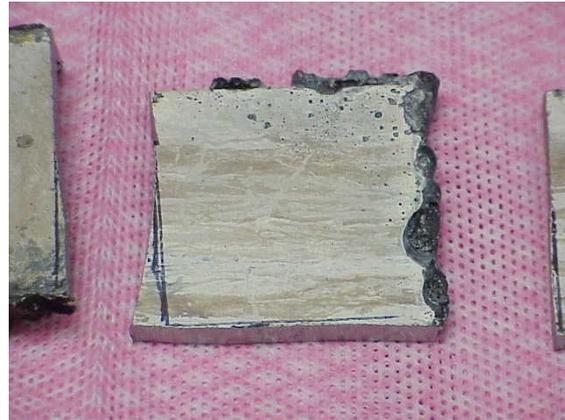
Figure 5-2. Overall view of one of the coated plate specimens as it appeared prior to immersion testing
