Amersham International plc

Packaging Design Group

Test Report No. 1901

1.1 Package Design No 3750A.

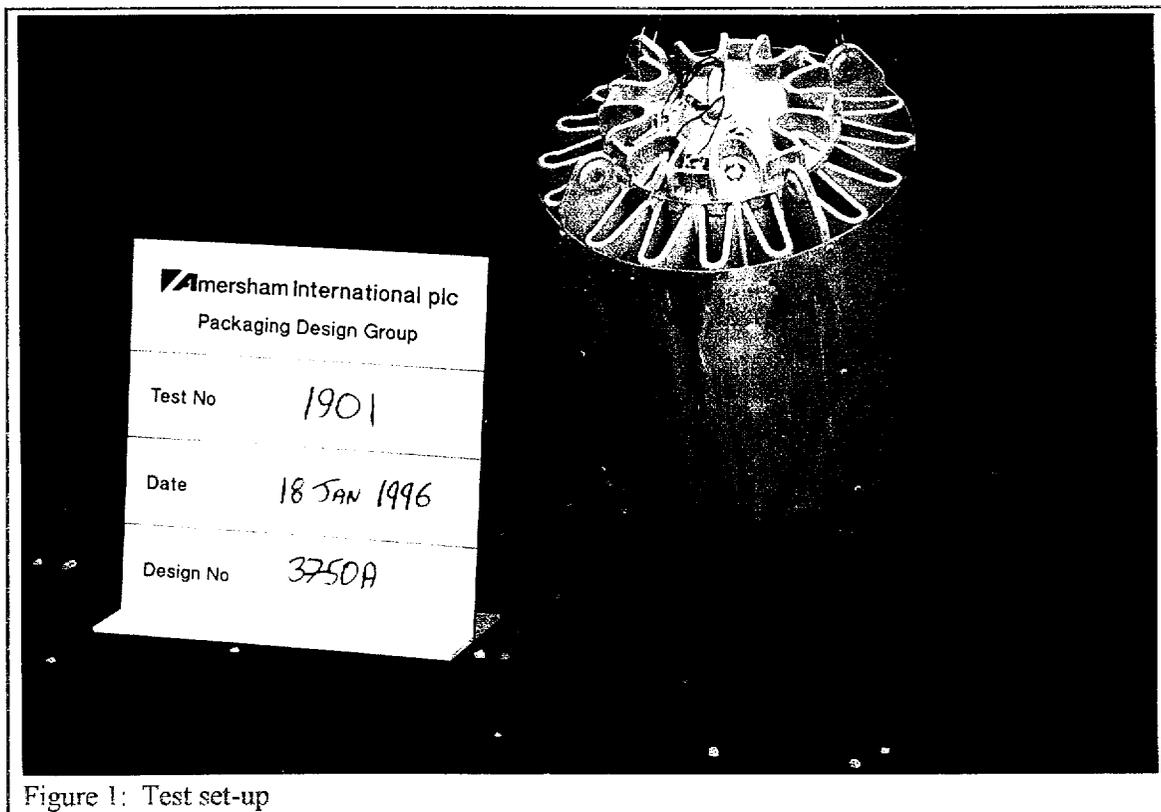
1.4 Orientation The cask was slung at an angle of 24° from the vertical, placing the centre of gravity over the point of impact (fig 1).

Figure 1: Test set-up

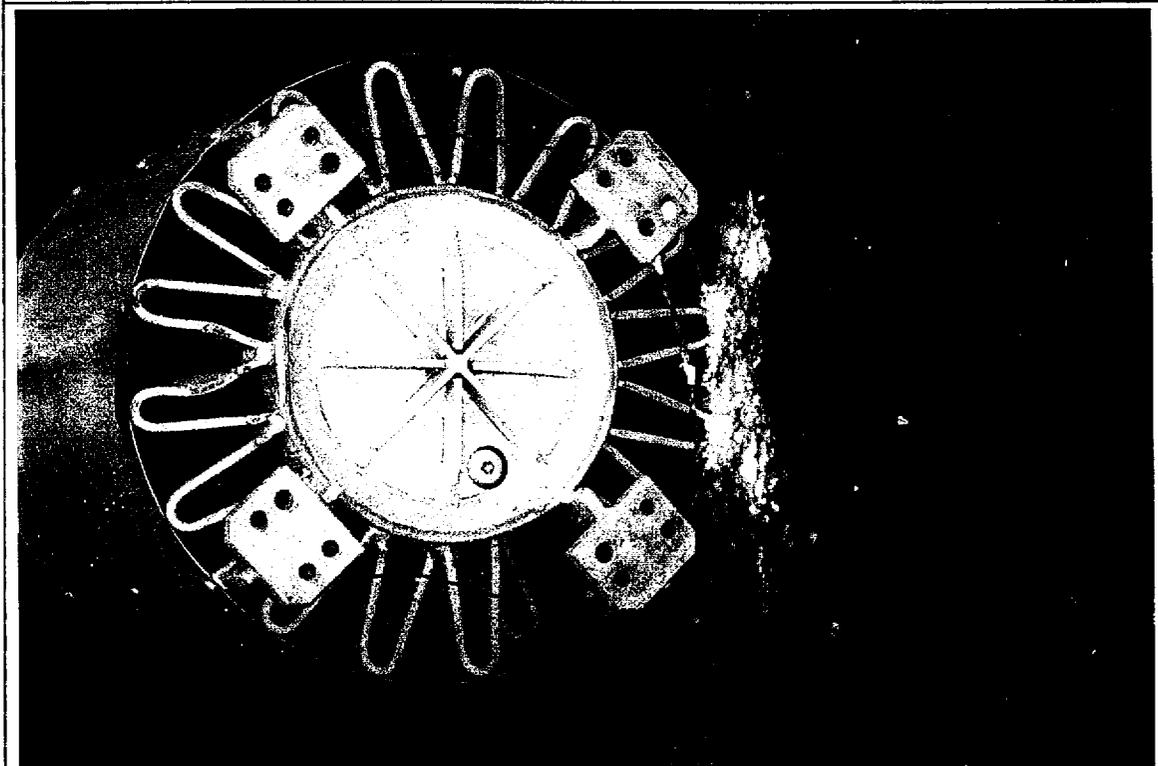
Figure 3: After impact

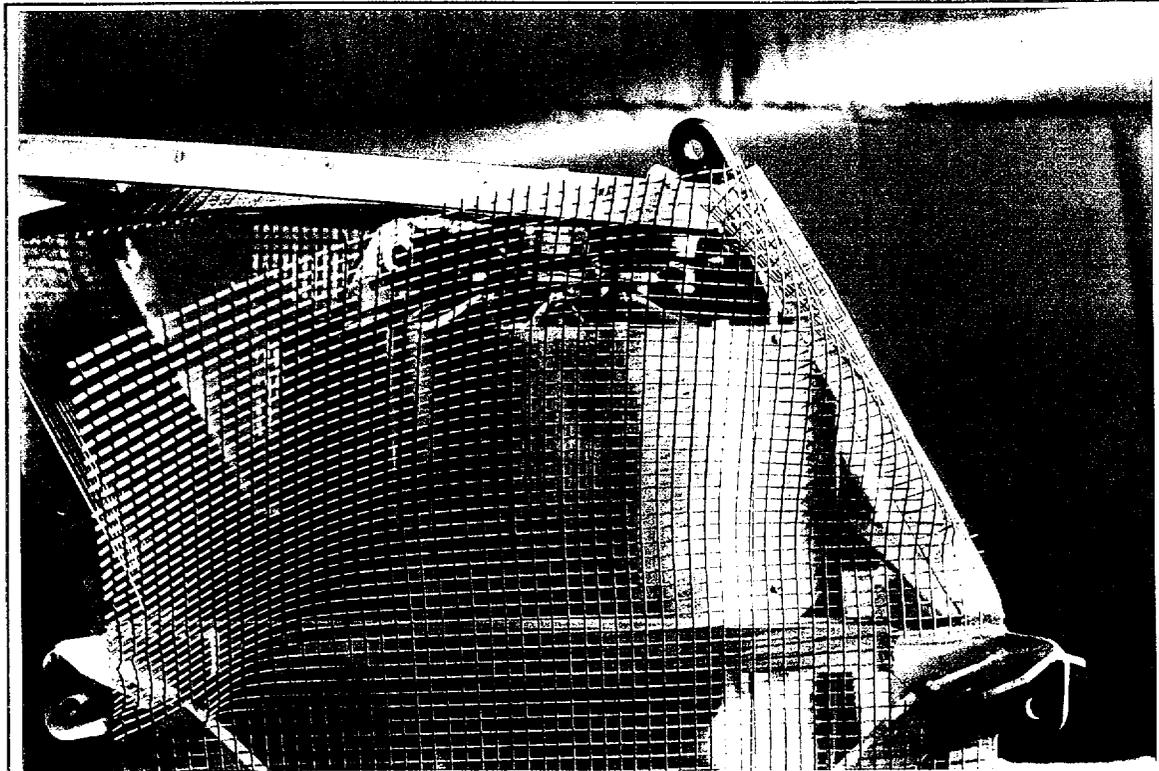
- 4.3.2 **Cage:** The upper section of the cage was twisted sideways by 100 mm at the top giving it an angle of 28° from the vertical (figs 5 & 6). Most of the joints had buckled to accommodate the movement (figs 7 & 8) but the two joints on each side that were in tension on their inner edge had split near the weld (figs 9 & 10). The mesh panel nearest the cask was 4 mm away from the top edge of the cask jacket and 40 mm from the top of the cask shell. The two lifting points underneath the impact were slightly bruised (fig 9). The top member underneath the impact was indented by the two of the shock absorbers on the cask closure (fig 11). The lower half of the cage was undamaged apart from scratches on two of the tie-down points. All twelve pallet screws were in place and appeared undamaged.

Figure 6: Side view

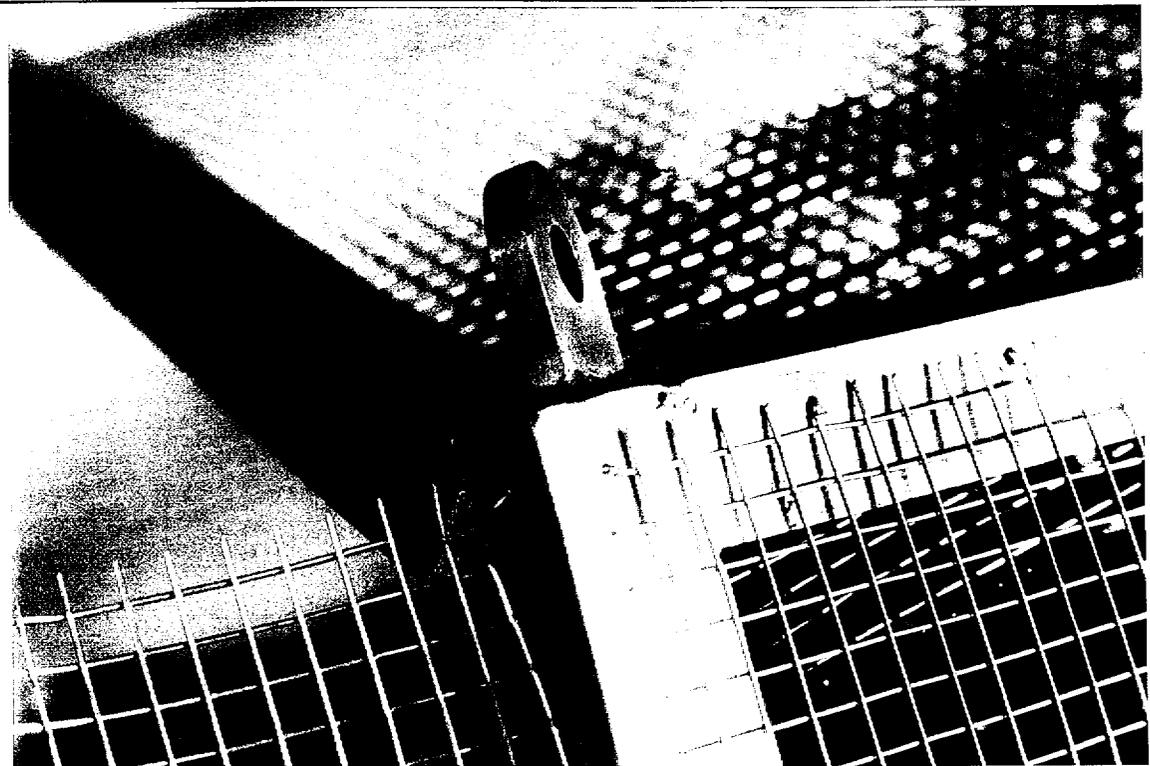
Figure 9: Split near cage weld and lifting point showing bruise

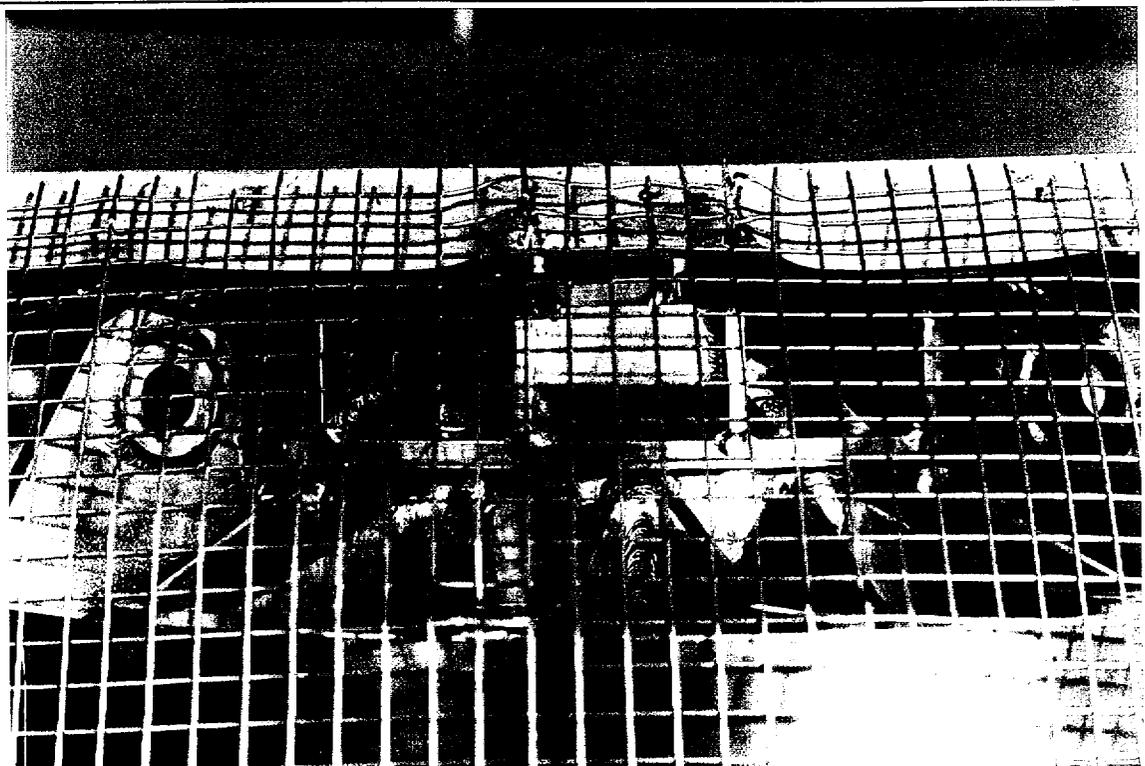
Figure 11: Indentation to cage cross member from closure fins

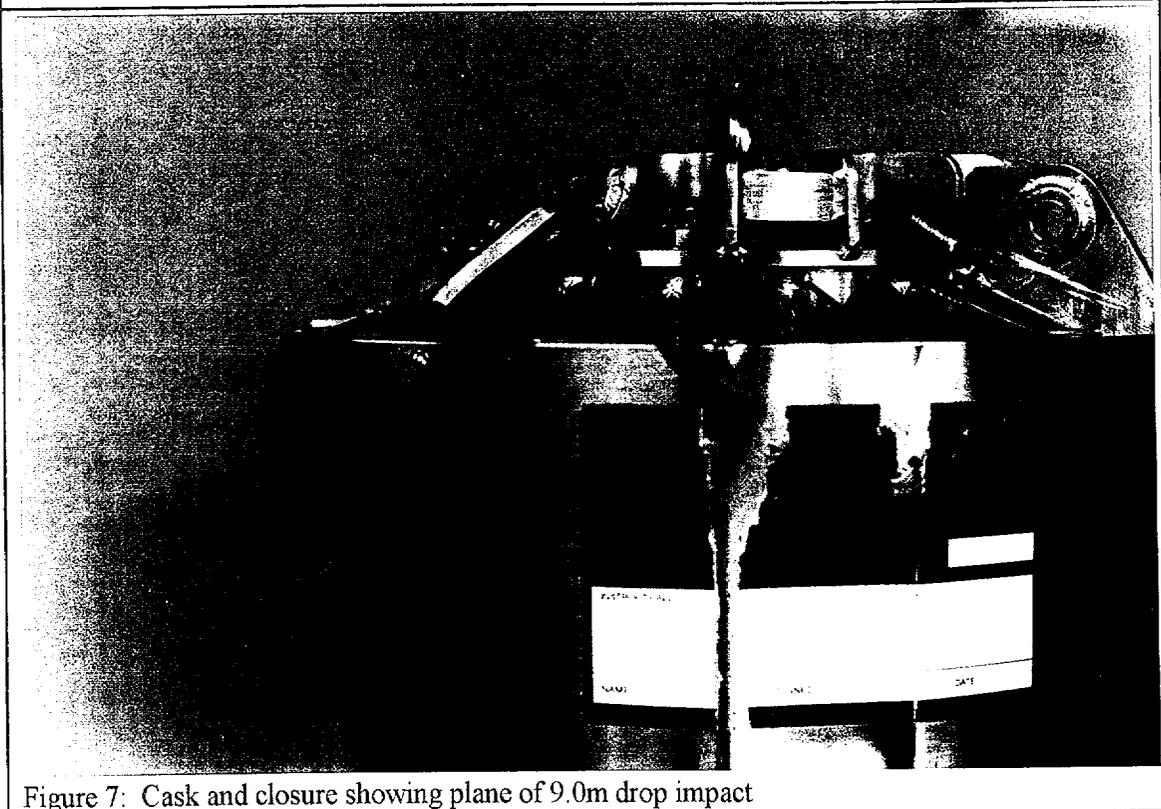
Figure 7: Cask and closure showing plane of 9.0m drop impact

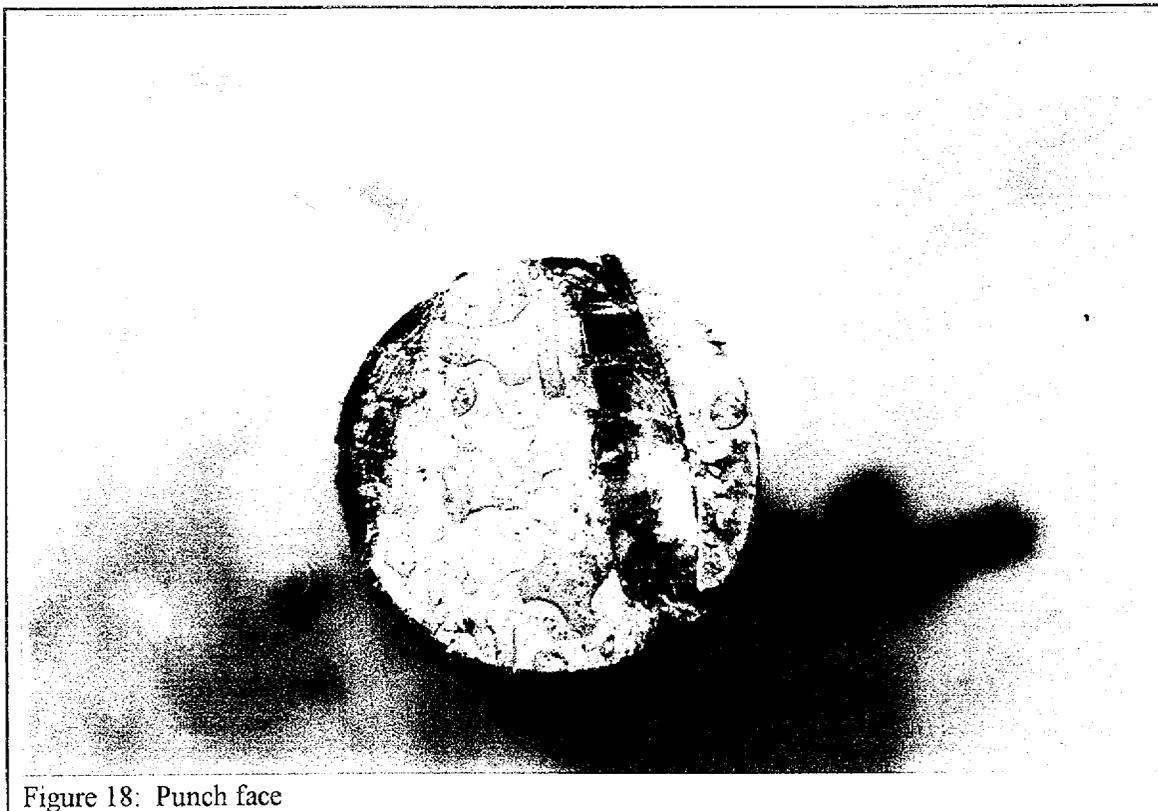
4.4.6 **Punch:** The punch carried two indentations from the cooling fins (figs 17 & 18) indicating a good impact.

Figure 18: Punch face

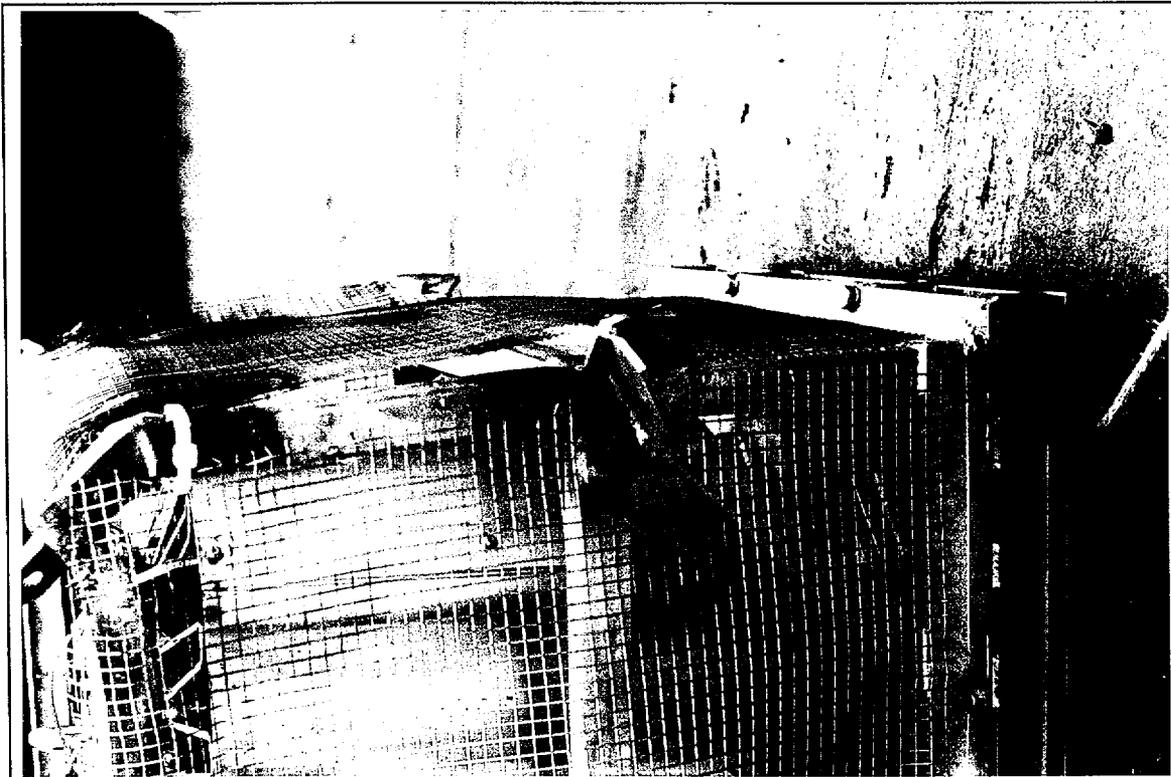
Figure 6: Cage impact face

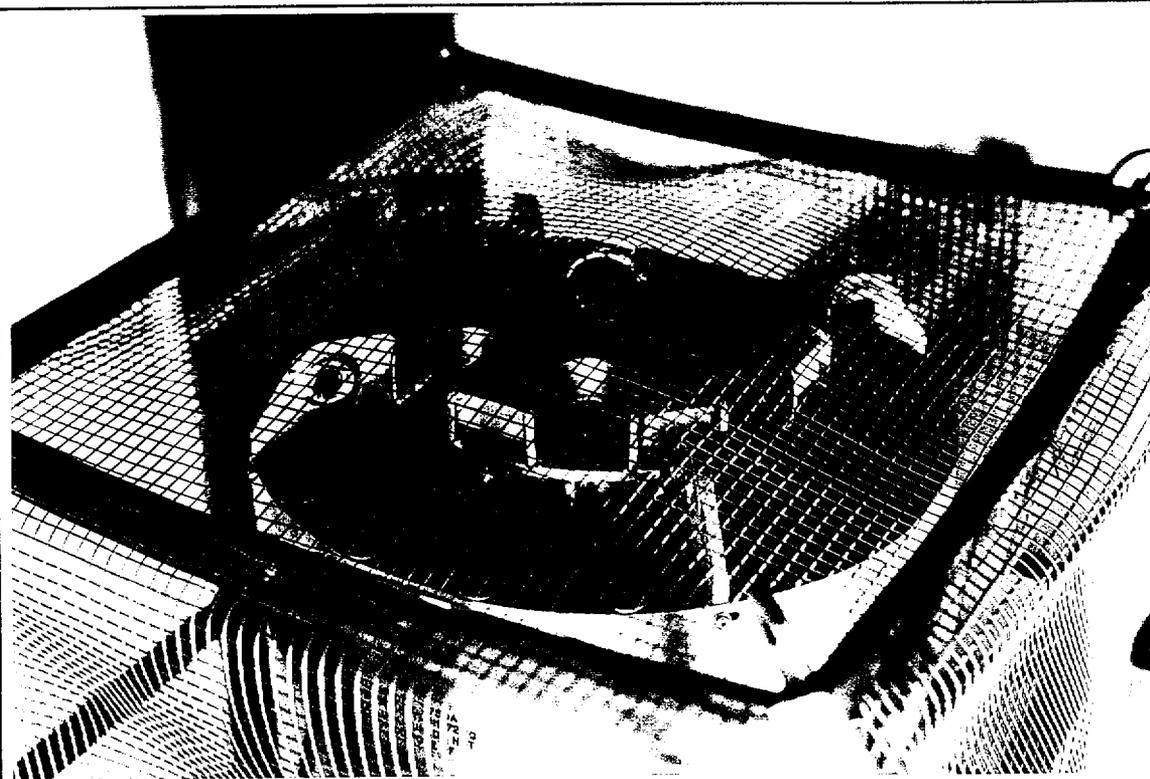
Figure 7: Closure and eyebolt

- 4.3.5 **Cask closure:** The closure, including the eyebolt, appeared undamaged (fig 7).

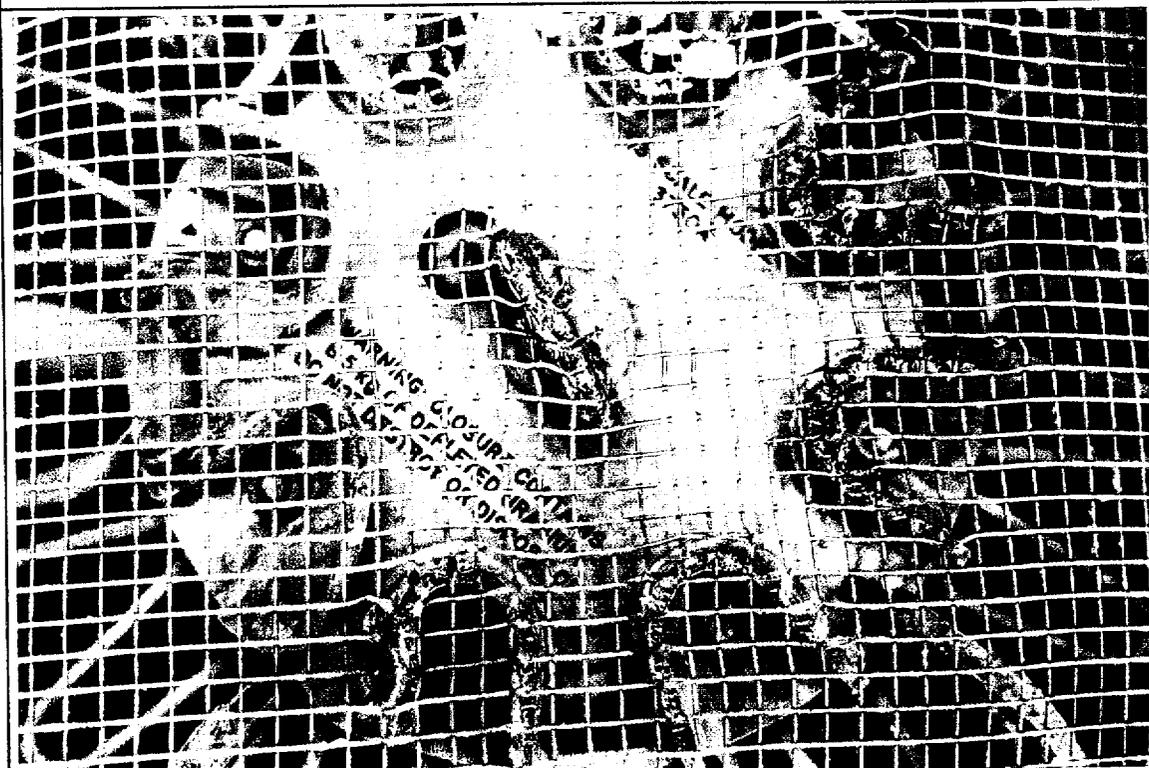
Figure 7: Closure from above

4.4.5 Cask closure: The central eyebolt was crushed onto its mounting boss (fig 7). The six shock absorbers remaining after Test 1904 were indented on their top edges with the pattern of the mesh. Other than this the closure appeared free from damage.

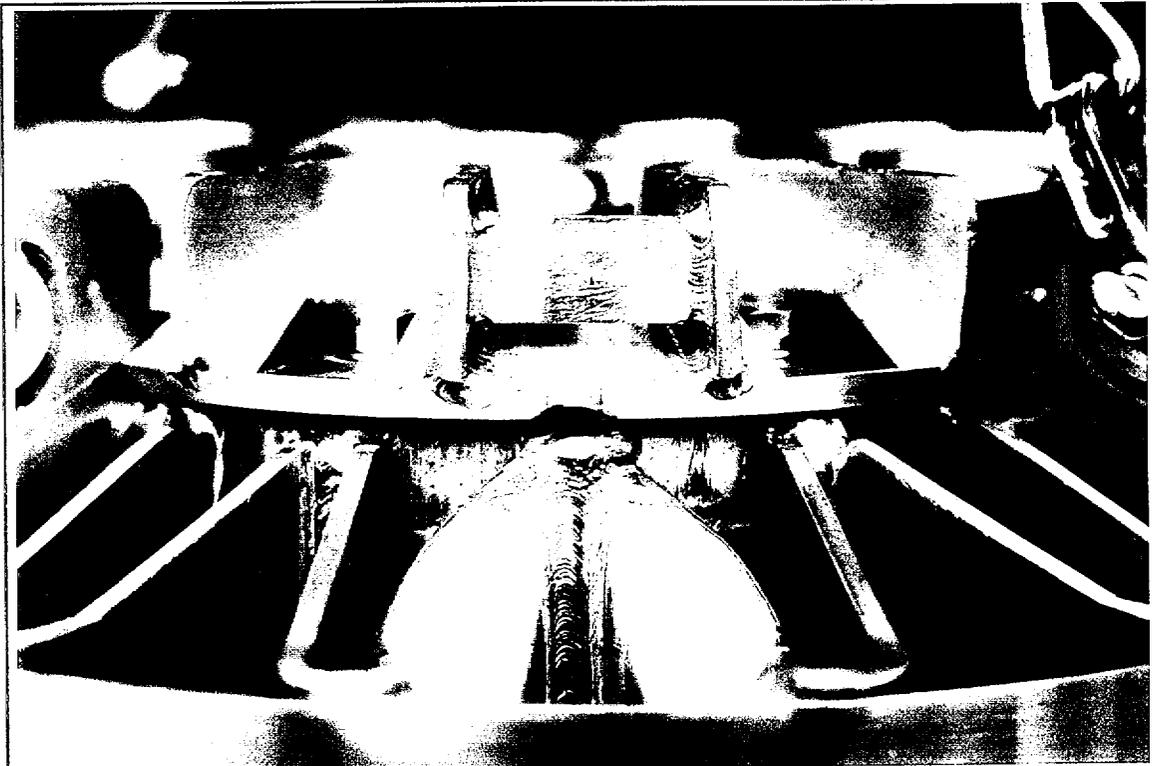
Figure 8: Cooling fin distortion

- 4.4.4 Cask body: The inner edges of the two fins hit by the punch were bent over away from each other (fig 8). There was no other damage to the cask body or jacket. All twelve jacket screws were secure, undamaged and unscrewed freely. All eight closure studs and nuts were secure, undamaged and unscrewed freely.

- 4.4.5 Cask closure: The closure disengaged freely from the body. It showed a small mark where the punch had just nicked it (fig 8). Otherwise it was completely undamaged by the punch. The 9.0m drop had crushed the central eyebolt down to a height of 12 mm (from 36 mm) onto its mounting boss (figs 9 & 10). The six shock absorbers undamaged from Test 1904 were indented on their top edges with the pattern of the mesh and crushed down to a height of 17 mm (from 20.4 mm). Other than this top of the closure was free from damage.
