SUBJECT: MEETING WITH EXELON REGARDING DRESDEN UNIT 2/3  
REACTOR BUILDING CRANE ISSUES

### May 23, 2001 Meeting Between NRC RIII and Exelon Generating Company Dresden Unit 2/3 Reactor Building Crane

Meeting with NRC  
Unit 2/3 Reactor Building Crane

Exelon Generation Company, LLC  
Dresden Nuclear Power Station  
May 23, 2001

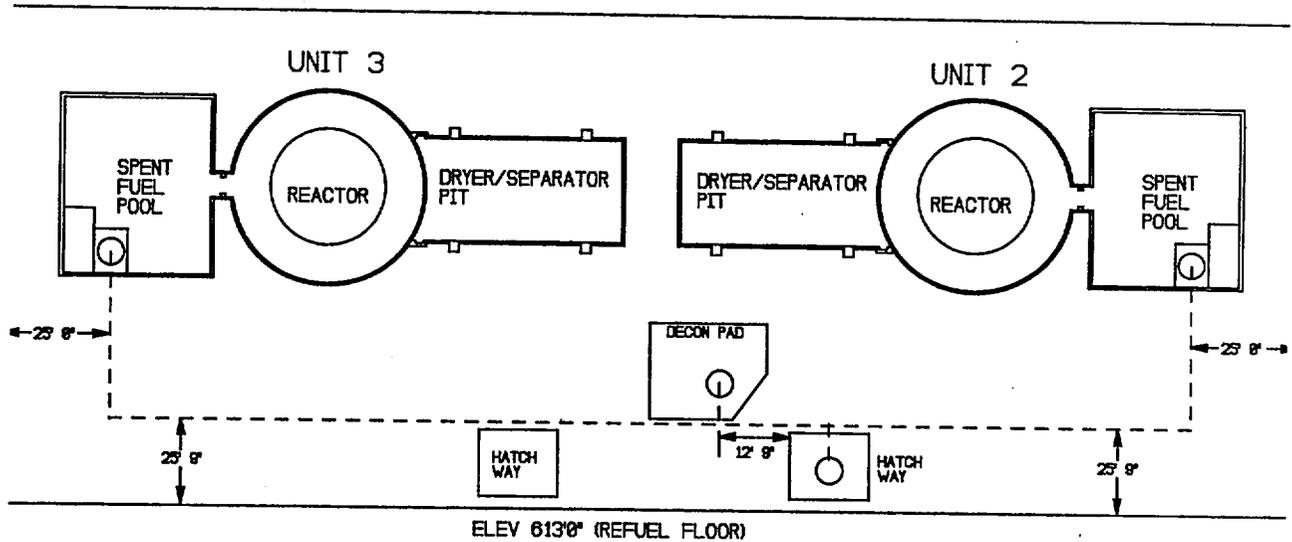
DRESDEN 2/3 REACTOR BUILDING REDUNDENT CRANE SYSTEM  
ALLOWABLE PATHWAY FOR RESTRICTED MODE

- Crane bridge and trolley movement is restricted to ensure the crane remains within a predefined pathway
- Governed by station procedures (DFP 0800-20 and DFP 0800-45)
  - Fuel cask handling above 545-foot level is “Restricted Mode”
  - Only permitted outside “Restricted Mode” in emergency or due to equipment failure to place the load in safe condition
- Reinforced by crane design
- Visual aid for crane operator
