Ref: University of California, Davis McClellan Nuclear Radiation Center (UCD/MNRC),  
Docket No. 50-607, Facility Operation License No. R-130

Subject: UCD/MNRC Annual Report for CY 2000

# 2000 ANNUAL REPORT

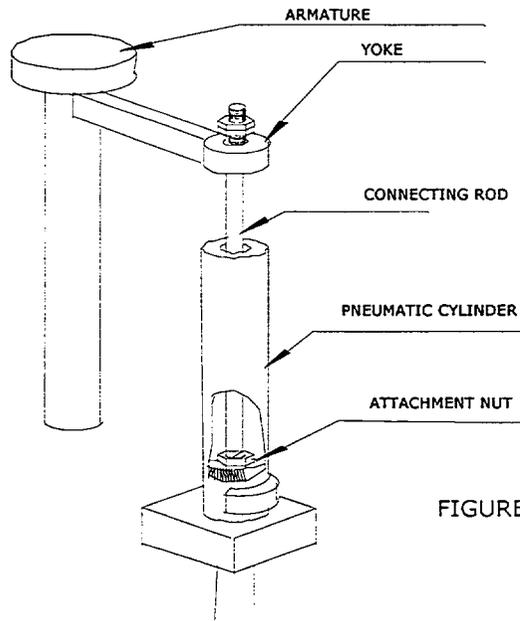
FIGURE 8

9. Operations personnel install a modified beam tube mask in the bay 4-beam tube (SOP 00-03).
10. During square wave testing and training, the transient rod's air cylinder connecting rod started to unthread and became loose. The connecting rod (**Figure 8**) attaches to the top of the pneumatic cylinder's piston and allows the control rod drive to raise the transient rod through a yoke assembly. This allows the transient rod to utilize the same rod drive mechanism as the other five control rods and still maintaining the capability of pulsing and square waving. Operations personnel disassembled the pneumatic cylinder and installed a lock washer at the attachment point of the connecting rod and the pneumatic cylinder piston. After reassembling the transient rod, operations personnel
