CENTRAL LABORATORIES SERVICES TECHNICAL REPORT	Report No.	95-1021
	Sheet No.:	1 of 2
	Date of Report:	JUN 19 1995
Plant/Project:	Watts Bar Nuclear Plant	
Subject:	ICE CONDENSER BASKET SCREWS	
Standards Used:	904694, 901387, 516825	
Copies Sent to:	Vonda Sisson, IOB 1M-WBN (4); RIMS; Lab Files	
Prepared by:	Daryl A. Smith / LAB	Approved by: <i>Deisa L. Frazier</i>

Ice Condenser Basket Screws, Watts Bar Nuclear Plant, Unit No. 1. Customer Identification No. 95-07, Laboratory Report No. 95-1021.

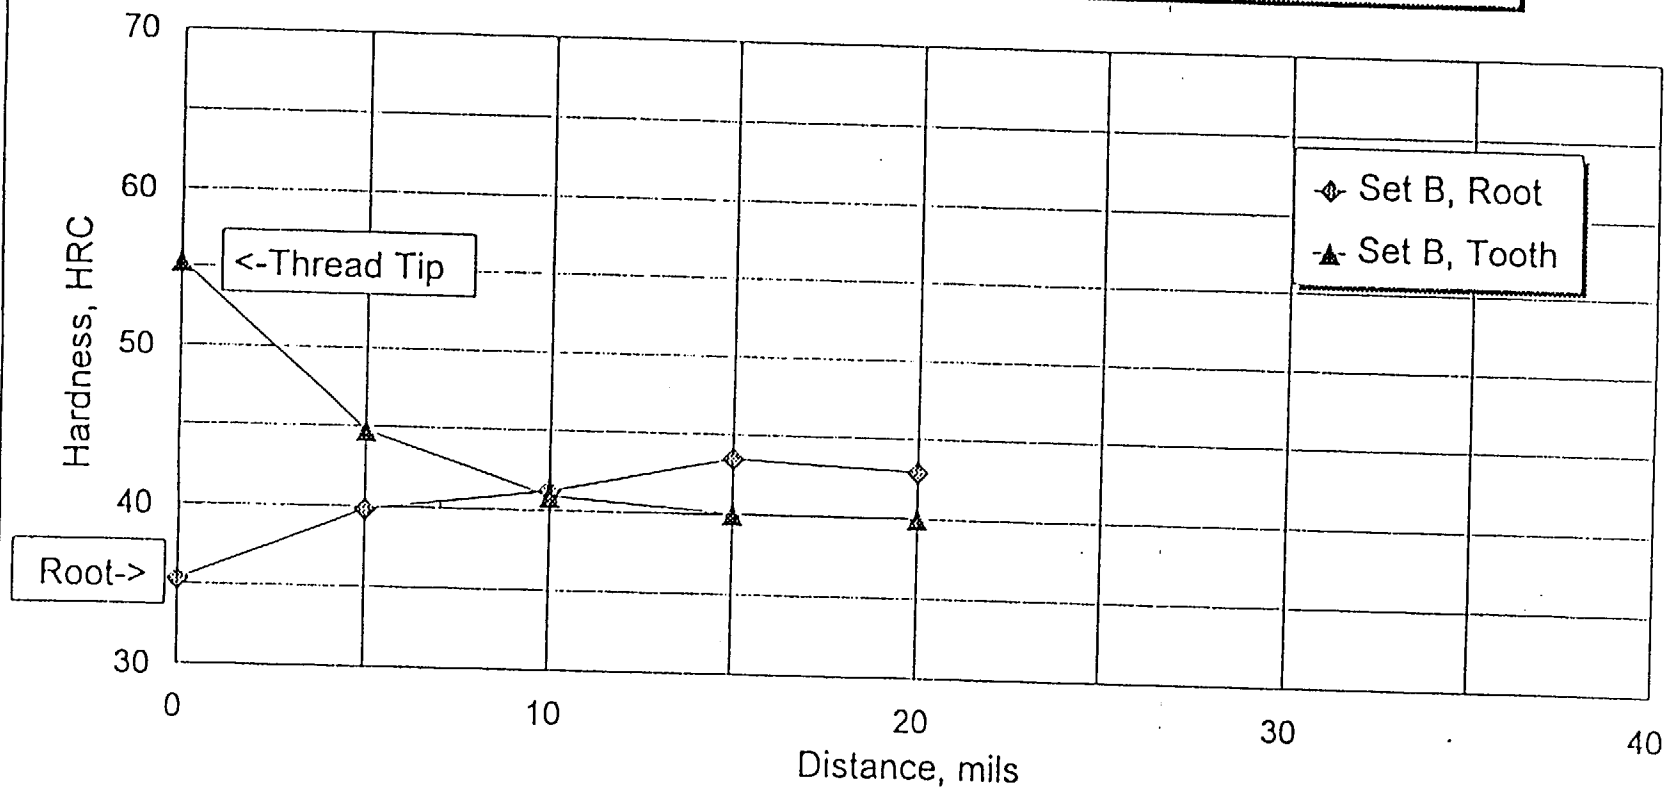
Figure 13 - Ice Condenser Basket Screws, Watts Bar Nuclear Plant, Unit No. 1. Customer Identification No. 95-07. Laboratory Report No. 95-1021.

New Screw (Set B) Hardness Traverses

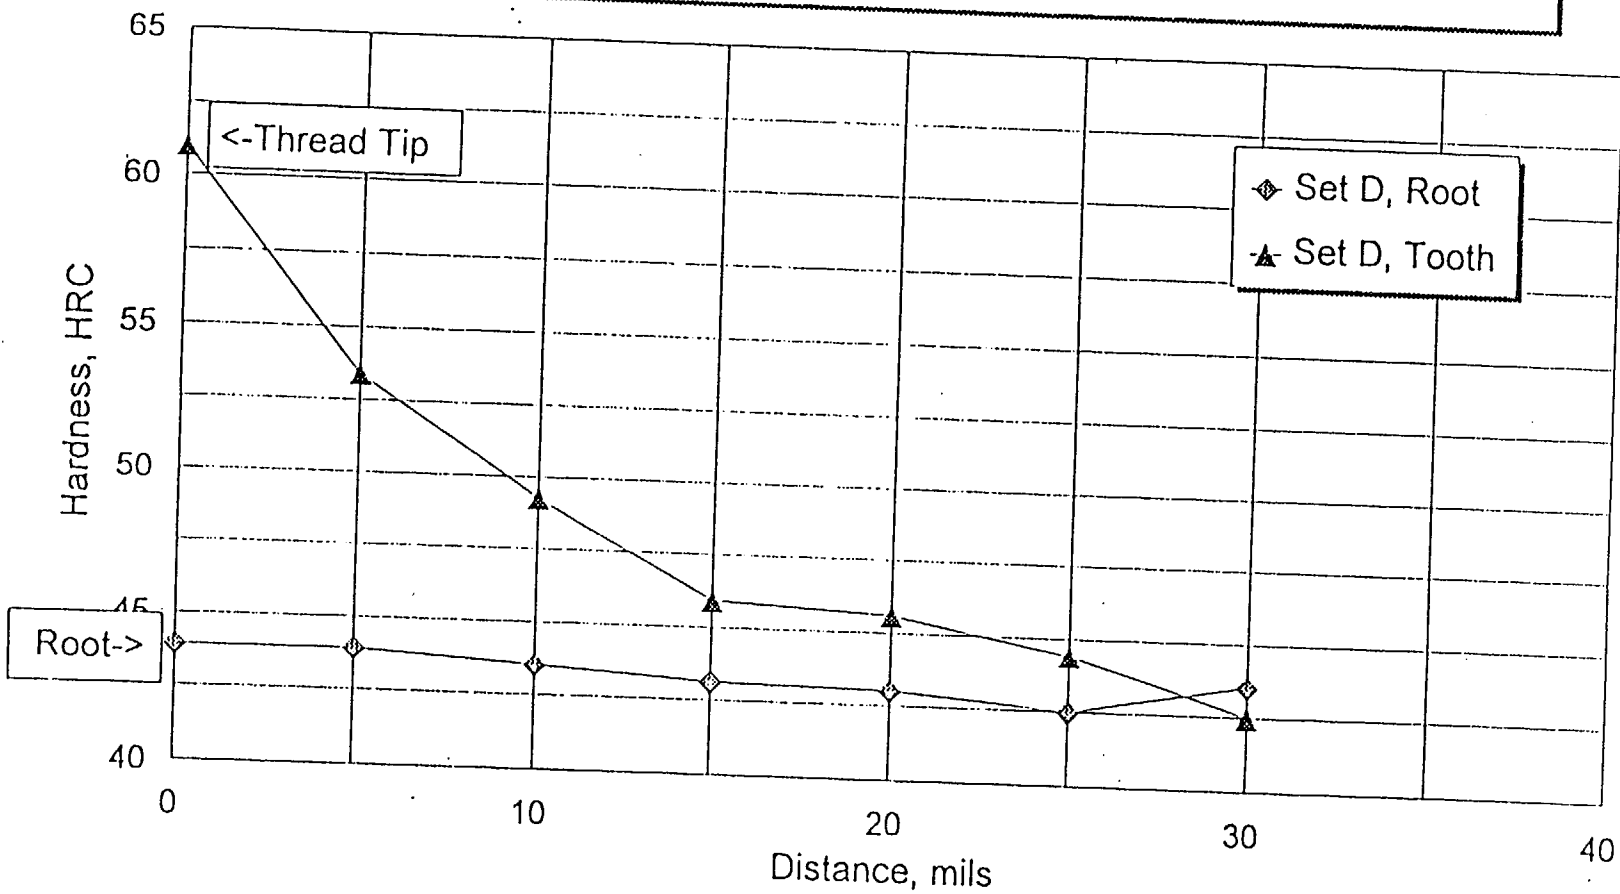
Figure 14 - Ice Condenser Basket Screws, Watts Bar Nuclear Plant, Unit No. 1. Customer Identification No. 95-07. Laboratory Report No. 95-1021.

Uncracked Screw (Set D) Hardness Traverses

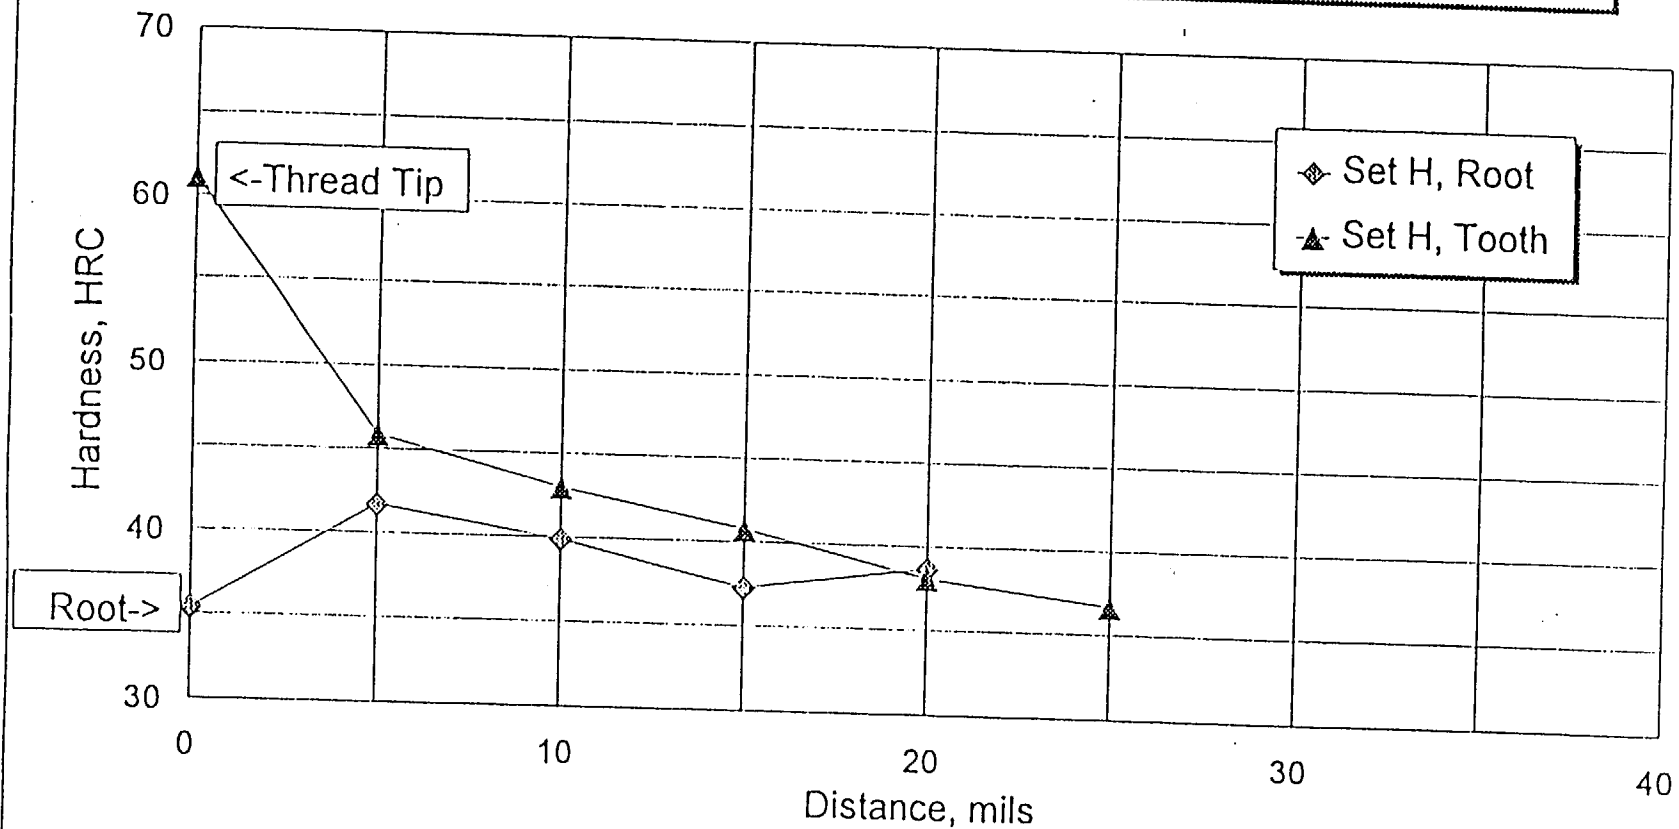
Figure 15 - Ice Condenser Basket Screws, Watts Bar Nuclear Plant, Unit No. 1. Customer Identification No. 95-07. Laboratory Report No. 95-1021.

Cracked Screw (Set H) Hardness Traverses

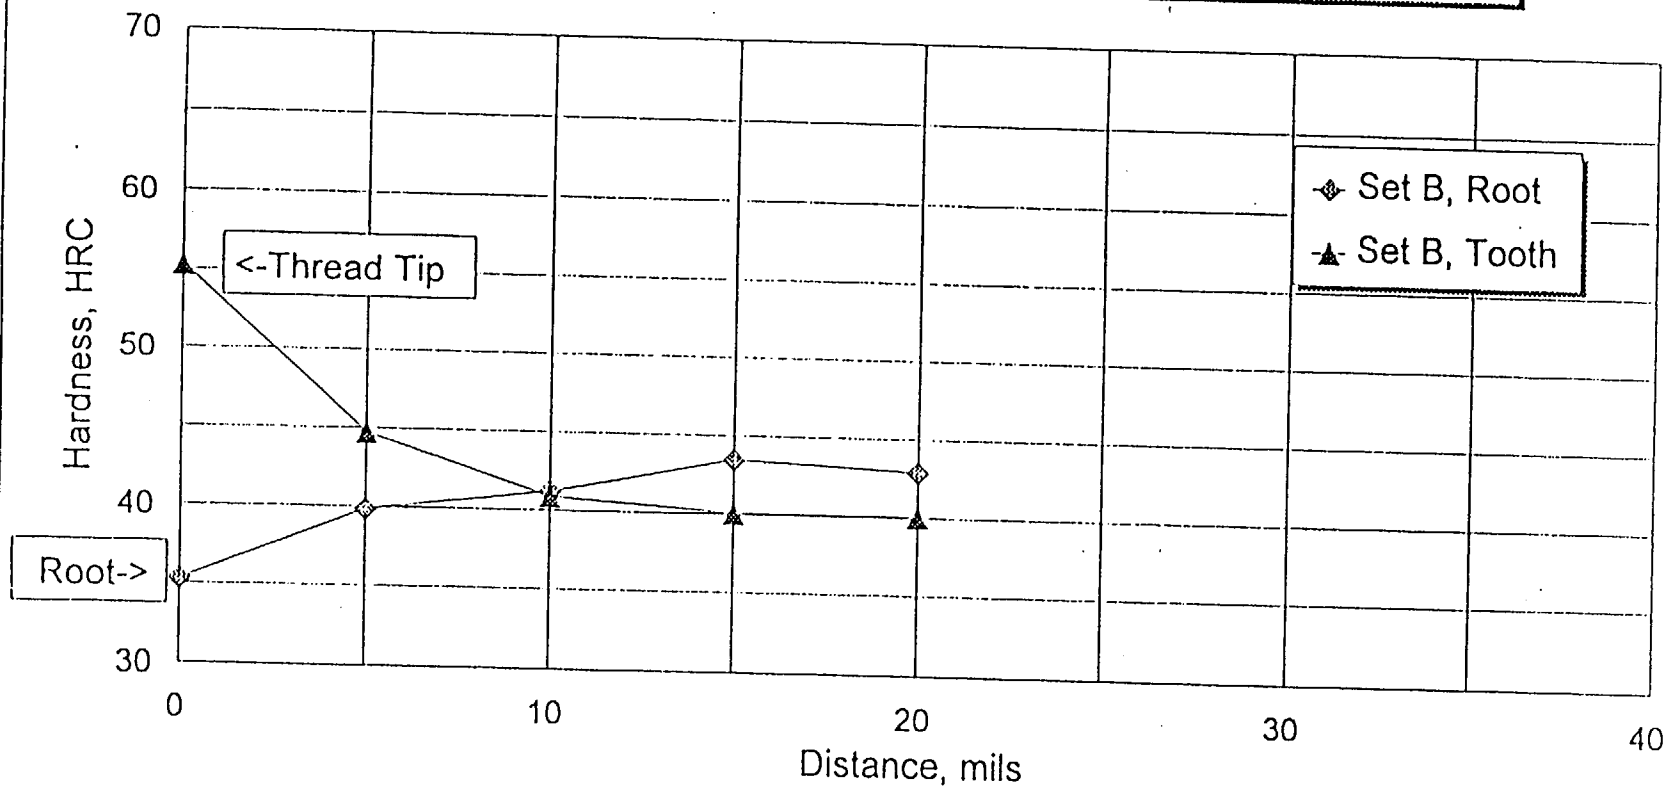
Figure 13 - Ice Condenser Basket Screws, Watts Bar Nuclear Plant, Unit No. 1. Customer Identification No. 95-07. Laboratory Report No. 95-1021.

New Screw (Set B) Hardness Traverses

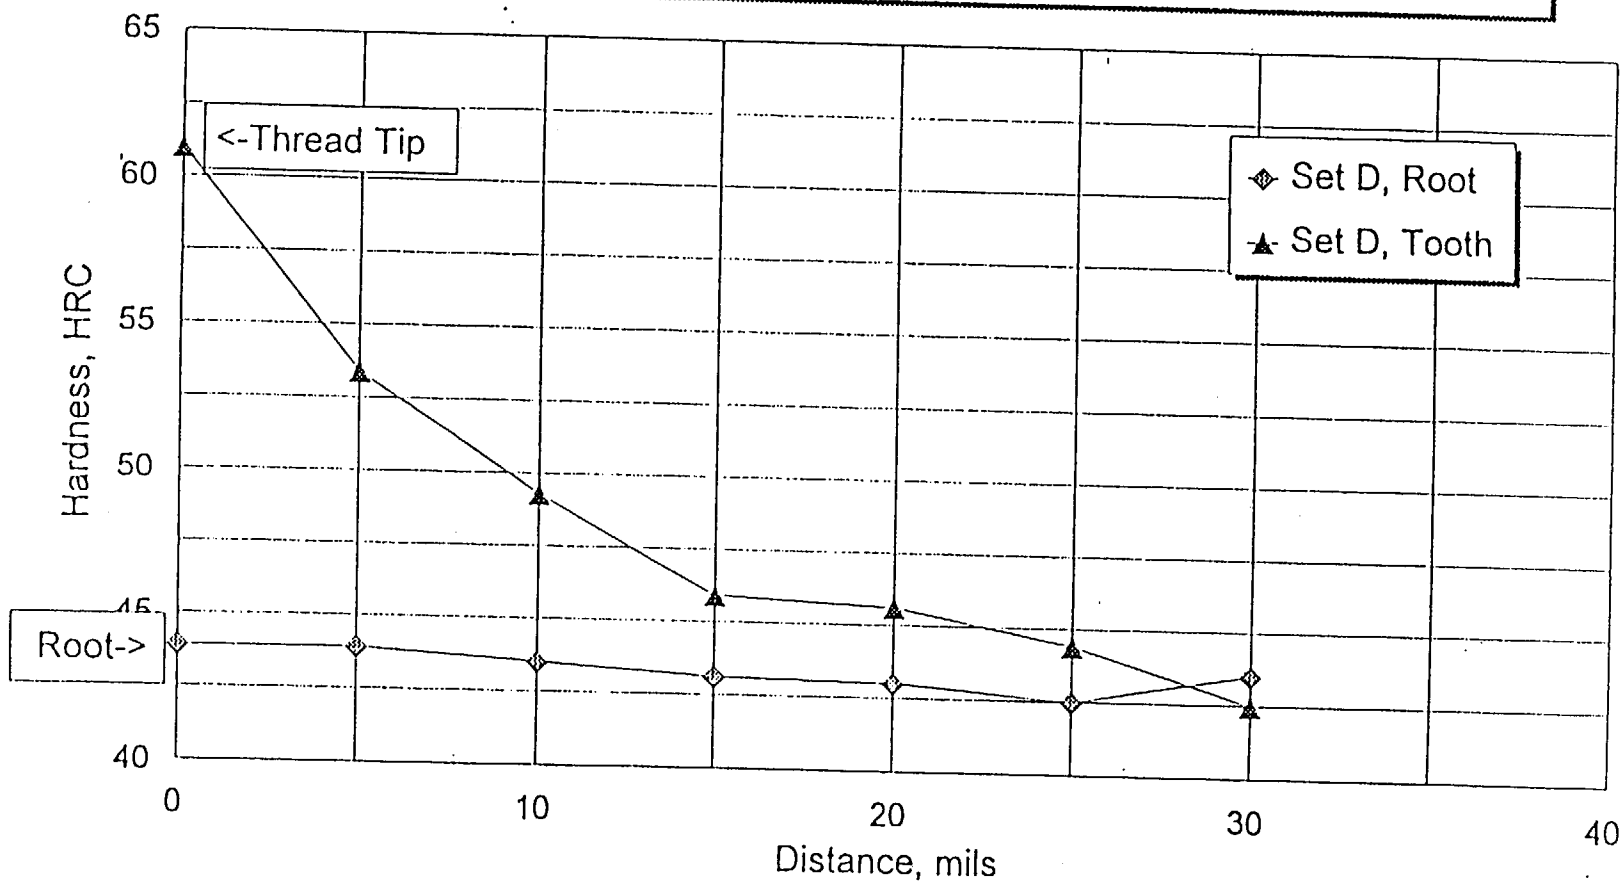
Figure 14 - Ice Condenser Basket Screws, Watts Bar Nuclear Plant, Unit No. 1. Customer Identification No. 95-07. Laboratory Report No. 95-1021.

Uncracked Screw (Set D) Hardness Traverses

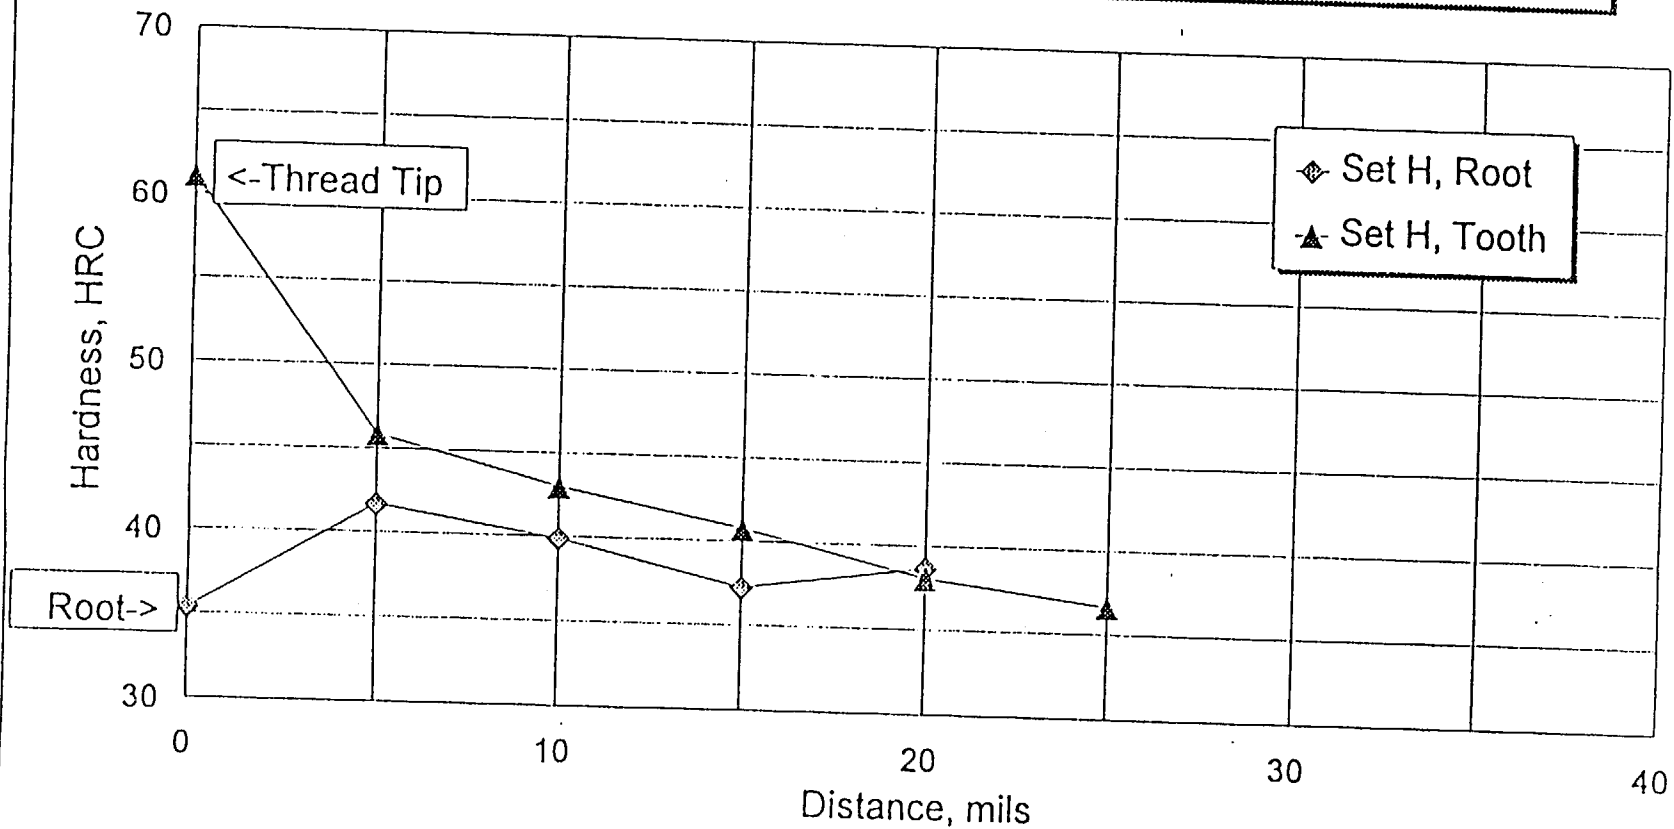
Figure 15 - Ice Condenser Basket Screws, Watts Bar Nuclear Plant, Unit No. 1. Customer Identification No. 95-07. Laboratory Report No. 95-1021.

Cracked Screw (Set H) Hardness Traverses

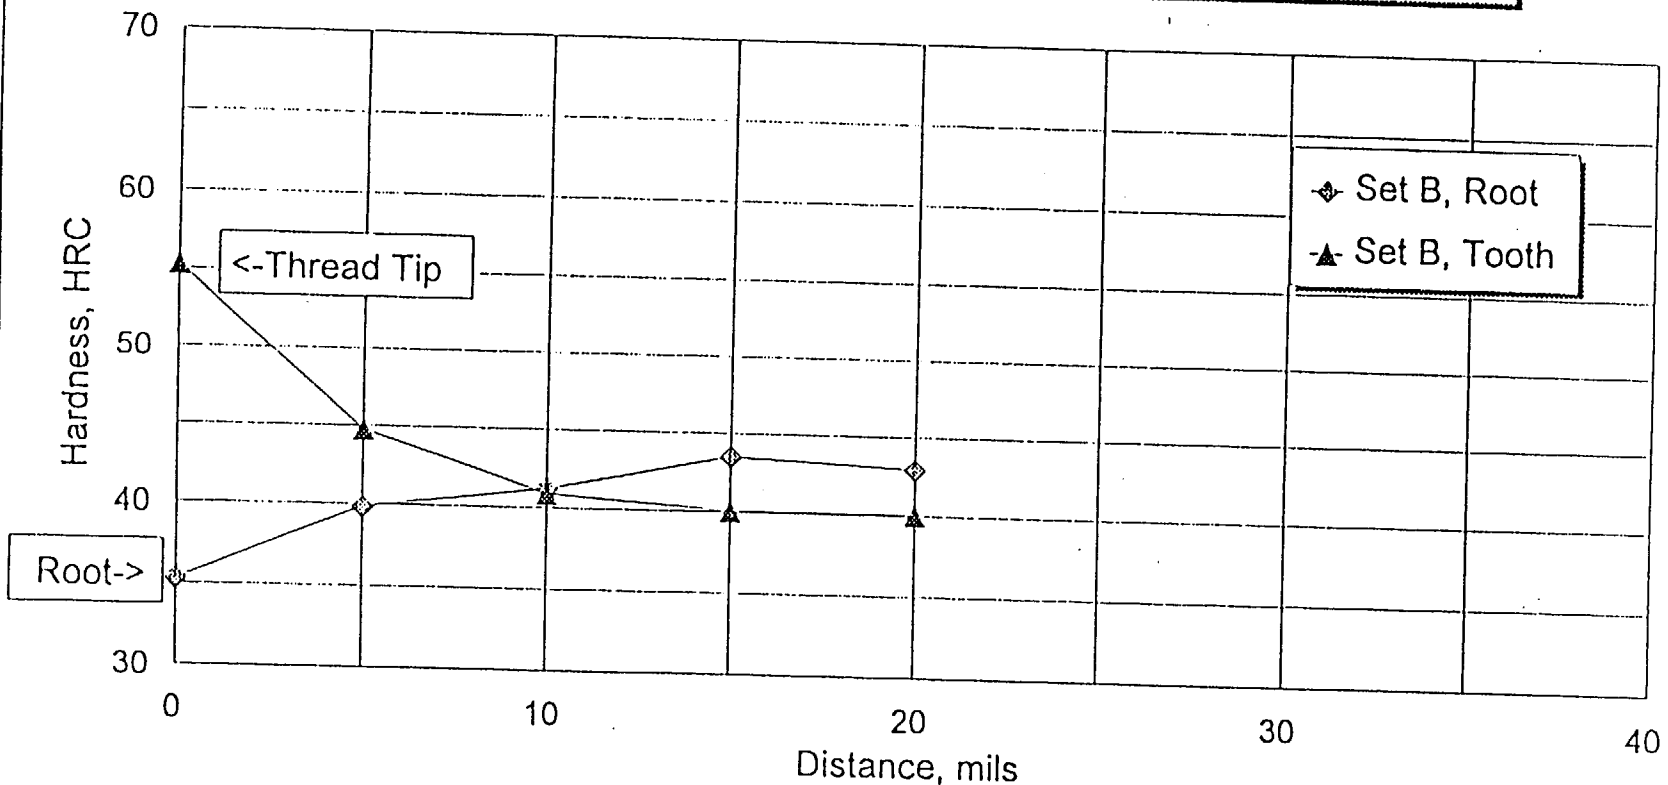
Figure 13 - Ice Condenser Basket Screws, Watts Bar Nuclear Plant, Unit No. 1. Customer Identification No. 95-07. Laboratory Report No. 95-1021.

New Screw (Set B) Hardness Traverses

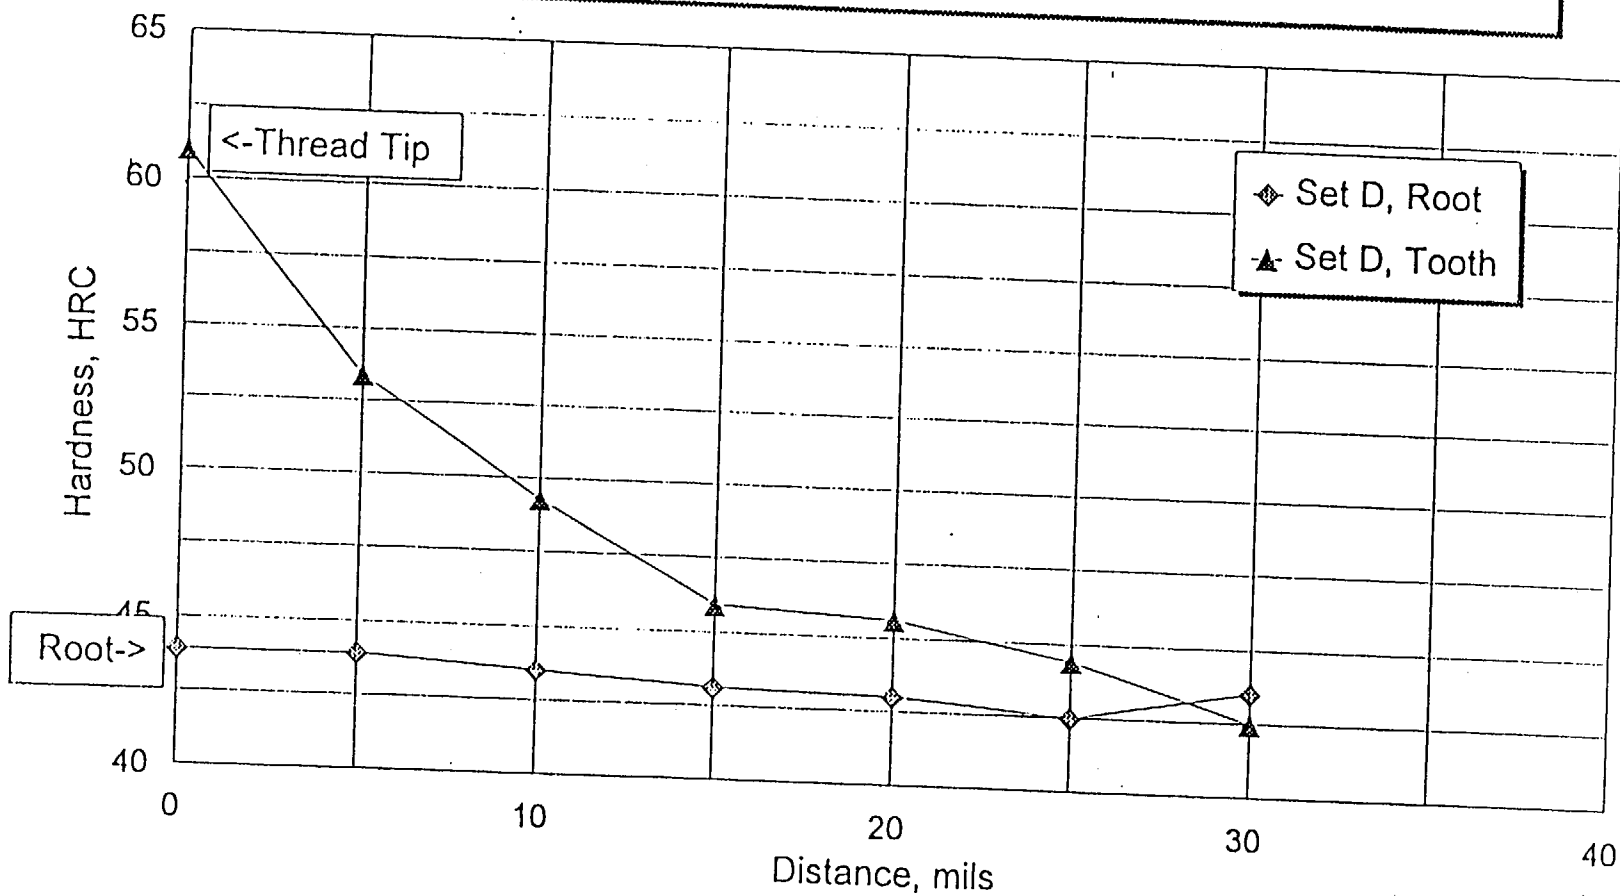
Figure 14 - Ice Condenser Basket Screws, Watts Bar Nuclear Plant, Unit No. 1. Customer Identification No. 95-07. Laboratory Report No. 95-1021.

Uncracked Screw (Set D) Hardness Traverses

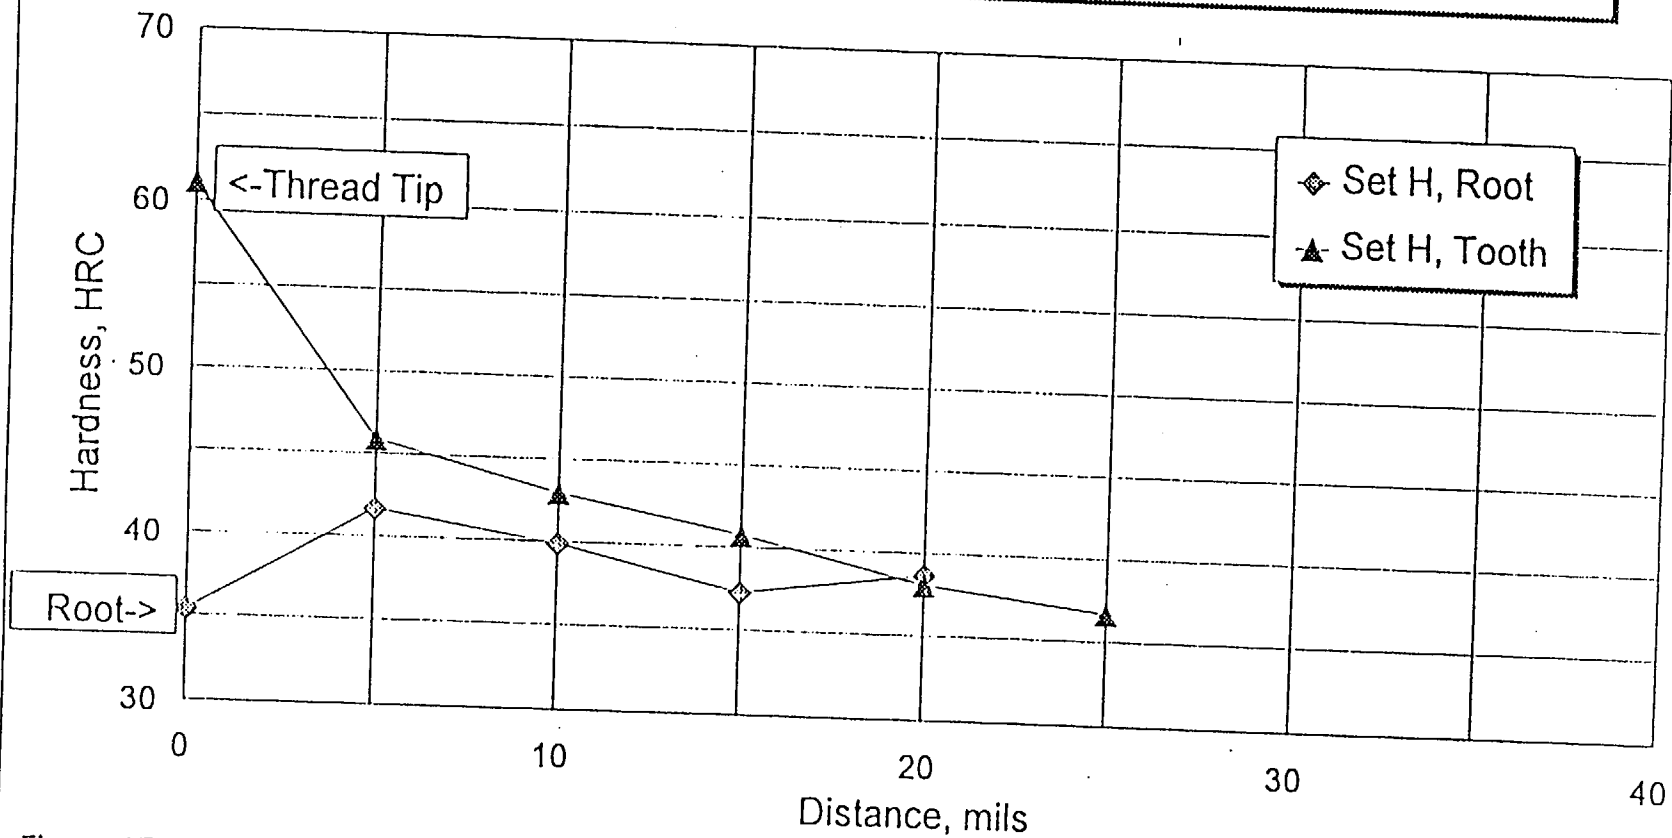
Figure 15 - Ice Condenser Basket Screws, Watts Bar Nuclear Plant, Unit No. 1. Customer Identification No. 95-07. Laboratory Report No. 95-1021.

Cracked Screw (Set H) Hardness Traverses
