CENTRAL L	ABORATORIES SERVICES	Report No. 95-1021			
	NUMBER DEPOST	Sheet No.: 1 of 2			
TECHNICAL REPORT		Date of Report: JUN 1 9 1995			
Plant/Project:	Watts Bar Nuclear Plant				
Subject:					
Standards Used:	904694, 901387, 516825				
Copies Sent to:	Vonda Sisson, IOB 1M-WBN (4); I	RIMS; Lab Files			
Prepared by:	Daryl A. Smith / LAB	Approved by: Delsa Z. Frazler

EXHIBIT _______ PAGE _____ OF 28_PAGE(S) Ice Condenser Basket Screws, Watts Bar Nuclear Plant, Unit No. 1. Customer Identification No. 95-07, Figure 1: Laboratory Report No. 95-1021.

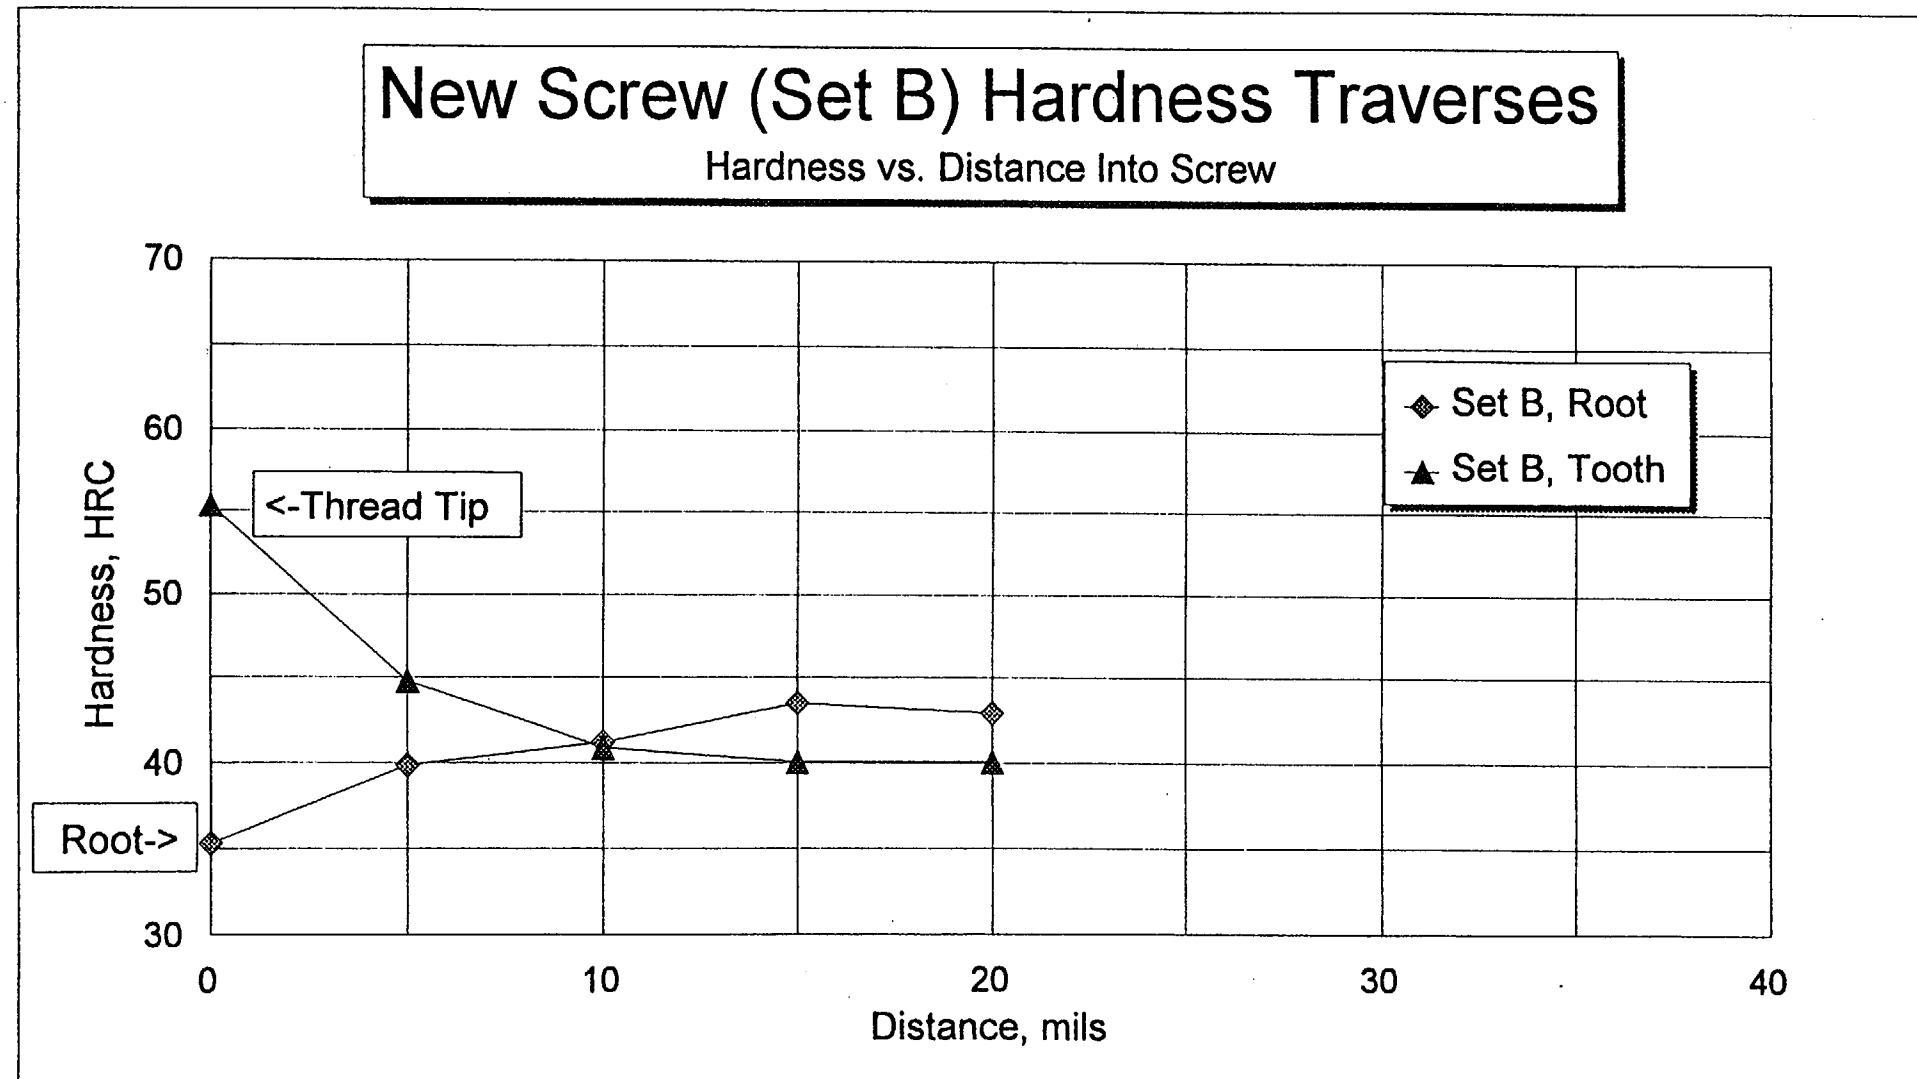
Figure 12: Ice Condenser Basket Screws, Watts Bar Nuclear Plant, Unit No. 1. Customer Identification No. 95-07, Laboratory Report No. 95-1021.

The general microstructure of representative screws from each set was determined to be tempered martensite (see Figures 10 and 11). Note in Figure 12 that slack-quenched areas consisting of ferrite networks on prior-austenite grain boundaries in a matrix of intermediate transformation products was discovered near the thread roots of four new screws from set "B" and one screw from set "H". The screw samples from set "G" were destroyed for other testing and could not be checked for the presence of the slack-quenched microstructure.
