Case No. 2-1998-023

CENTRAL LABORATORIES SERVICES TECHNICAL REPORT	Report No. 95-1021
	Sheet No.: 1 of 2
	Date of Report: JUN 19 1995
Plant/Project: Watts Bar Nuclear Plant	
Subject: ICE CONDENSER BASKET SCREWS	
Standards Used: 904694, 901387, 516825	
Copies Sent to: Vonda Sisson, IOB 1M-WBN (4); RIMS; Lab Files	
Prepared by: Daryl A. Smith / LAB	Approved by: <i>Delsa L. Frazier</i>

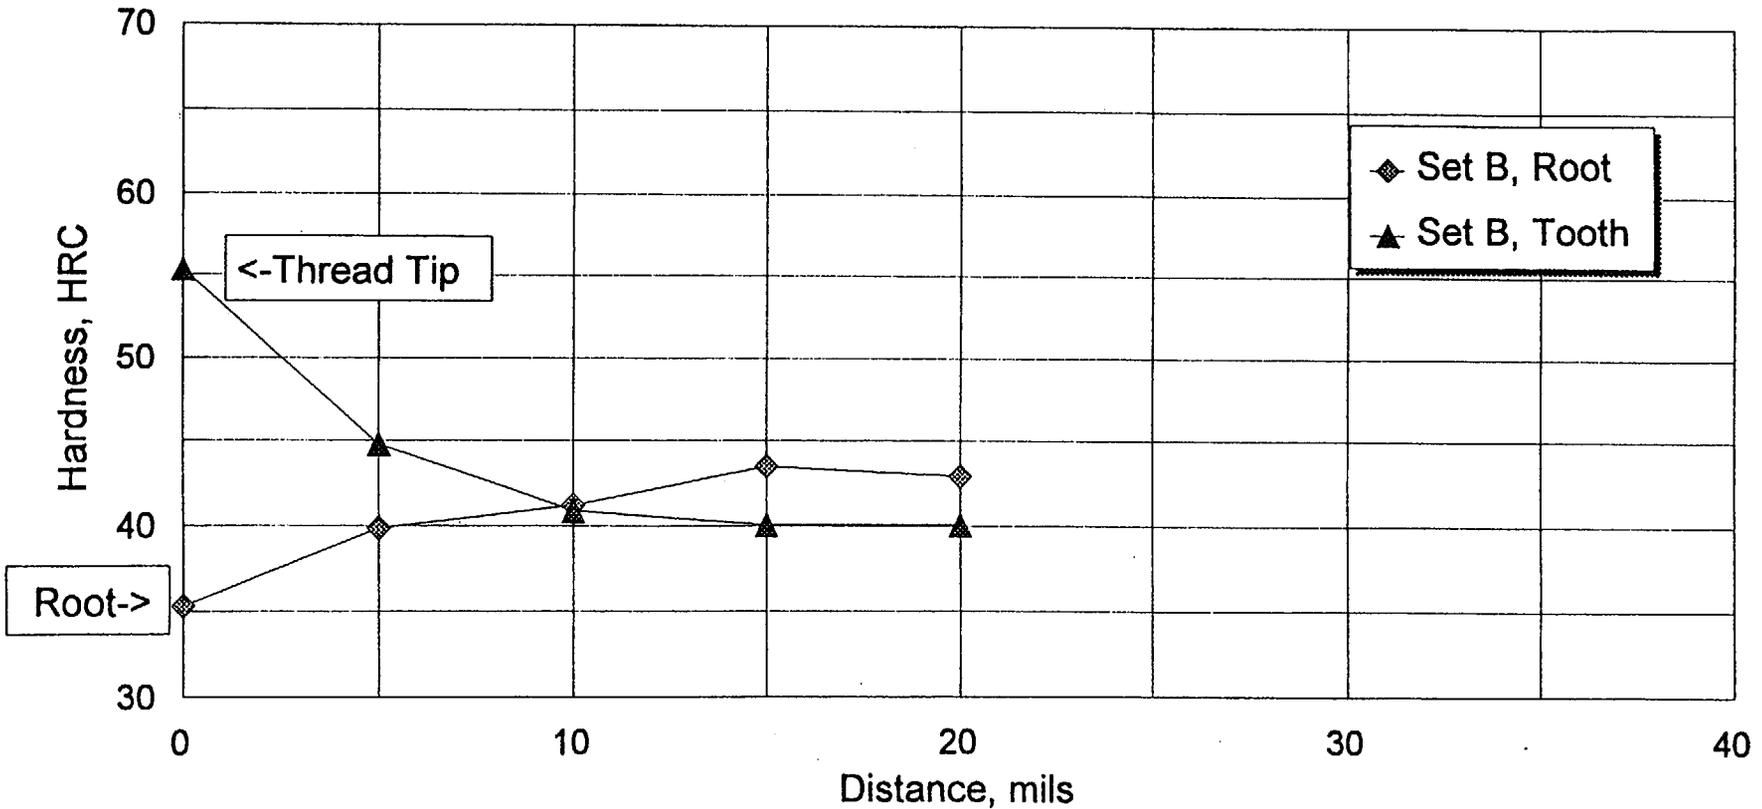
Figure 13 - Ice Condenser Basket Screws, Watts Bar Nuclear Plant, Unit No. 1. Customer Identification No. 95-07. Laboratory Report No. 95-1021.

New Screw (Set B) Hardness Traverses

Hardness vs. Distance Into Screw

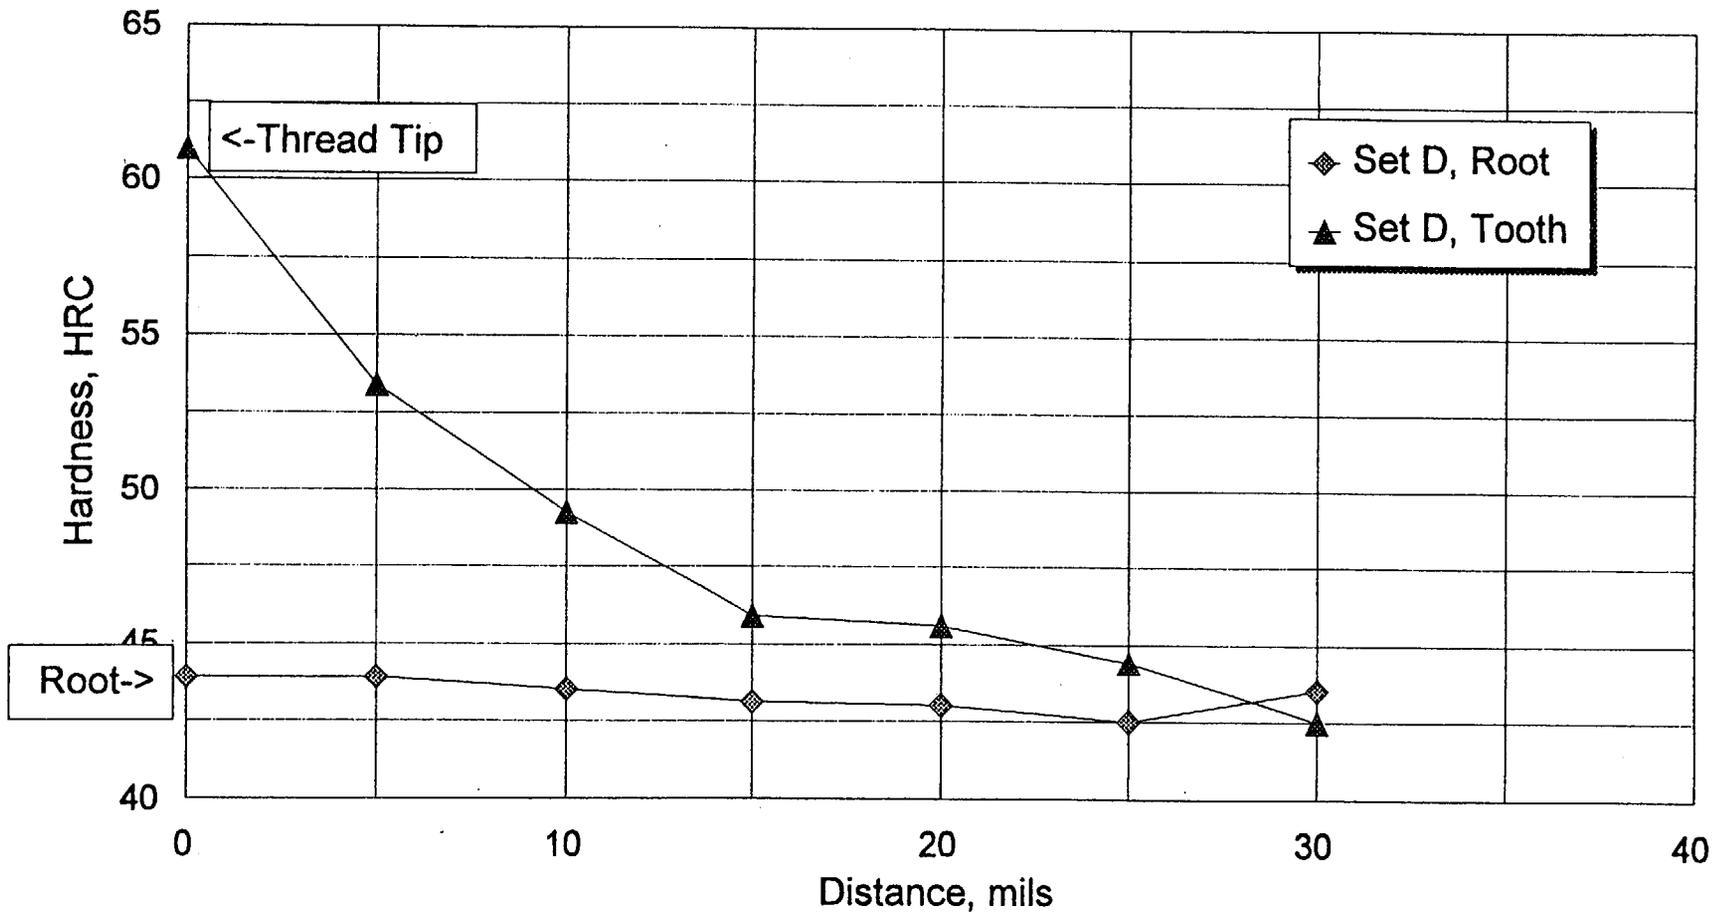
Figure 14 - Ice Condenser Basket Screws, Watts Bar Nuclear Plant, Unit No. 1. Customer Identification No. 95-07. Laboratory Report No. 95-1021.

Uncracked Screw (Set D) Hardness Traverses

Hardness vs. Distance Into Screw

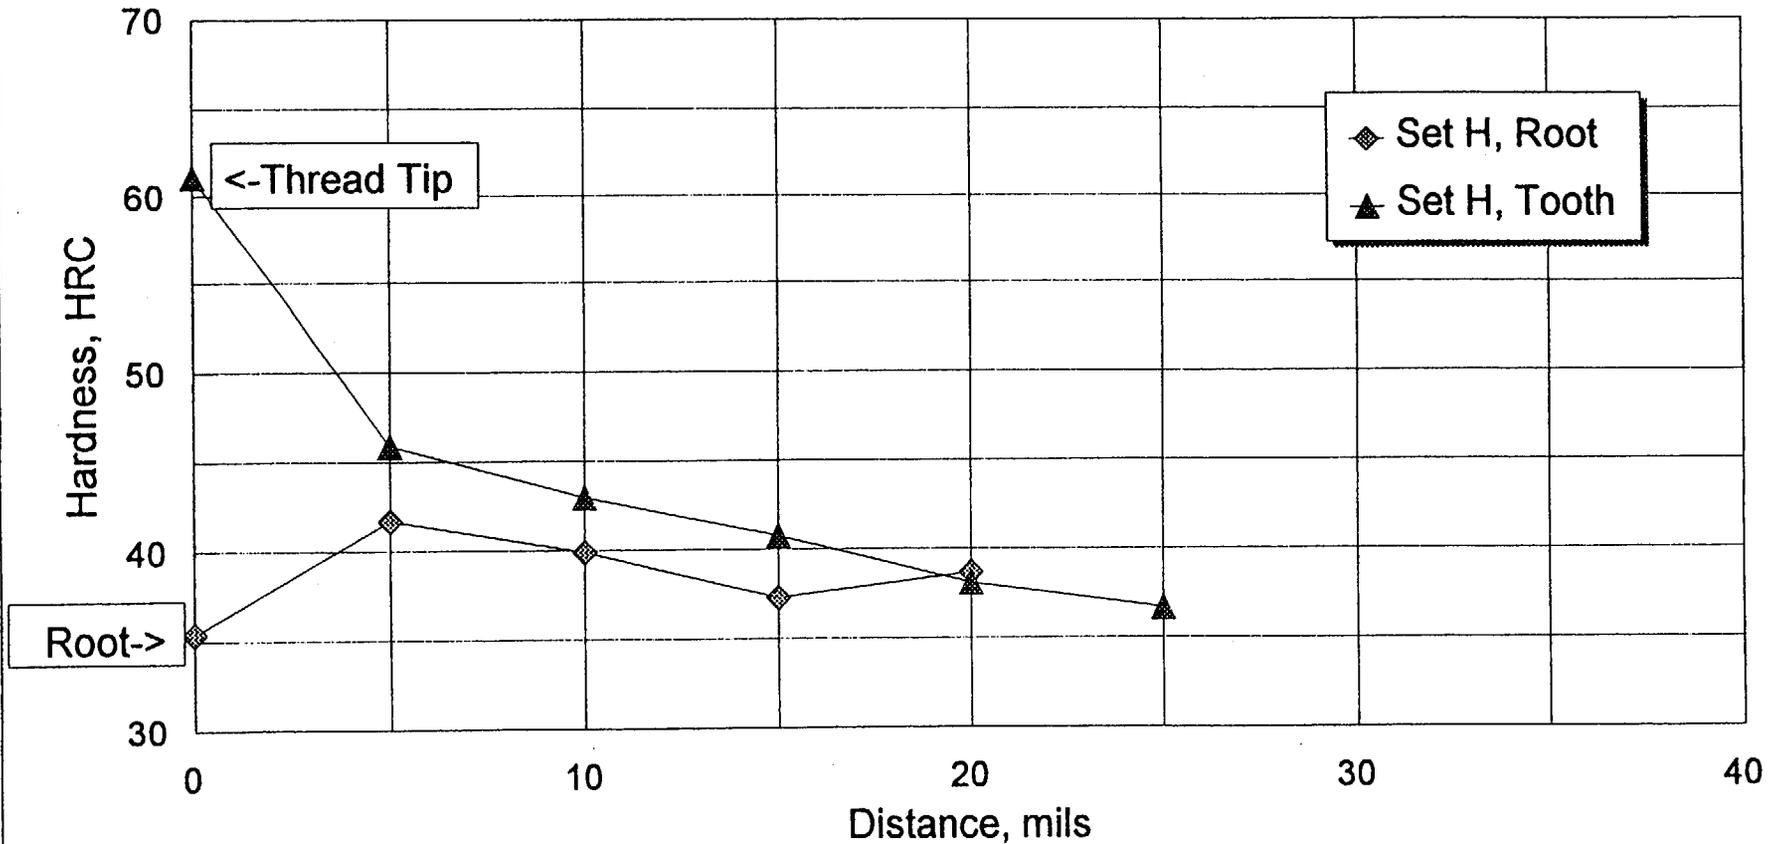
Figure 15 - Ice Condenser Basket Screws, Watts Bar Nuclear Plant, Unit No. 1. Customer Identification No. 95-07. Laboratory Report No. 95-1021.

Cracked Screw (Set H) Hardness Traverses

Hardness vs. Distance Into Screw

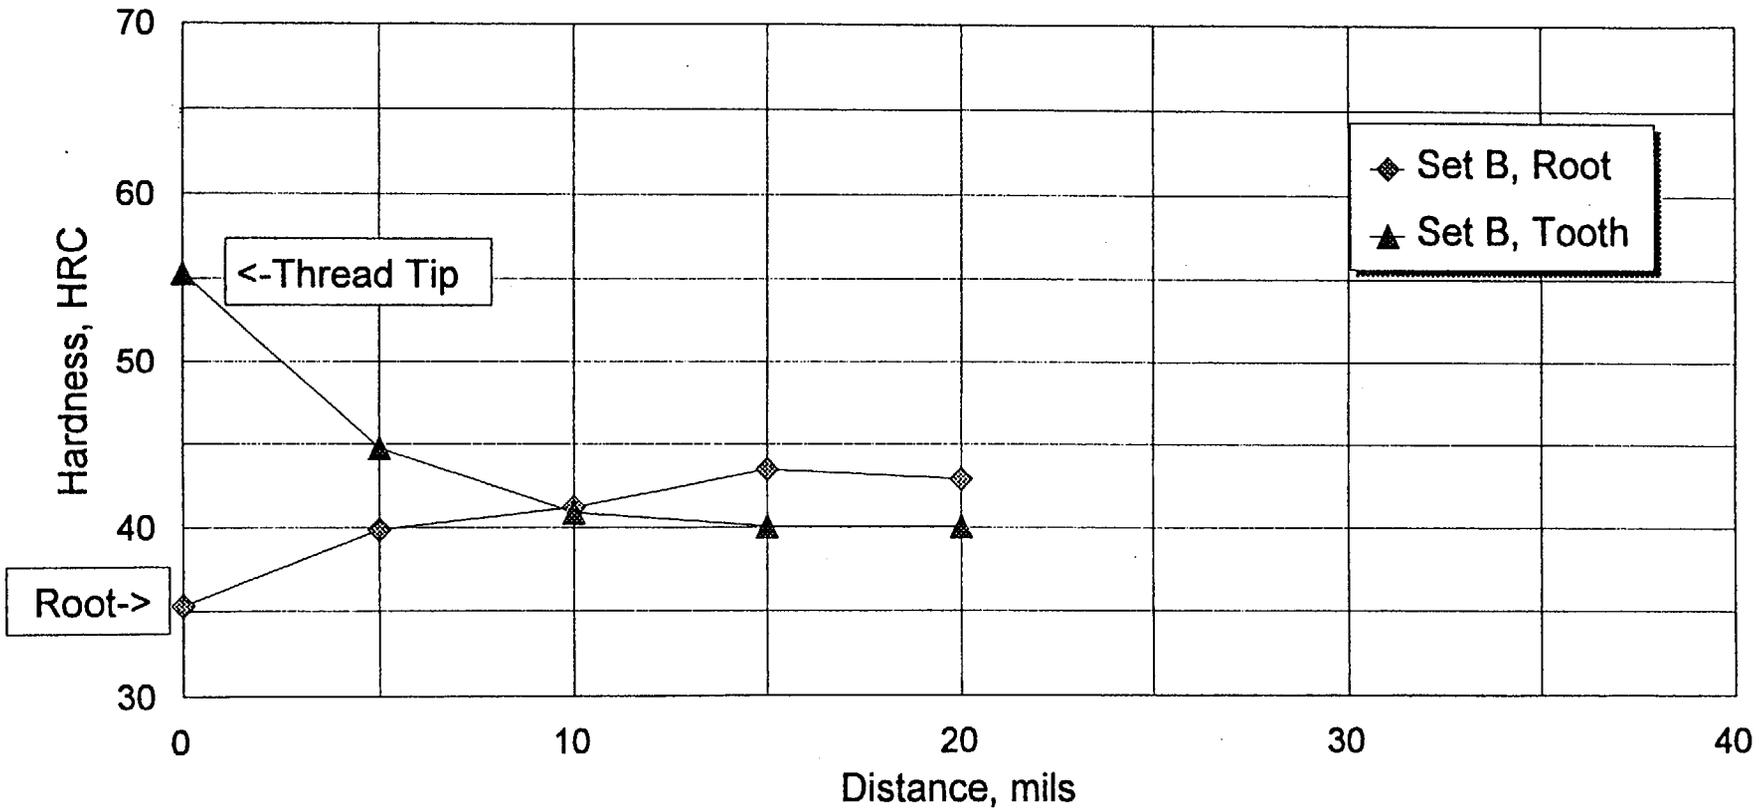
Figure 13 - Ice Condenser Basket Screws, Watts Bar Nuclear Plant, Unit No. 1. Customer Identification No. 95-07. Laboratory Report No. 95-1021.

New Screw (Set B) Hardness Traverses

Hardness vs. Distance Into Screw

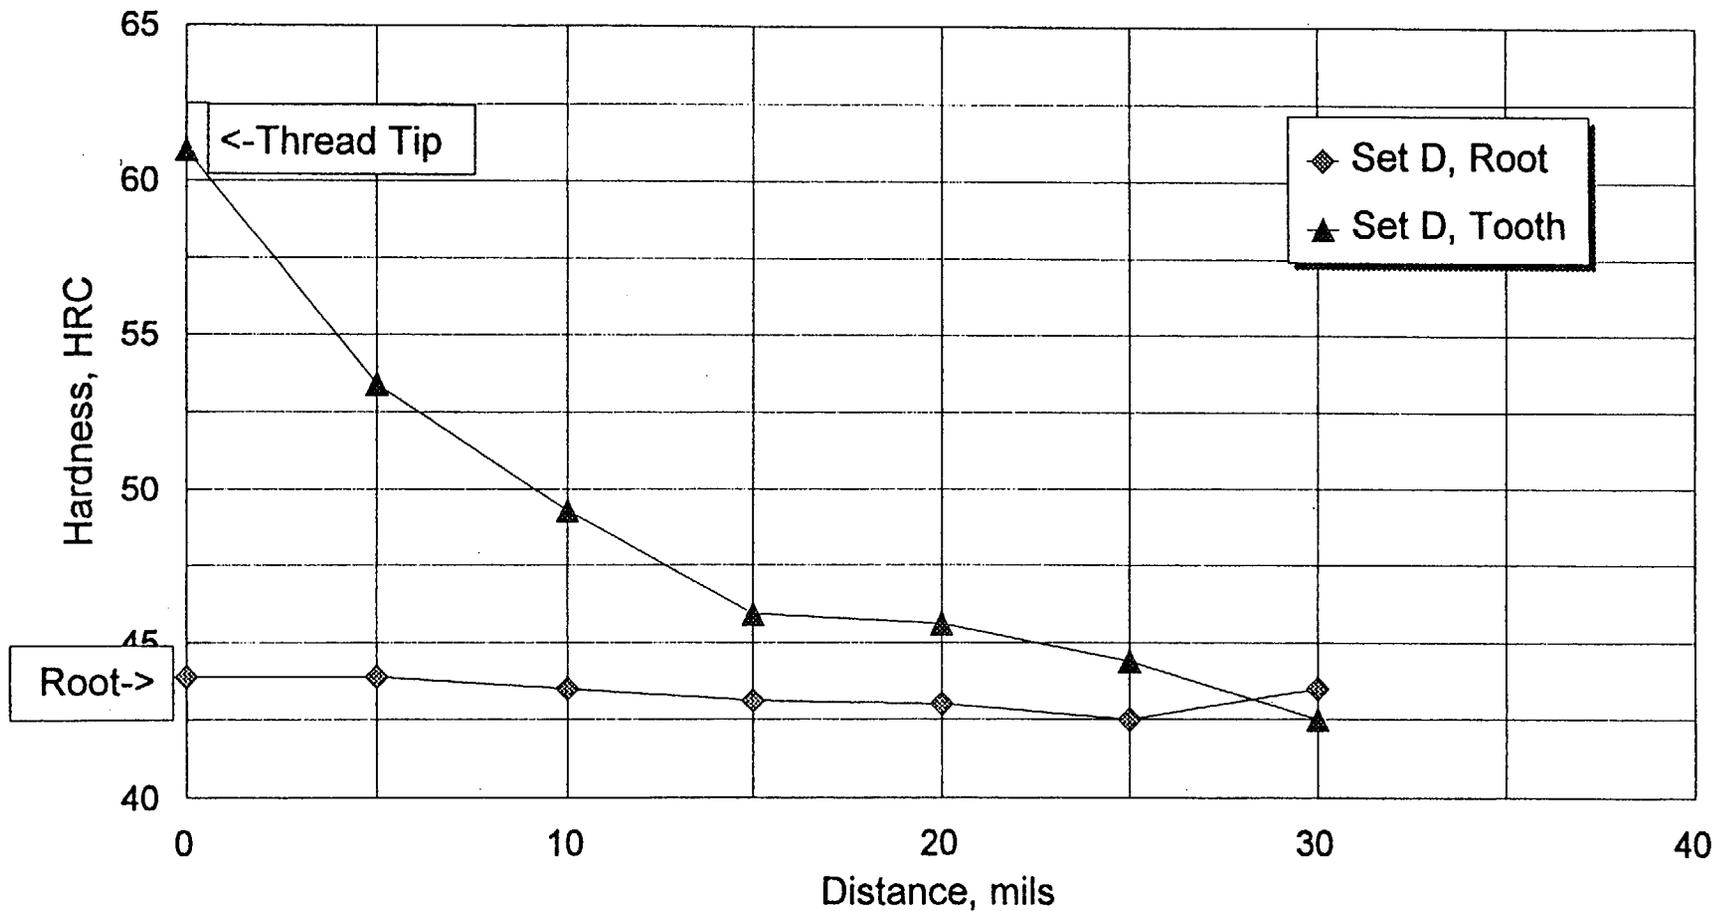
Figure 14 - Ice Condenser Basket Screws, Watts Bar Nuclear Plant, Unit No. 1. Customer Identification No. 95-07. Laboratory Report No. 95-1021.

Uncracked Screw (Set D) Hardness Traverses

Hardness vs. Distance Into Screw

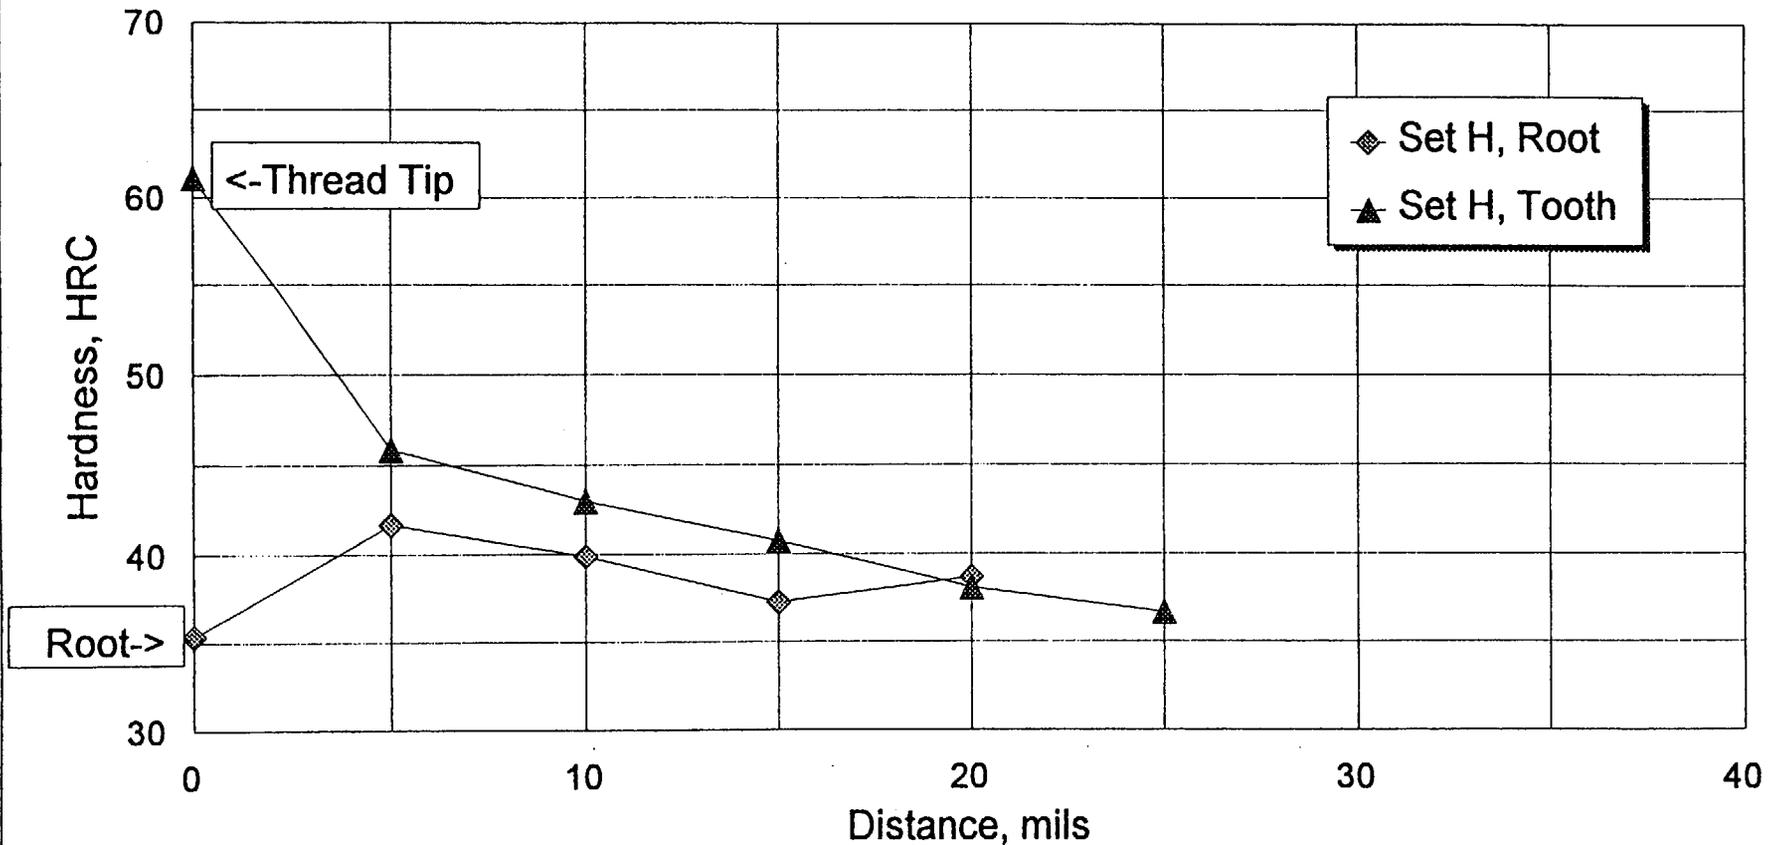
Figure 15 - Ice Condenser Basket Screws, Watts Bar Nuclear Plant, Unit No. 1. Customer Identification No. 95-07. Laboratory Report No. 95-1021.

Cracked Screw (Set H) Hardness Traverses

Hardness vs. Distance Into Screw

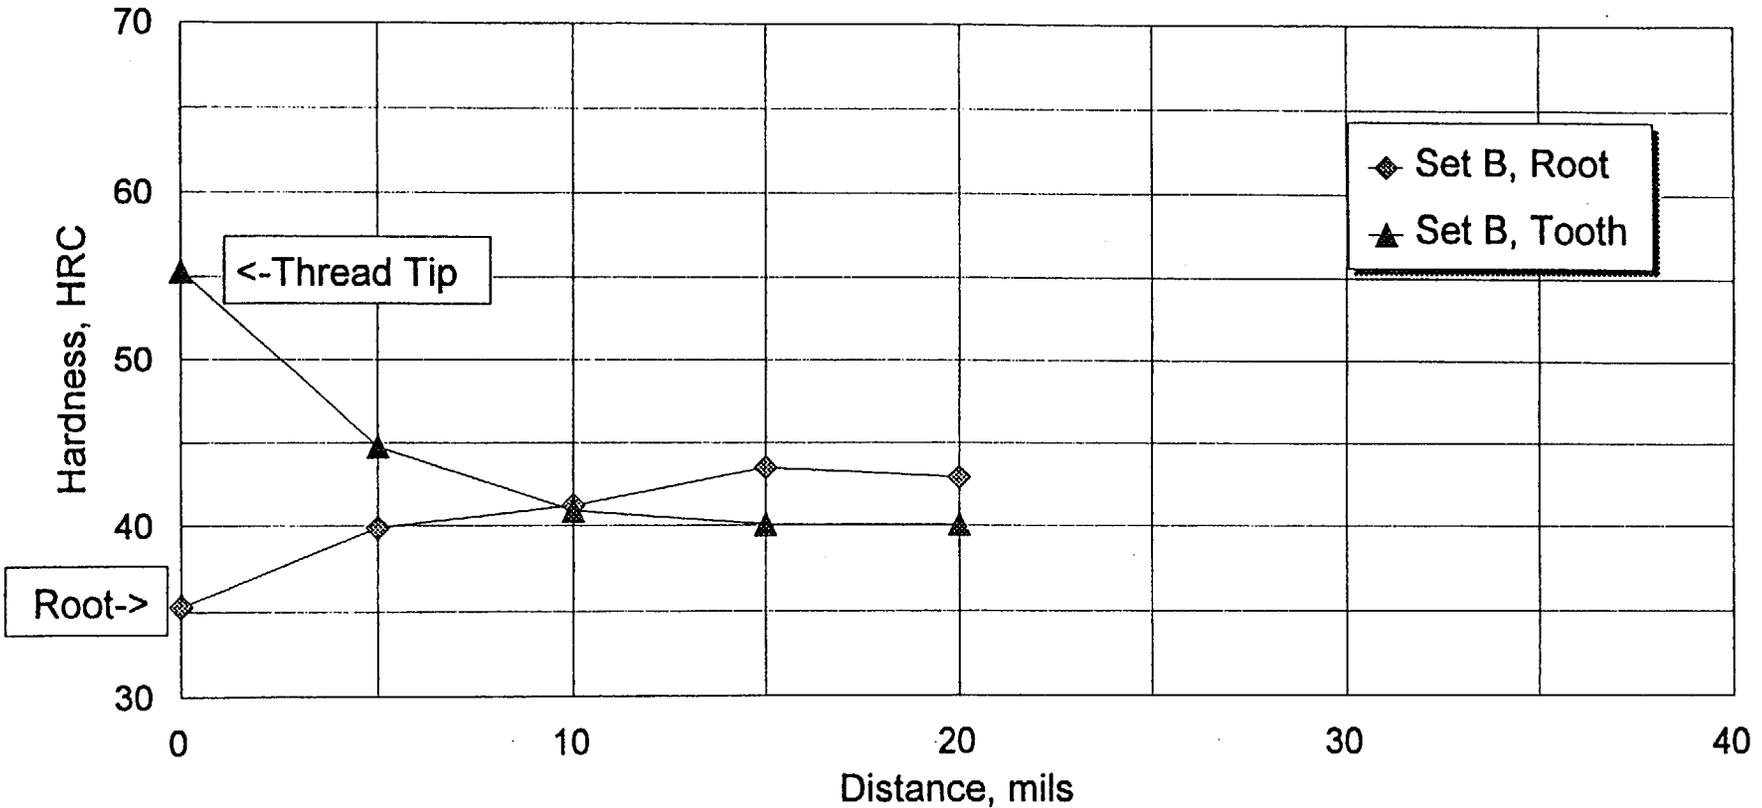
Figure 13 - Ice Condenser Basket Screws, Watts Bar Nuclear Plant, Unit No. 1. Customer Identification No. 95-07. Laboratory Report No. 95-1021.

New Screw (Set B) Hardness Traverses

Hardness vs. Distance Into Screw

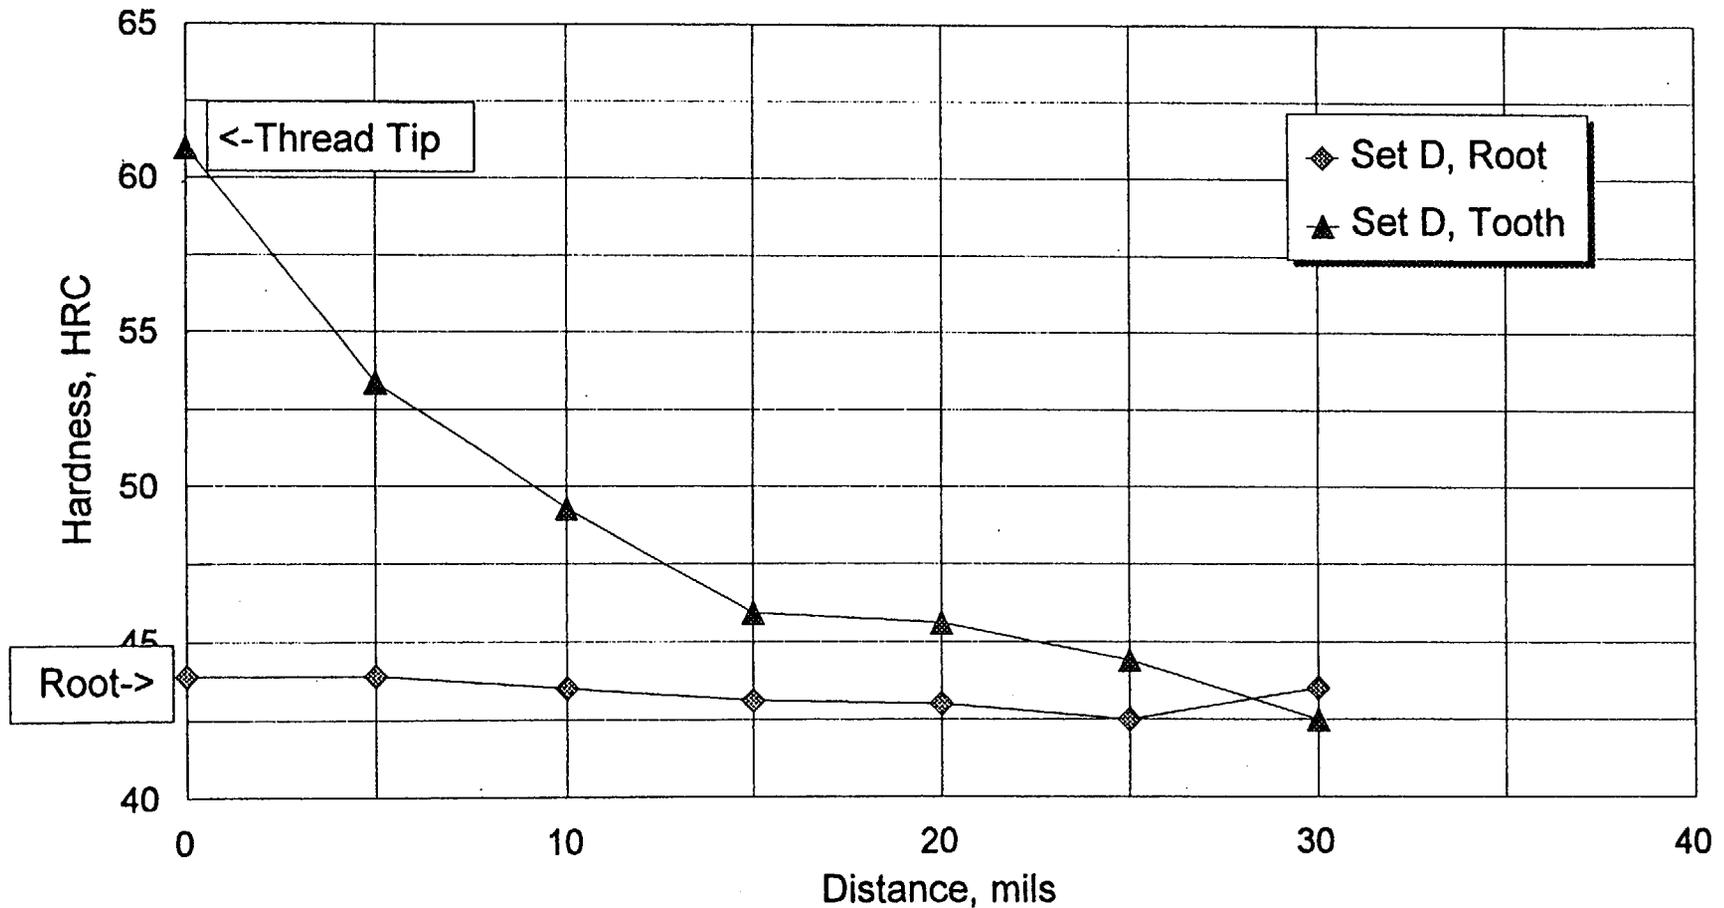
Figure 14 - Ice Condenser Basket Screws, Watts Bar Nuclear Plant, Unit No. 1. Customer Identification No. 95-07. Laboratory Report No. 95-1021.

Uncracked Screw (Set D) Hardness Traverses

Hardness vs. Distance Into Screw

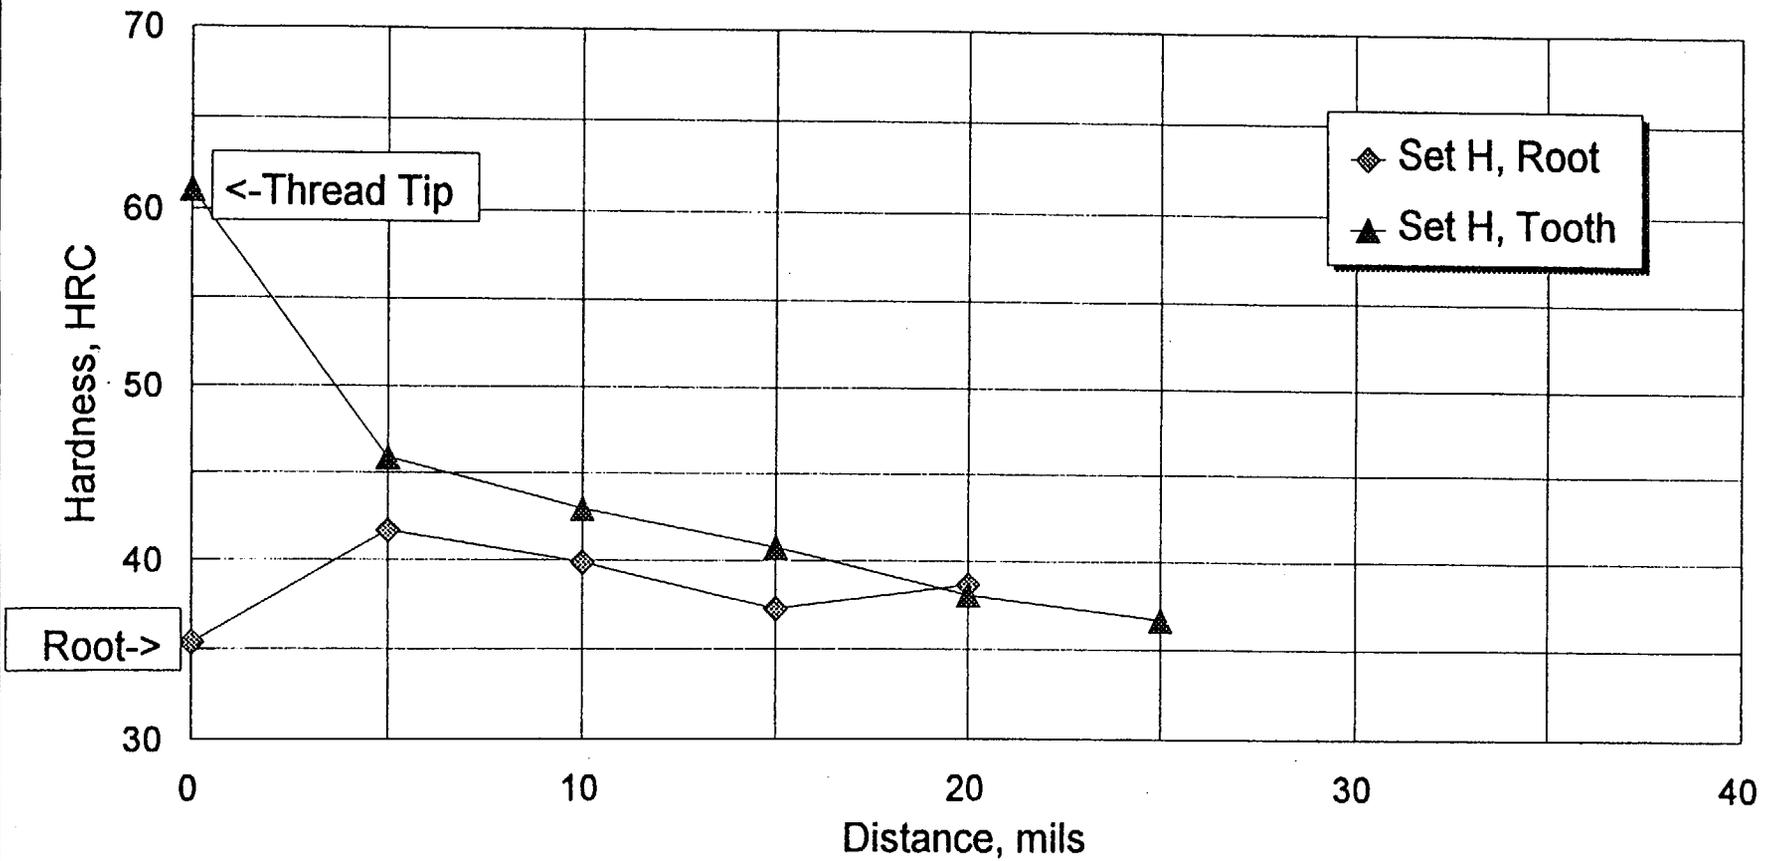
Figure 15 - Ice Condenser Basket Screws, Watts Bar Nuclear Plant, Unit No. 1. Customer Identification No. 95-07. Laboratory Report No. 95-1021.

Cracked Screw (Set H) Hardness Traverses

Hardness vs. Distance Into Screw
