South Texas Project
Unit 2
Docket No. STN 50-499
2RE08 Steam Generator Condition Monitoring Report

Attachment: Westinghouse Report SG-01-07-002, "South Texas Project Unit 2 2RE08 Refueling Outage Condition Monitoring"

South Texas Project 2RE08 Condition Monitoring Assessment

This report documents the condition monitoring assessment of the NDE results from the South Texas Project 2RE08 refueling outage and inspection, performed in March 2001.

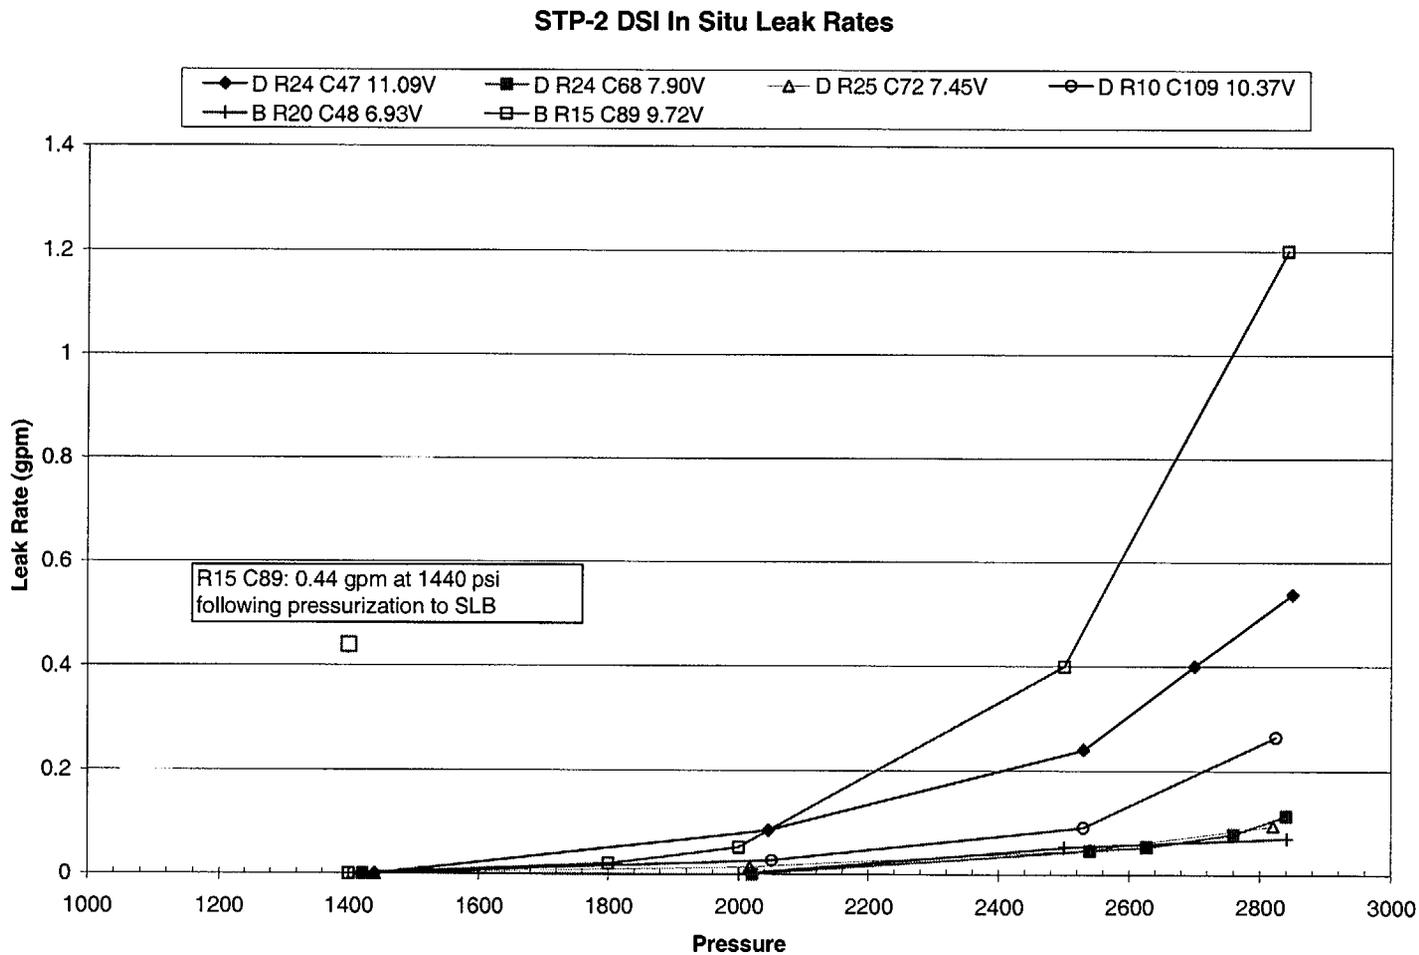
Figure 5.1

SG	Tube	Insitu Test		616°F Leak Rate (L/hr) @ 2405 psid	Tube Flow Stress @ RT (ksi)
		Pressure (psid)	RT Leak Rate (gpm)		
B	R15C89	2841	1.2	32.6	76.0
B	R20C48	2841	0.07	3.0	79.0
D	R24C47	2849	0.54	21.4	79.5
D	R24C68	2840	0.11	3.8	70.5
D	R25C72	2820	0.09	4.1	80.5
D	R10C109	2824	0.26	7.6	84

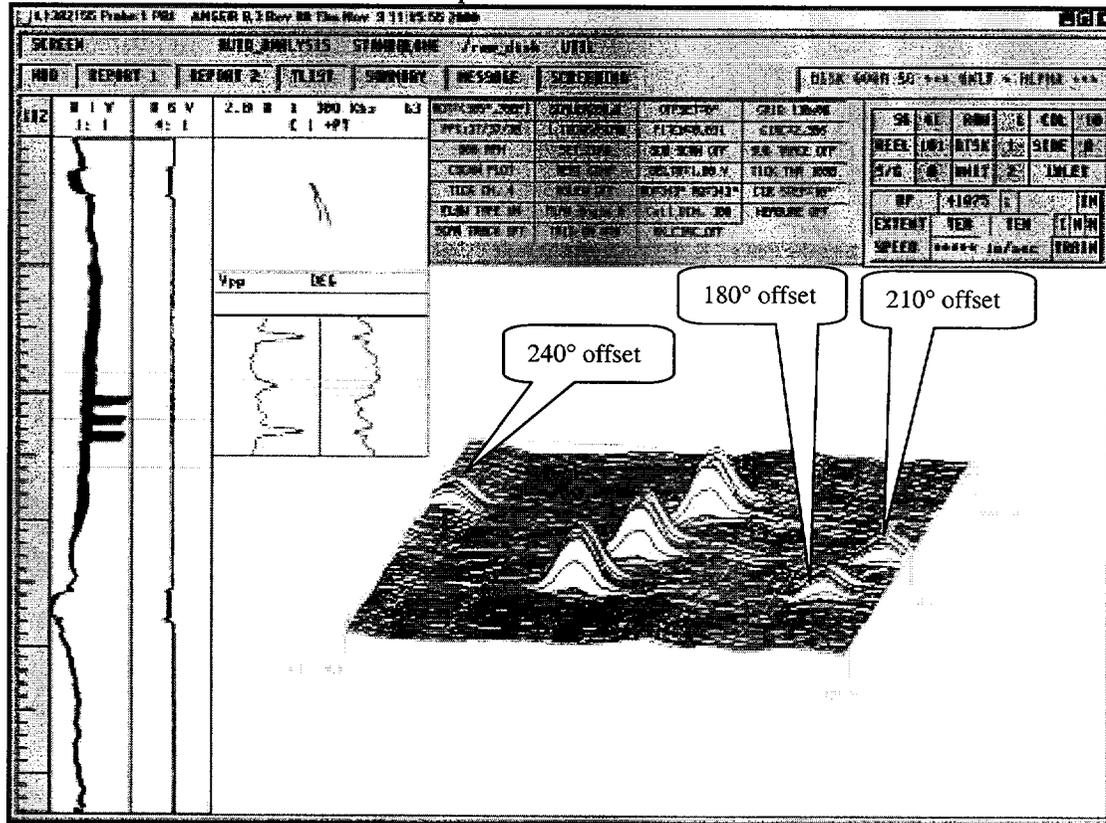
Figure 3. 0.50 volt 40% OD indications from the standard inserted into data displaying nominal noise characteristics with 180°, 210° and 240° offsets relative to the original data. 60% OD indications are also present.

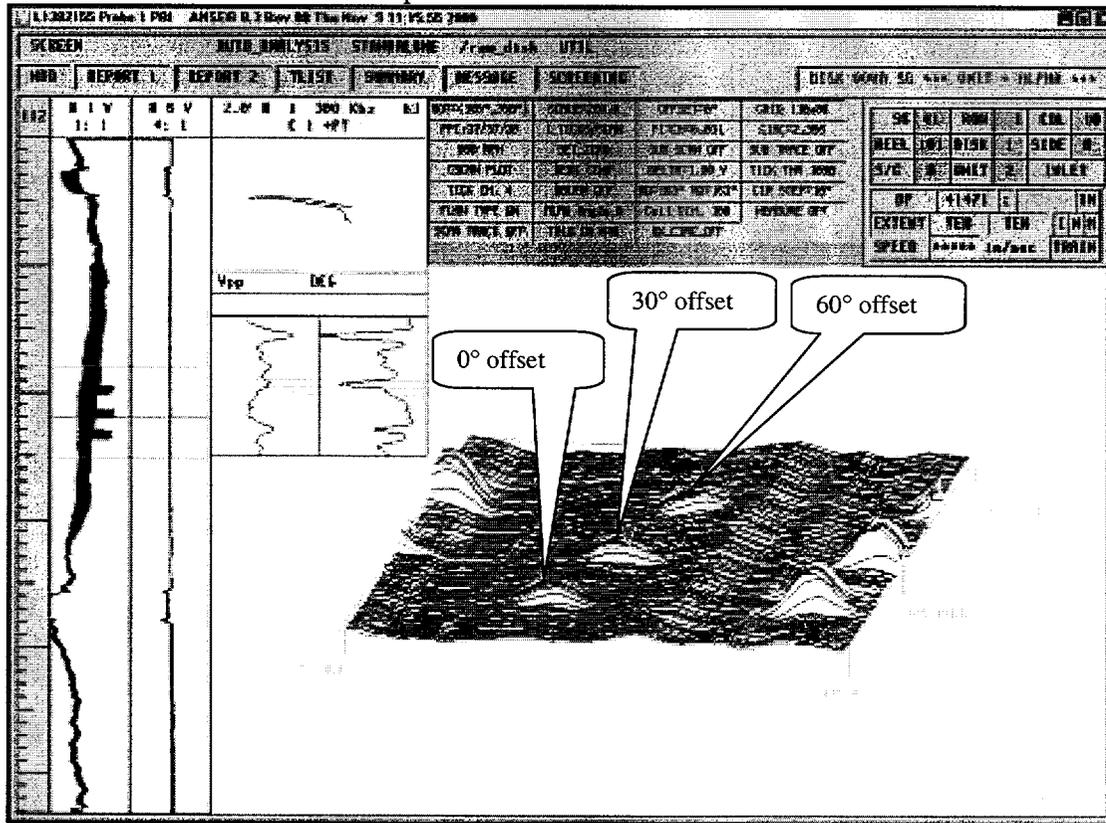
Figure 5. 0.50 volt 40% ID indications from the standard inserted into data displaying nominal noise characteristics with 0°, 30° and 60° offsets relative to the original data. 60% ID indications are also present.

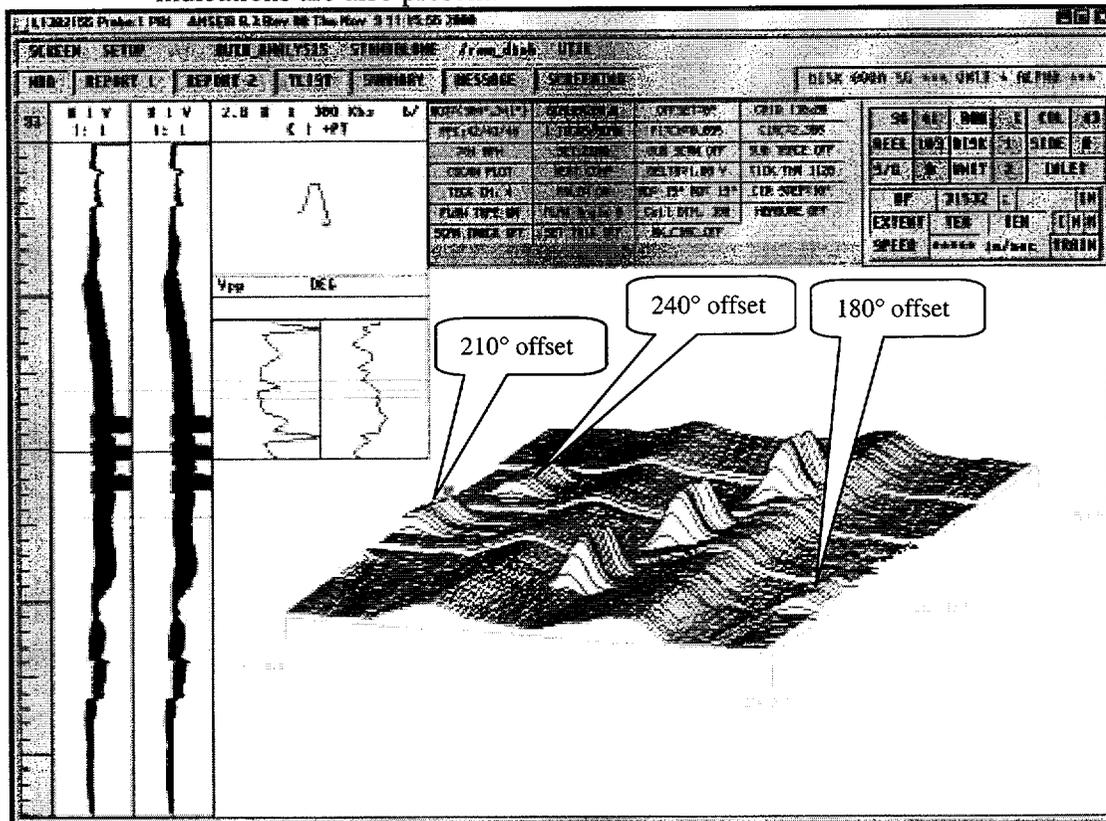
Figure 11. 0.50 volt 40% OD indications from the standard inserted into data displaying high noise characteristics with 180°, 210° and 240° offsets relative to the original data. 60% OD indications are also present.

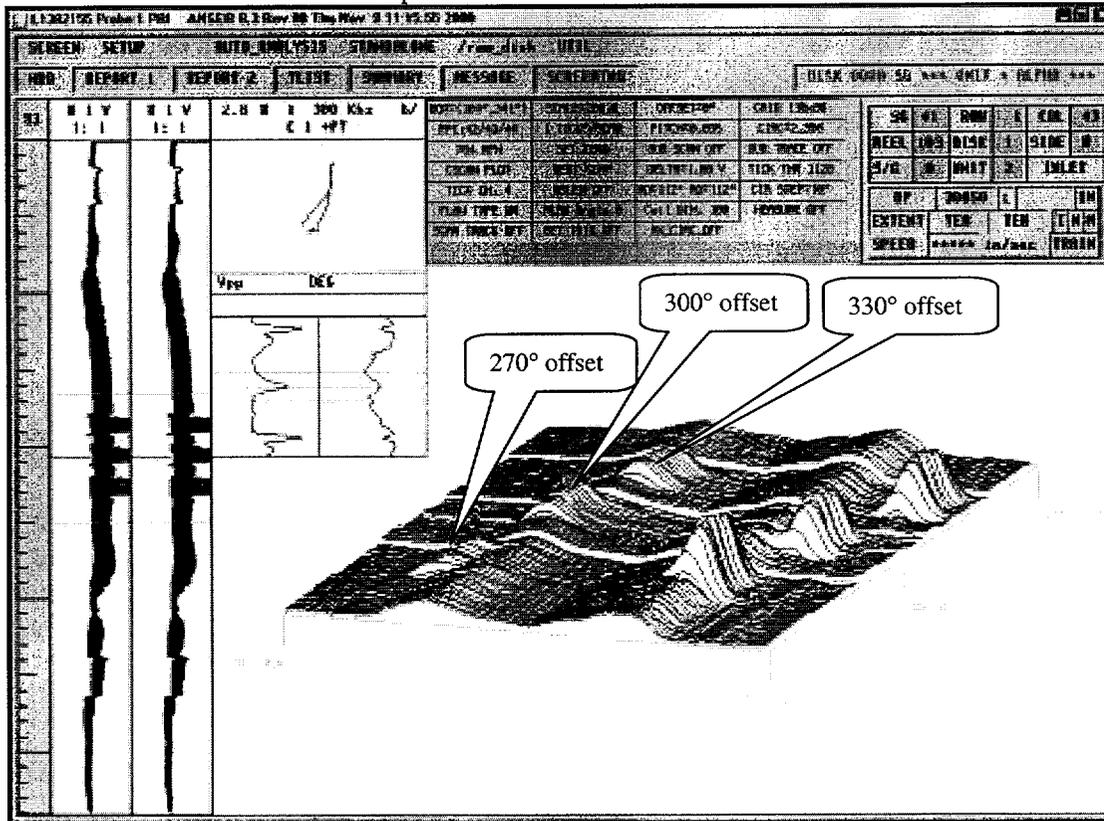
Figure 12. 0.50 volt 40% OD indications from the standard inserted into data displaying high noise characteristics with 270°, 300° and 330° offsets relative to the original data. 60% OD indications are also present.

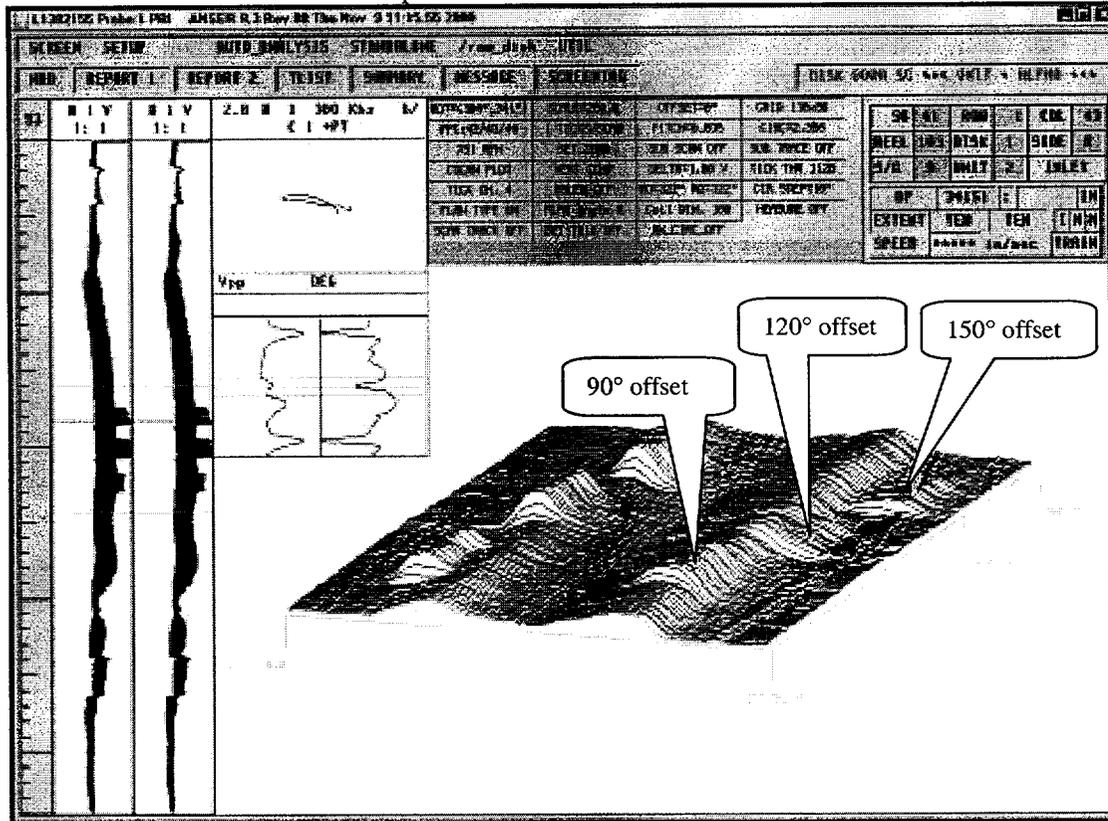
Figure 14. 0.50 volt 40% ID indications from the standard inserted into data displaying high noise characteristics with 90°, 120° and 150° offsets relative to the original data. 60% ID indications are also present.

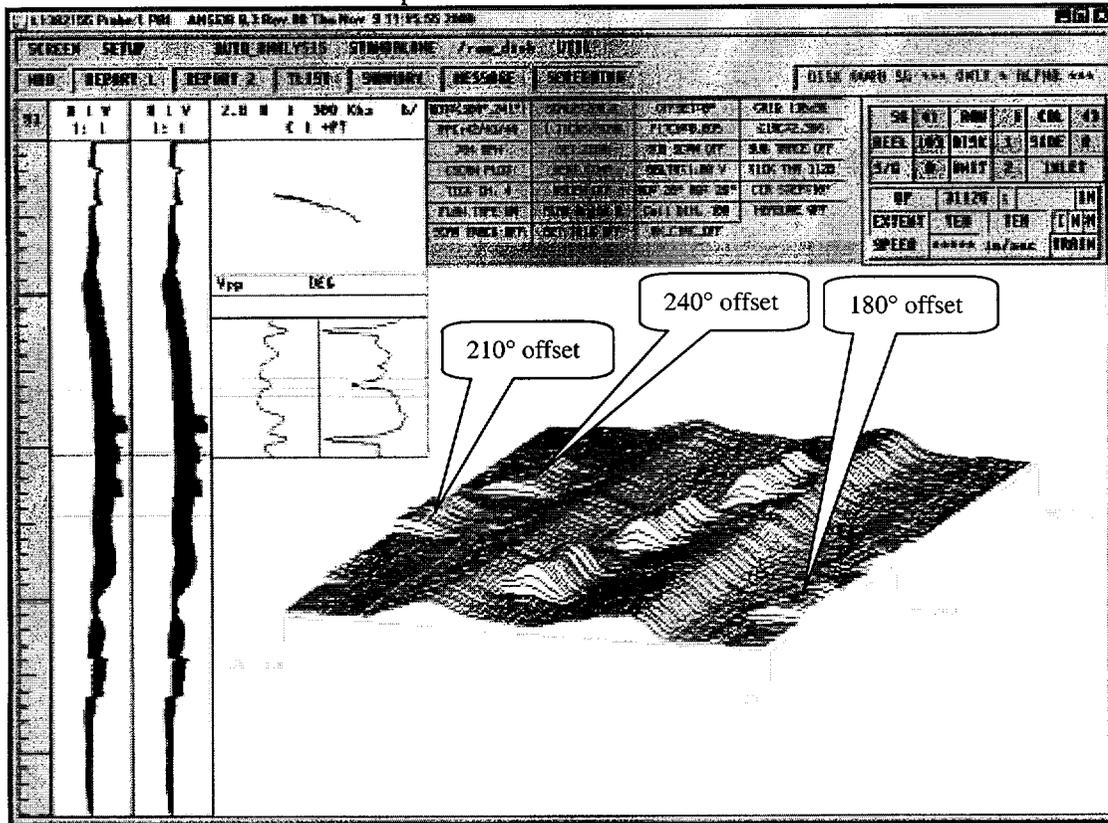
Figure 15. 0.50 volt 40% ID indications from the standard inserted into data displaying high noise characteristics with 180°, 210° and 240° offsets relative to the original data. 60% ID indications are also present.
