South Texas Project Electric Generating Station P.O. Box 289 Wadsworth, Texas 77483

South Texas Project
Unit 2
Docket No. STN 50-499
2RE08 Steam Generator Condition Monitoring Report

Attachment: Westinghouse Report SG-01-07-002, "South Texas Project Unit 2 2RE08 Refueling Outage Condition Monitoring"

South Texas Project 2RE08 Condition Monitoring Assessment

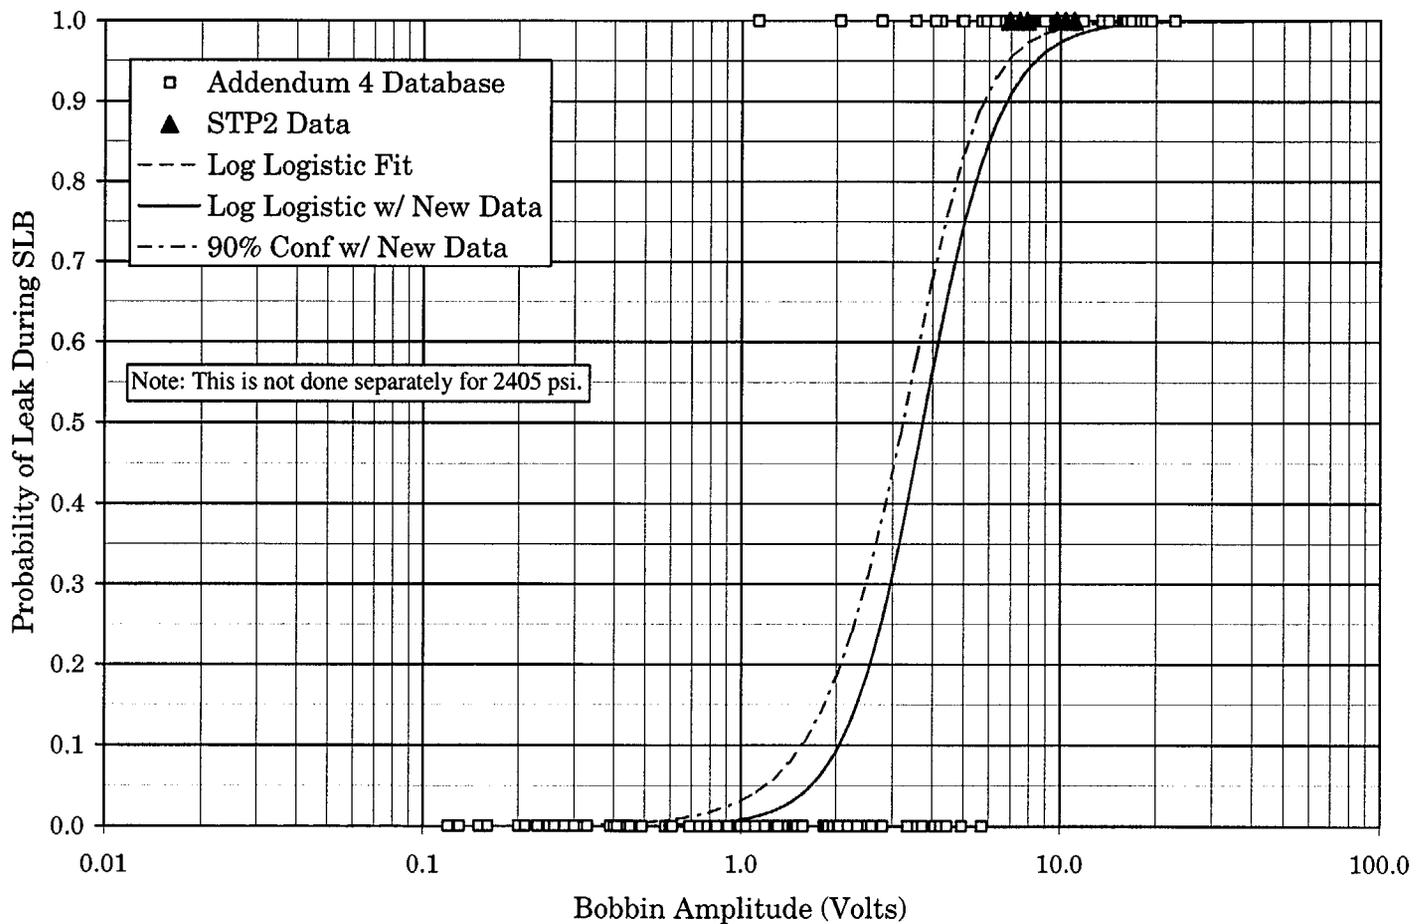
Probability of Leak for 3/4" SG Tubes @ 650°F, ΔP = 2560 psi
 Comparison of STP2 Data with Addendum 4 Reference Database

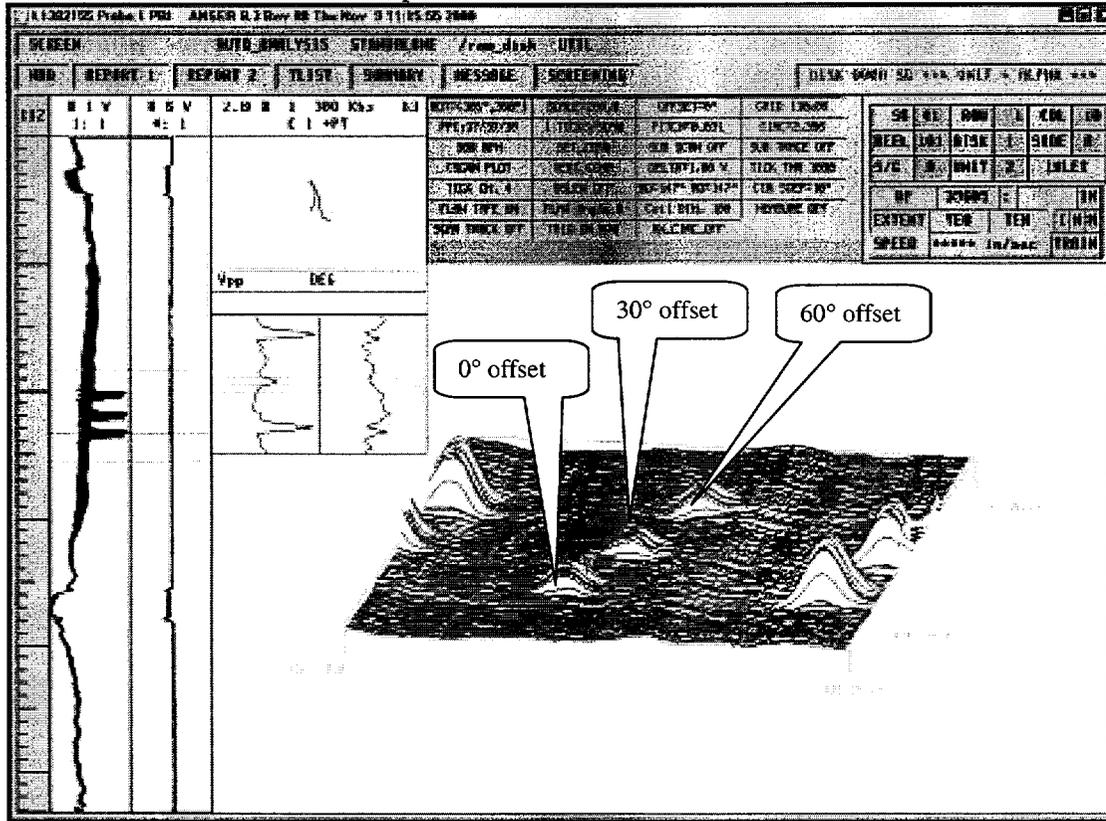
Figure 1. 0.50 volt 40% OD indications from the standard inserted into data displaying nominal noise characteristics with 0°, 30° and 60° offsets relative to the original data. 60% OD indications are also present.

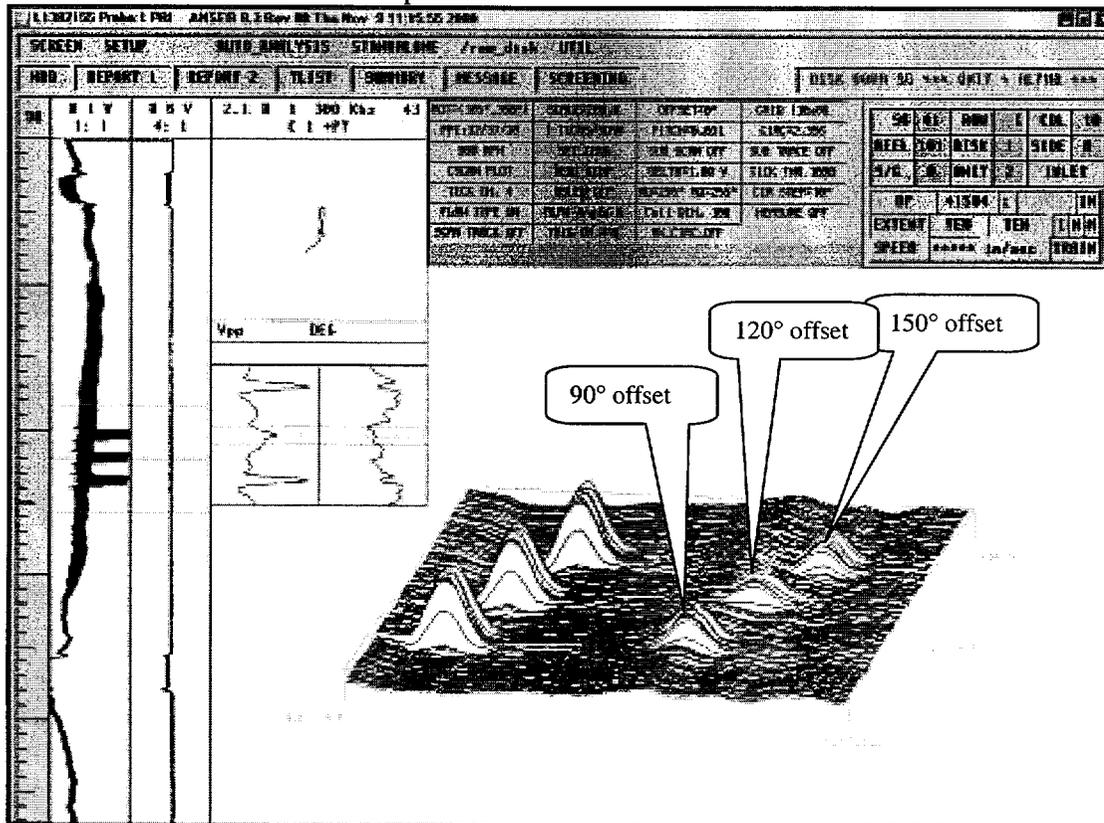
Figure 2. 0.50 volt 40% OD indications from the standard inserted into data displaying nominal noise characteristics with 90°, 120° and 150° offsets relative to the original data. 60% OD indications are also present.

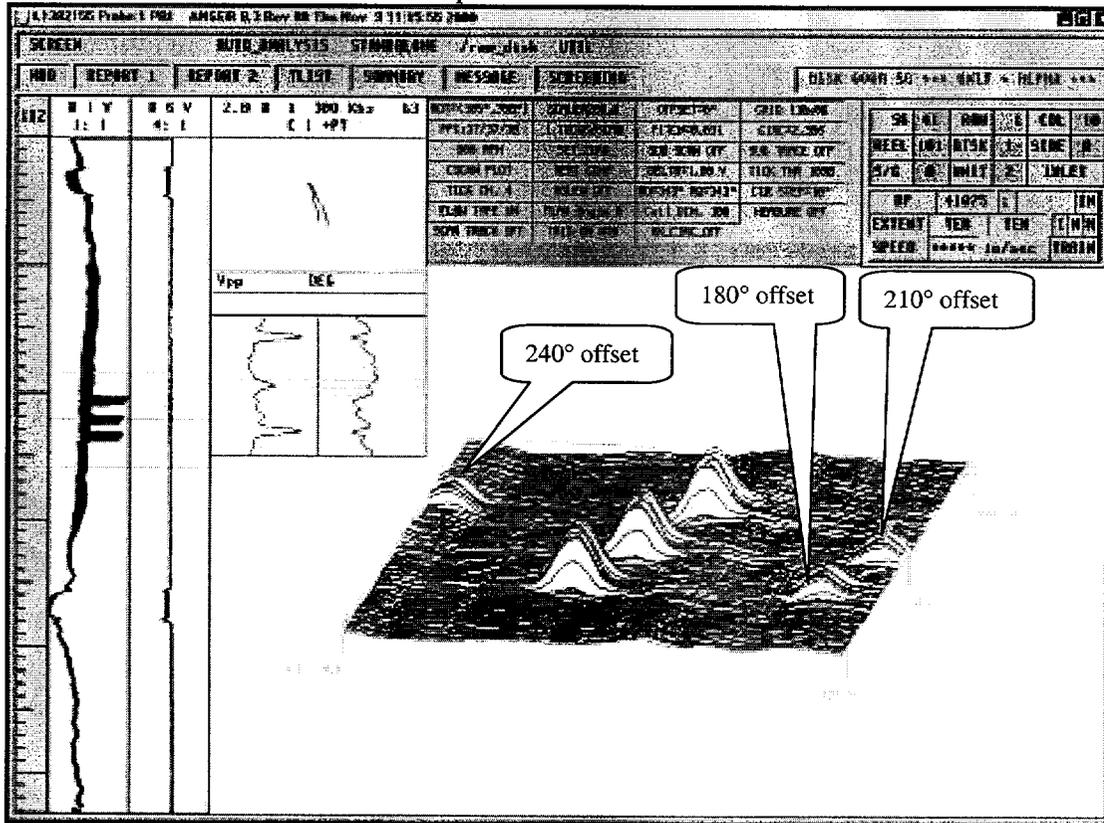
Figure 3. 0.50 volt 40% OD indications from the standard inserted into data displaying nominal noise characteristics with 180°, 210° and 240° offsets relative to the original data. 60% OD indications are also present.

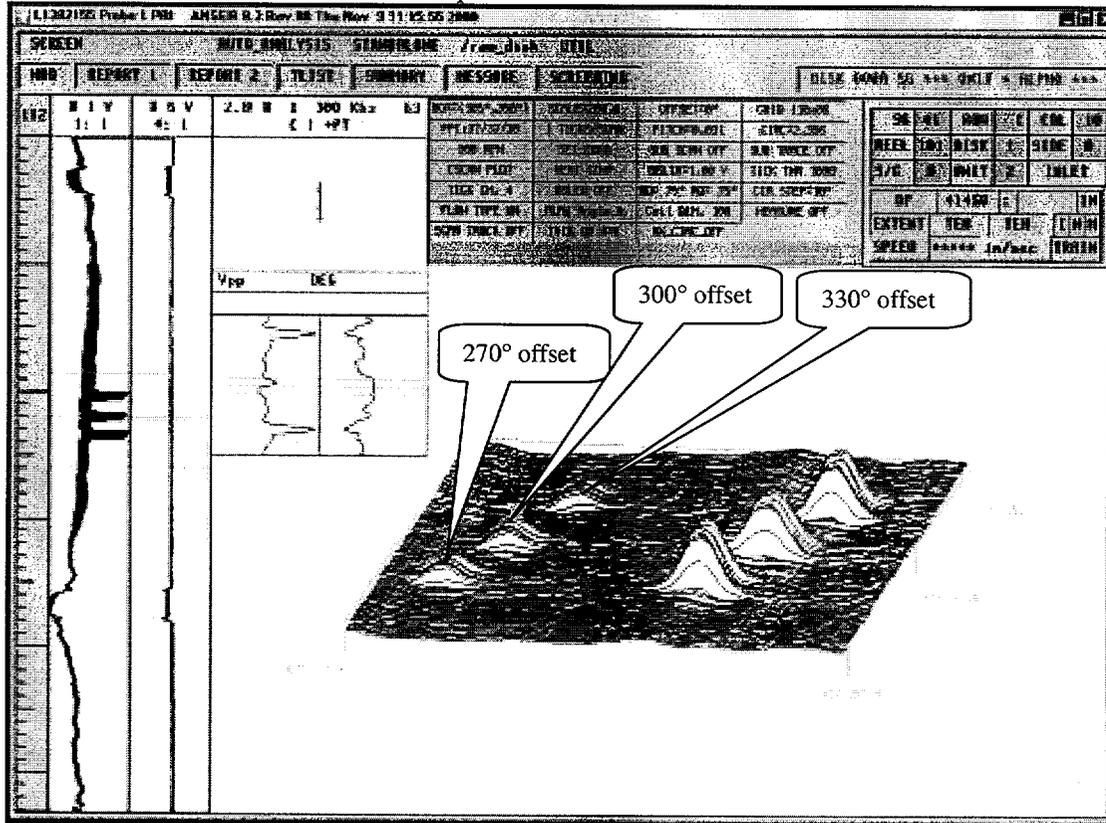
Figure 4. 0.50 volt 40% OD indications from the standard inserted into data displaying nominal noise characteristics with 270°, 300° and 330° offsets relative to the original data. 60% OD indications are also present.

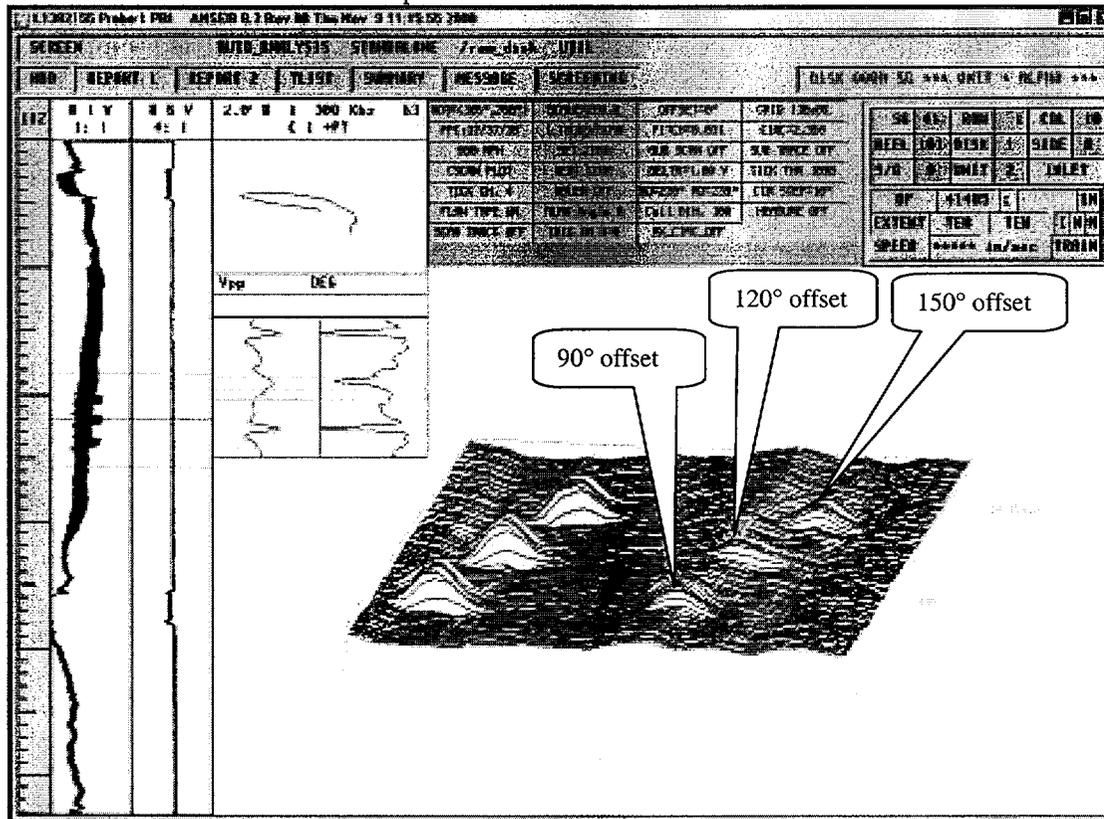
Figure 6. 0.50 volt 40% ID indications from the standard inserted into data displaying nominal noise characteristics with 90°, 120° and 150° offsets relative to the original data. 60% ID indications are also present.

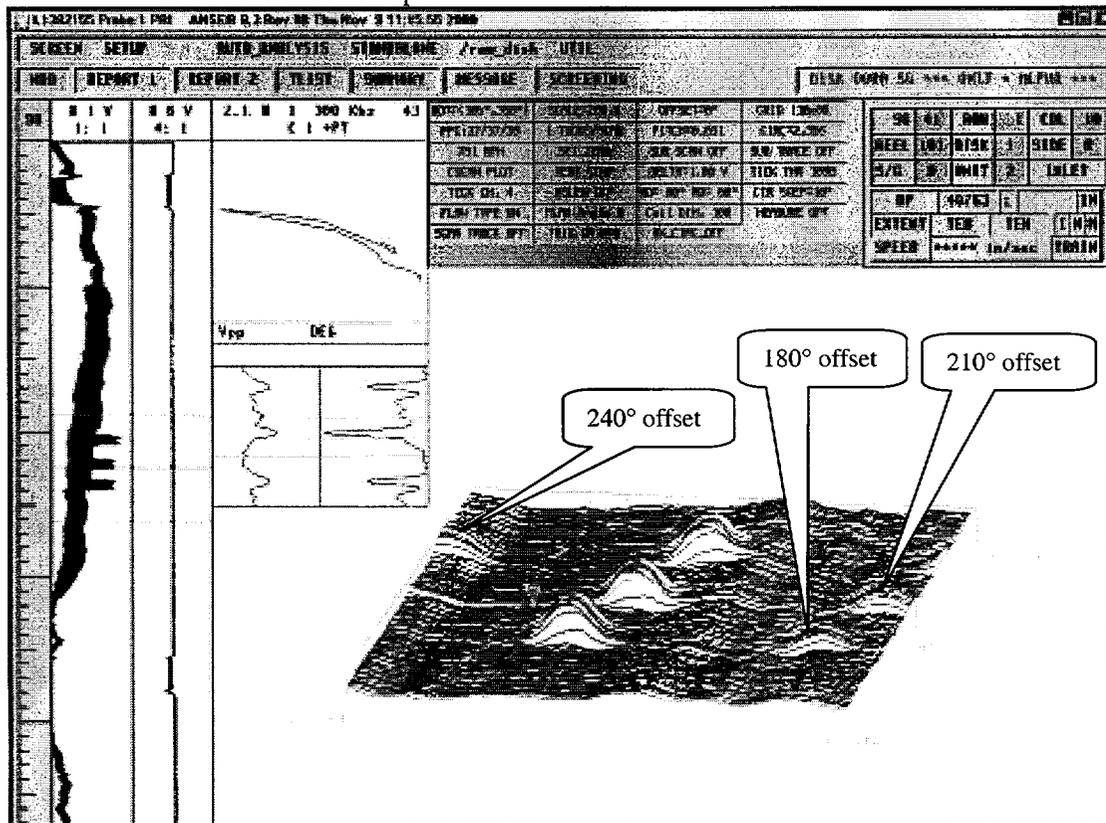
Figure 7. 0.50 volt 40% ID indications from the standard inserted into data displaying nominal noise characteristics with 180°, 210° and 240° offsets relative to the original data. 60% ID indications are also present.

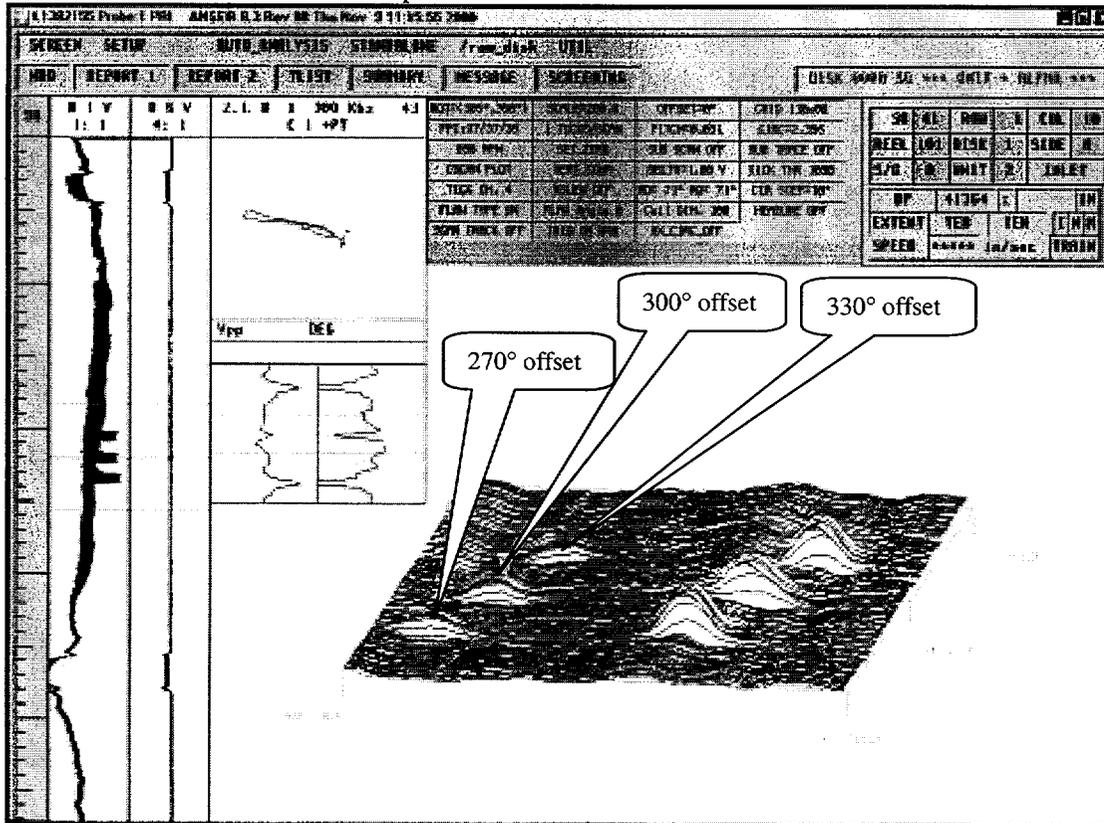
Figure 8. 0.50 volt 40% ID indications from the standard inserted into data displaying nominal noise characteristics with 270°, 300° and 330° offsets relative to the original data. 60% ID indications are also present.

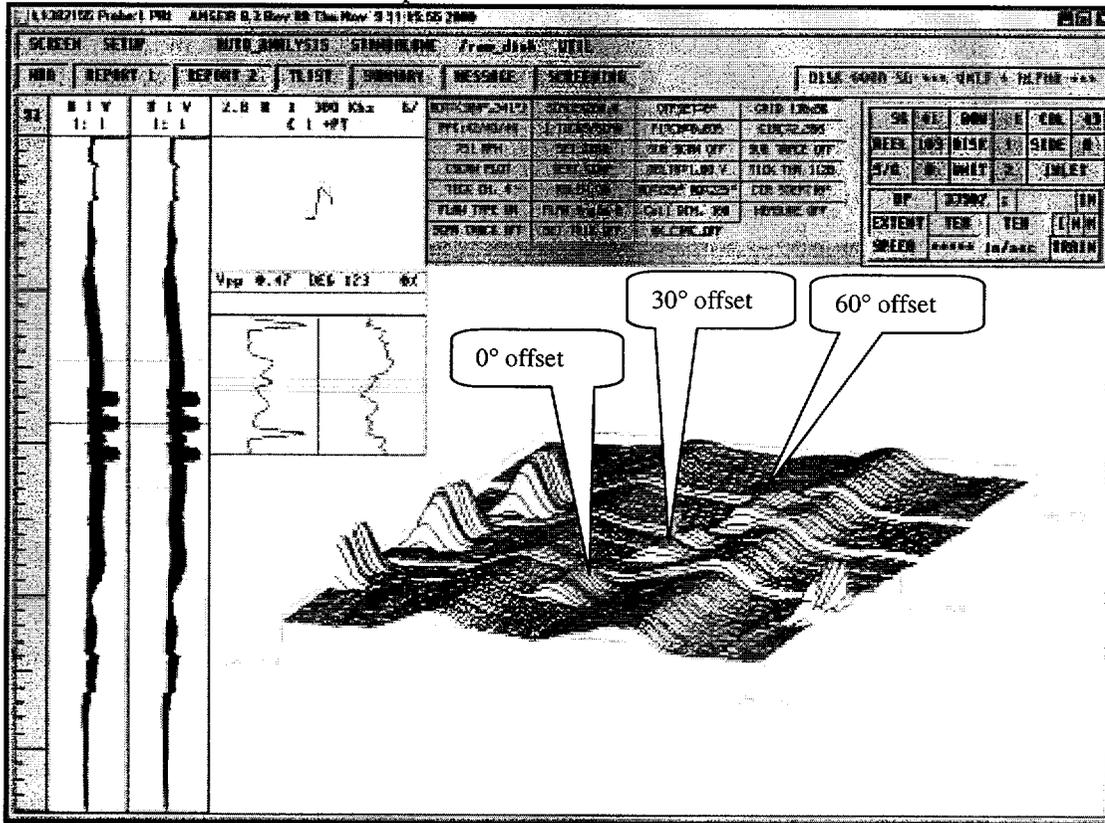
Figure 9. 0.50 volt 40% OD indications from the standard inserted into data displaying high noise characteristics with 0°, 30° and 60° offsets relative to the original data. 60% OD indications are also present.

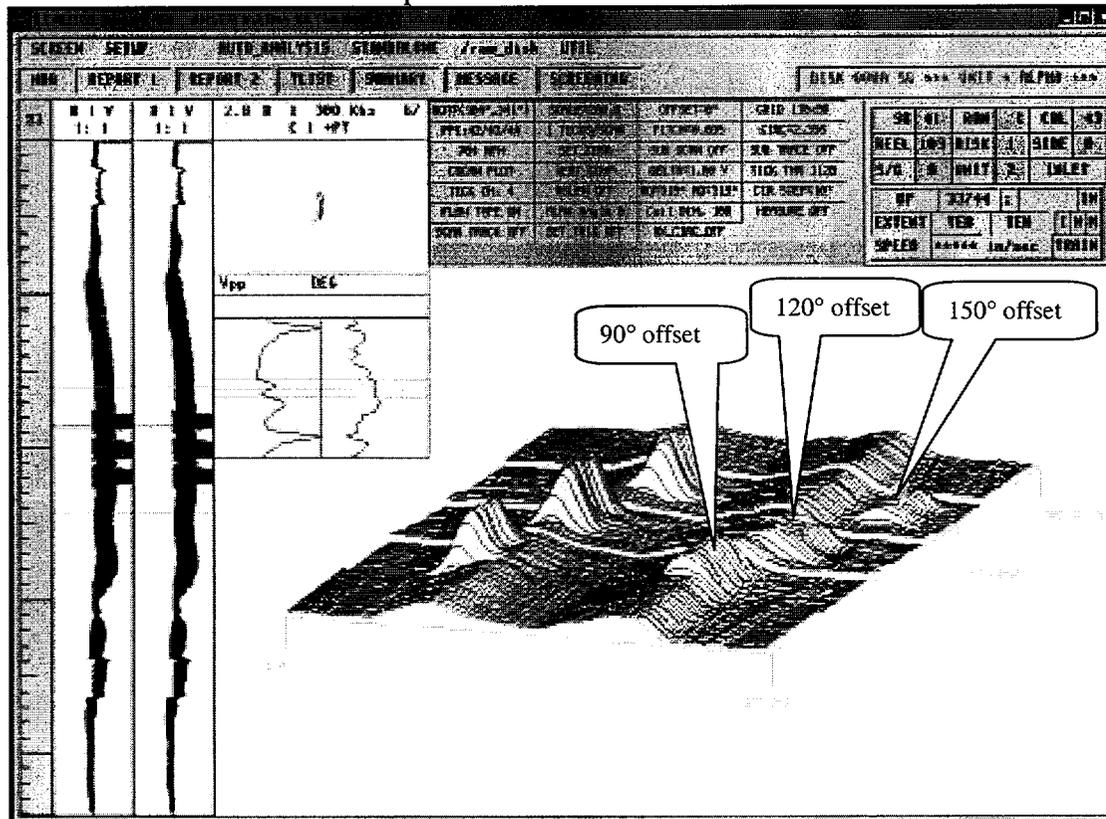
Figure 10. 0.50 volt 40% OD indications from the standard inserted into data displaying high noise characteristics with 90°, 120° and 150° offsets relative to the original data. 60% OD indications are also present.

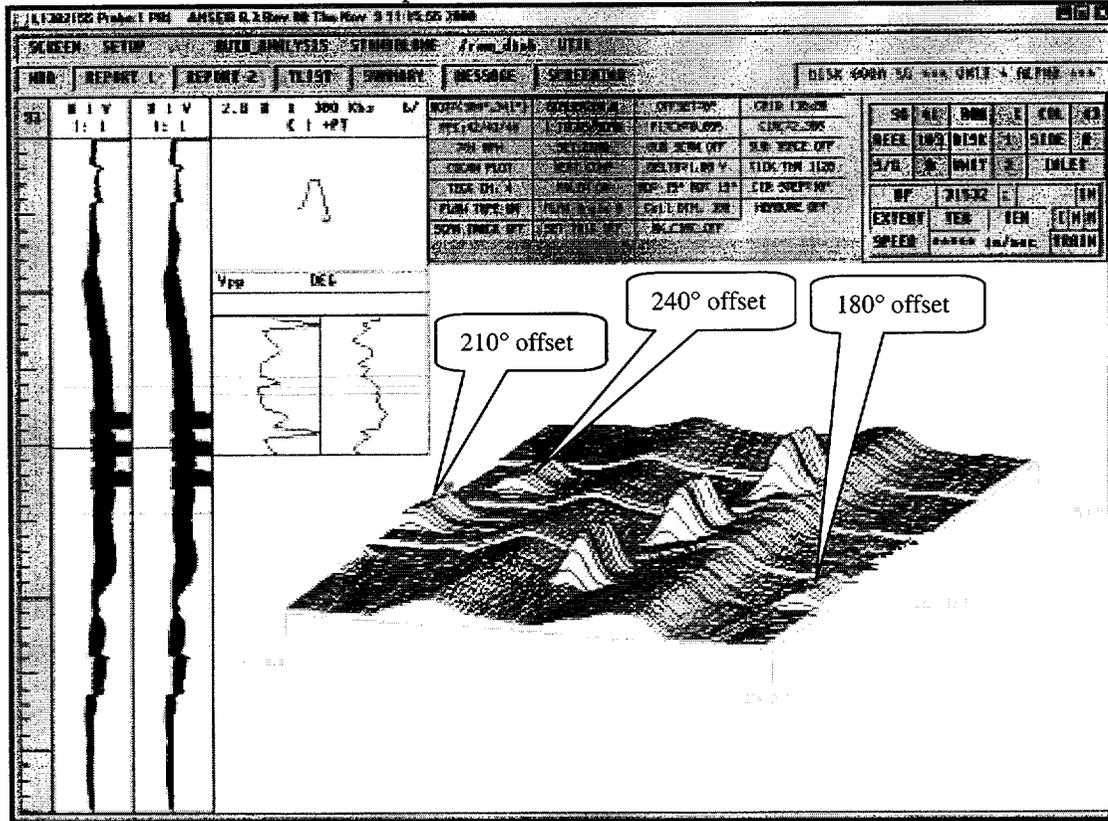
Figure 11. 0.50 volt 40% OD indications from the standard inserted into data displaying high noise characteristics with 180°, 210° and 240° offsets relative to the original data. 60% OD indications are also present.

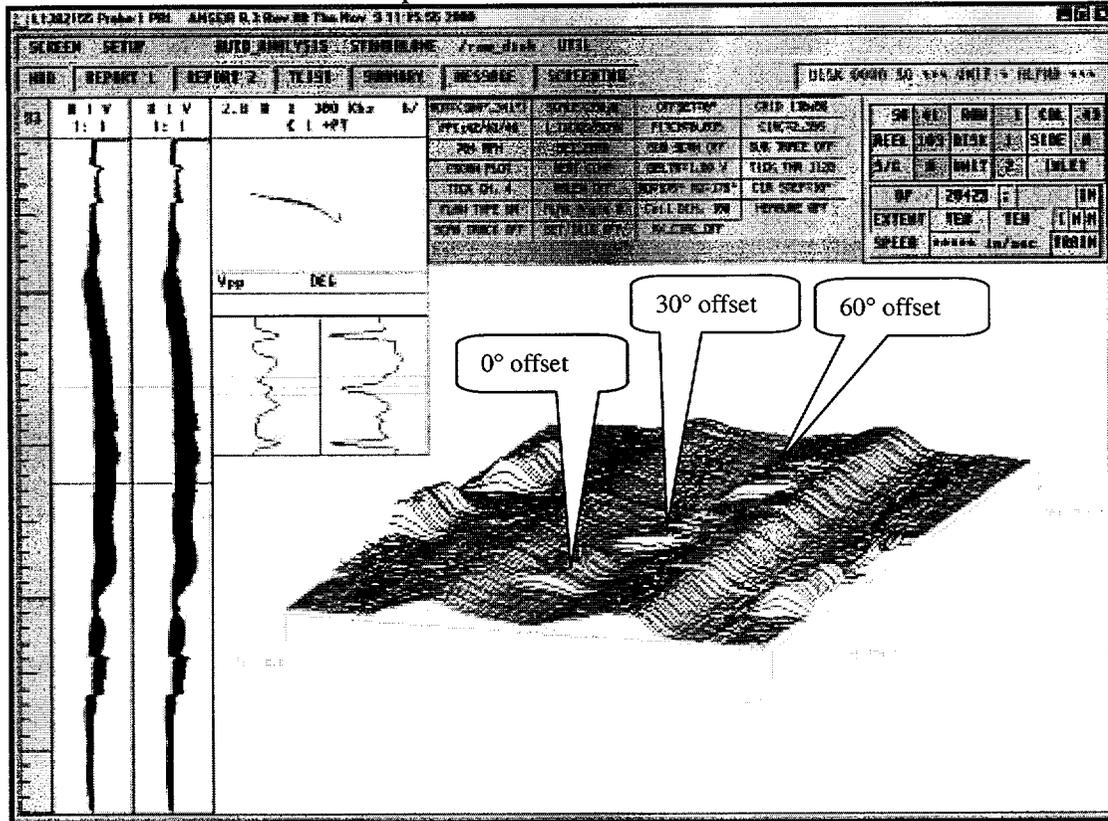
Figure 13. 0.50 volt 40% ID indications from the standard inserted into data displaying high noise characteristics with 0°, 30° and 60° offsets relative to the original data. 60% ID indications are also present.

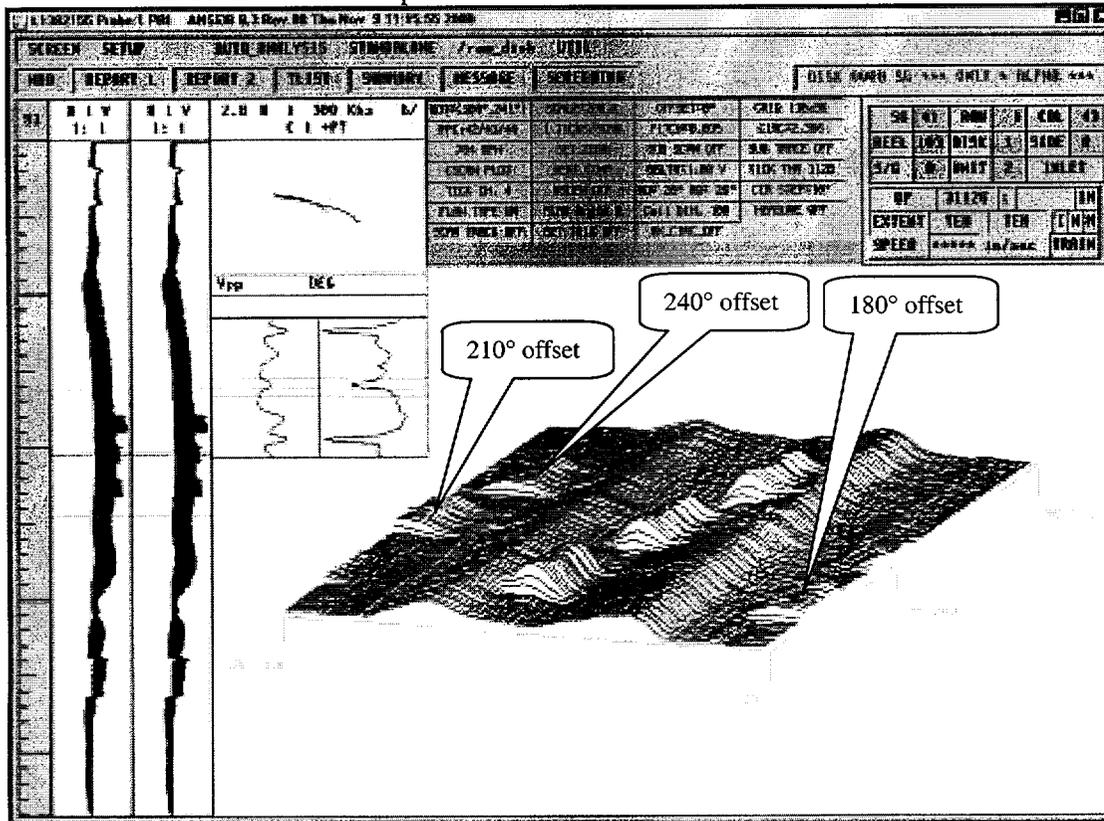
Figure 15. 0.50 volt 40% ID indications from the standard inserted into data displaying high noise characteristics with 180°, 210° and 240° offsets relative to the original data. 60% ID indications are also present.

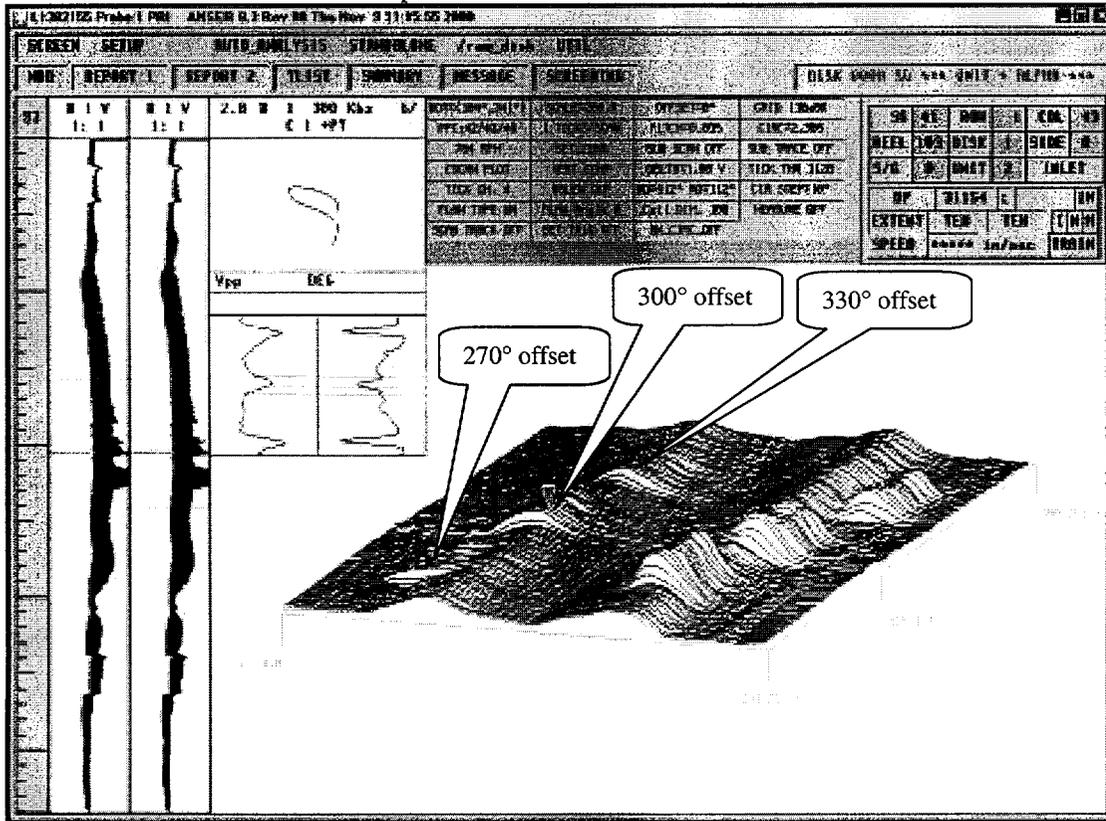
Figure 16. 0.50 volt 40% ID indications from the standard inserted into data displaying high noise characteristics with 270°, 300° and 330° offsets relative to the original data. 60% ID indications are also present.
