EOC18 Refueling Outage Report Oconee Unit 2 Section 9

Oconee Nuclear Station Units 2

Third 10-YEAR INTERVAL REQUEST FOR RELIEF NO. 01-011

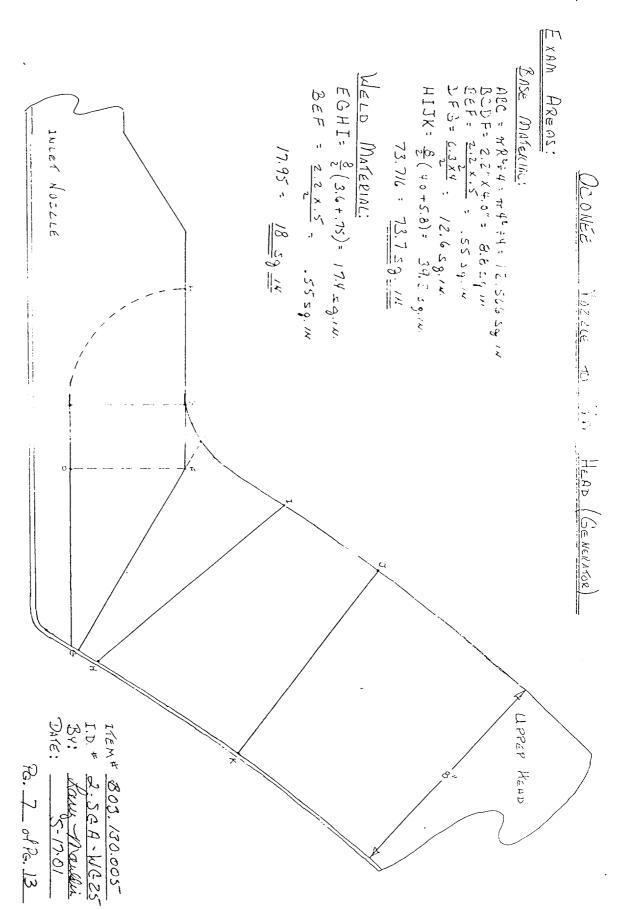
NDE-91-1						
1		Revision 0						
at 464,52.05 \$2.000 \$2.000 \$2.000 \$2.000	1	Exar	nination Vol	ume/A	rea Define	1	nie of the off particular	
Base Metal	\boxtimes	Weld	🗆 Ne	ar Sur	face	🗆 Bolting]	Inner Radius
	Area Ca	Iculation			V	olume Ca	lculat	ion
								1
							•	
			Coverage	Calcu	lations			
	Beam	Ar		ngth	Volume	Volu		
Scan # Angle	Directio	Exan ^{on} (sq		nined n)	Examined (cu in.)	Requ (cu	lirea .in)	Percent Coverage
BASE					33753 6	563	307	59.95
WELC					13247-7		53 6	53 52
					47001.3	810	60.6	57.98

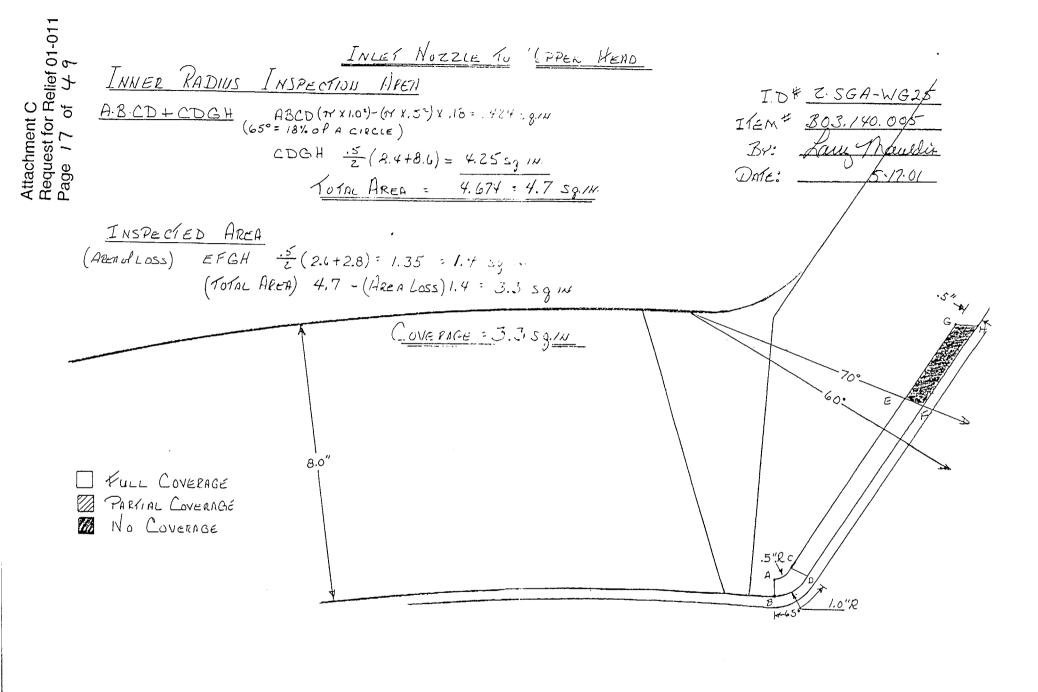
This weld is limited to 70.21% coverage of the required volume. Limitations were caused by the ratio of the nozzle OD to the vessel thickness. When the nozzle OD is large in relation to the vessel thickness, less coverage can be obtained when scanning from the vessel side.

NDE-91-1						
ann an a	Limited Examination Coverage Worksheet								Revision 0
				on Volu	me/A	rea Define	1		V al vali i sere an l'i va va si na va san di dan a sa sa sa di dan si na va sa di dan si na va sa di dan si n
🗆 Ba	se Metal		/eld	🗆 Nea	ır Sui	rface	Bolting	J	🗵 Inner Radius
		Area Calcul	ation			V	olume Ca	Icula	tion
4.7 SQ.		R CALCULATI			718.	SQ. IN. X 152.		•	
			Cov	verage C	alcu	lations			
Scan #	Angle	Beam Direction	Area Examined (sq.in.)	Leng Examii (in.	ned	Volume Examined (cu.in.)	Volu Requ (cu.)	ired	Percent Coverage
1	60/70	CW	3.3	152.8	8	504.24	718	16	70 21
2	60/70	CCW	33	152 8	9	504.24	718	-	70.21
						1008.48	1436	.32	70.21

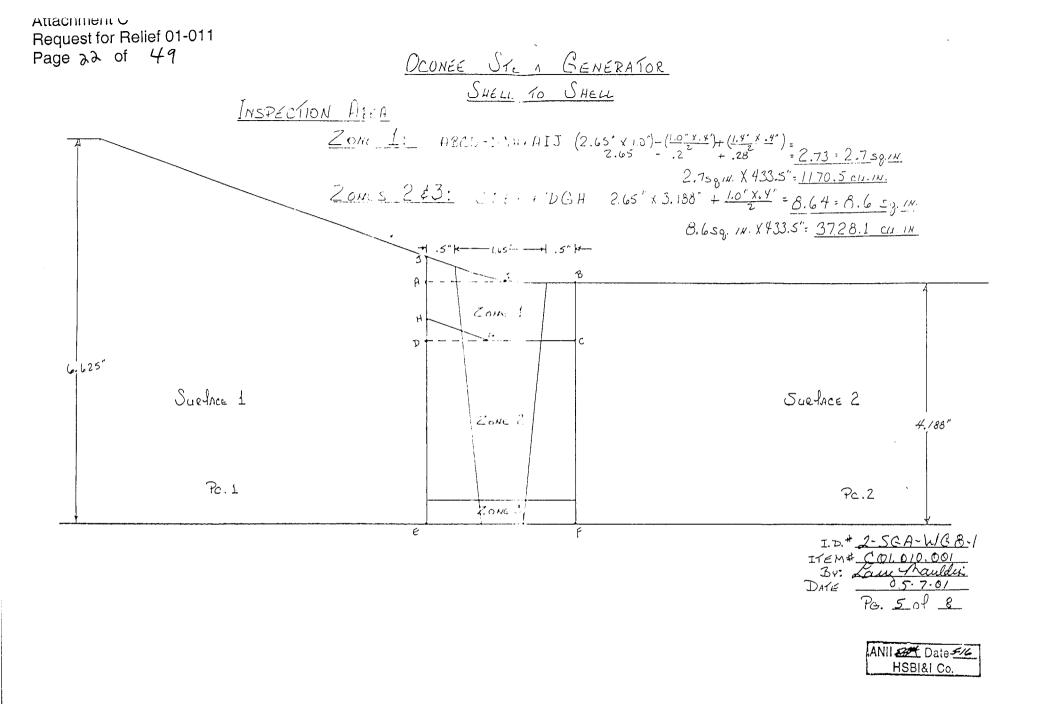
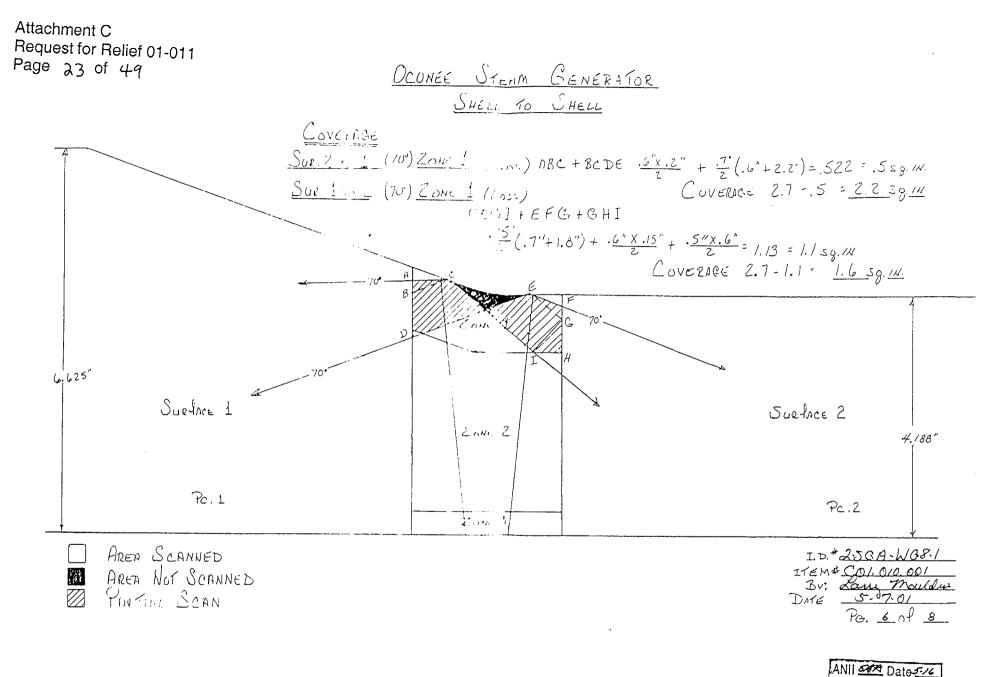
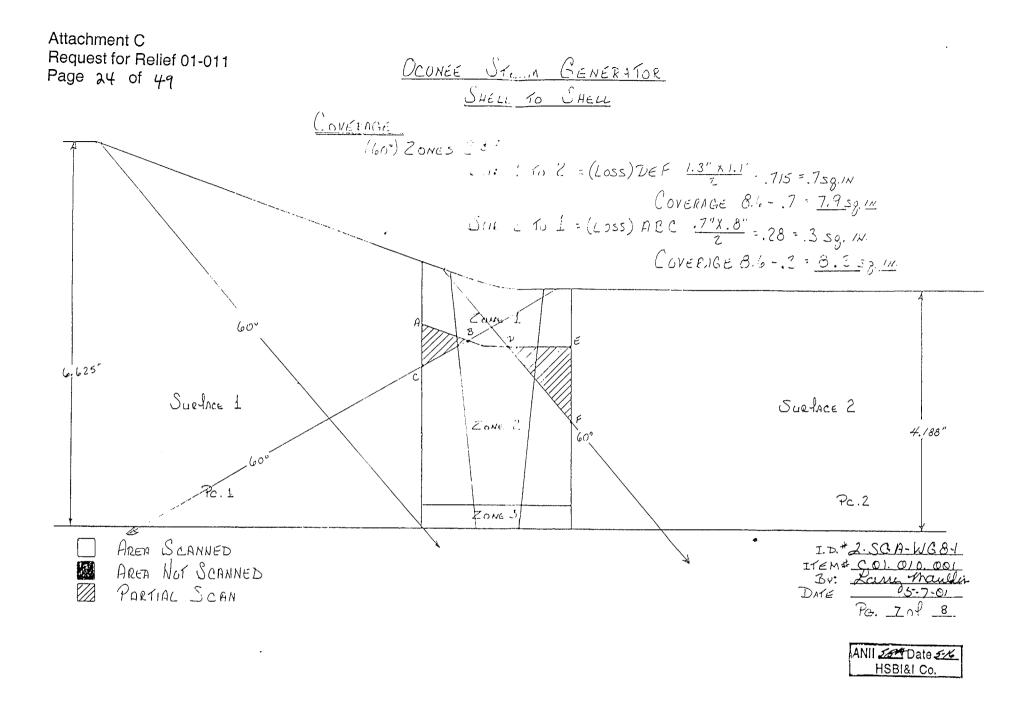
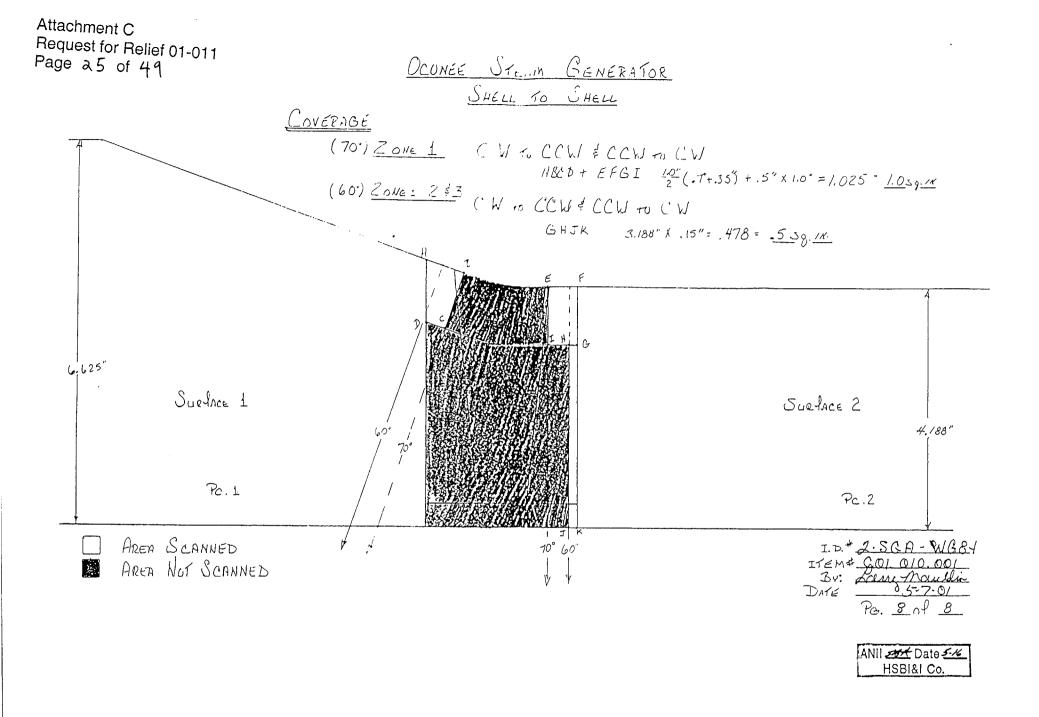
NDE-91-1									
		*******	Revision 0								
	Examination Volume/Area Defined										
🖾 Bas	se Metal	J	Inner Radius								
	Area Calculation Volume Calculation										
SEE DRWGS ZONE 1 ZONE 1- 2.7 SQ. IN. 2.7 SQ. IN. X 433.5 IN = 1170.5 CU. IN. ZONES 2 & 3 - 8.6 SQ. IN ZONES 2 & 3 8.6 SQ. IN X 433.5 IN. = 3728.1 CU. IN. Coverage Calculations											
Scan #	Angle	Beam Directior		ea Le nined Exa	ngth nined in)	Volume Examined (cu in)	Volu Requ (cu	ired	Percent Coverage		
1	70°	1	2	2 43	3.5	953 7	117	05	81.48		
2	70°	2	1.	6 43	3.5	693 6	117		59 26		
3	70°	CW	1	0 43	3 5	433 5	• • 7	0.5	37 04		
4	70°	CCW	1.	.0 43	3.5	433.5	117	0.5	37.04		
5	60°	1	8.	.3 43	3.5	3598.1	372	8.1	96.51		
6	60°	2	7.	.9 43	3.5	3424.7	372	8.1	91.86		
7	60°	CW		5 43	3.5	216.8	372	8.1	5.82		
8	60°	CCW		5 43	3.5	216.8	372	8.1	5.82		
						9970.7	1959	94.4	50.89

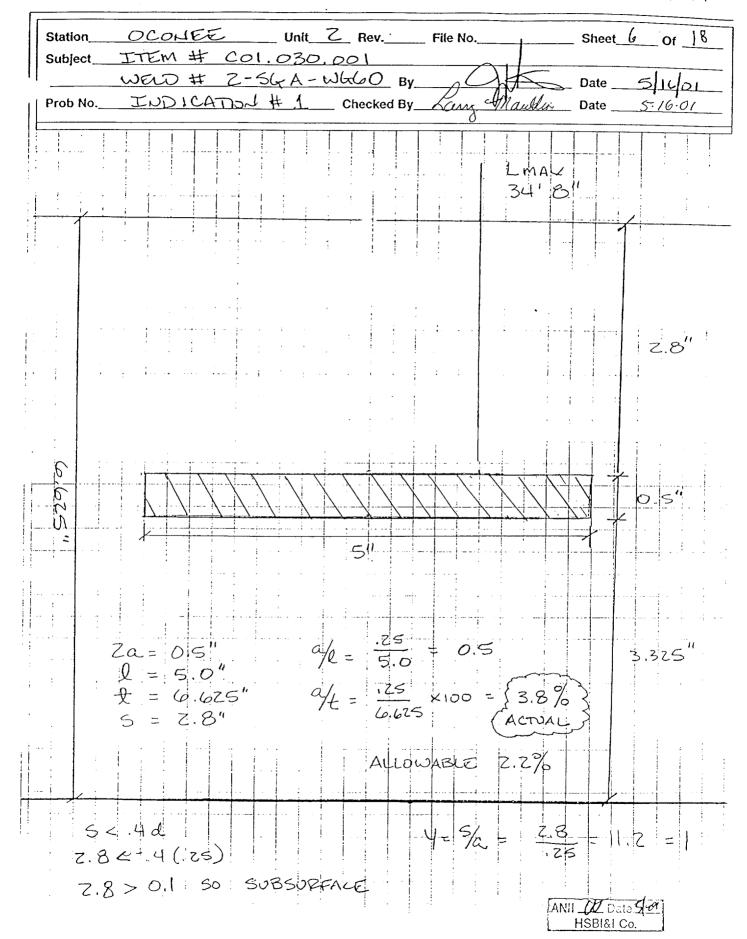
DUKE POWER COMPANY	Form NDE-UT-
ULTRASONIC INDICATION RESOLUTION SHEET	Revision 1
Acceptance Standard: INDICATION #1 - 60° IS A SUBSURFACE INDICATION WITH AN a/t RATIO OF 3.8%. THE CC REPORTABLE PER ACCEPTANCE STANDARD: 1WB-3510-1. SEE THE ATTACHED CALCUL BEEN ISSUED FOR EVALUATION. SEE PIP+0-01-01857.	DE ALLOWS 2.2%. THIS INDICATI ATION SHEET. FORM QA 516A H/
Item No: - C01 030 001	
Item No: C01.030.001	
Item No: C01.030.001 Acceptable Indications: REPORTABLE - IND. #1 - 60°	
Acceptable Indications: REPORTABLE - IND. #1 - 60° Rejectable Indications:	data available
Acceptable Indications: REPORTABLE - IND. #1 - 60° Rejectable Indications:	data available Sheet <u>7</u> of

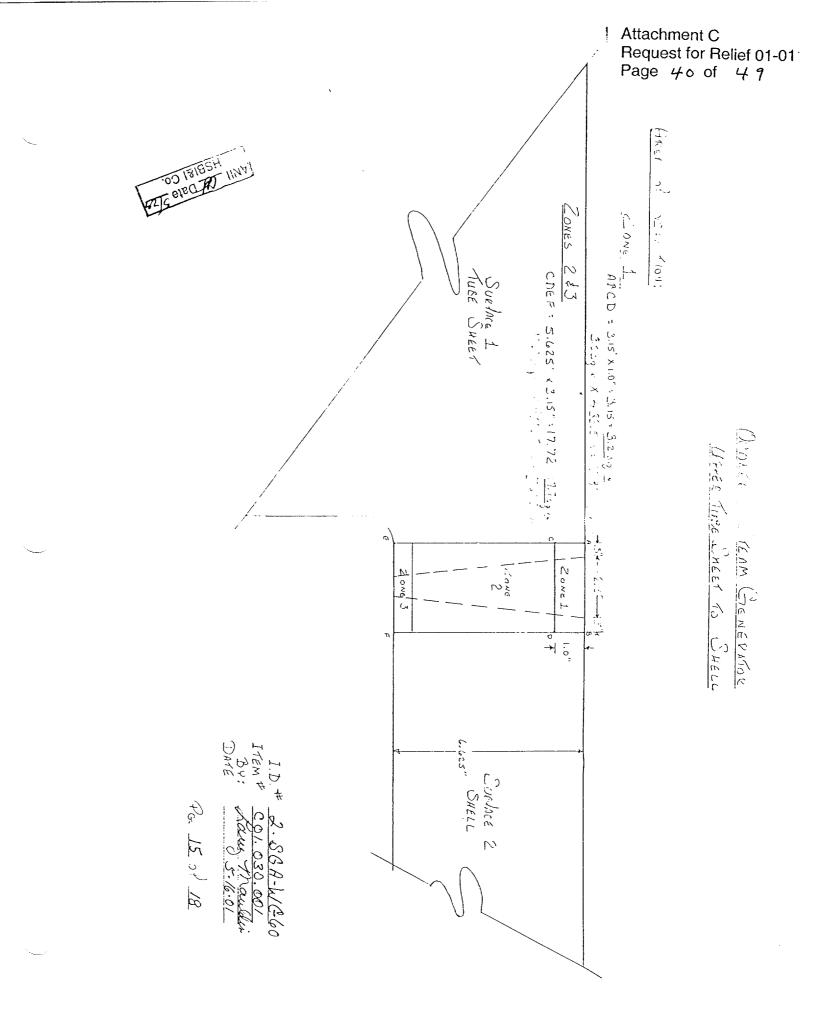
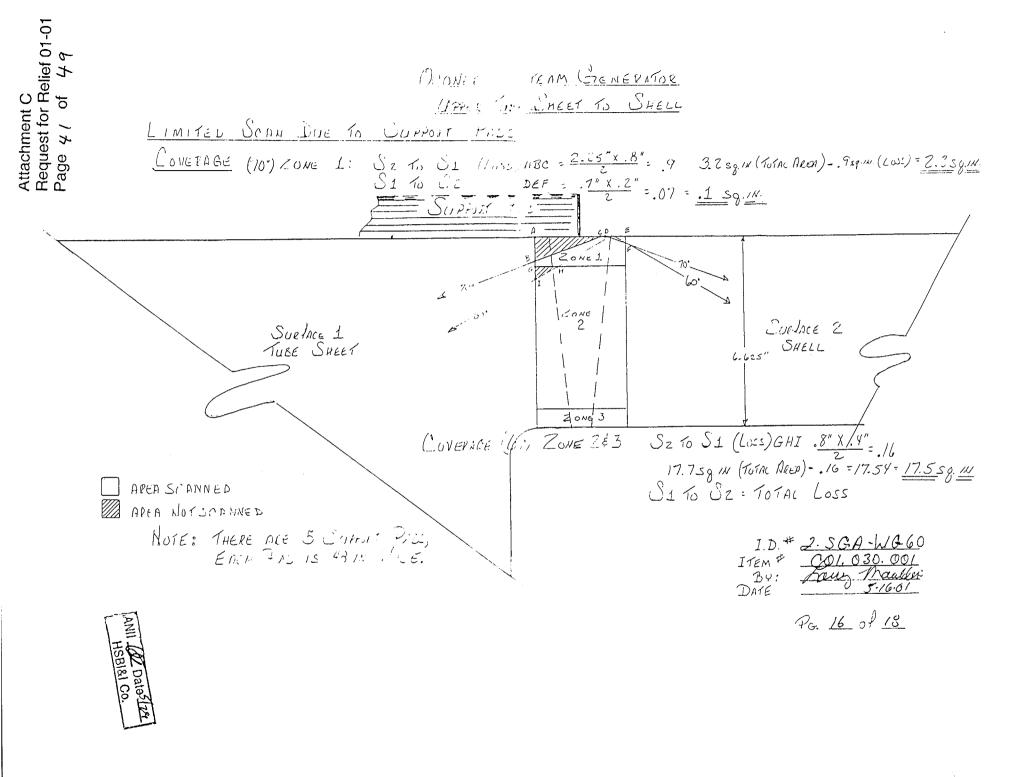
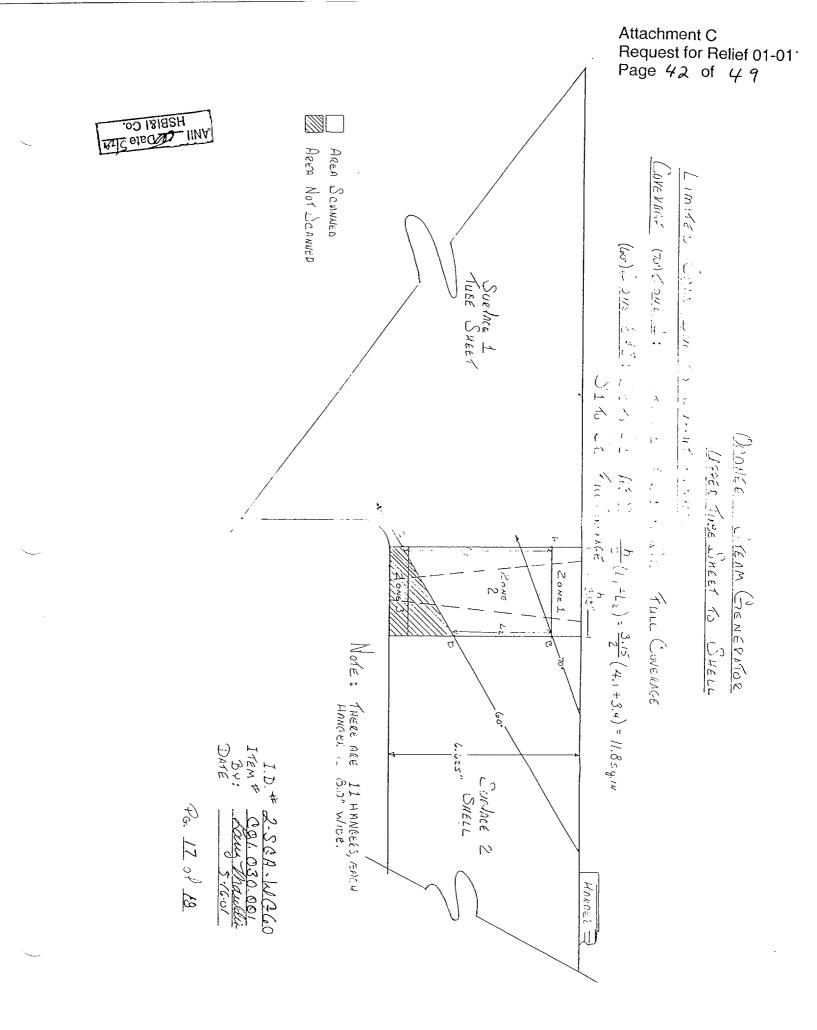
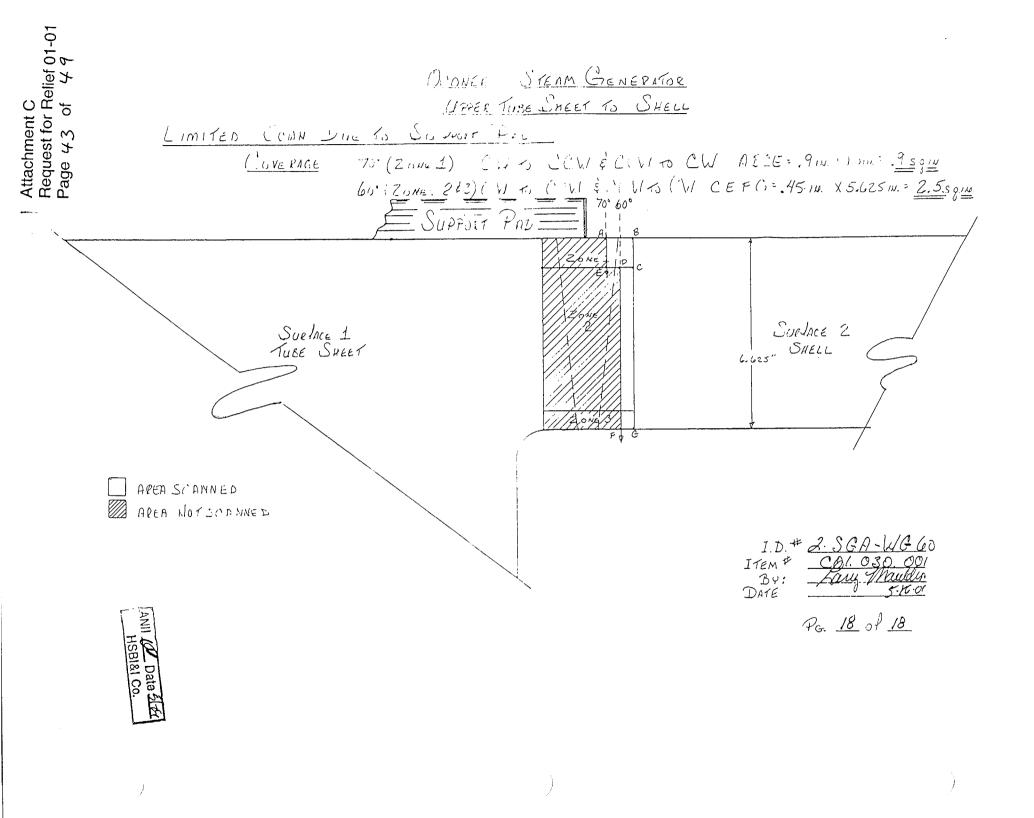
NDE-91-1						
	!		Revision 0						
ing ang sana sa pang ang ang ang ang sana sa		a la antidada de la desarra de esta de la compositiva de la compositiva de la compositiva de la compositiva de	Exan	ninatio	on Volume/A	rea Define	d		
□ Base	Base Metal Weld Near Surface Bolting]	Inner Radius
		Area Cal	culation	<u>.</u>		V	olume Ca	Iculat	lion
				Cov	erage Calcu	lations		`	
				COV	-				
Scan #	Angle	Beam Direction	Exam	Area Length Volum amined Examined Examin sq in.) (in) (cu.in			Volu Requ (cu	uired	Percent Coverage
	70					2594.7	554		46 76
	60					12698.2 15292 9	307: 362:		41 32 42 15

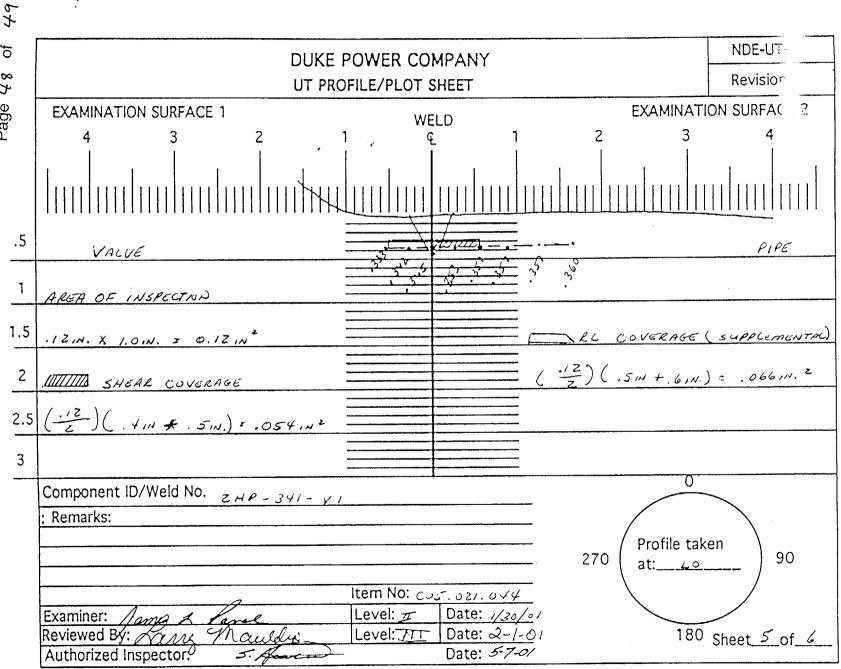
NDE	-91-1				
			Revi	sion 0				
Examination Volume/Area Defined								
🖾 Bas	se Meta	Bolting	🗆 In	ner Radius				
		Area Calcul	ation			Volume Cal	culation	
.12 in. X 1.0 in. = 0.12 sq.in. 0.12 sq.in. X 9.03 in. = 1.08 cu.in.								
			Cov	verage Ca	alculations			
Scan #	Angle	Beam Direction	Area Examined (sq in)	Lengt Examin (in-)	ed Examine	d Requ	red Perce	ent Coverage
1	60°	1	054	<u> </u>	0 49	1.0	8	
2	601	2	0	9.03	C	10	8	
3	45°	CW	.12	.12 9.03 1.08 1.0			8	
4	45°	CCW	.12	0.03	1.08	1.0	8	
		Shear Wave	Aggregate	Coveraç	ge 2.65	4.3	2	61.34
	60°L	Supplemental	Coverage					0.00
1	60°L	1	.066	9.03	0.6	1.0	8	55.56
								0.00
