SUBJECT: RESOLUTION OF DEGRADED CEQ FAN ROOM WALL

Discussion of Containment
Subcompartment Walls

Restarting D. C. Cook
June 1, 2000

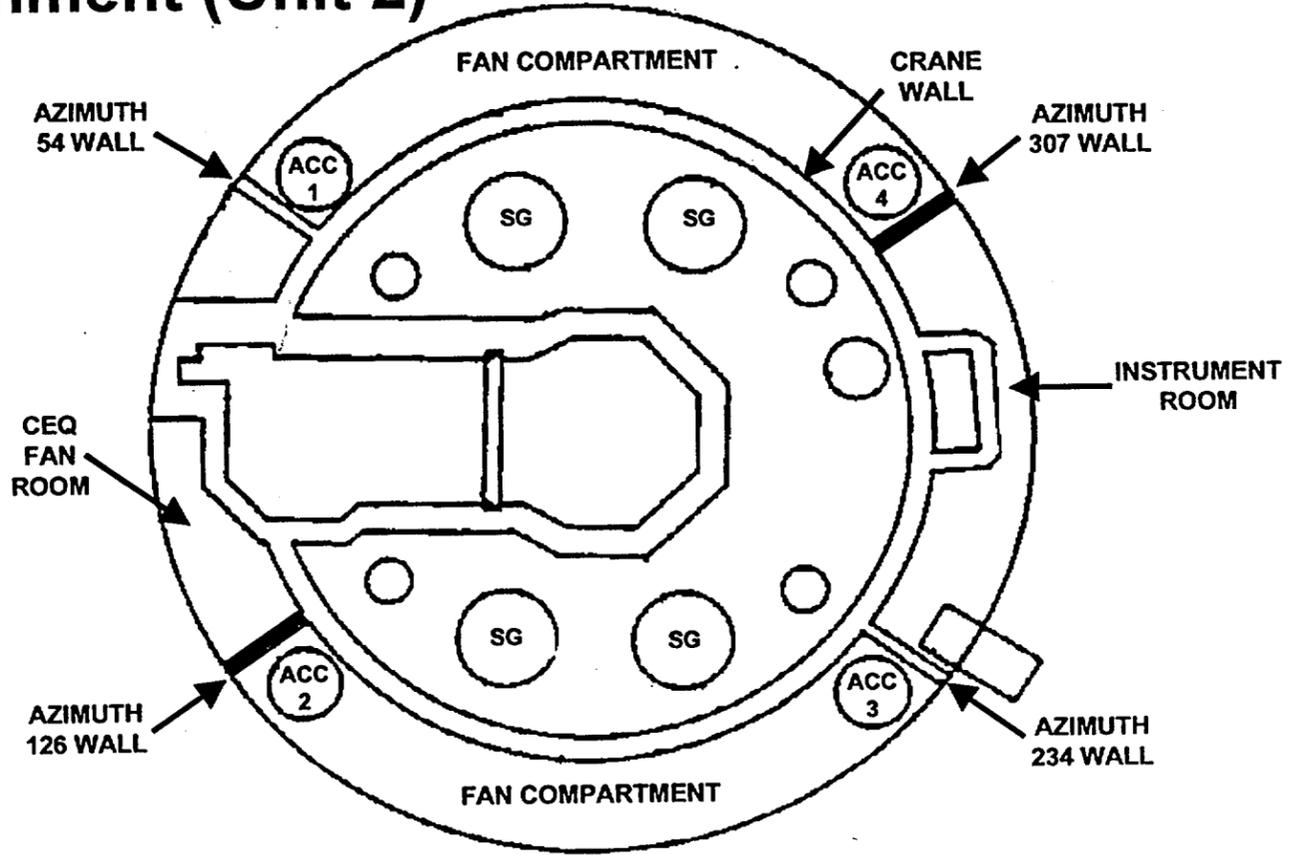
Background: Diagram of Containment Subcompartment Walls

■ Containment (Unit 2)
