American Electric Power

Nuclear Regulatory Commission

Discussion of Containment
Subcompartment Walls

Restarting D. C. Cook
June 1, 2000

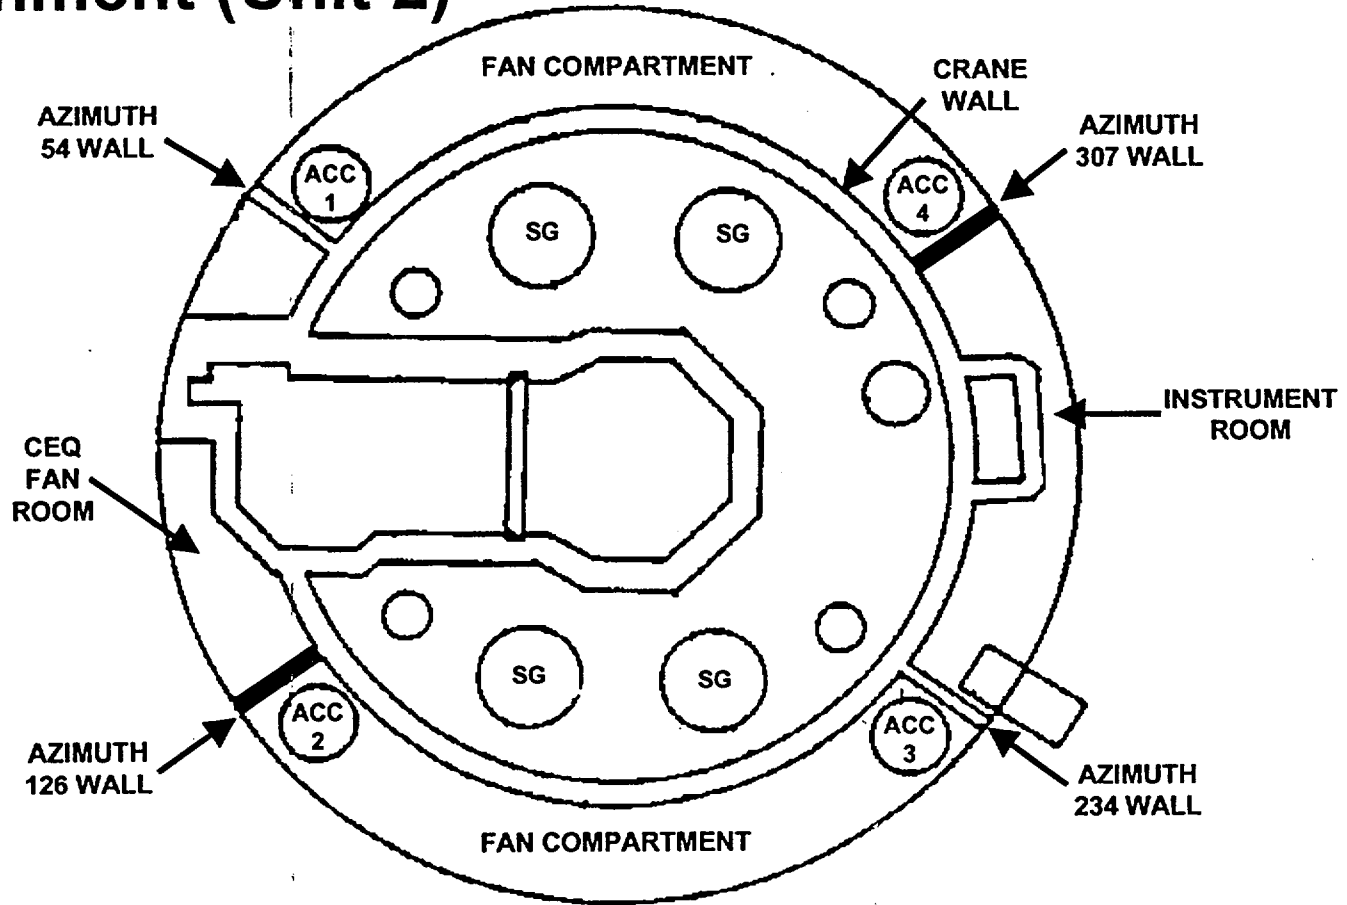
■ Containment (Unit 2)

- **Two end walls of CEQ Fan Room (Upper Compartment)**
- **Two end walls of Instrument Room (Lower Compartment)**
- **All walls restrained at three sides**
