# HSA

Historical Site Assessment

**HSA ID# 50**

OPERATIONS DEPARTMENT  
UNUSUAL OCCURRENCE REPORT (UOR)

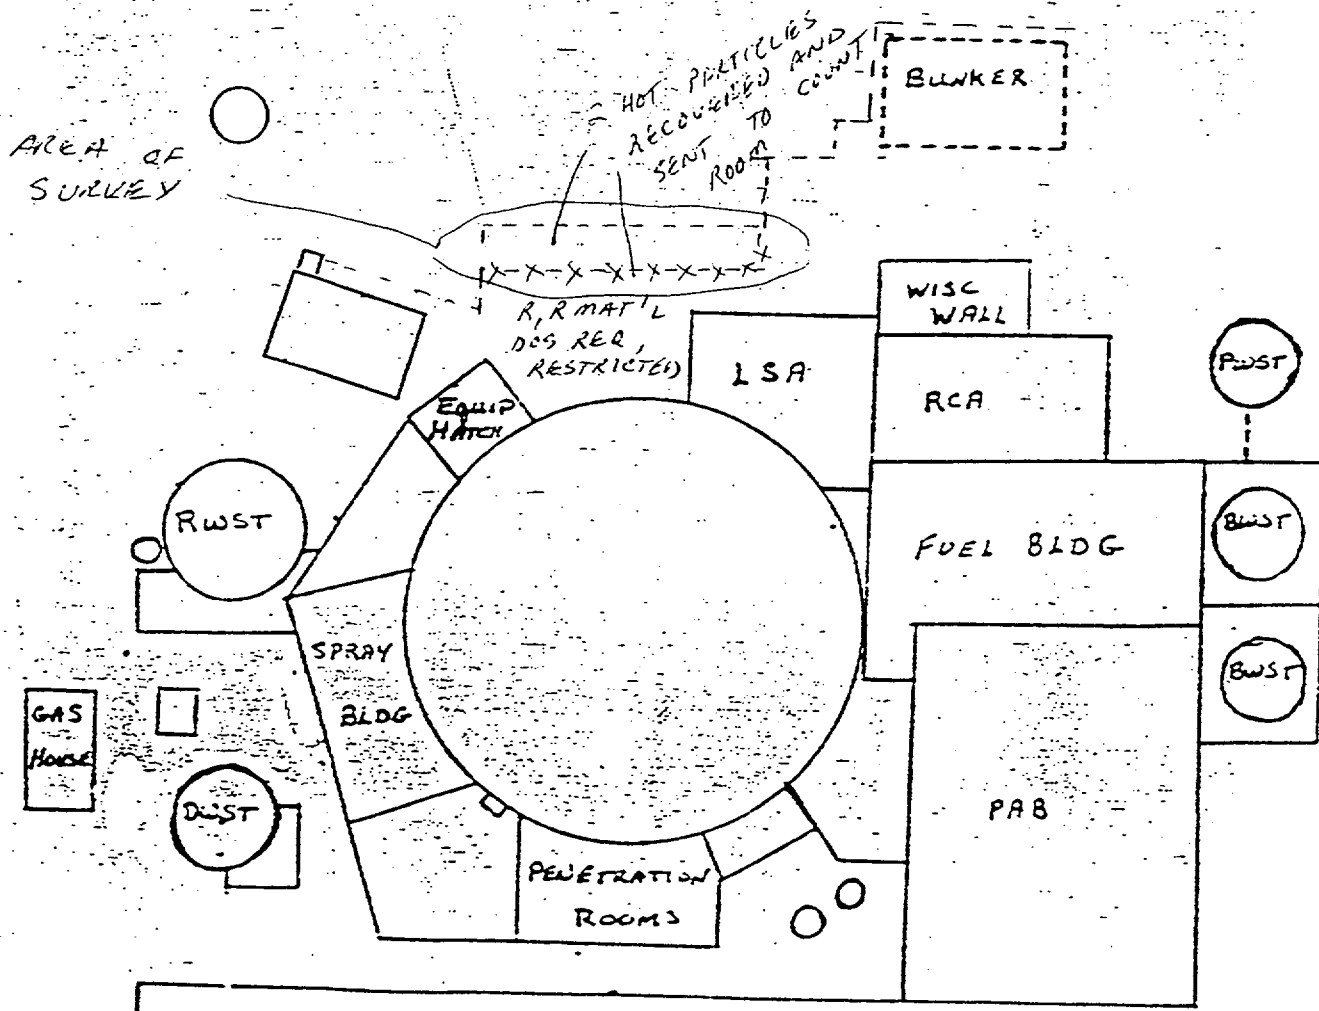
NOTE: AREA RELEASED BY  
 DIRECT FRISK. ALL  
 AREA RELEASED <  
 500 CPM. 2 HOT  
 PARTICLES REMOVED  
 AND SENT TO COUNT  
 ROOM.

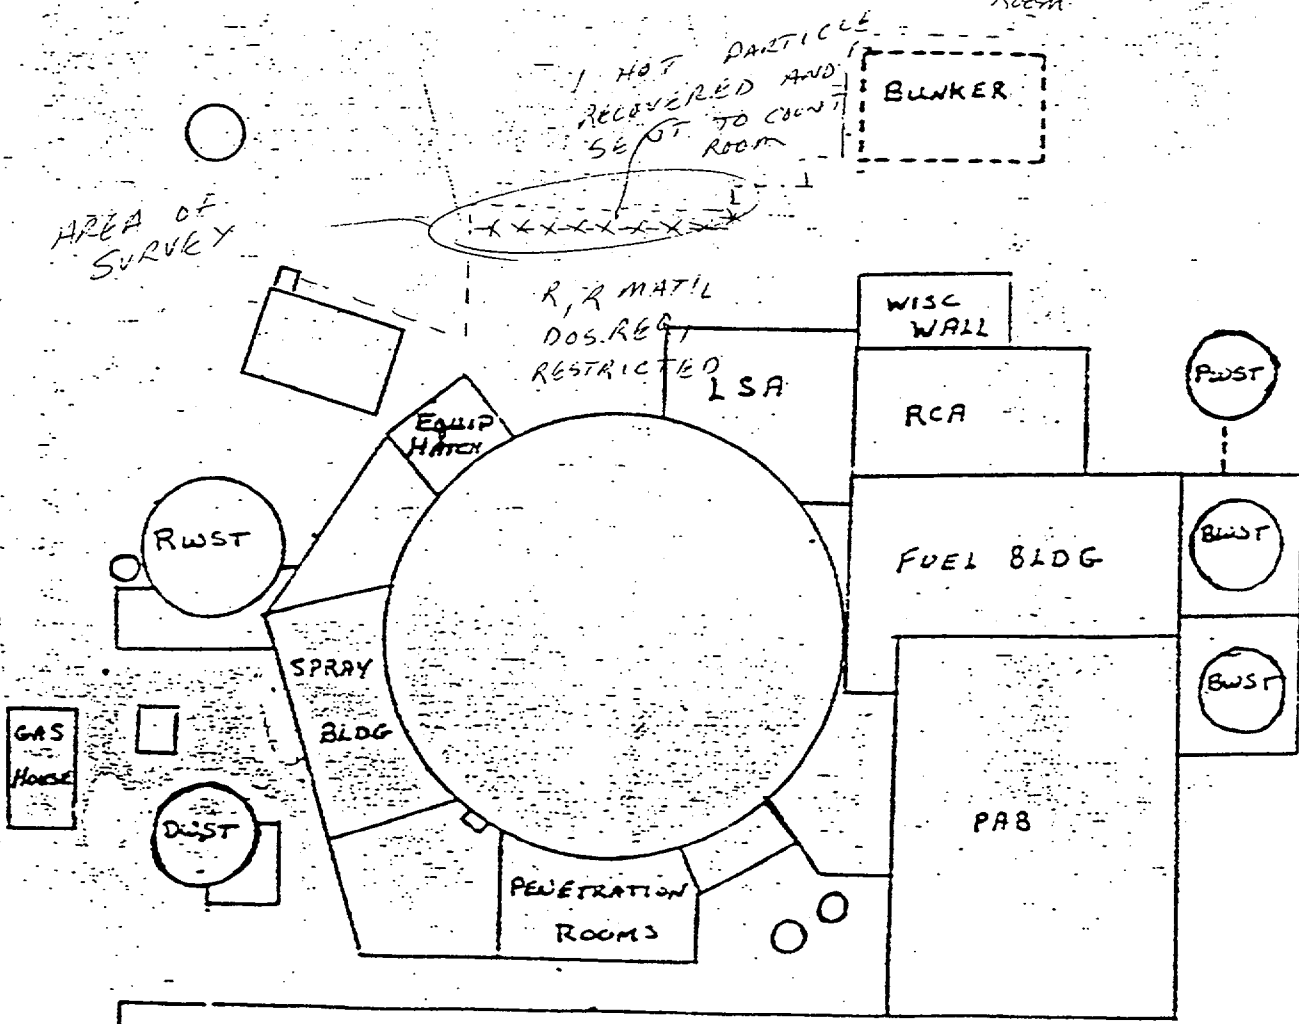
NOTE: AREA RELEASED BY DIRECT FRISK. ALL AREA RELEAS. 2500 CPM. 1 HOT PARTICLE RECOVERED AND SENT TO COUNT ROOM

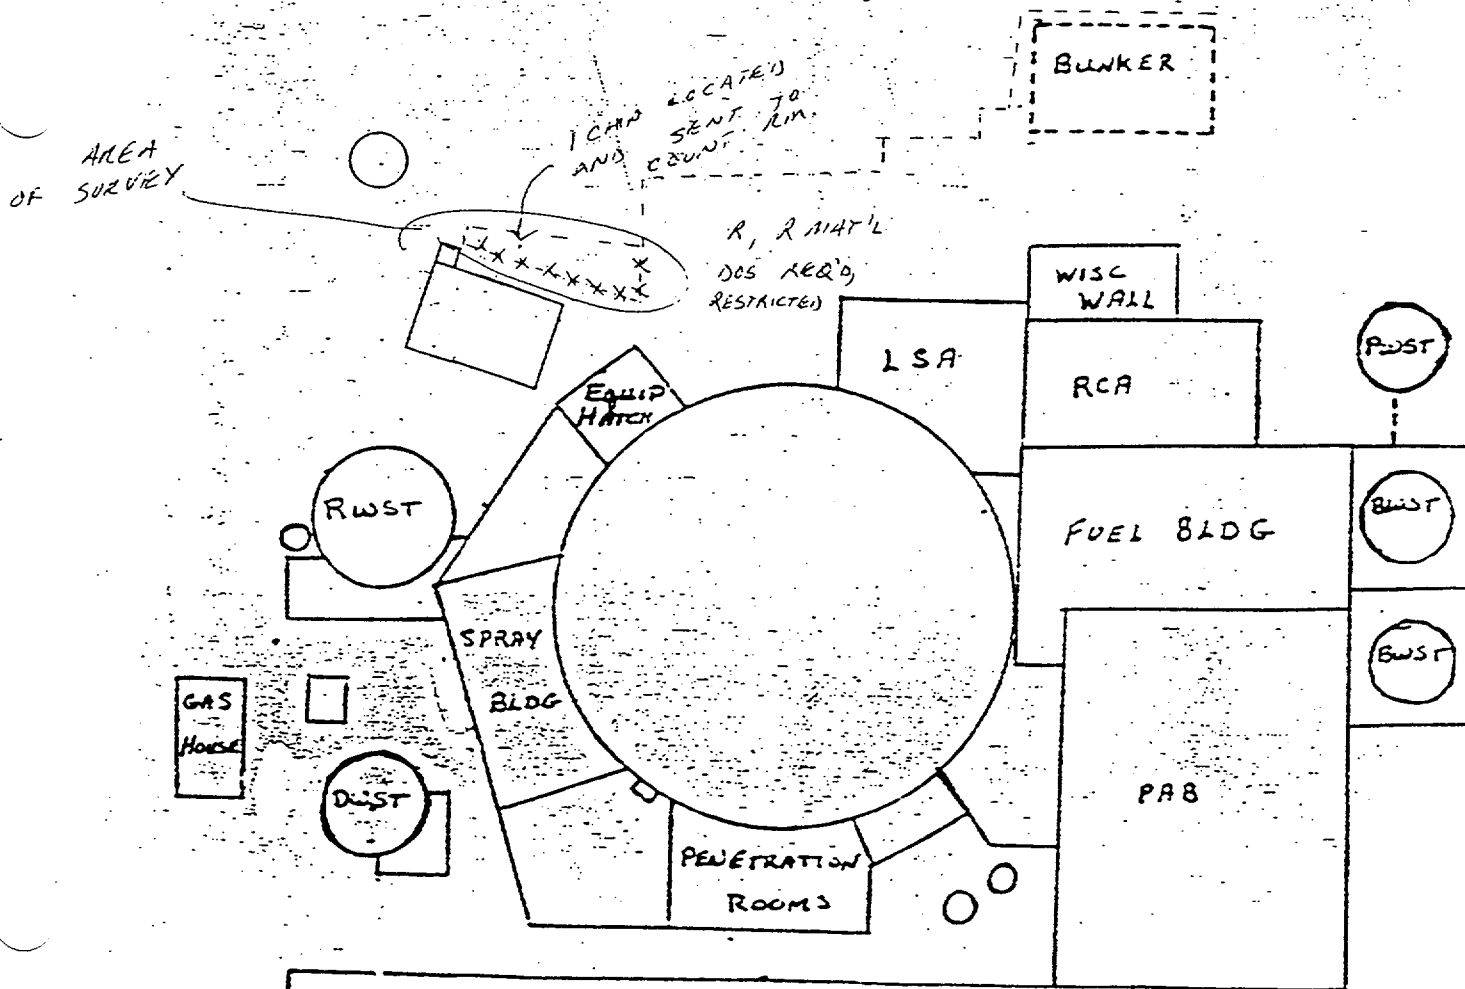
NOTE: AREA RELEASED BY DIRECT  
 RISK, ALL AREA RELEASED  
 < 500 CPM. 1 HOT PARTICLE  
 COLLECTED AND SENT TO  
 COUNT ROOM.

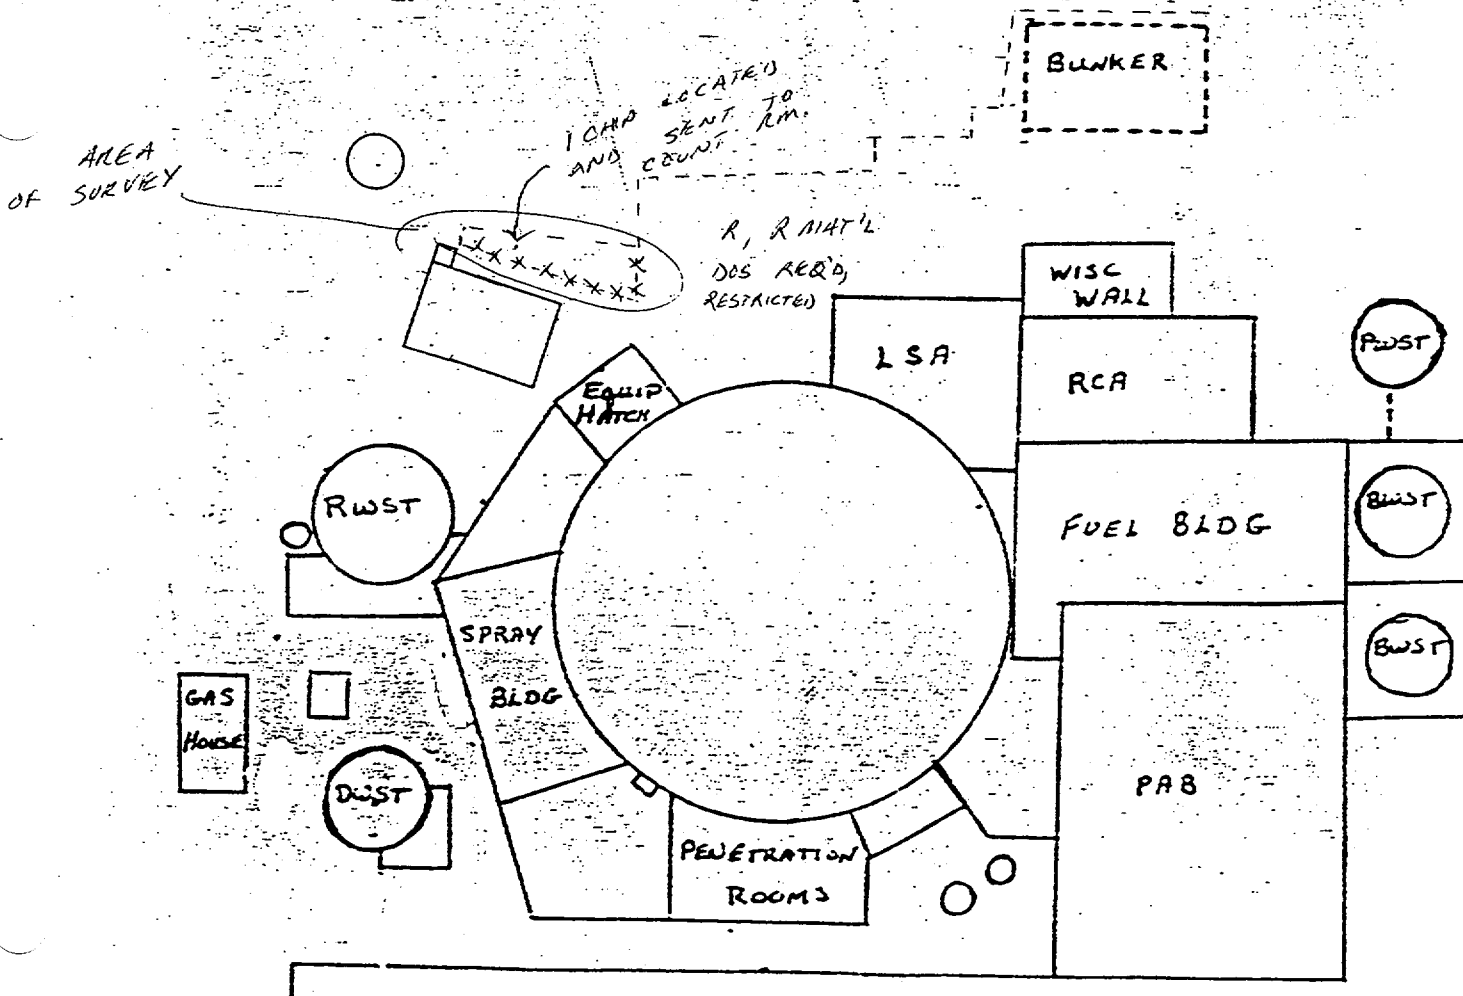
NOTE: AREA RELEASED BY DIRECT  
 FRISK, ALL AREA RELEASED  
 < 500 CPM. 1 HOT PARTICLE  
 COLLECTED AND SENT TO  
 COUNT ROOM.

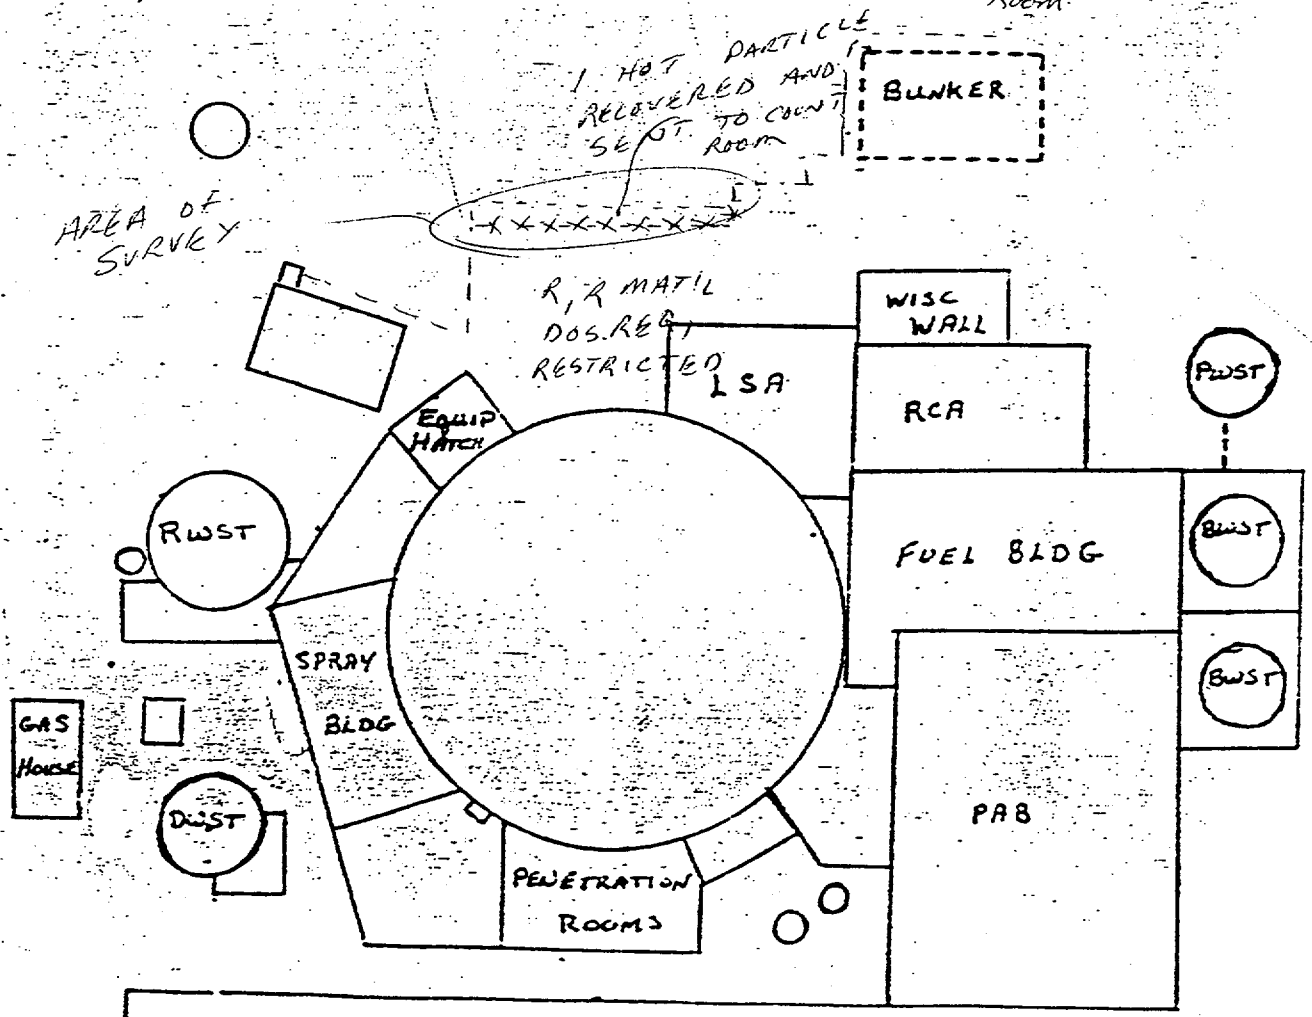
NOTE: AREA RELEASED BY DIRECT FRISK. ALL AREA RELEASE 2500 cpm. 1 HOT PARTICLE RECOVERED AND SENT TO COUNT ROOM.

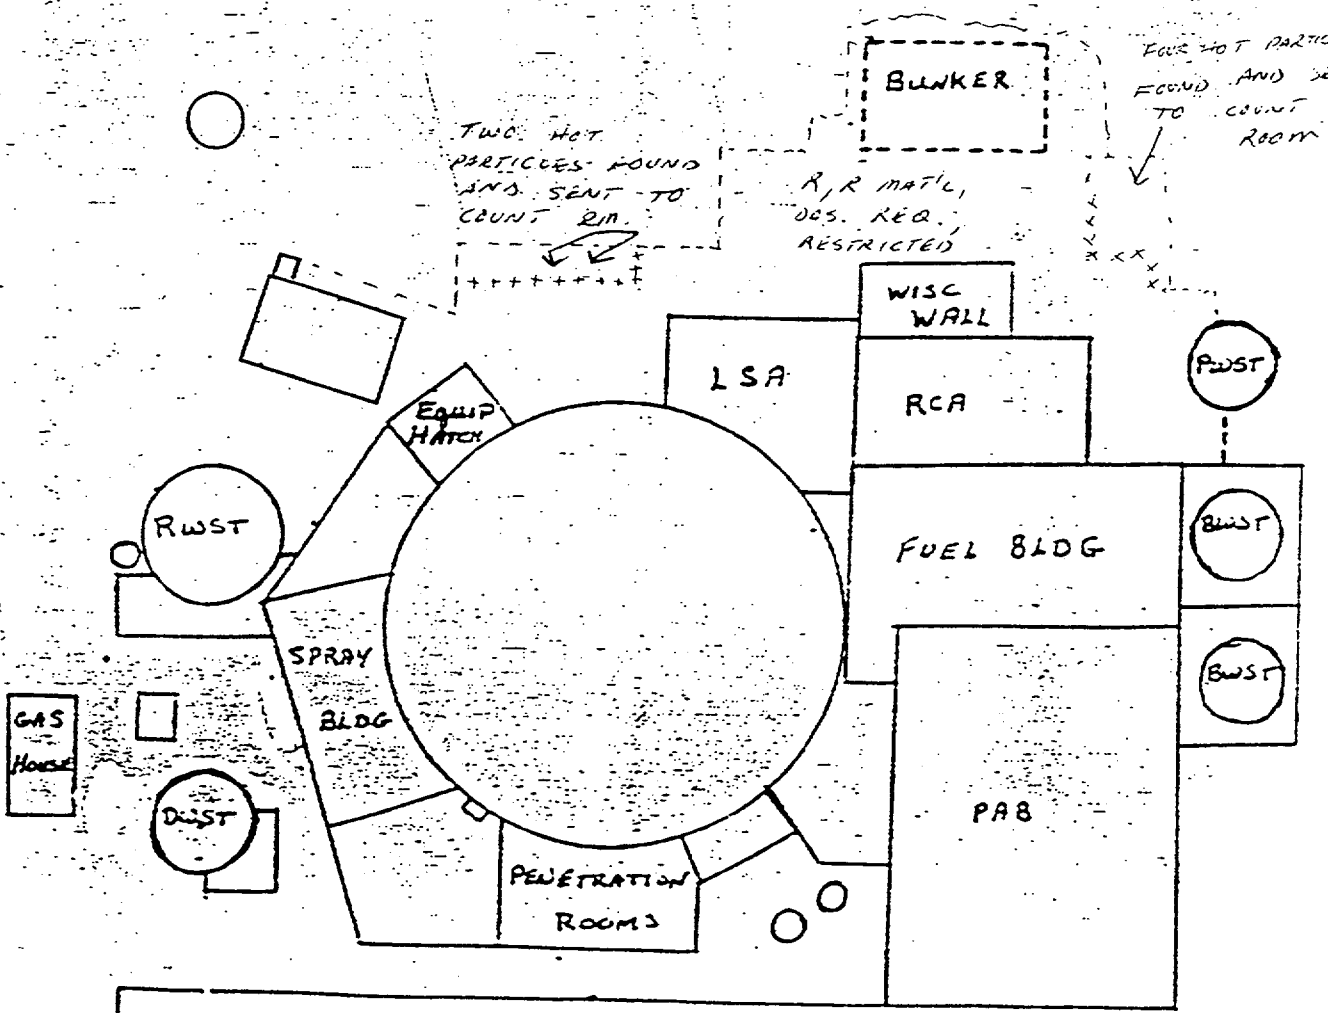
NOTE: AREA RELEASED BY DIRECT  
FRISK. ALL AREA RELEASED  
2300 CPM. SIX HOT  
PARTICLES COLLECTED AND  
SENT TO COUNT ROOM.

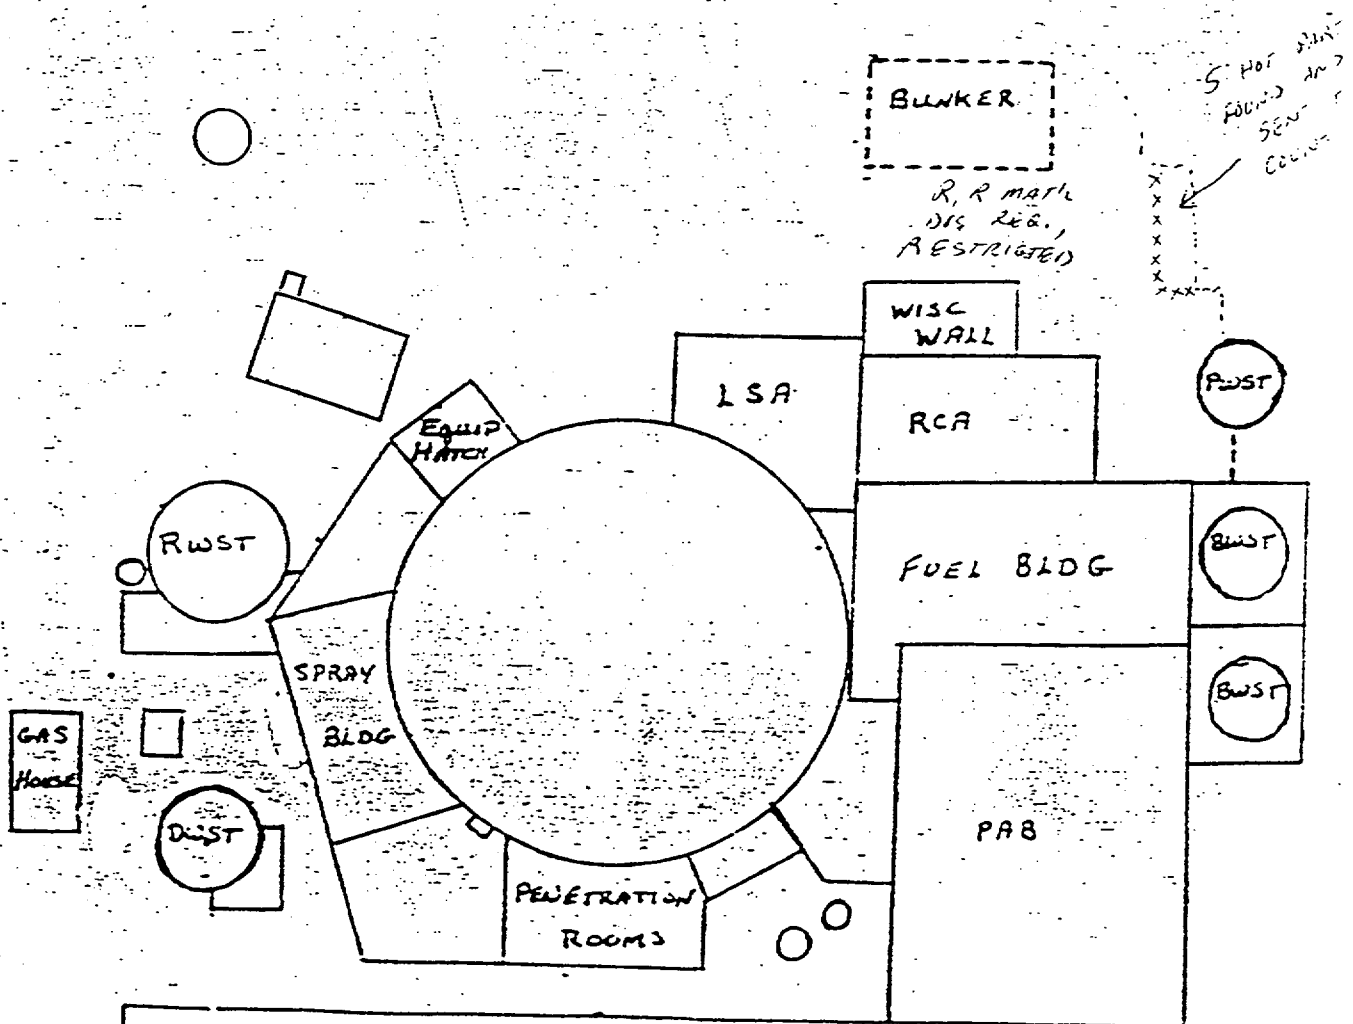
NOTE: AREA SURVEYED BY DIRECT FRISK. ALL AREA RECEIVED  $\approx$  200 CPM. FIVE HOT PARTICLES FOUND AND SENT TO COUNT ROOM.

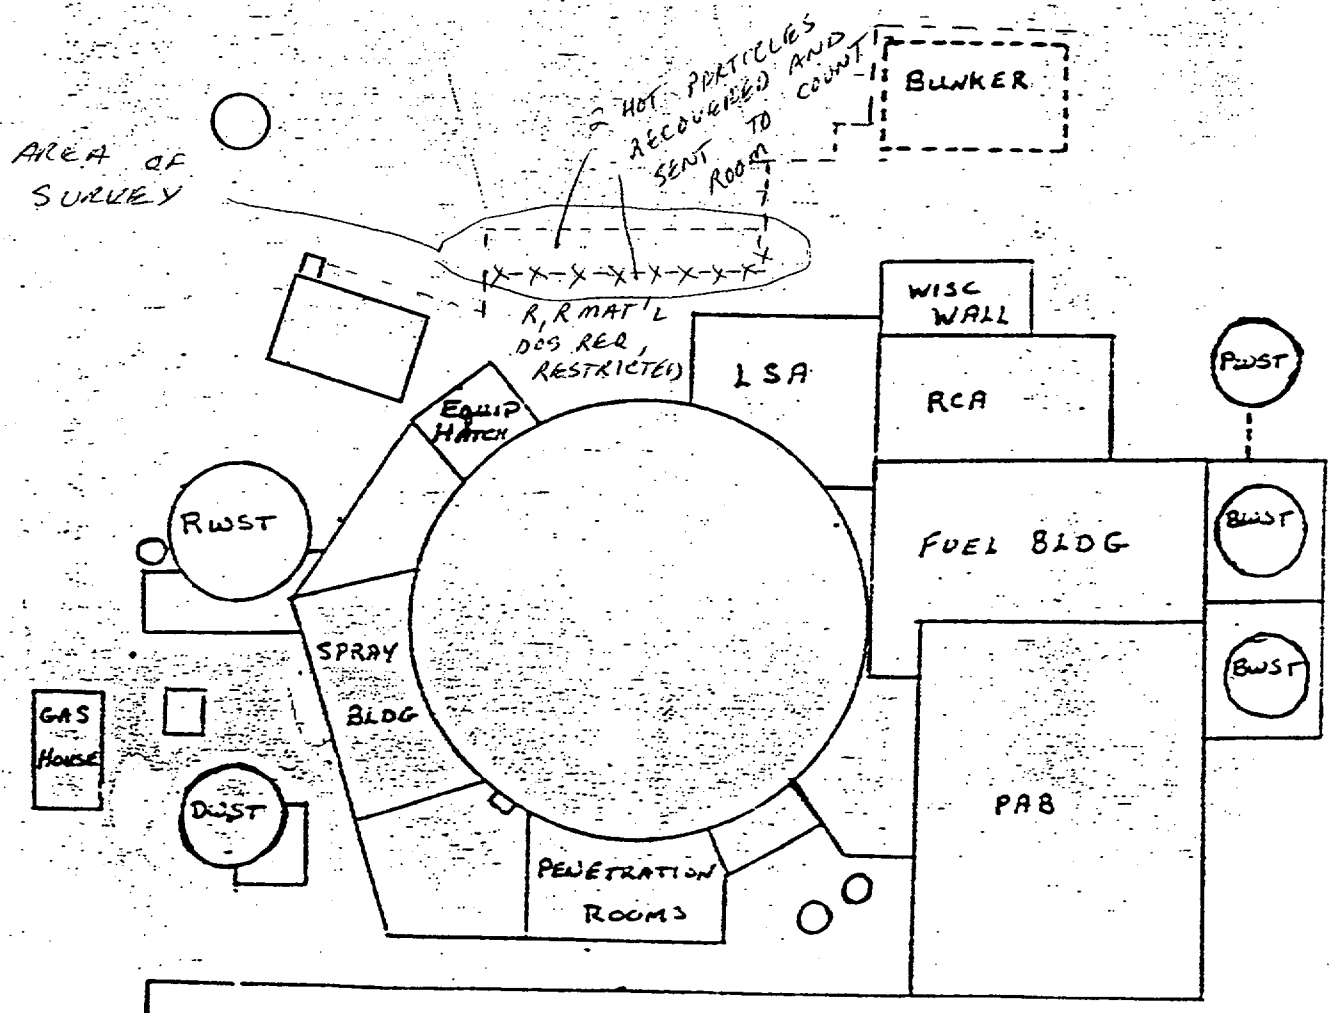
NOTE: AREA RELEASED BY  
 DIRECT FRISK. ALL  
 AREA RELEASED <  
 500 CPM. 2 HOT  
 PARTICLES REMOVED  
 AND SENT TO COUNT  
 ROOM.

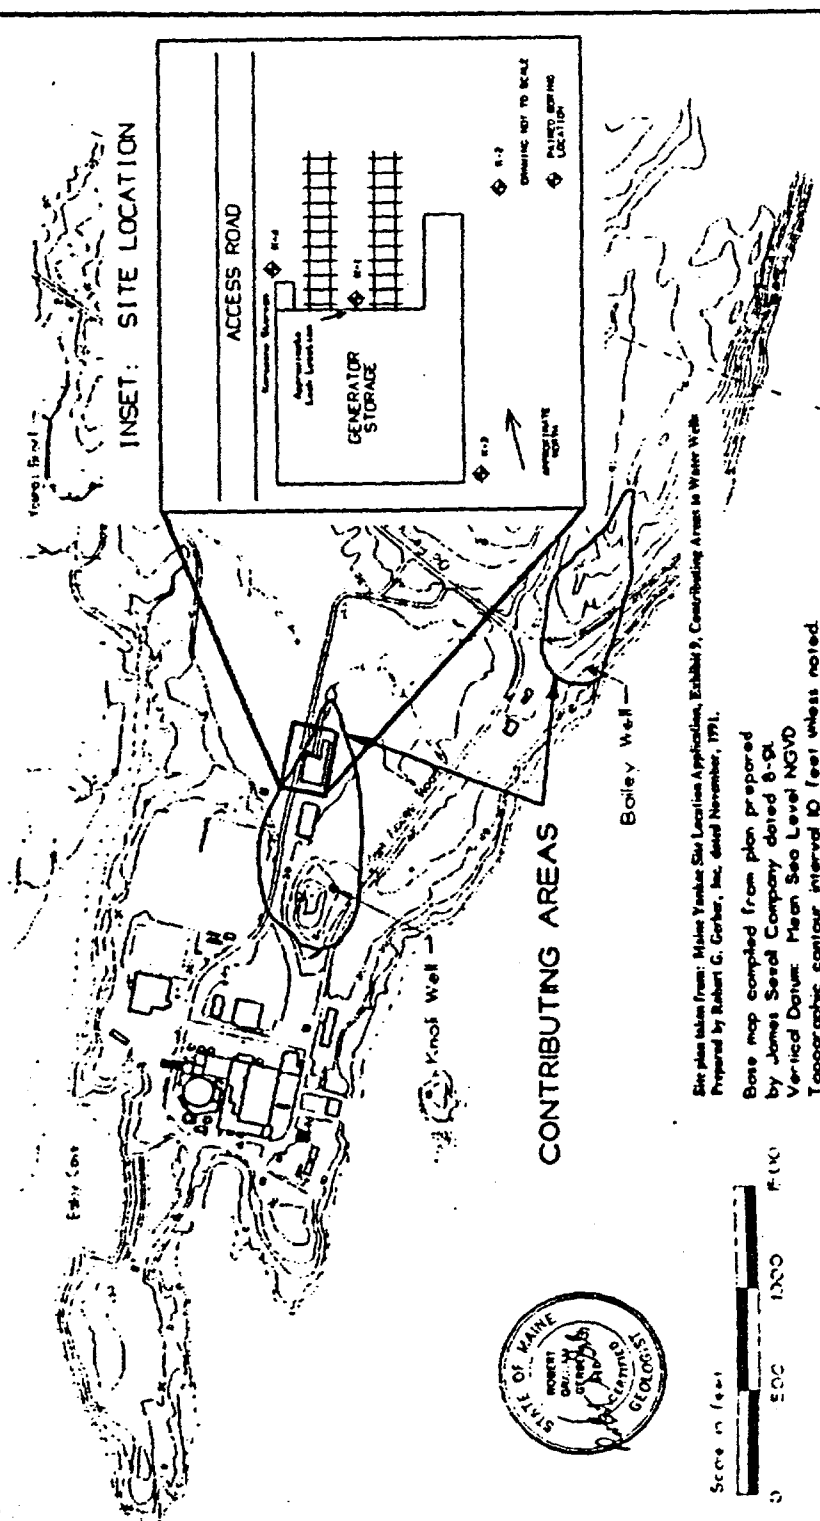
FIGURE 1. Approximate Site Plan and Boring Locations

At your request, GERBER began the current subsurface investigation August 8, 1994. The boring program consisted of three pairs of borings. These pairs are located in a triangular pattern around the leak location (Figure 1). The pattern was ideally arranged so that one pair of borings is located 30 to 50 ft. from the leak location on a line with the Knoll Well. The other two pairs are located approximately 30 to 50 ft. from the leak location and in 120° increments around the leak location as a pole. We followed this arrangement as closely as possible; however, some adjustments were required by structural obstacles, underground utilities, and overhead power lines.

We have estimated the direction of ground water flow as generally west at the site from hydraulic gradients observed in wells installed in the overburden (Figure 2) and shallow bedrock (Figure 3). This is supported by westerly surficial drainage to discharge in Bailey Cove (Figure 1). Borings advanced during this investigation indicate that native overburden is typically slowly permeable glaciomarine deposits ranging from about 15 to 30 ft. in thickness. High concentrations of VOC's were only measured at soil boring B-1. Concentrations of VOC's increased with depth to a maximum (150 ppm) at approximately 5 ft. Detected values quickly became negligible.
