**HSA ID# 25**

RADIOLOGICAL INCIDENT REPORT

LOCATION: RWST SIPHON HEATER AREA

MAINE YANKEE ATOMIC POWER COMPANY  
GENERAL SURVEY FORM

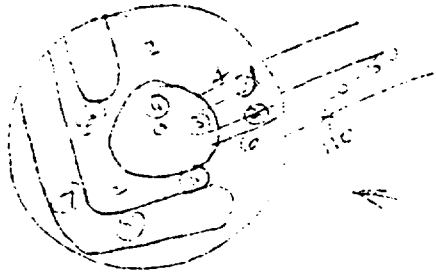
Area/Item Area 1

- 1-1100
- 2-2300
- 5-2950
- 9-1550
- 10-3560
- 12-10900
- 13-4300
- 15-1100
- 17-2000
- 18-3500
- 20-2000
- 22-1400

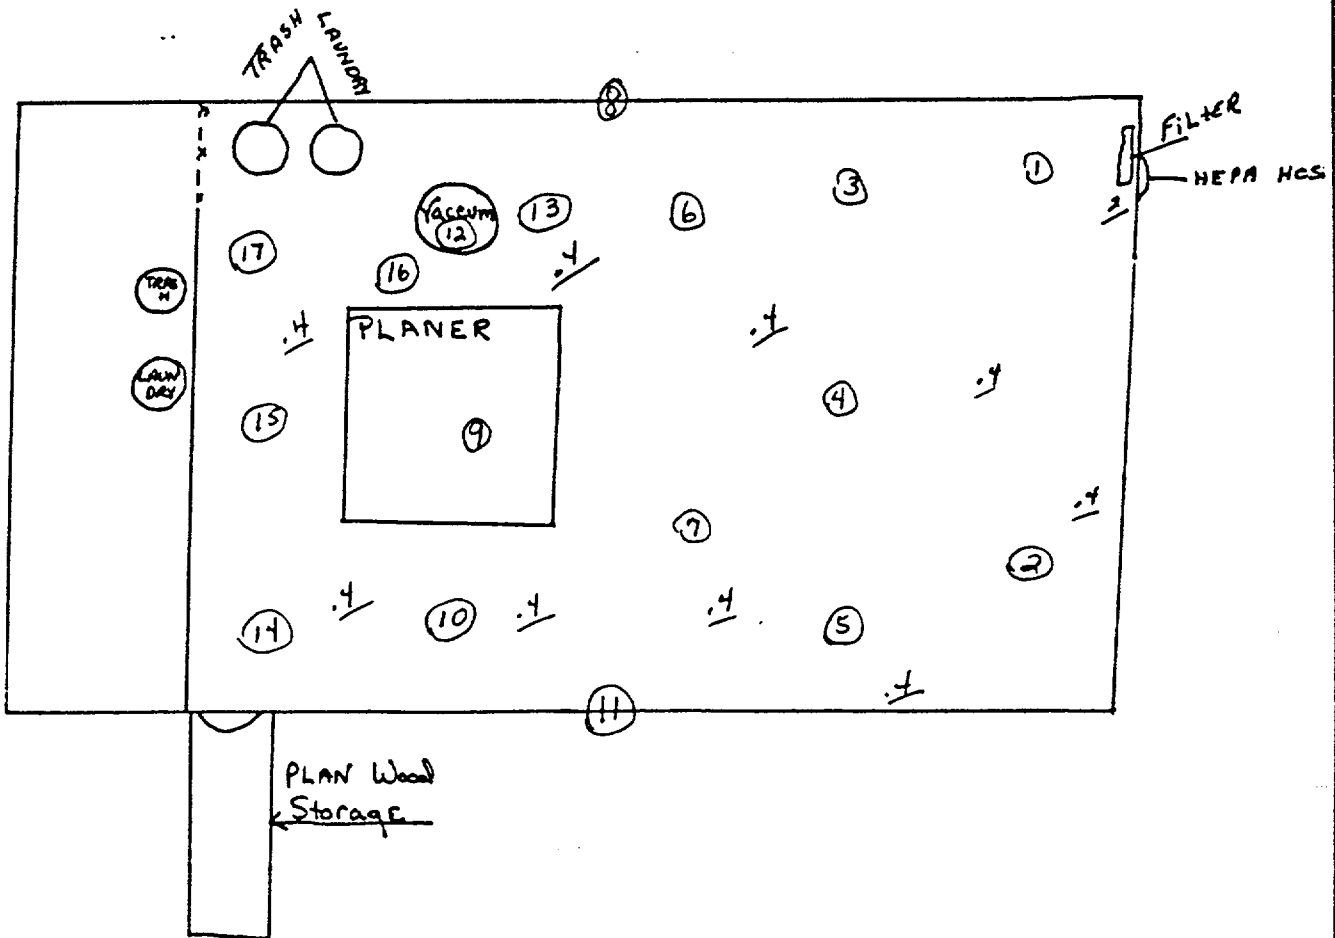
Area/Item Boxing Test  
RWP 89-10-770

*All smears < 1K*

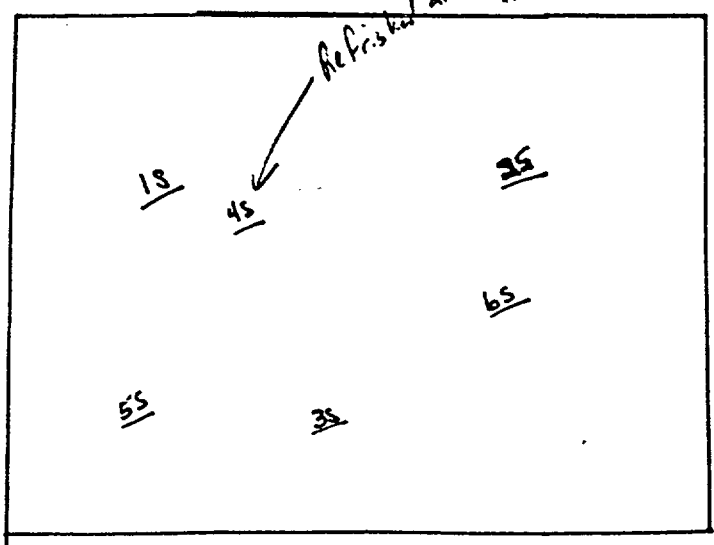
Area/Item Area Where  
Wood was Store  
on clean side.

- 1 attach
- 2 see attach
- 3 < 7.57E-7  
1.29E-4 via Env. CS-137  
see attached.
- 5 < LLD
- 6 see attach

Sample 3 was  
water  
< 7.57E-7

1S was snow reading 800 cpm when removed  
area was Reading < 100 cpm

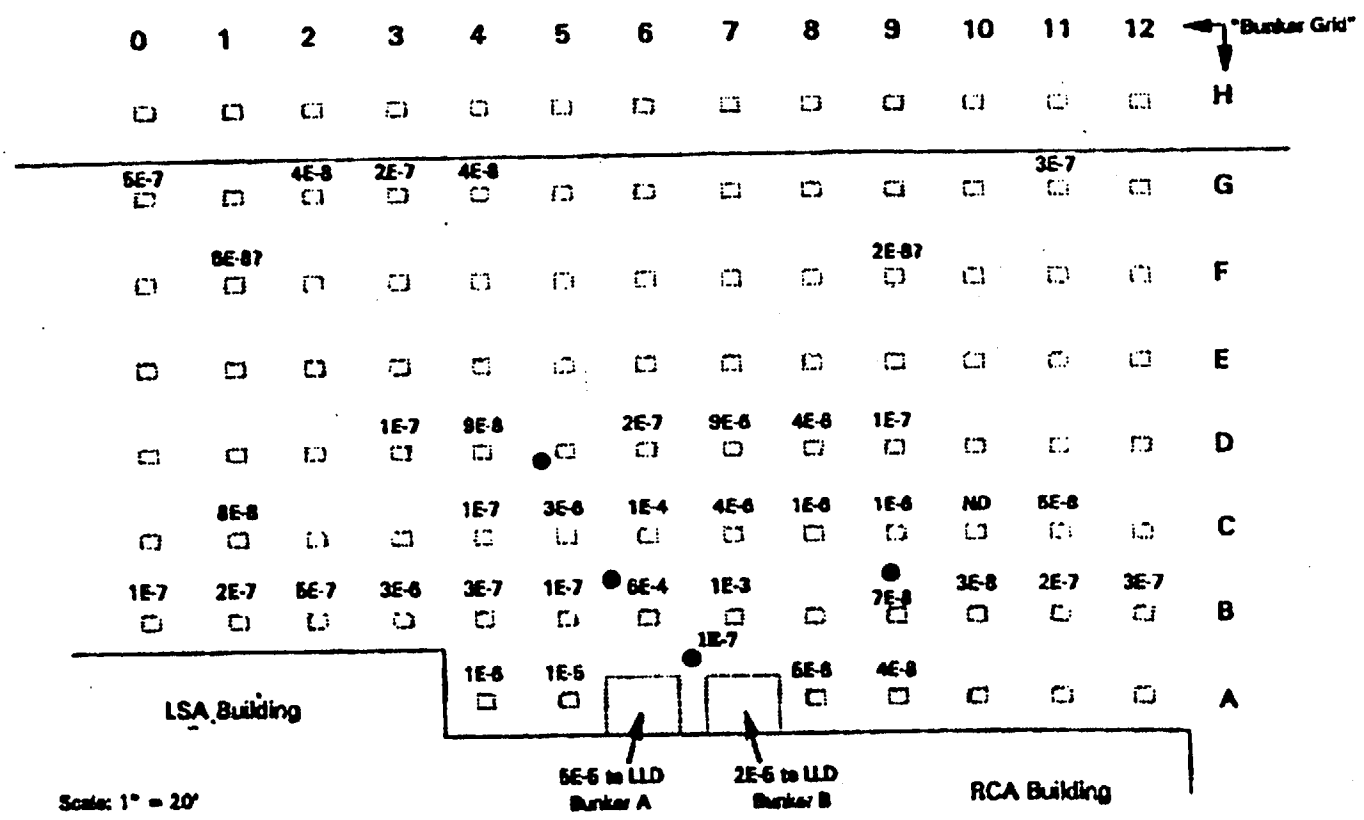
### Co 60 concentrations uCi/gm MY Rad Bunker Area

● 1E-7 BK-1 Soil Boring with activity in top 24"

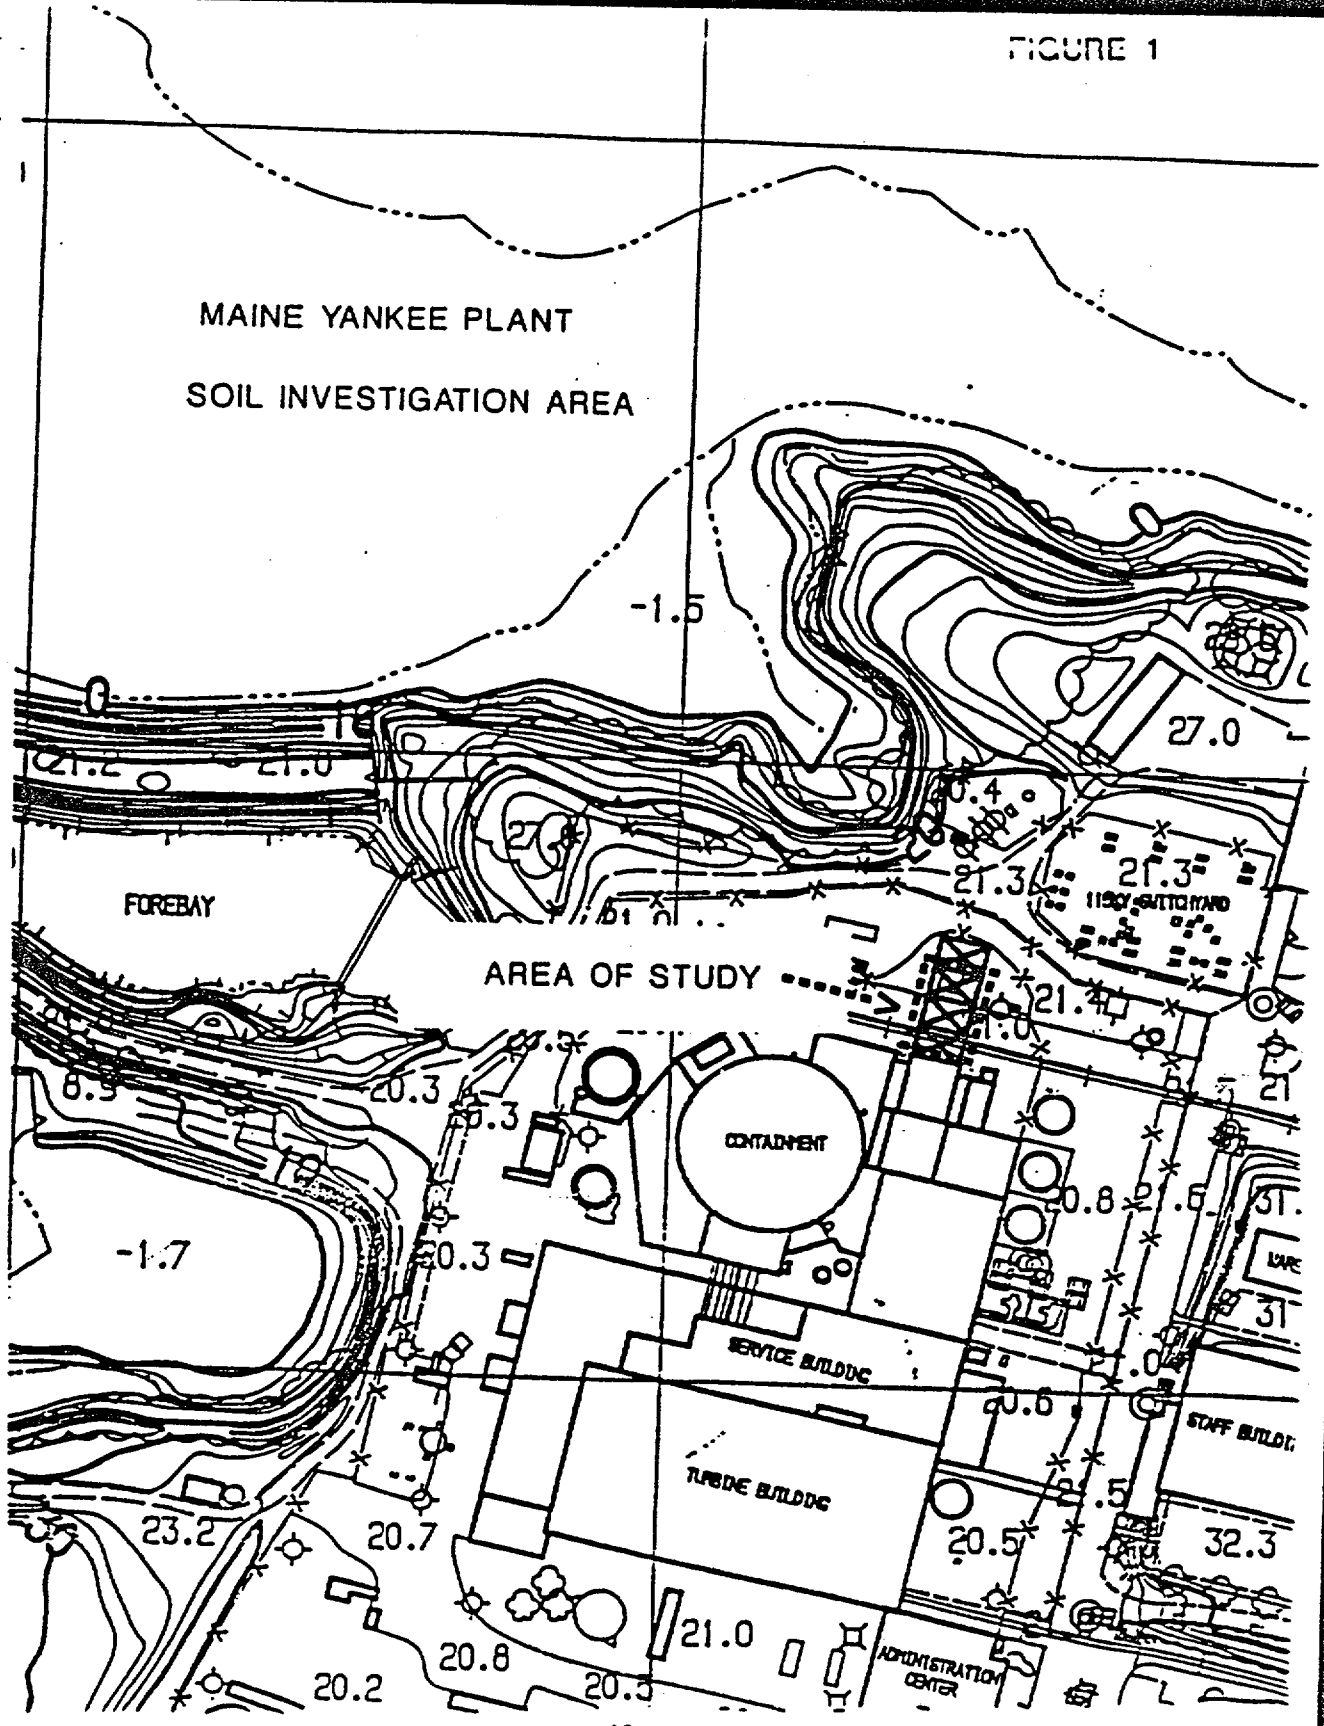
FIGURE 1

The study area is located in the plant yard adjacent to the Rad Waste Building (Figure 1). It occupies a total area of approximately 2000 ft<sup>2</sup>.

MAINE YANKEE PLANT  
SOIL INVESTIGATION AREA

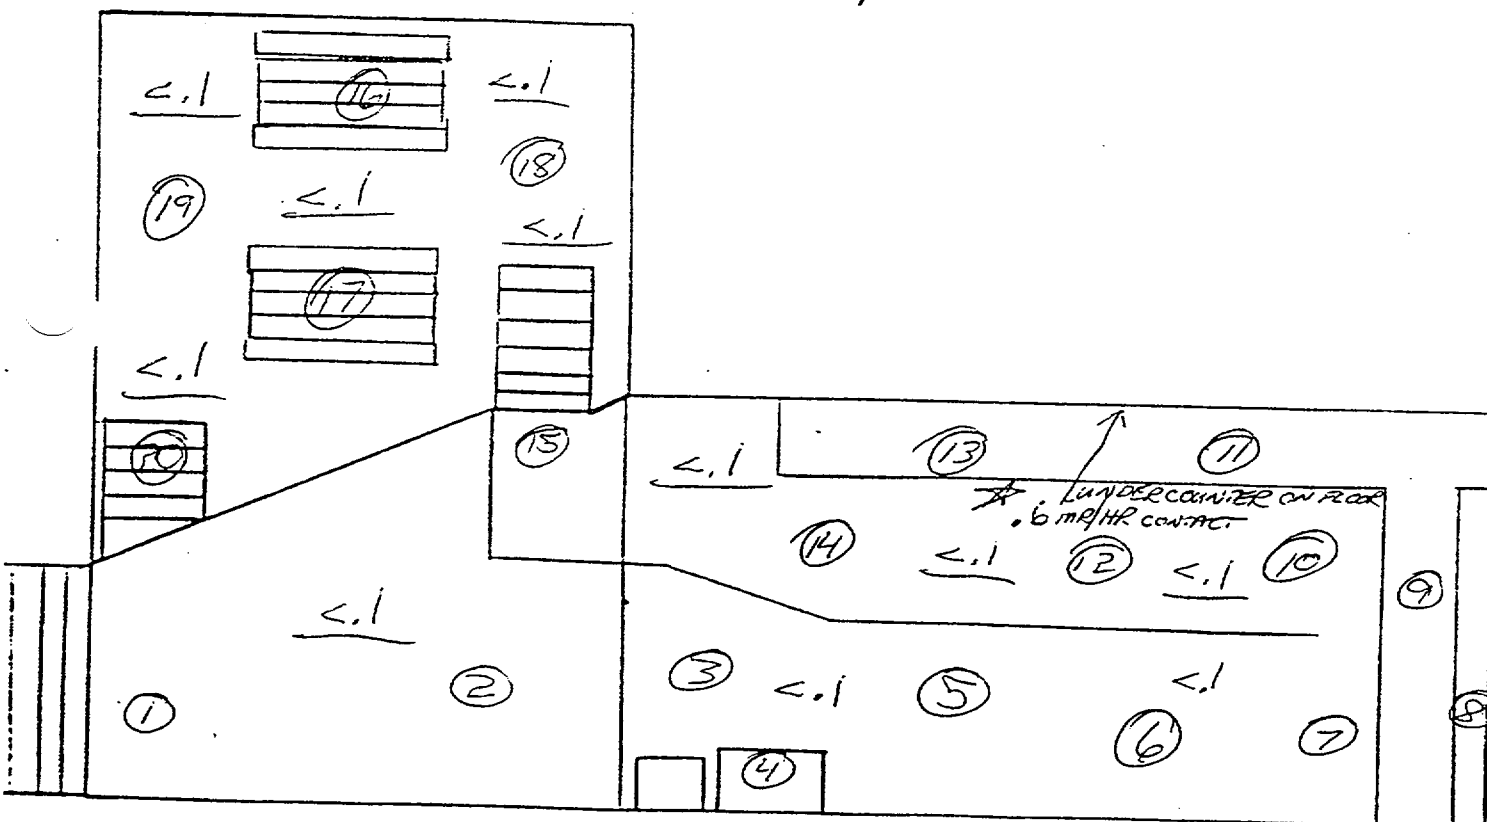
Area/Item DOCK TRAILER

ALL CONTAM. LEVELS < 100 DPM/100cm<sup>2</sup>

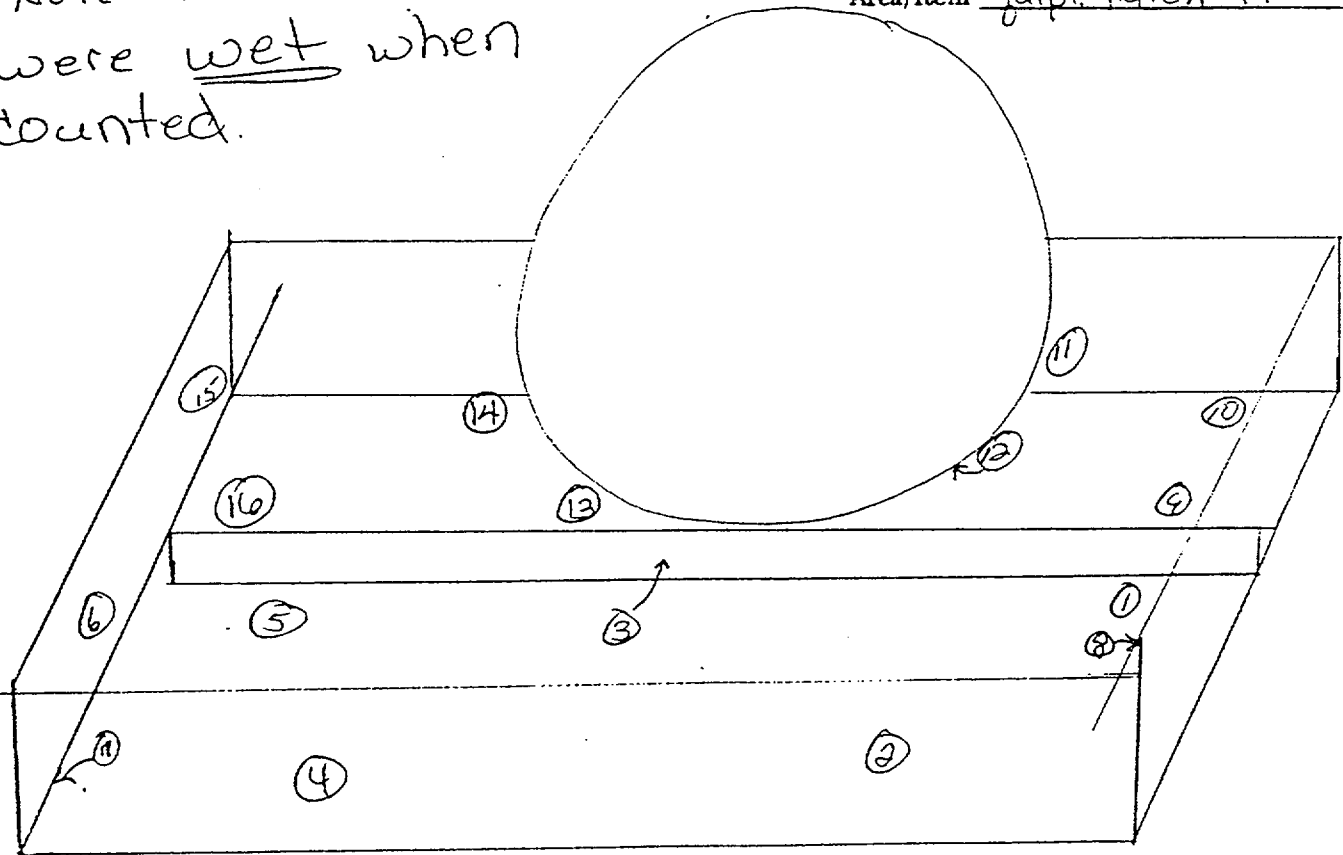
Area/Item Equip. Hatch Pit

① 220 dpm/100cm <sup>2</sup>	⑨ 390 dpm/100cm <sup>2</sup>
② 890	⑩ 385
③ 240	⑪ 395
④ 893	⑫ 410
⑤ 925	⑬ 395
⑥ 285	⑭ 435
⑦ 320	⑮ 320
⑧ 333	⑯ 450
