HSA ID# 78

OPERATIONS DEPARTMENT  
UNUSUAL OCCURRENCE REPORT (UOR)

- A. TITLE OF UOR: SCAT TANK LEAK IN LINE TO LT 3201
- B. DATE/TIME OF EVENT: 9/19/90 1700
- C. DATE/TIME UOR COMPLETED: 9/19/90 2000

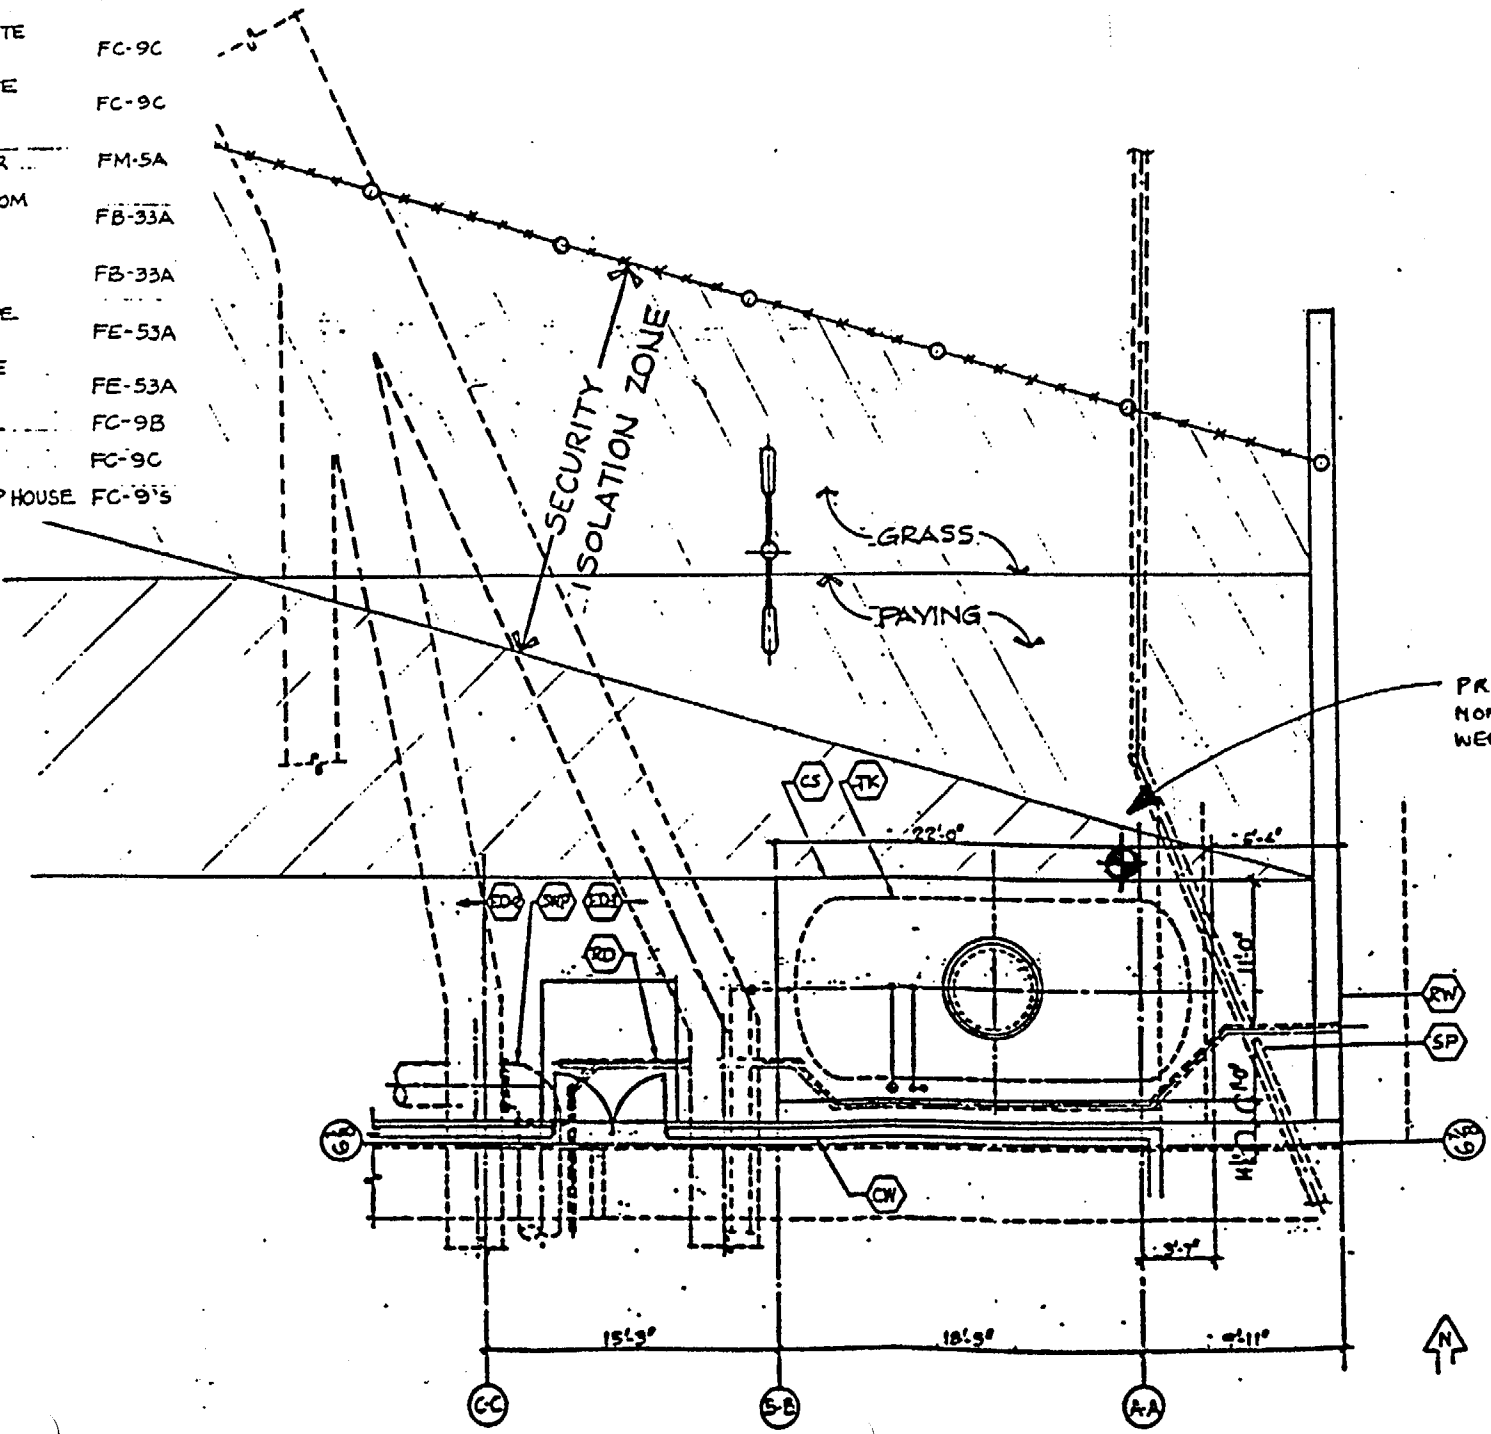
**Fig 1**  
**Monitoring 1**  
**Maine Yankee Fe**  
 Robert G. I  
 Freepor  
 Date: Ap  
 Base map compiled  
 Maine Yankee data

Robert G. Gerber, Inc. (RGGI), in the attached memo, has changed their original recommendation of ferrous sulfate tank removal to abandoning in place based on the following issues:

1. Removal is very complex because of the proximity to the tank of the electrical power supply duct to the seawater pumps for the service water system and the service water piping itself.
2. The tank is adjacent to the circulating water pump house and its removal may raise foundation support concerns for this structure.
3. Shoring will be needed on at least two sides and may be difficult to install on the side away from the pump house.
4. Working in the security zone presents substantial logistical problems.

- FERROUS SULFATE TANK TK-33 FP-74A
- 24" THK CONCRETE HOLD DOWN SLAB FC-9C
- 8" THK CONCRETE COVER SLAB FC-9C
- 24" C.I. PIPE SERVICE WATER FM-5A
- 8" C.I. PIPE FROM SEWAGE PLANT FB-33A
- 4" C.I. PIPE ROOF DRAIN FB-33A
- 2'-0" x 3'-5 1/2" WIDE ELECTRIC DUCT FE-53A
- 12 1/2" x 2'-0" WIDE ELECTRIC DUCT FE-53A
- RETAINING WALL FC-9B
- BLACKTOP PAVING FC-9C
- CIRC. WATER PUMP HOUSE FC-9'S

Based on the above, I recommend that we request permission to fill the tank in place and leave it there until decommissioning when it would be removed.

We recommend that you add a section to the bid specification for abandoning the tank in place. This section would be an alternative to removing the tank which should remain in the specification. We anticipate some complications involved with abandoning the tank in place, although dangers to plant operations and facility structures should be comparatively reduced.
