TRIP REPORT

SUBJECT: Trip Report for Busted Butte Rock Sampling and Observations of PTn on West Flank of Yucca Mountain (20.01402.861)

DATE/PLACE: May 22-23, 2000
Yucca Mountain, Nevada

AUTHORS: R. Fedors and J. Evans

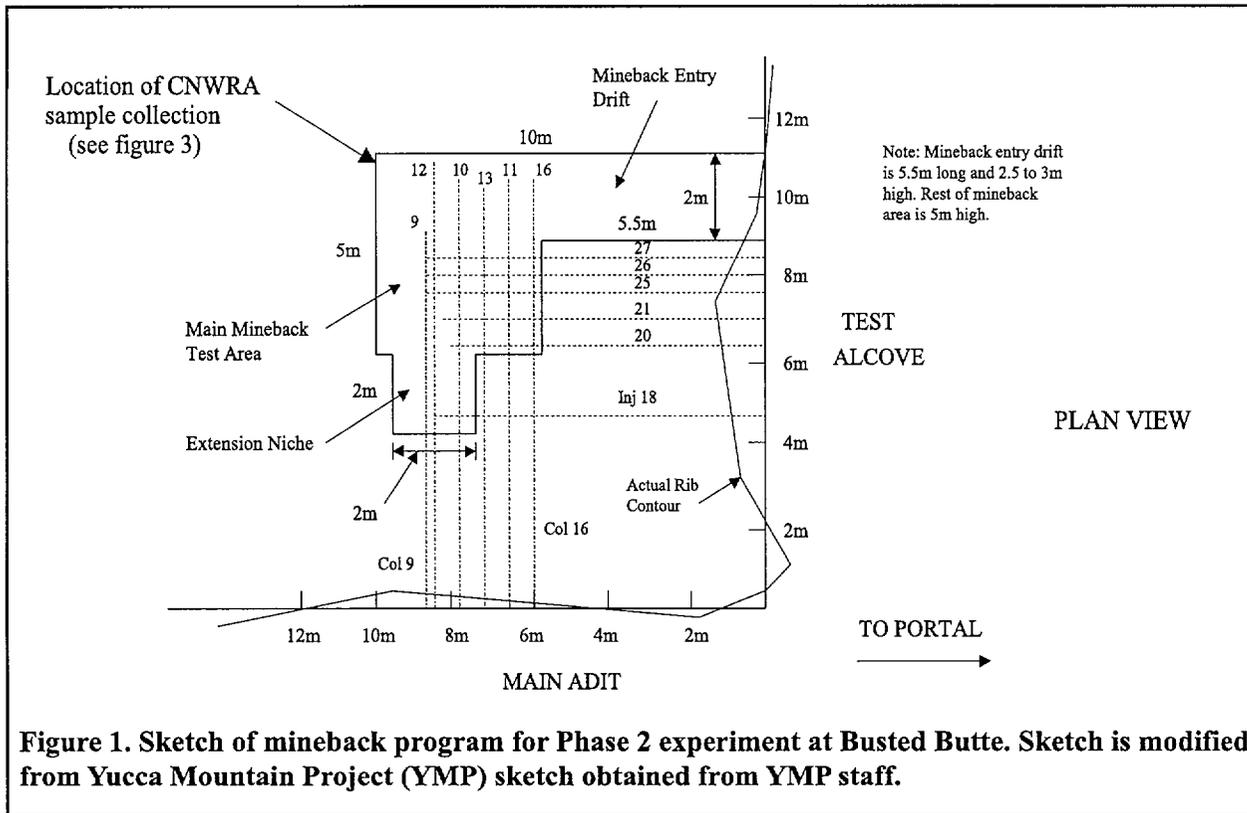
Figure 1. Sketch of mineback program for Phase 2 experiment at Busted Butte. Sketch is modified from Yucca Mountain Project (YMP) sketch obtained from YMP staff.
