UNITED STATES  
NUCLEAR REGULATORY COMMISSION

SUBJECT: RESOLUTION OF DEGRADED CEQ FAN ROOM WALL

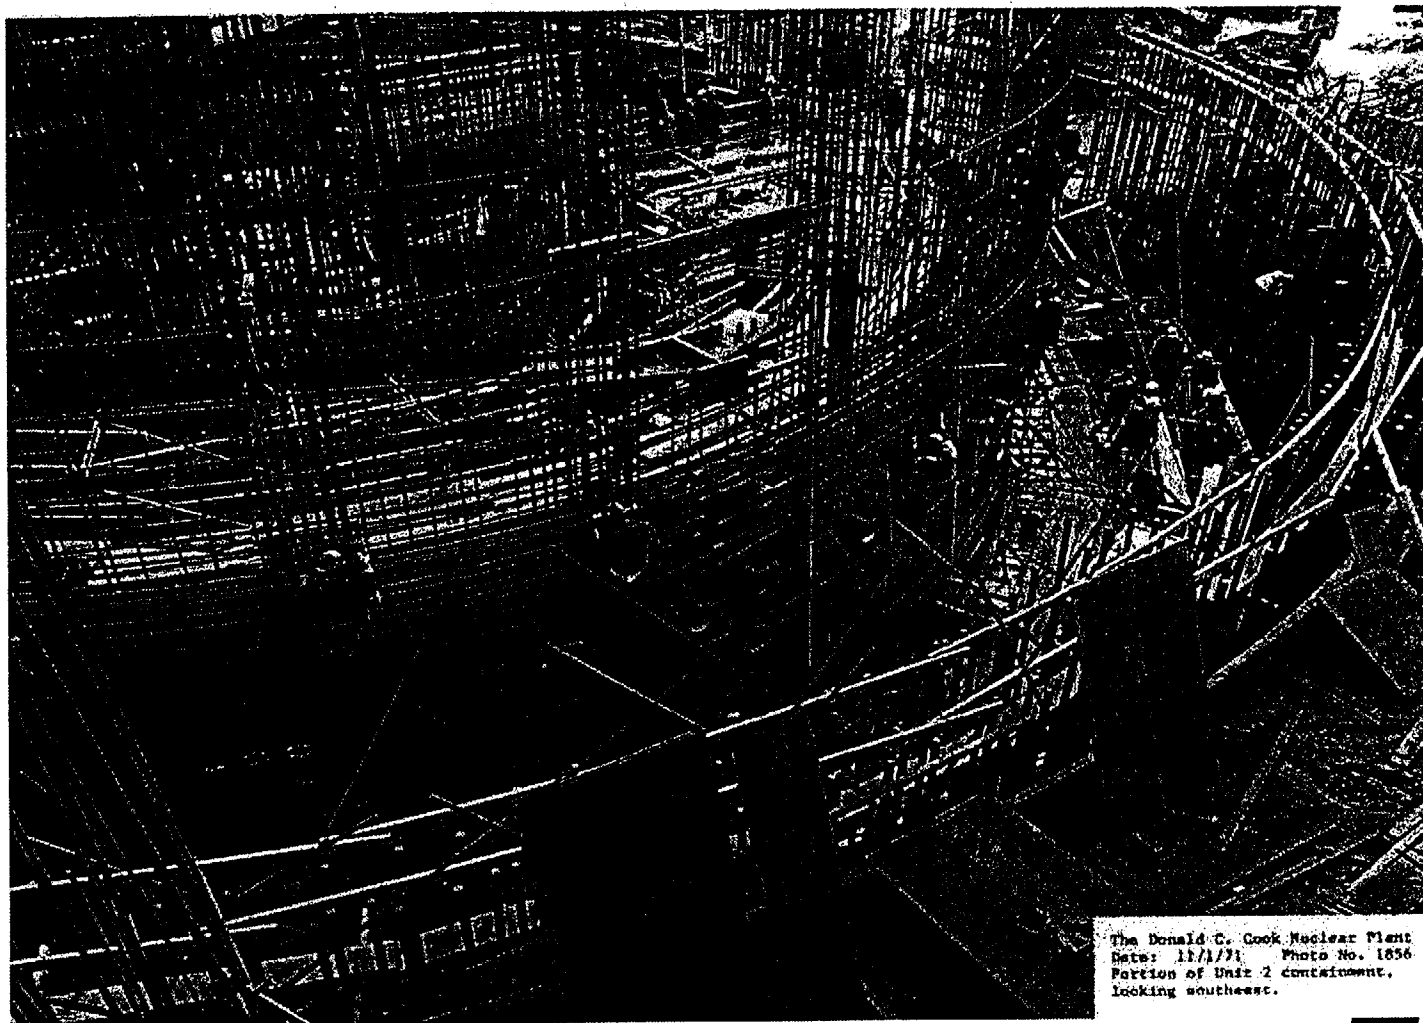
The Donald C. Cook Nuclear Plant  
Date: 11/1/71 Photo No. 1856  
Portion of Unit 2 containment,  
looking southeast.
