Prairie Island Nuclear Generating Plant

Regulatory Conference
November 27, 2001

D6 Condition

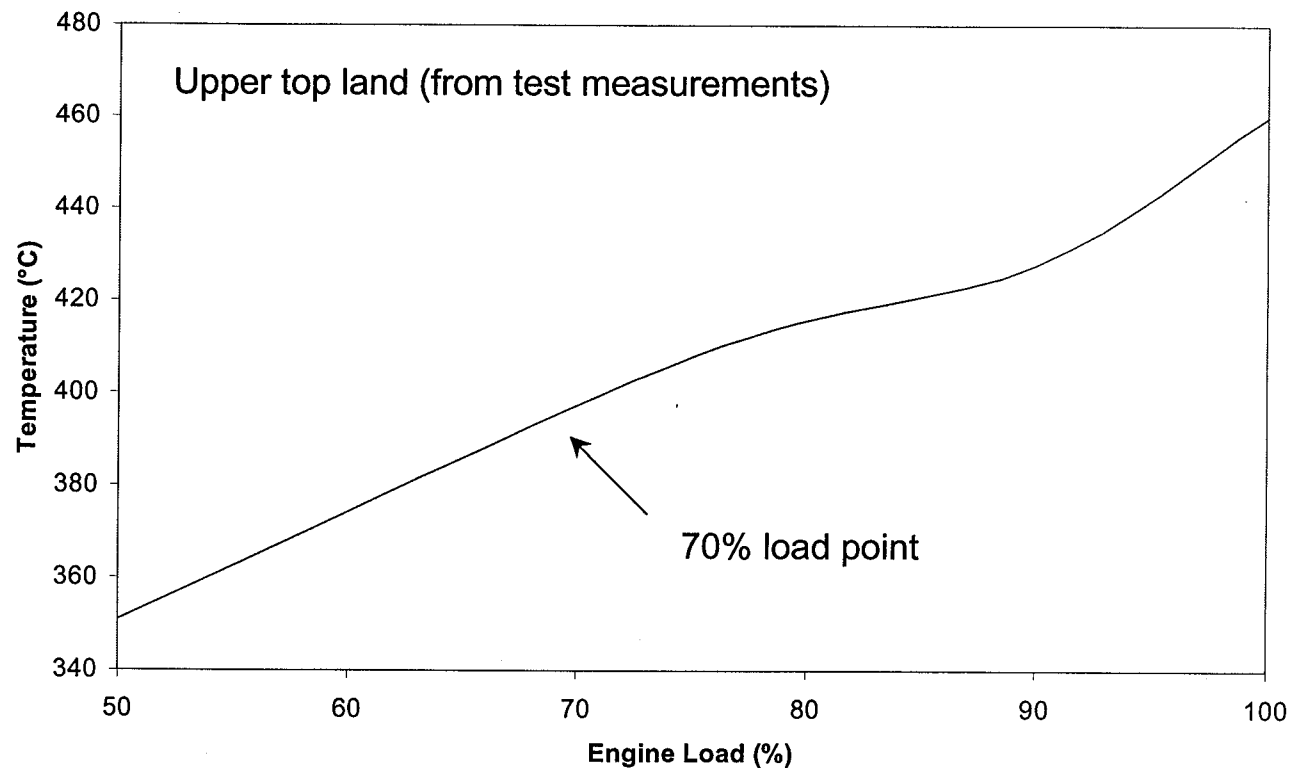
Piston Temperature

- Temperature load dependant
- Note rapid increase towards 100% load
- 110% load increases temperatures significantly
