VIRGINIA ELECTRIC AND POWER COMPANY
SURRY POWER STATION UNITS 1 AND 2
NRC SPECIAL INSPECTION REPORT NOS. 50-280/01-06 AND 50-281/01-06
TRANSMITTAL OF TECHNICAL REPORTS

FAILURE ANALYSIS
FOR (1) ONE
POWER ASSEMBLY, FORK ROD
EMD P/N 8470863

Dominion Virginia Power
Surry Power Station

FAILURE ANALYSIS
FOR (10) TEN
POWER ASSEMBLY, FORK ROD
EMD P/N 8470863
& (10) TEN
POWER ASSEMBLY, BLADE ROD
EMD P/N 8470864

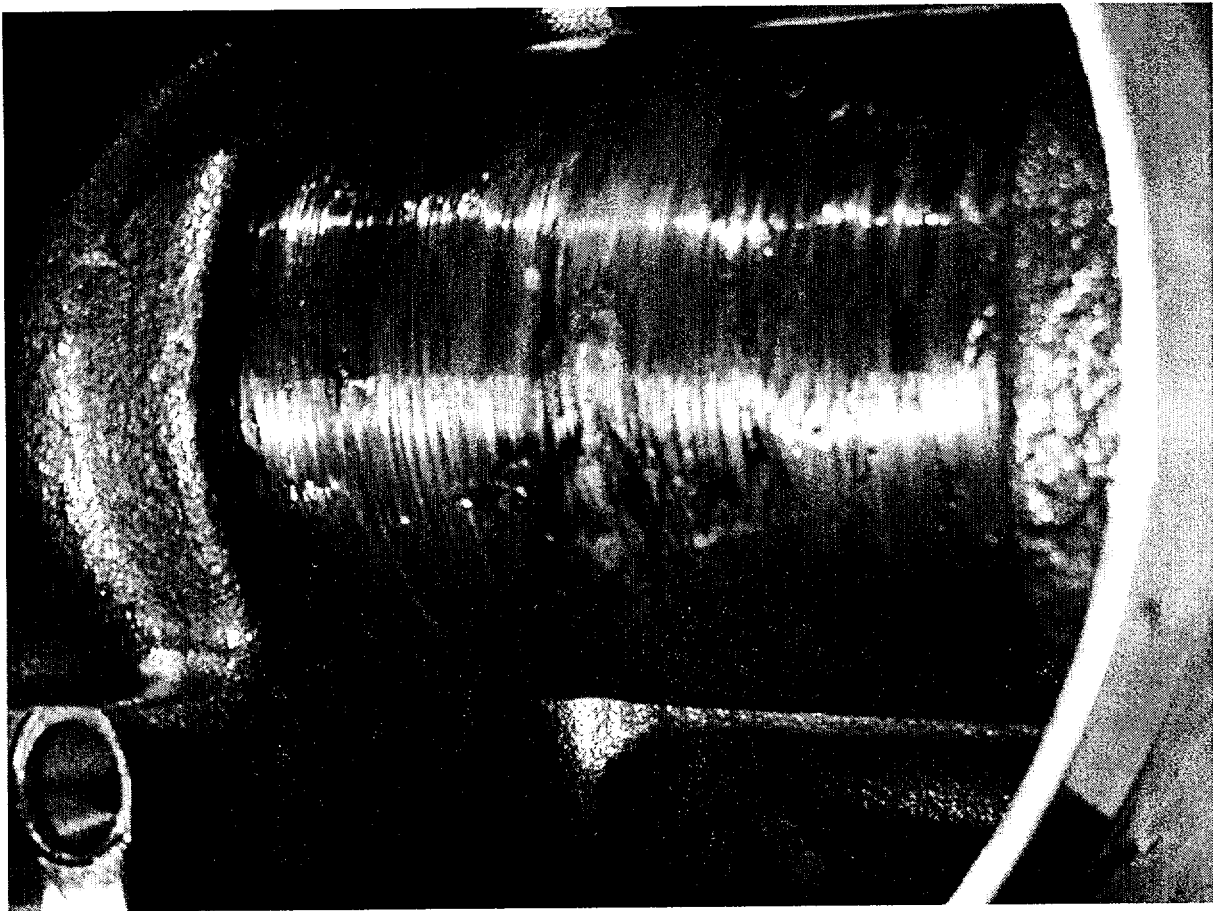
The two bolts clamping the rod trunnion to the piston pin were removed, and the connecting rod was separated from the piston pin. Bearing fragments were visible at the edge of the insert bearing. The lower portion of the piston pin had a normal appearance. The pin was rolled over, exposing the portion of the piston pin in contact with the insert bearing during operation. See Figure 7. This portion of the pin exhibits substantial distress from metal transfer between the insert bearing and the pin, resulting in a "seized" appearance. The insert bearing has a similar appearance. See Figure 8. The bearing did not actually seize to the pin – the retaining tabs were still intact and secure to the carrier. See Figure 9.

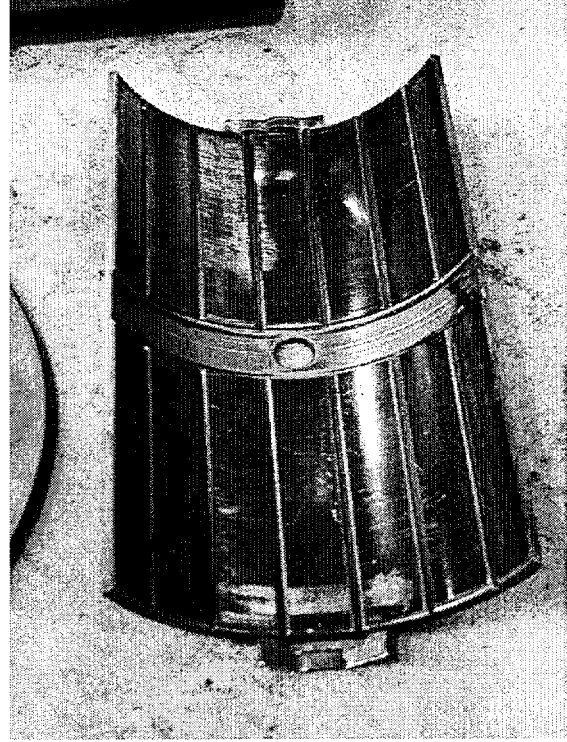
87360-13	Not available
87360-14	Not available
87360-15	Bearing - heavy distress, pin - major distress
87360-16	Bearing - minor distress, pin - OK
87360-17	Bearing - heavy distress, overlay displacement blocking oil channels, pin - heavy distress, mirror finish damage, heat discoloration
87360-18	Bearing - medium distress, pin - medium distress, mirror finish damage
87360-19	Bearing - heavy distress, overlay displacement blocking oil channels, pin - heavy distress
87360-20	Bearing - minor distress, pin - OK

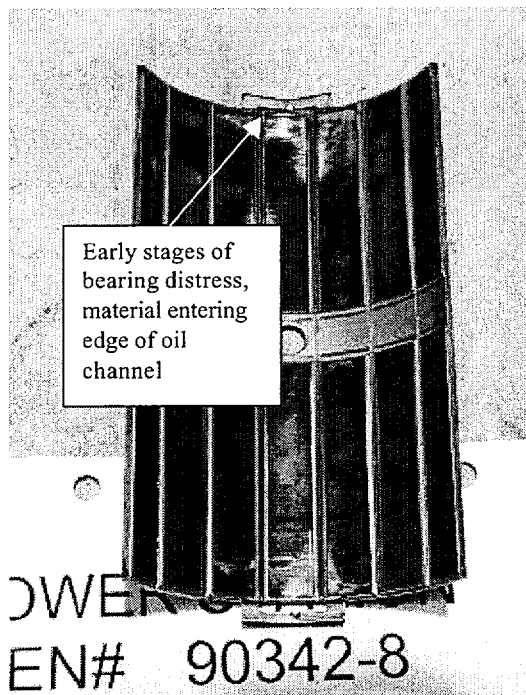
90342-7	Bearing – some polishing, all oil channels open, Pin – Sat, Thrust Washer & Piston Carrier exhibit some circular grooves
90342-8	Bearing – some polishing, some material displacement beginning to enter an oil channel, Pin – Sat, Thrust Washer – wear step and circular grooves, Piston Carrier – some circular grooves
90342-9	All components – Sat
90342-10	Bearing – Catastrophic damage, all oil channels blocked, Pin – Catastrophic, Thrust Washer – wear step, debris scratches, Piston Carrier – Sat w/some debris scratches
90342-11	Bearing – some polishing, all oil channels open, Pin – Sat, Thrust Washer – some debris scratches, Piston Carrier – Sat
90342-12	Bearing – some distress, beginning of material displacement, all oil channels open, Pin/Thrust Washer/Piston Carrier – all Sat
90342-13	Bearing – polishing, 1 oil groove beginning to be blocked, some material displacement, Pin – Sat, Thrust Washer – wear step, Piston Carrier – Sat

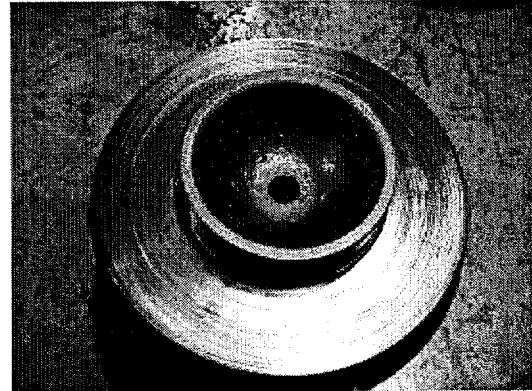
90342-15 Carrier

90342-14	Bearing/Pin/Piston Carrier – Sat, Thrust Washer has a wear step
90342-15	Bearing – some polishing, all oil channels open, Pin – Sat, Thrust Washer & Piston Carrier exhibit a significant number of circular grooves across the mating surfaces
90342-16	Bearing – some polishing, 1 oil groove beginning to be blocked, Pin – Sat, Thrust Washer – wear step, Piston Carrier – Sat
90342-17	Bearing – polishing present, all oil channels open, Pin – Sat, Thrust Washer & Piston Carrier have 1 heavy groove apparently from a debris scratch
90342-18	Bearing/Pin/Piston Carrier – Sat, Thrust Washer has a wear step
90342-19	Bearing – distressed, heavy polishing, 1 oil channel 50% blocked, 1 oil channel 25% blocked, Pin – Sat, Thrust Washer – wear step, Piston Carrier – Sat
90342-20	Bearing – polishing, 1 oil channel beginning to exhibit blocking from displaced material, Pin – Sat, Thrust Washer – wear step, Piston Carrier – Sat
