Author(s): Clive Wotton
Abe Aon

Ricardo has undertaken an examination of components, reports and laboratory data from Surry Station following the failure of the wrist pin bearings on two EMD 645 engines. The engines were found to have severely or partially degraded wrist pin bearings. Ricardo were engaged to review the failure mode and determine if it were possible to predict when the EDG3 engine entered a degraded condition such that it could not operate for a period of 24 hours supplying emergency power.

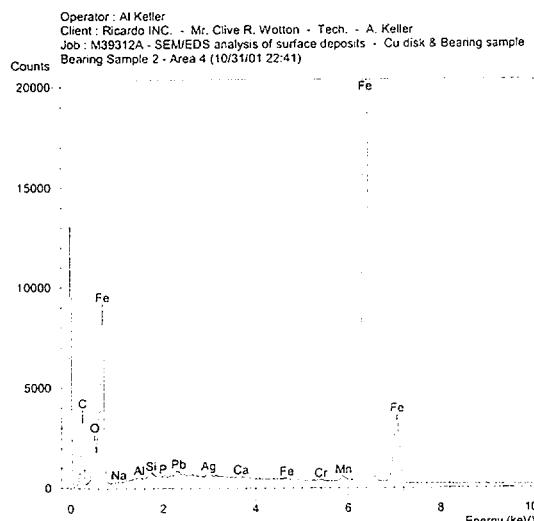
Figure 8 – Iron Sample

the surface of the washer. The elemental analysis of the silver section, iron-lead section and iron-silver section are shown in figures 8, 9 and 10.

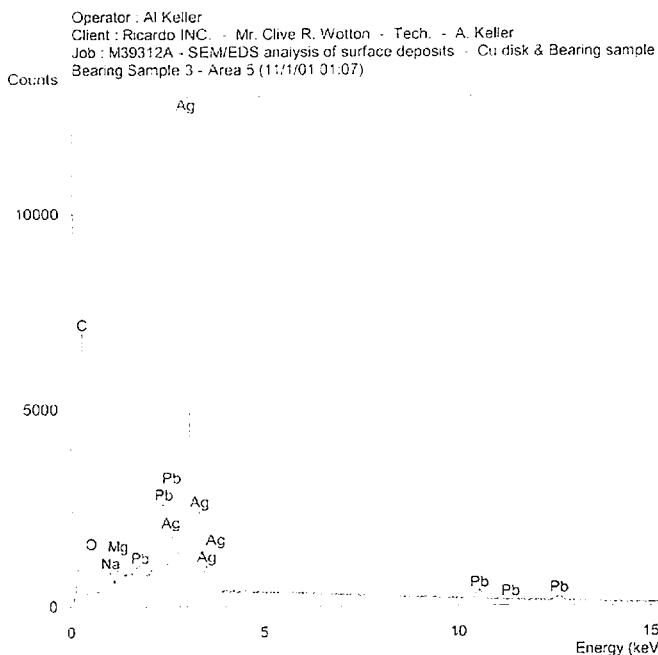
Figure 12 – Baring Surface

A "good" bearing from EDG1 was visually examined and found to be discolored in a regular pattern beginning at the outermost parts of the bearing moving in towards the oil feed hole, see highlighted section of figure 11. The bearing was then analyzed using the SEM and the results showed a pattern of lead "islands" surrounded by silver see figure 12 and figures 13 and 14 for elemental analysis. This was again in line with findings of the un-

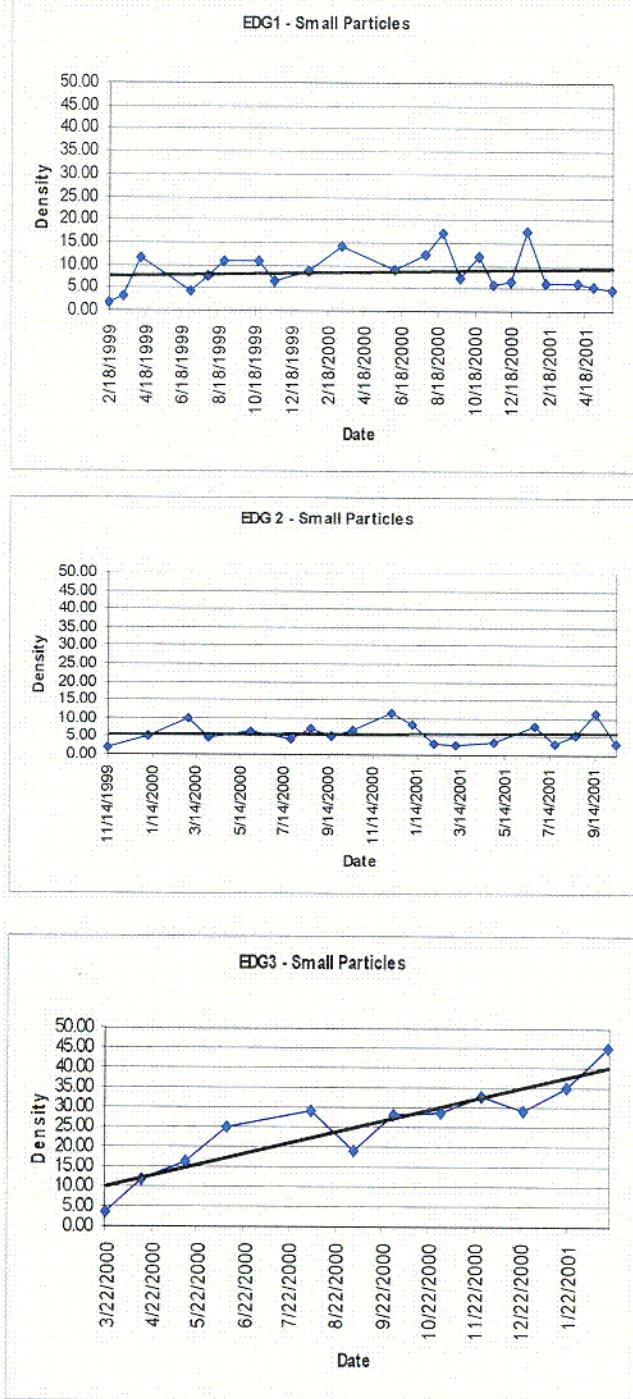
Figure 17 – DR Ferrographic Analysis of Small Particles

Examination of Figures above which contain the ferrography results extracted for just the Chevron oil and excludes data from oil changes, reveals some apparently contradictory trends. The graphs are all plotted on similar scales with a linear trend-line put through the data set. EDG3 clearly shows a trend in increasing large and small particle counts resulting in the increase in wpc. Conventional ferrographic trending data states that a growth in Lp density is a sign of abnormal wear. However, the %LP is very consistent, around 40% for the 4 months up to Feb 2001 (the last oil sample taken from the engine) and, indeed, has hovered around that reading since May 2000. Thus the DR ferrography results give no clear indication of when a bearing started to fail catastrophically but the increase in small and large particle densities indicate wear was occurring, probably since the oil was changed to Chevron. A similar trend could not be detected for EDG1 and EDG2. The percentage of large particles seen for EDG2 is generally higher than for EDG3 and EDG1, however the silver concentration in the oil did not correlate with the apparent high concentration of large particles, but for the reasons discussed below, the ferrography may not be detecting all issues associated with the failure mechanism.
