Client Name: Dominion Virginia Power
Project No.: H0829
Archive: D01-1740
Client Confidential

Ricardo Inc.

Ricardo has undertaken an examination of components, reports and laboratory data from Surry Station following the failure of the wrist pin bearings on two EMD 645 engines. The engines were found to have severely or partially degraded wrist pin bearings. Ricardo were engaged to review the failure mode and determine if it were possible to predict when the EDG3 engine entered a degraded condition such that it could not operate for a period of 24 hours supplying emergency power.

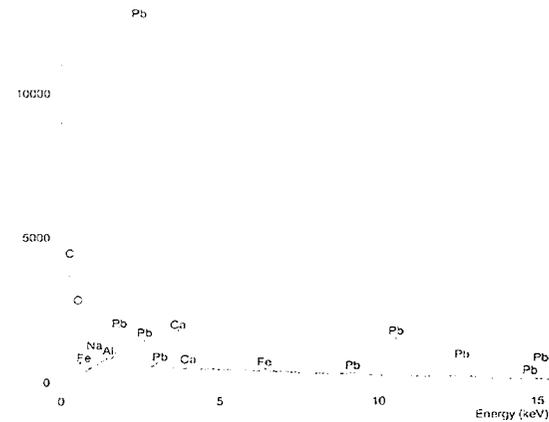
Figure 13 – Spectrum 4

A "good" bearing from EDG1 was visually examined and found to be discolored in a regular pattern beginning at the outermost parts of the bearing moving in towards the oil feed hole, see highlighted section of figure 11. The bearing was then analyzed using the SEM and the results showed a pattern of lead "islands" surrounded by silver see figure 12 and figures 13 and 14 for elemental analysis. This was again in line with findings of the un-
