VIRGINIA ELECTRIC AND POWER COMPANY
NORTH ANNA POWER STATION UNIT 2
ALTERNATIVE REPAIR TECHNIQUES-RELIEF REQUESTS NDE-048 and NDE-049
REQUEST FOR ADDITIONAL INFORMATION

**Response to NRC Request for Additional Information
Relief Request NDE-048 and NDE-049
North Anna Power Station Unit 2**

**REQUEST TO USE EMBEDDED FLAW REPAIR TECHNIQUE
NORTH ANNA POWER STATION UNIT 2 RELIEF REQUEST NDE-048**

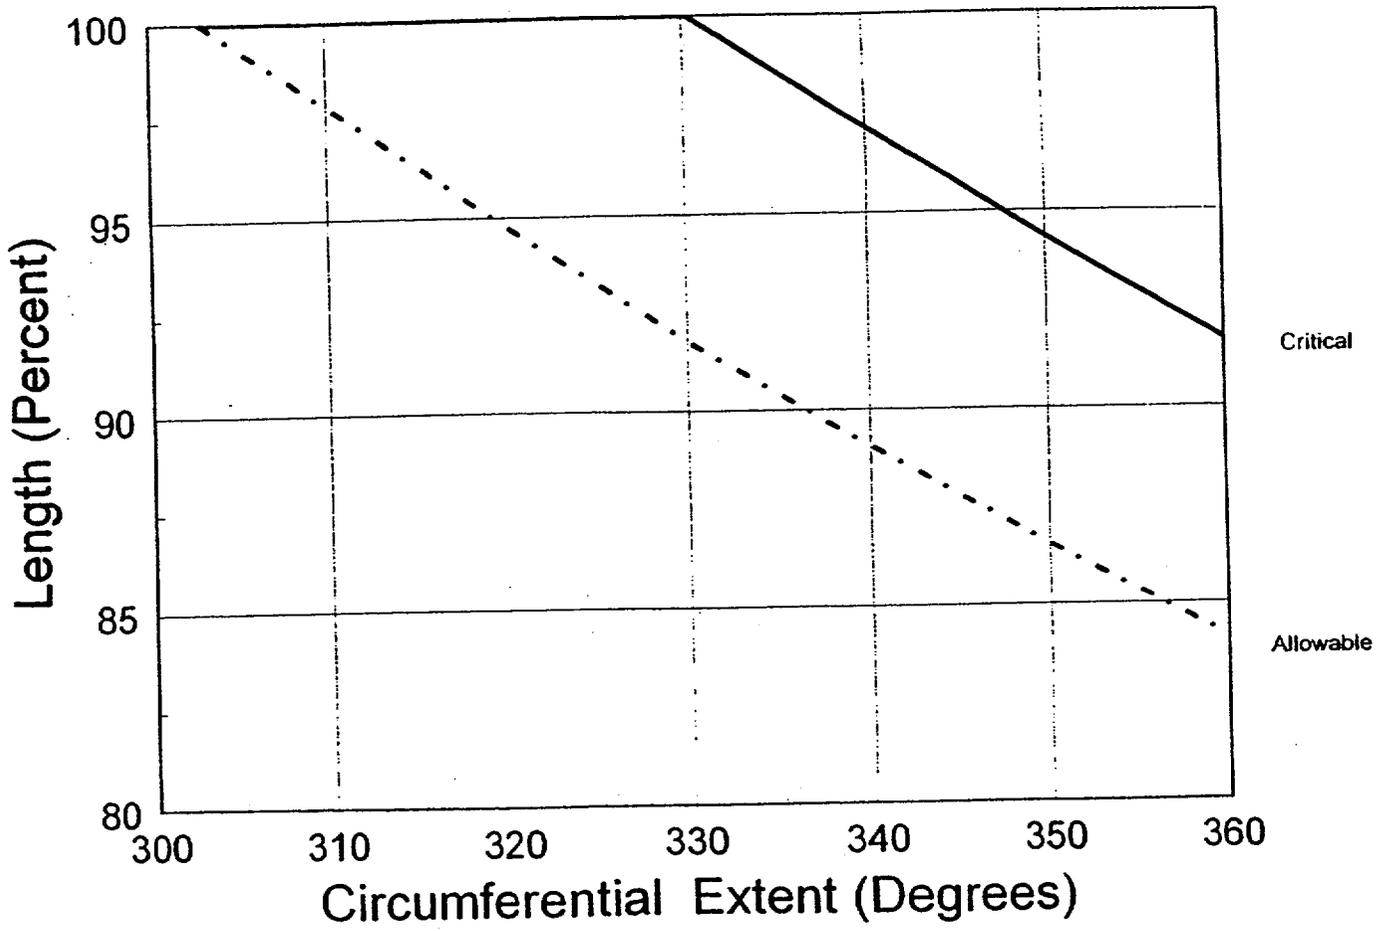
Figure 5. Allowable Regions of Lack of Fusion for the Outermost Penetration Tube to Weld Fusion Zone: Detailed View.

The total surface contact area for the fusion zone on the outermost head penetration is 17.4 in². The calculations above result in a required area to avoid failure of only 1.45 in², and using the ASME Code criteria, the area required is 2.79 in². These calculations show that as much as 83.9 percent of the weld may be unfused, and the code acceptance criteria can still be met.

To envision the extent of lack of fusion which is allowable, Figure 5 was prepared. In this figure, the weld fusion region for the outermost penetration has been shown in an unwrapped, or developed view. The figure shows the extent of lack of fusion which is allowed, in terms of limiting lengths for a range of circumferential lack of fusion. This figure shows that the allowable vertical length of lack of fusion for a full circumferential unfused region is 84 percent of the weld length. Conversely, for a region of lack of fusion which extends the full vertical length of the weld, the circumferential extent is limited to 302 degrees. The extent of lack of fusion which would cause failure is labelled "critical" on this figure, and is even larger. The dimensions shown on this figure are based on an assumed rectangular area of lack of fusion.

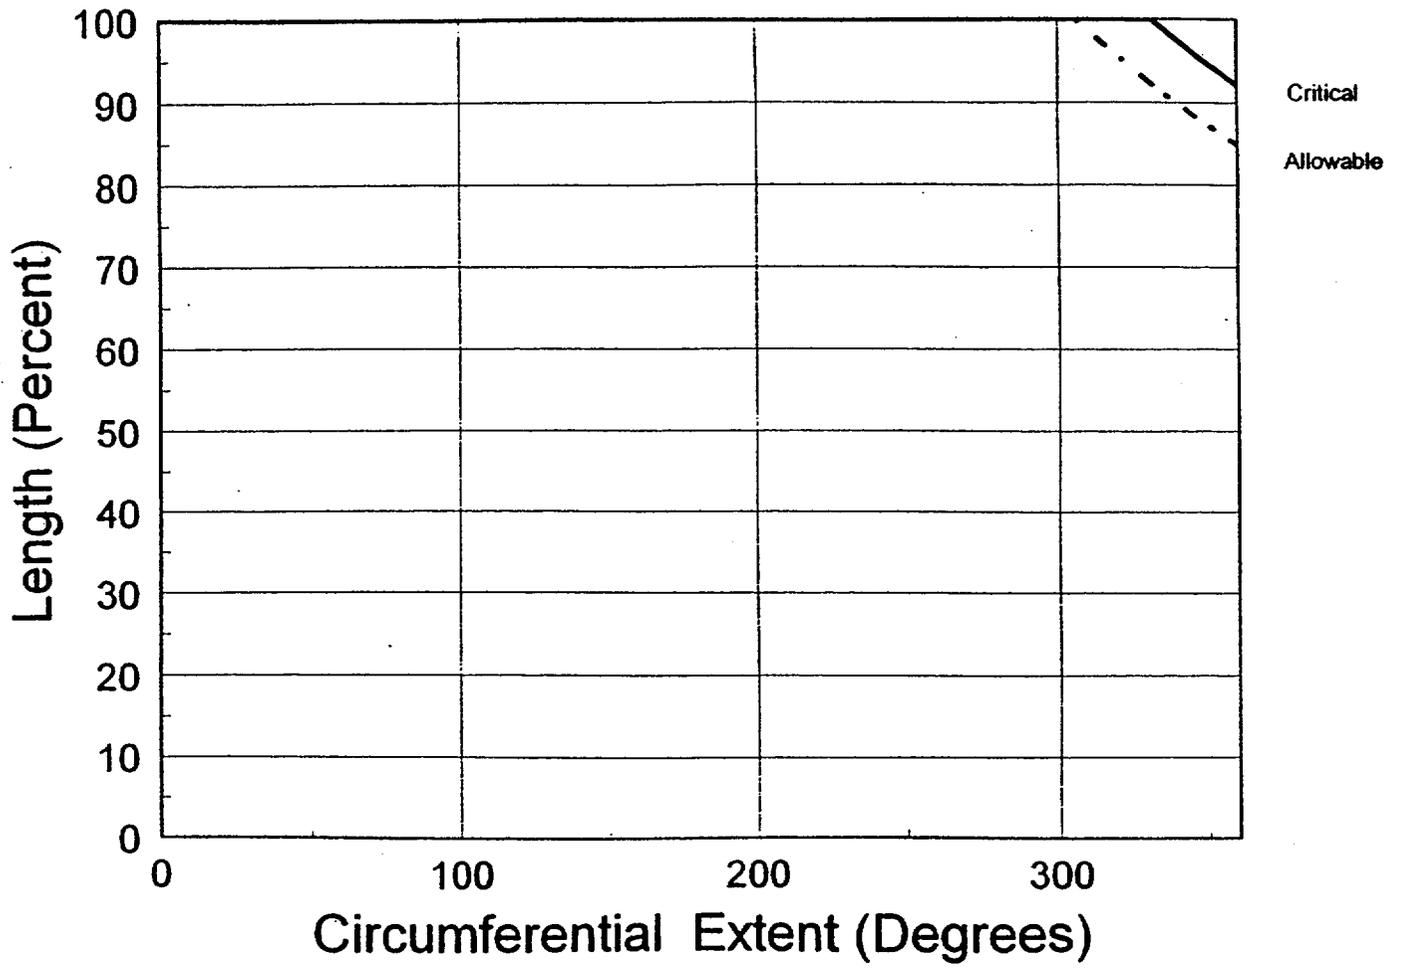
Figure 7. Allowable Regions of Lack of Fusion for All Penetrations: Weld to Vessel Fusion Zone.

A similar calculation was also carried out for the fusion zone between the weld and the head, and the result is shown in Figure 7. The allowable area of unfused weld for this location is 84.8 percent of the total area. This approach to the fusion zone with the carbon steel head is only approximate, but may provide a realistic estimate of the allowable. Note that even a complete lack of fusion in this region would not result in rod ejection, because the weld to the tube would prevent it.

The allowable lack of fusion for the weld fusion zone to the head may be somewhat in doubt, because of the different geometry, where one cannot ensure that the failure would be due to pure shear. To investigate this concern, additional finite element models were constructed with various degrees of lack of fusion discretely modelled, ranging from 30 to 65 percent. The stress intensities around the circumference of the penetration were calculated, to provide for the effects of all stresses, as opposed to the shear stress only, as used above. When the average stress intensity reaches the flow stress (53.7 ksi), failure is expected to occur. The code allowable stress intensity is 1.5 S_m , or 35 ksi, using the lower of the Alloy 600 and ferritic allowables at 320°C (610°F).
