VIRGINIA ELECTRIC AND POWER COMPANY
NORTH ANNA POWER STATION UNIT 2
ALTERNATIVE REPAIR TECHNIQUES-RELIEF REQUESTS NDE-048 and NDE-049
REQUEST FOR ADDITIONAL INFORMATION

**Response to NRC Request for Additional Information
Relief Request NDE-048 and NDE-049
North Anna Power Station Unit 2**

**REQUEST TO USE EMBEDDED FLAW REPAIR TECHNIQUE
NORTH ANNA POWER STATION UNIT 2 RELIEF REQUEST NDE-048**

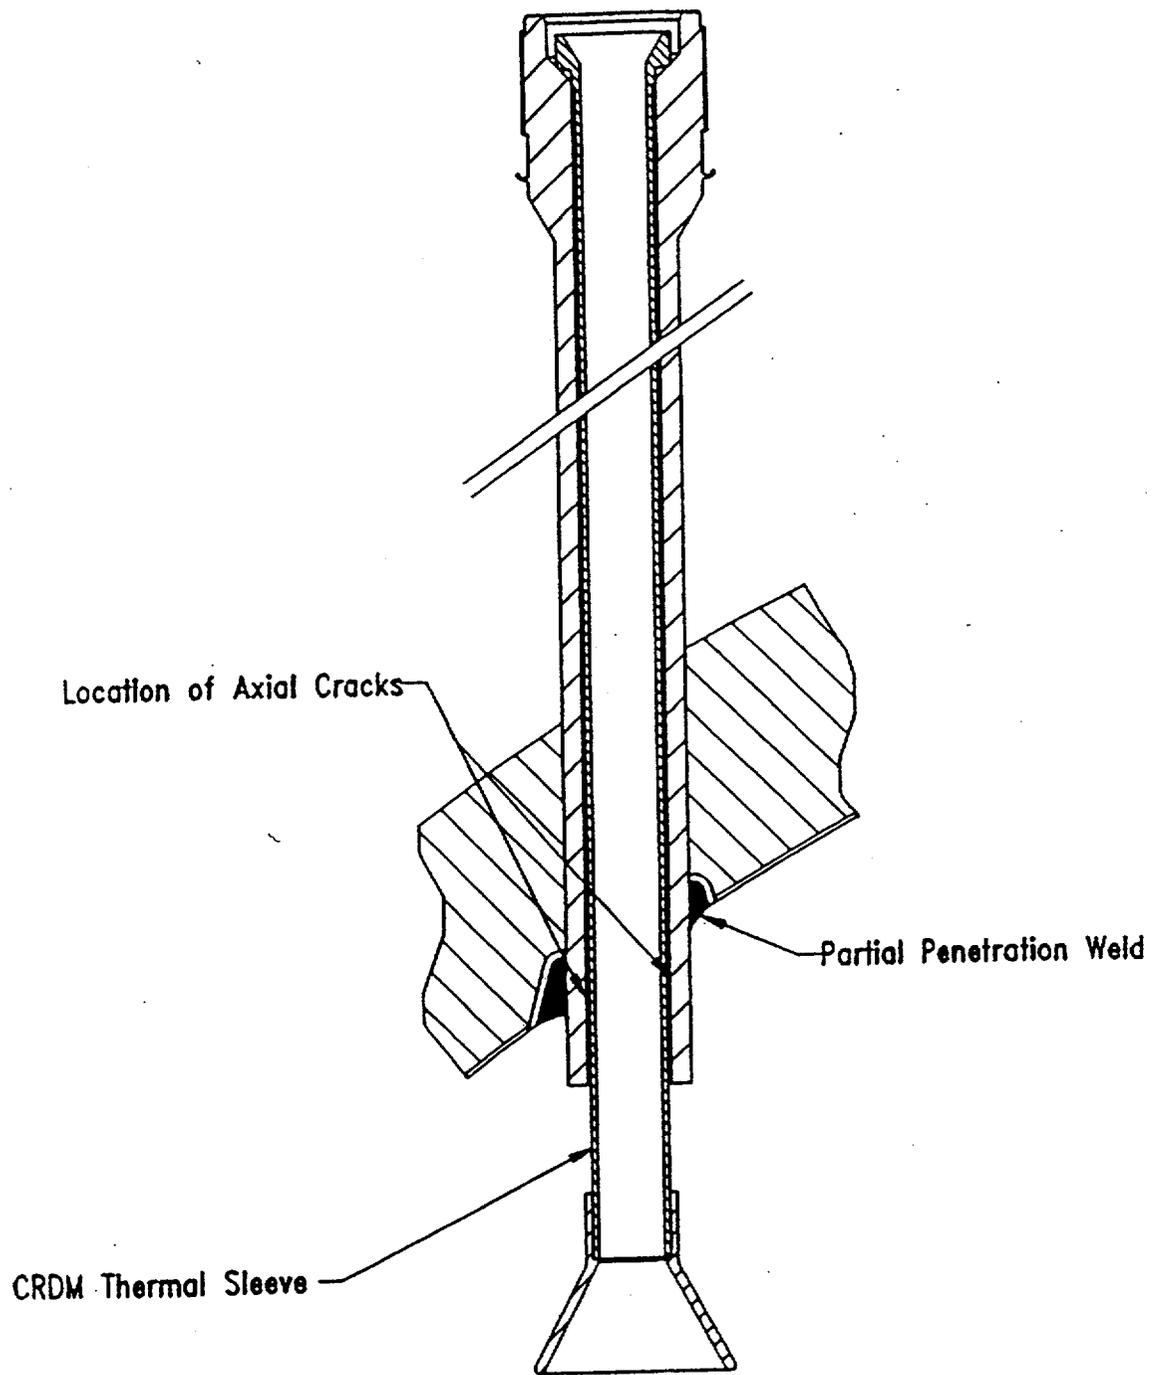
Figure 1. Typical Head Penetration

In the fall of 1991, a hydrotest was underway at a plant in France, and leakage was detected in the reactor vessel upper head region. Investigation showed that the leak was originating from a through-wall flaw in one of the control rod drive mechanism head penetrations. These are heavy wall Alloy 600 tubes about 102 mm (four inches) in outside diameter which penetrate the reactor vessel head, and are secured by partial penetration welds at the inside surface, as shown for example in Figure 1. Detailed inspections revealed additional cracks in the penetration which had leaked, and cracks in some of the other penetrations in the same reactor vessel. This led to inspections of other plants in France, and additional cracking was found, although it was not widespread.
