50-277/278

From: Faye L. Stocum <fstocum@state.de.us>
To: <Peach_Bottom_EIS@nrc.gov>
Date: Fri, Oct 26, 2001 9:52 AM
Subject: NRC: Keeney Transmission Line Photos

I want to send along photos of the area where the Keeney Transmission line bisected the National Register eligible C & D Feeder Canal. Some of the photos were taken this summer while others were taken when we visited the project area on Oct. 15th. Since I can only attach 7 photographs at a time and I have a total of 15 photos, there will be a total of three (3) transmissions of 6-6-3.

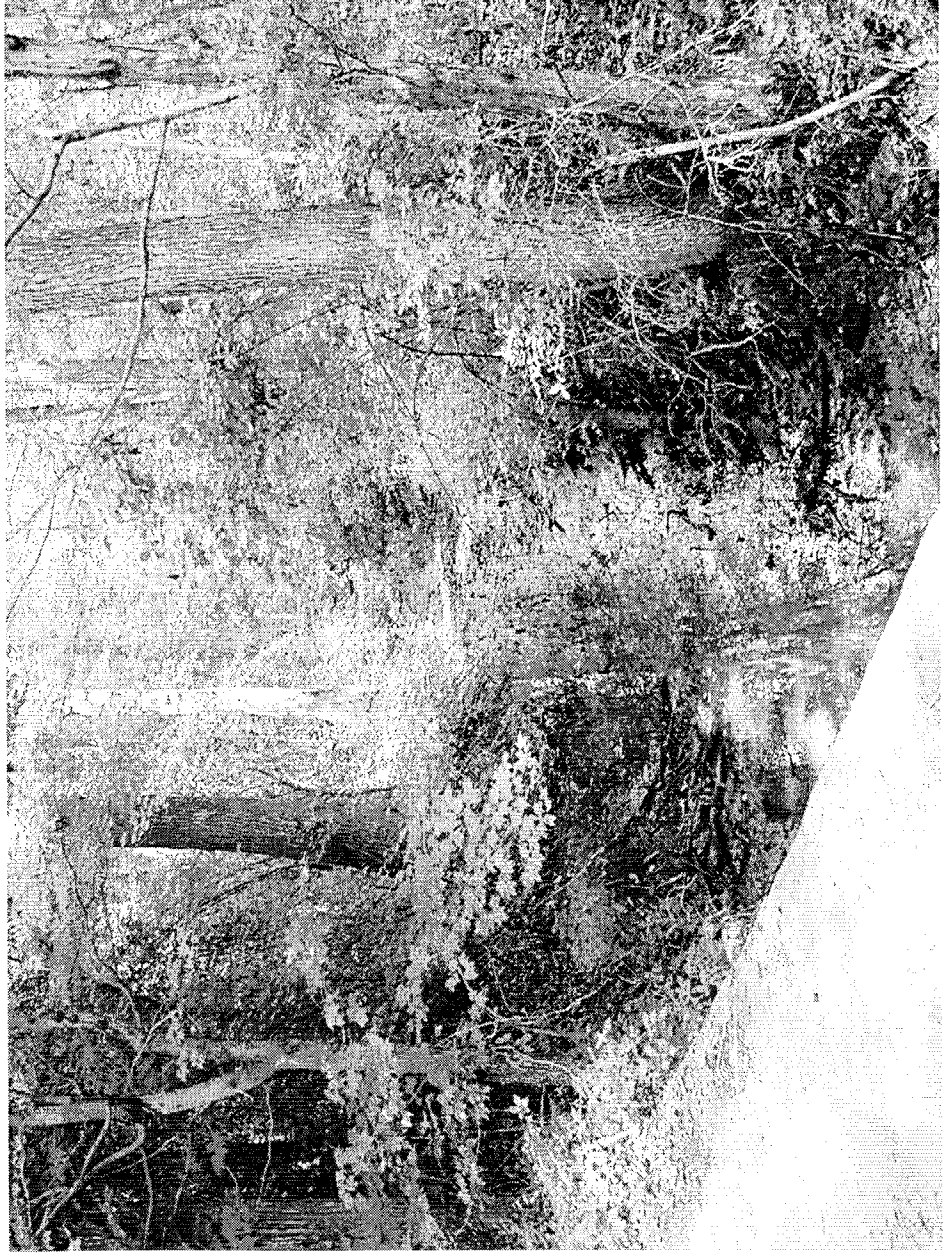
- #1: North Side: looking north of the concrete bridge
- #2: North Side: looking south from the rear deck of Casapulla residence
- #3: South Side: looking north towards cleared transmission line; toe path to left; canal center-right

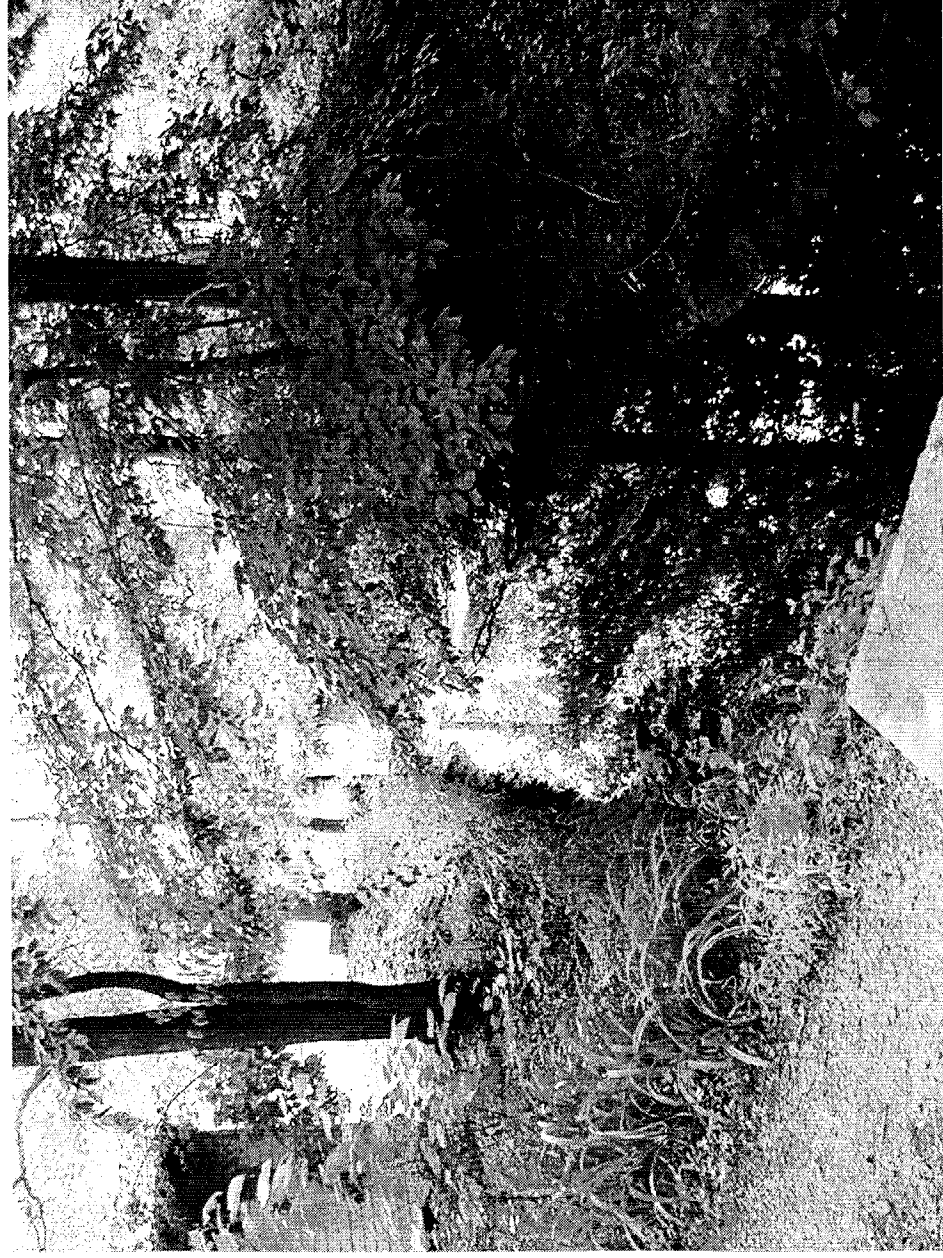
- #4: North Side: looking south from the concrete bridge
- #5: North Side: looking south from the concrete bridge
- #6: North Side: looking northerly-back borrow area and edge of canal; note poorly drained environment contrasted against well drained environment of south side.
