December 21, 2001

SUBJECT: Potential Manufacturing Problem With Certain Limit Switch Assemblies Used in
ASCO General Controls Hydramotor[®] Actuators.

**POTENTIAL MANUFACTURING PROBLEMS WITH
LIMIT SWITCH ASSEMBLIES USED IN ASCO GENERAL CONTROLS
HYDRAMOTOR® ACTUATORS**

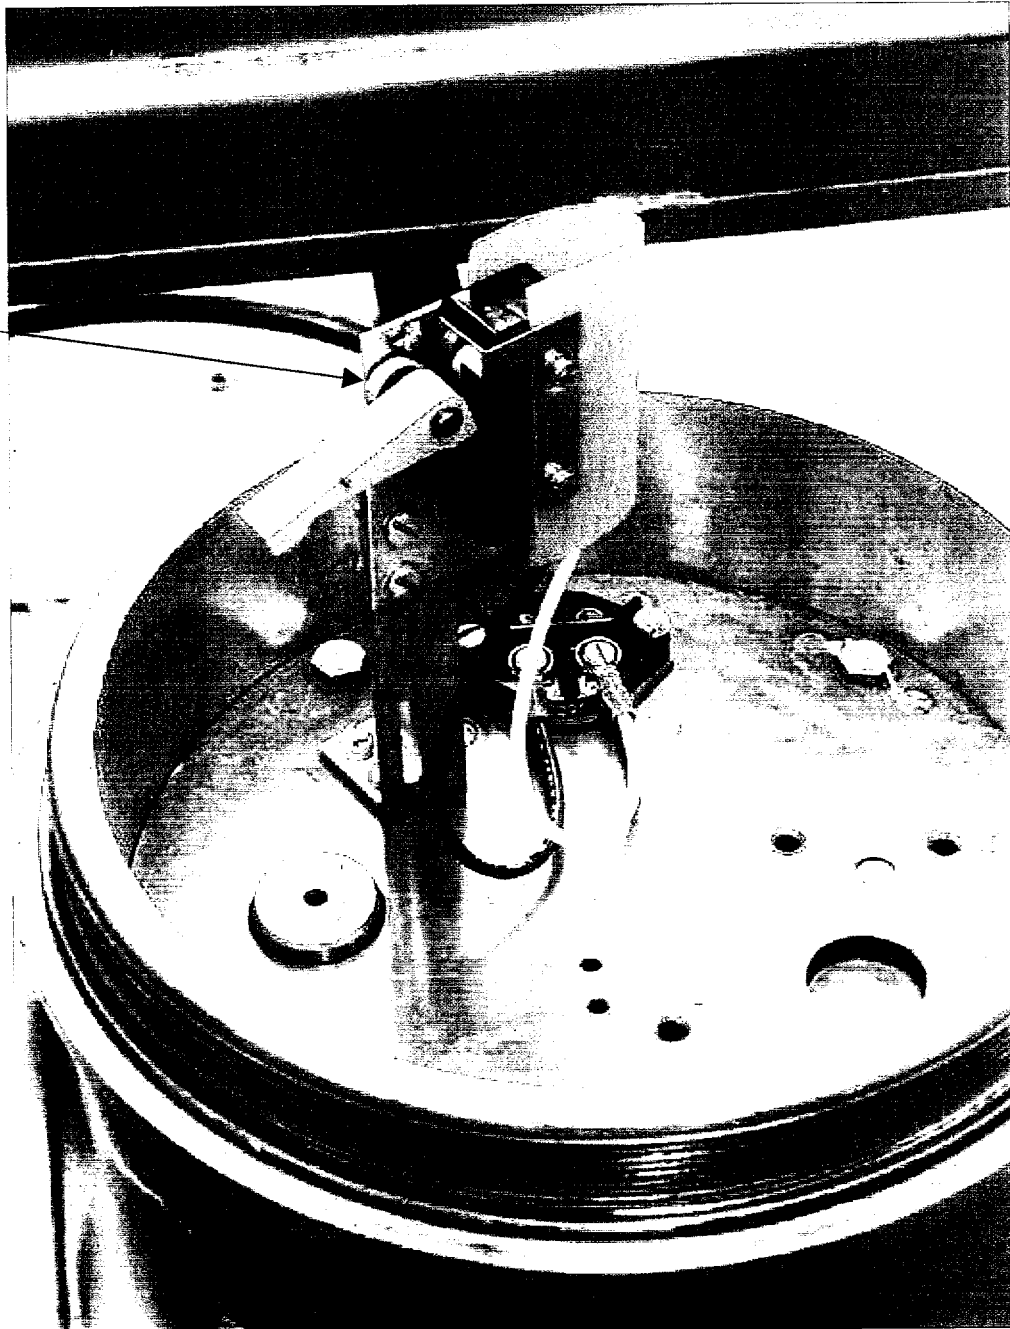
TYPICAL INSTALLATION
NH95 LIMIT SWITCH ASSEMBLY

Analysis of the returned Limit Switch Assembly (see attachment 1) revealed that the shaft on which the position sensing lever operates was not secured tightly to the plate, causing wobble of the shaft. This wobble may result in the rotation of the lever past its actuation point, which would leave the switch contacts in the normally open (N.O.) position. This condition will result in the failure of the actuator piston to retract when the Hydramotor® is powered. The shaft is staked to the plate assembly. Manufacturing instructions for this assembly defines the maximum pressure to be applied for the staking press, but no minimum value. This led to variation of the staking process, which resulted in inconsistent and incomplete attachment of the shaft to the plate. (See attachment 2). In addition to the field return, Asco has found several limit switch assemblies in our inventory with this condition.
