From: Wayne Schmidt
To: "Doddyc [redacted]@tees@ [redacted] David
Lew, Gregory Cranston, Stephanie Coffin
Date: Wed, Aug 9, 2000 7:16 PM
Subject: Hot off my keyboard

EA No. 00-179-1

SUBJECT: NRC SPECIAL INSPECTION 50-247/2000010- STEAM GENERATOR TUBE
FAILURE

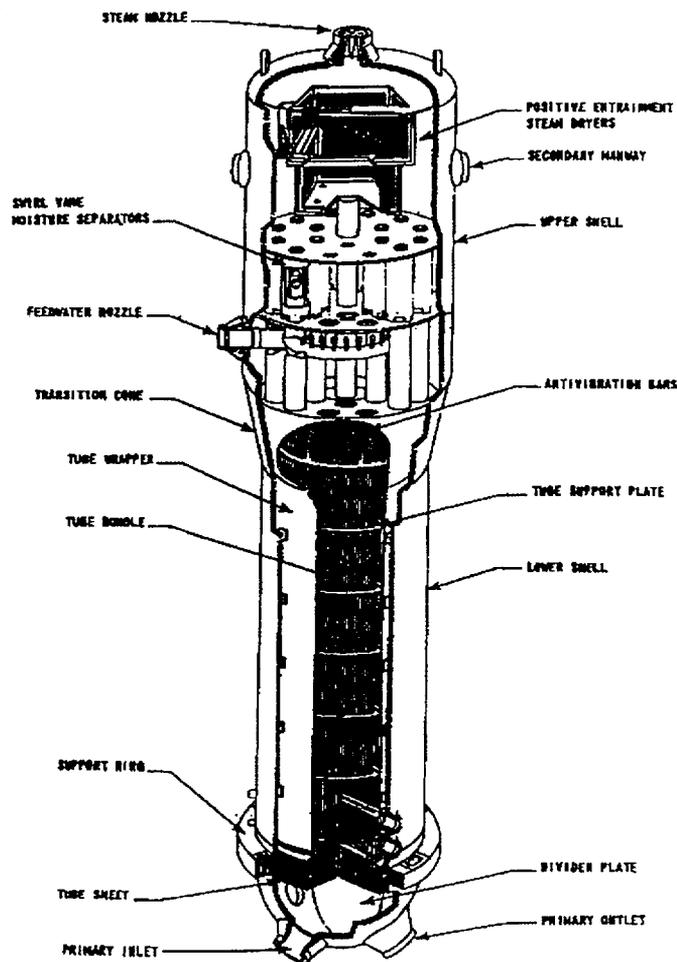
REFERENCED FIGURES
Figure 1 - Westinghouse Model 44 Steam Generator

Indian Point 2 is a four loop pressurized water reactor, meaning that there are four SGs, one per loop, that transfer heat from the reactor coolant to the secondary water. This heat causes the secondary water boil and the associated steam is used to run the turbine which turns the electrical generator. Figure 1 shows a Westinghouse Model 44 SG, like those installed at Indian Point 2.

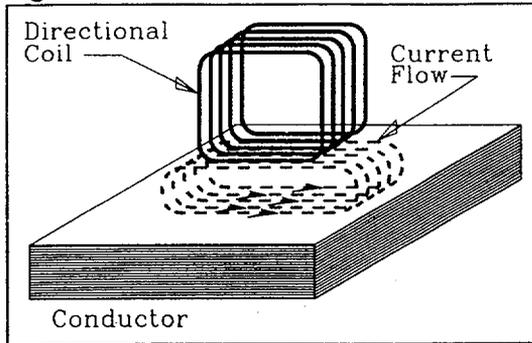
Figures 2 thru 4 - EDDY CURRENT EXAMINATION

Single coil probes as shown in Figure 2 will induce the eddy current in only one direction, which is a compressed mirror image of the current in the coils. If the defect is not in the direction which interrupts the eddy-current flow (parallel to the defect direction rather than perpendicular to the current flow), then that particular coil will not detect the defect. Specially designed eddy-current probes can classify defects as axial cracks, circumferential cracks or both.

The Plus Point probe consists of two coils wound at 90 degrees to each other, as shown in Figure 3. The coils are mounted on a shoe that rotates as it passes through the tube to allow a complete examination. The turns of the two coils are interleaved so that both are effectively the same distance from the surface of the conductor. The coils are connected in a bridge circuit, as shown in Figure 4, and voltage the difference between the two signals is amplified. The two coils allow the scanning for both axial and circumferential defects. The mid range Plus Point probe used during the 1997 examination is multifrequency probe, operating at 10, 300, and 400 KHz.

Figure 2 Directional pancake probe

Figure 3 Plus Point probe
