Subject: 2001 Annual Site Inspection and Monitoring Compliance Report for UMTRCA  
Title I Disposal Sites

# 2001 Annual Site Inspection and Monitoring Report for Uranium Mill Tailings Radiation Control Act Title I Disposal Sites

January 2002

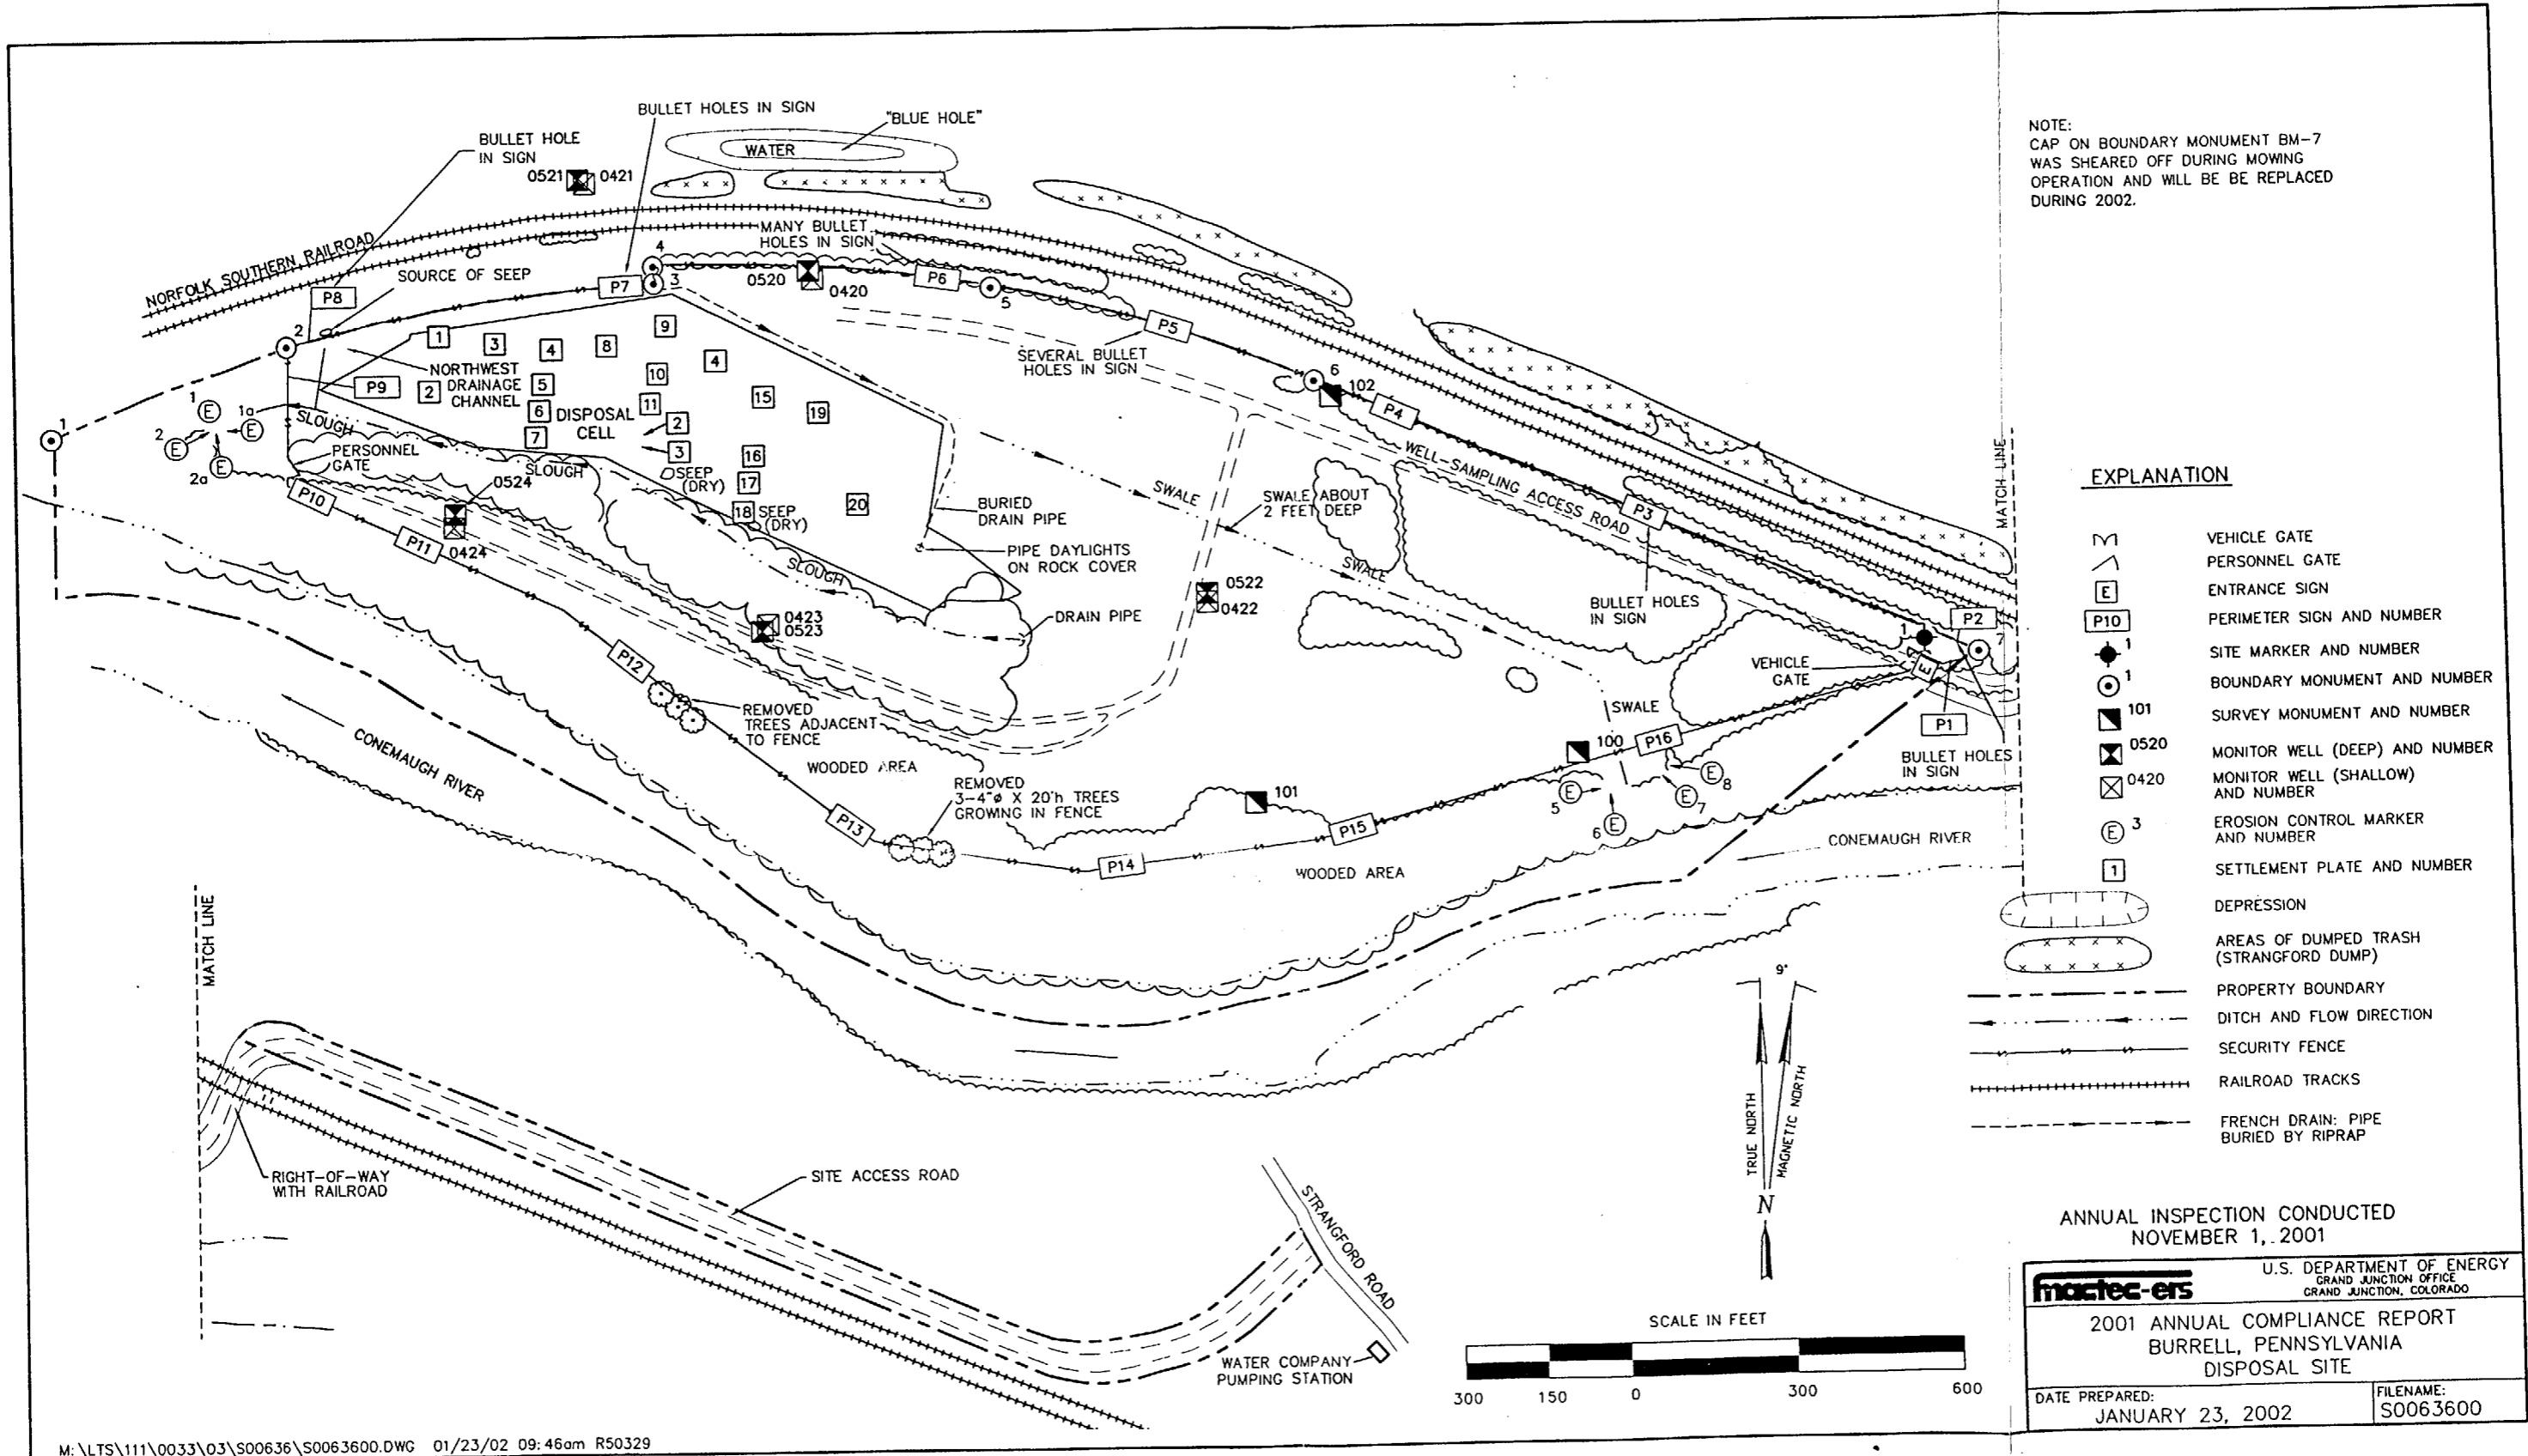
NOTE:  
CAP ON BOUNDARY MONUMENT BM-7  
WAS SHEARED OFF DURING MOWING  
OPERATION AND WILL BE BE REPLACED  
DURING 2002.

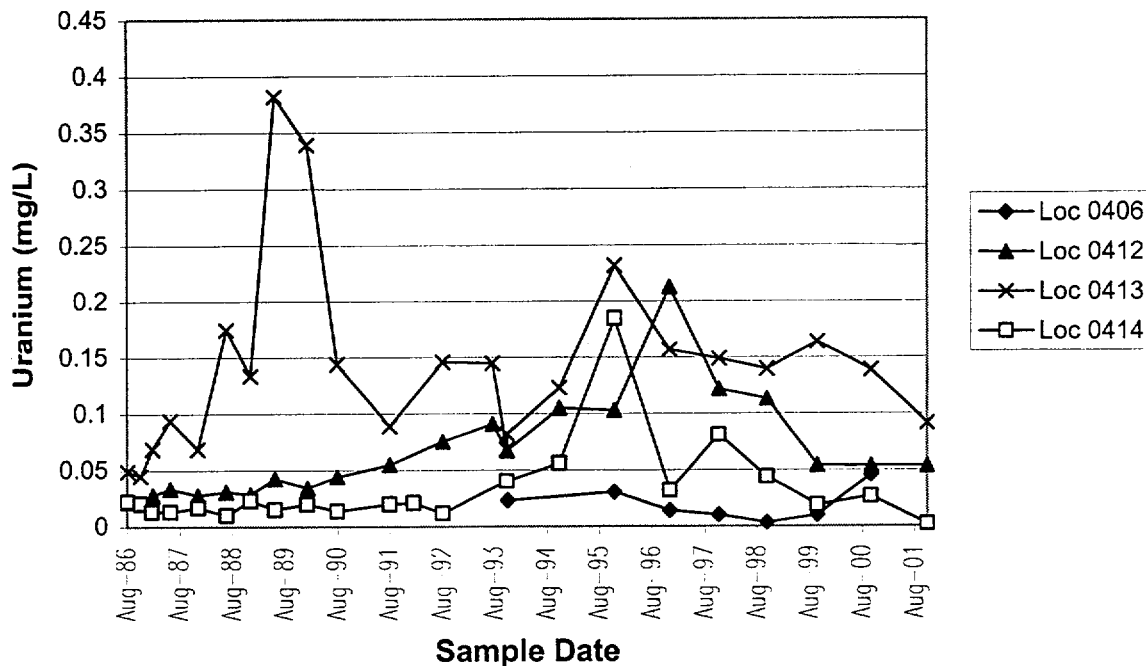
Figure 3-2. Time-Concentration Plot of Uranium in Ground Water at the Canonsburg, Pennsylvania, Disposal Site

In 2001, uranium concentration exceeded the standard at two of the three sampled downgradient wells: 0412 and 0413. All results are consistent with previous results. Although long-term trends in the data are conjectural, short-term trends, since about 1995, may be developing. DOE is cautious on this point because of the wide variations in the historical results (Figure 3-2).

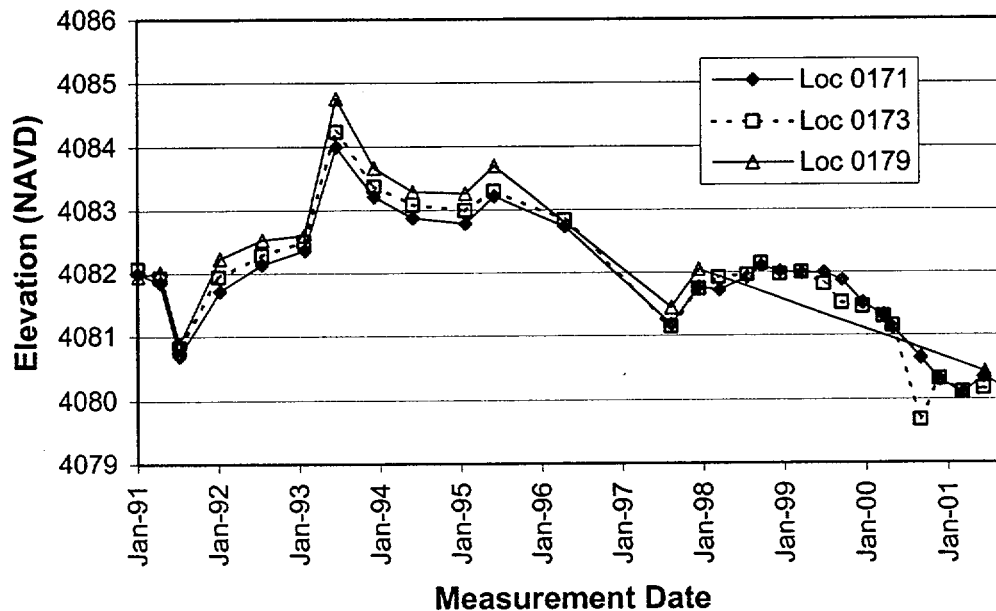
Figure 7-2. Ground Water Levels at the Green River, Utah, Disposal Site

**Ground-Water Level Monitoring**—Water level hydrographs for wells 0171, 0173, and 0179 indicate a drop of approximately 3 feet in all three wells since 1993 (Figure 7-2).

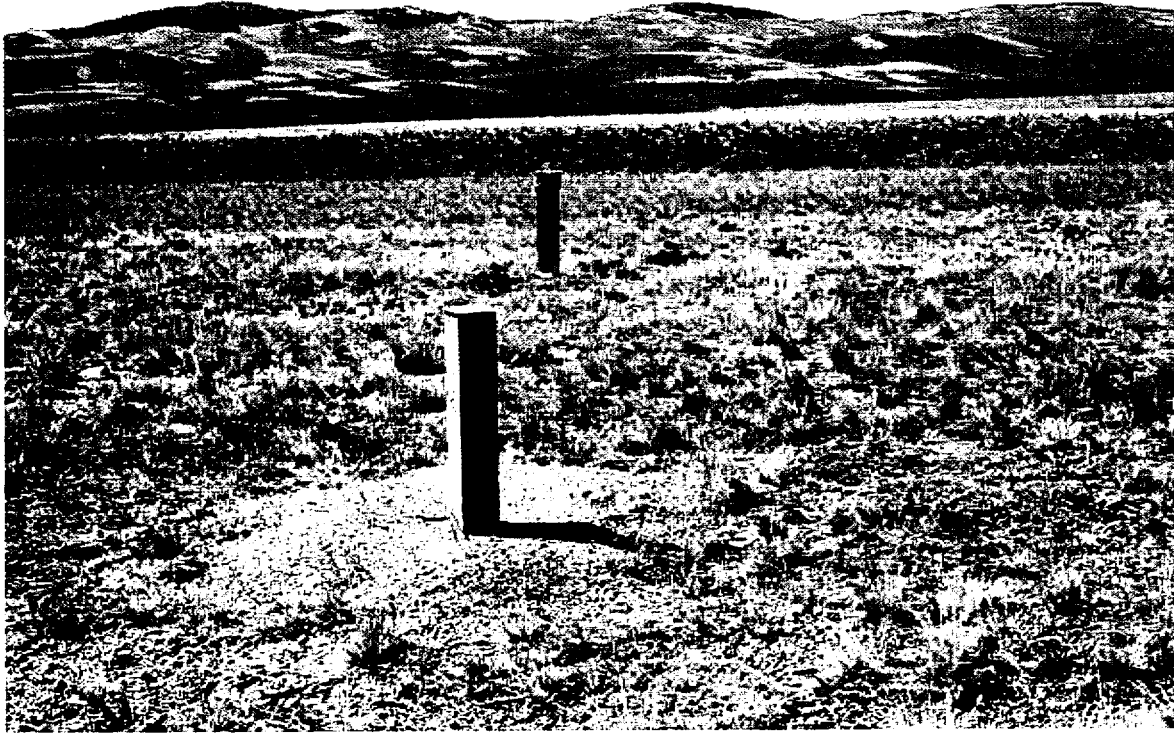
*PL-3. New Landfill Monitor Well Located Approximately 50 Feet North of Well 0663*

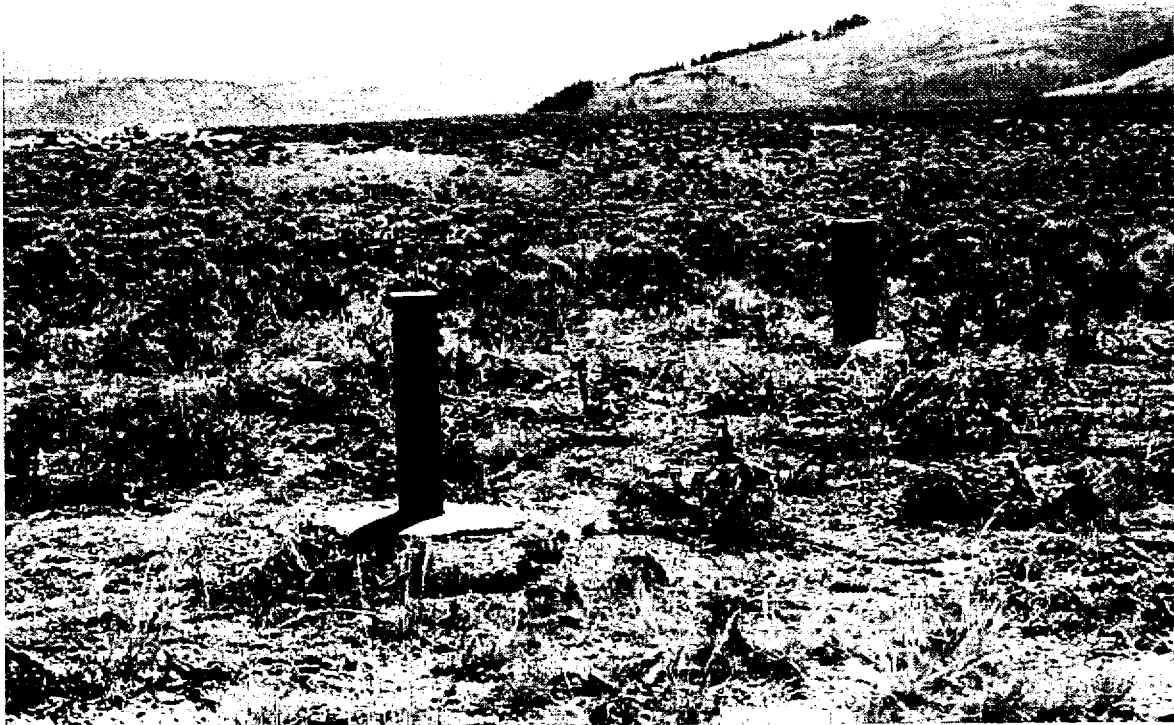
*PL-4. New Landfill Monitor Wells Located Approximately 800 Feet North of Well 0717*

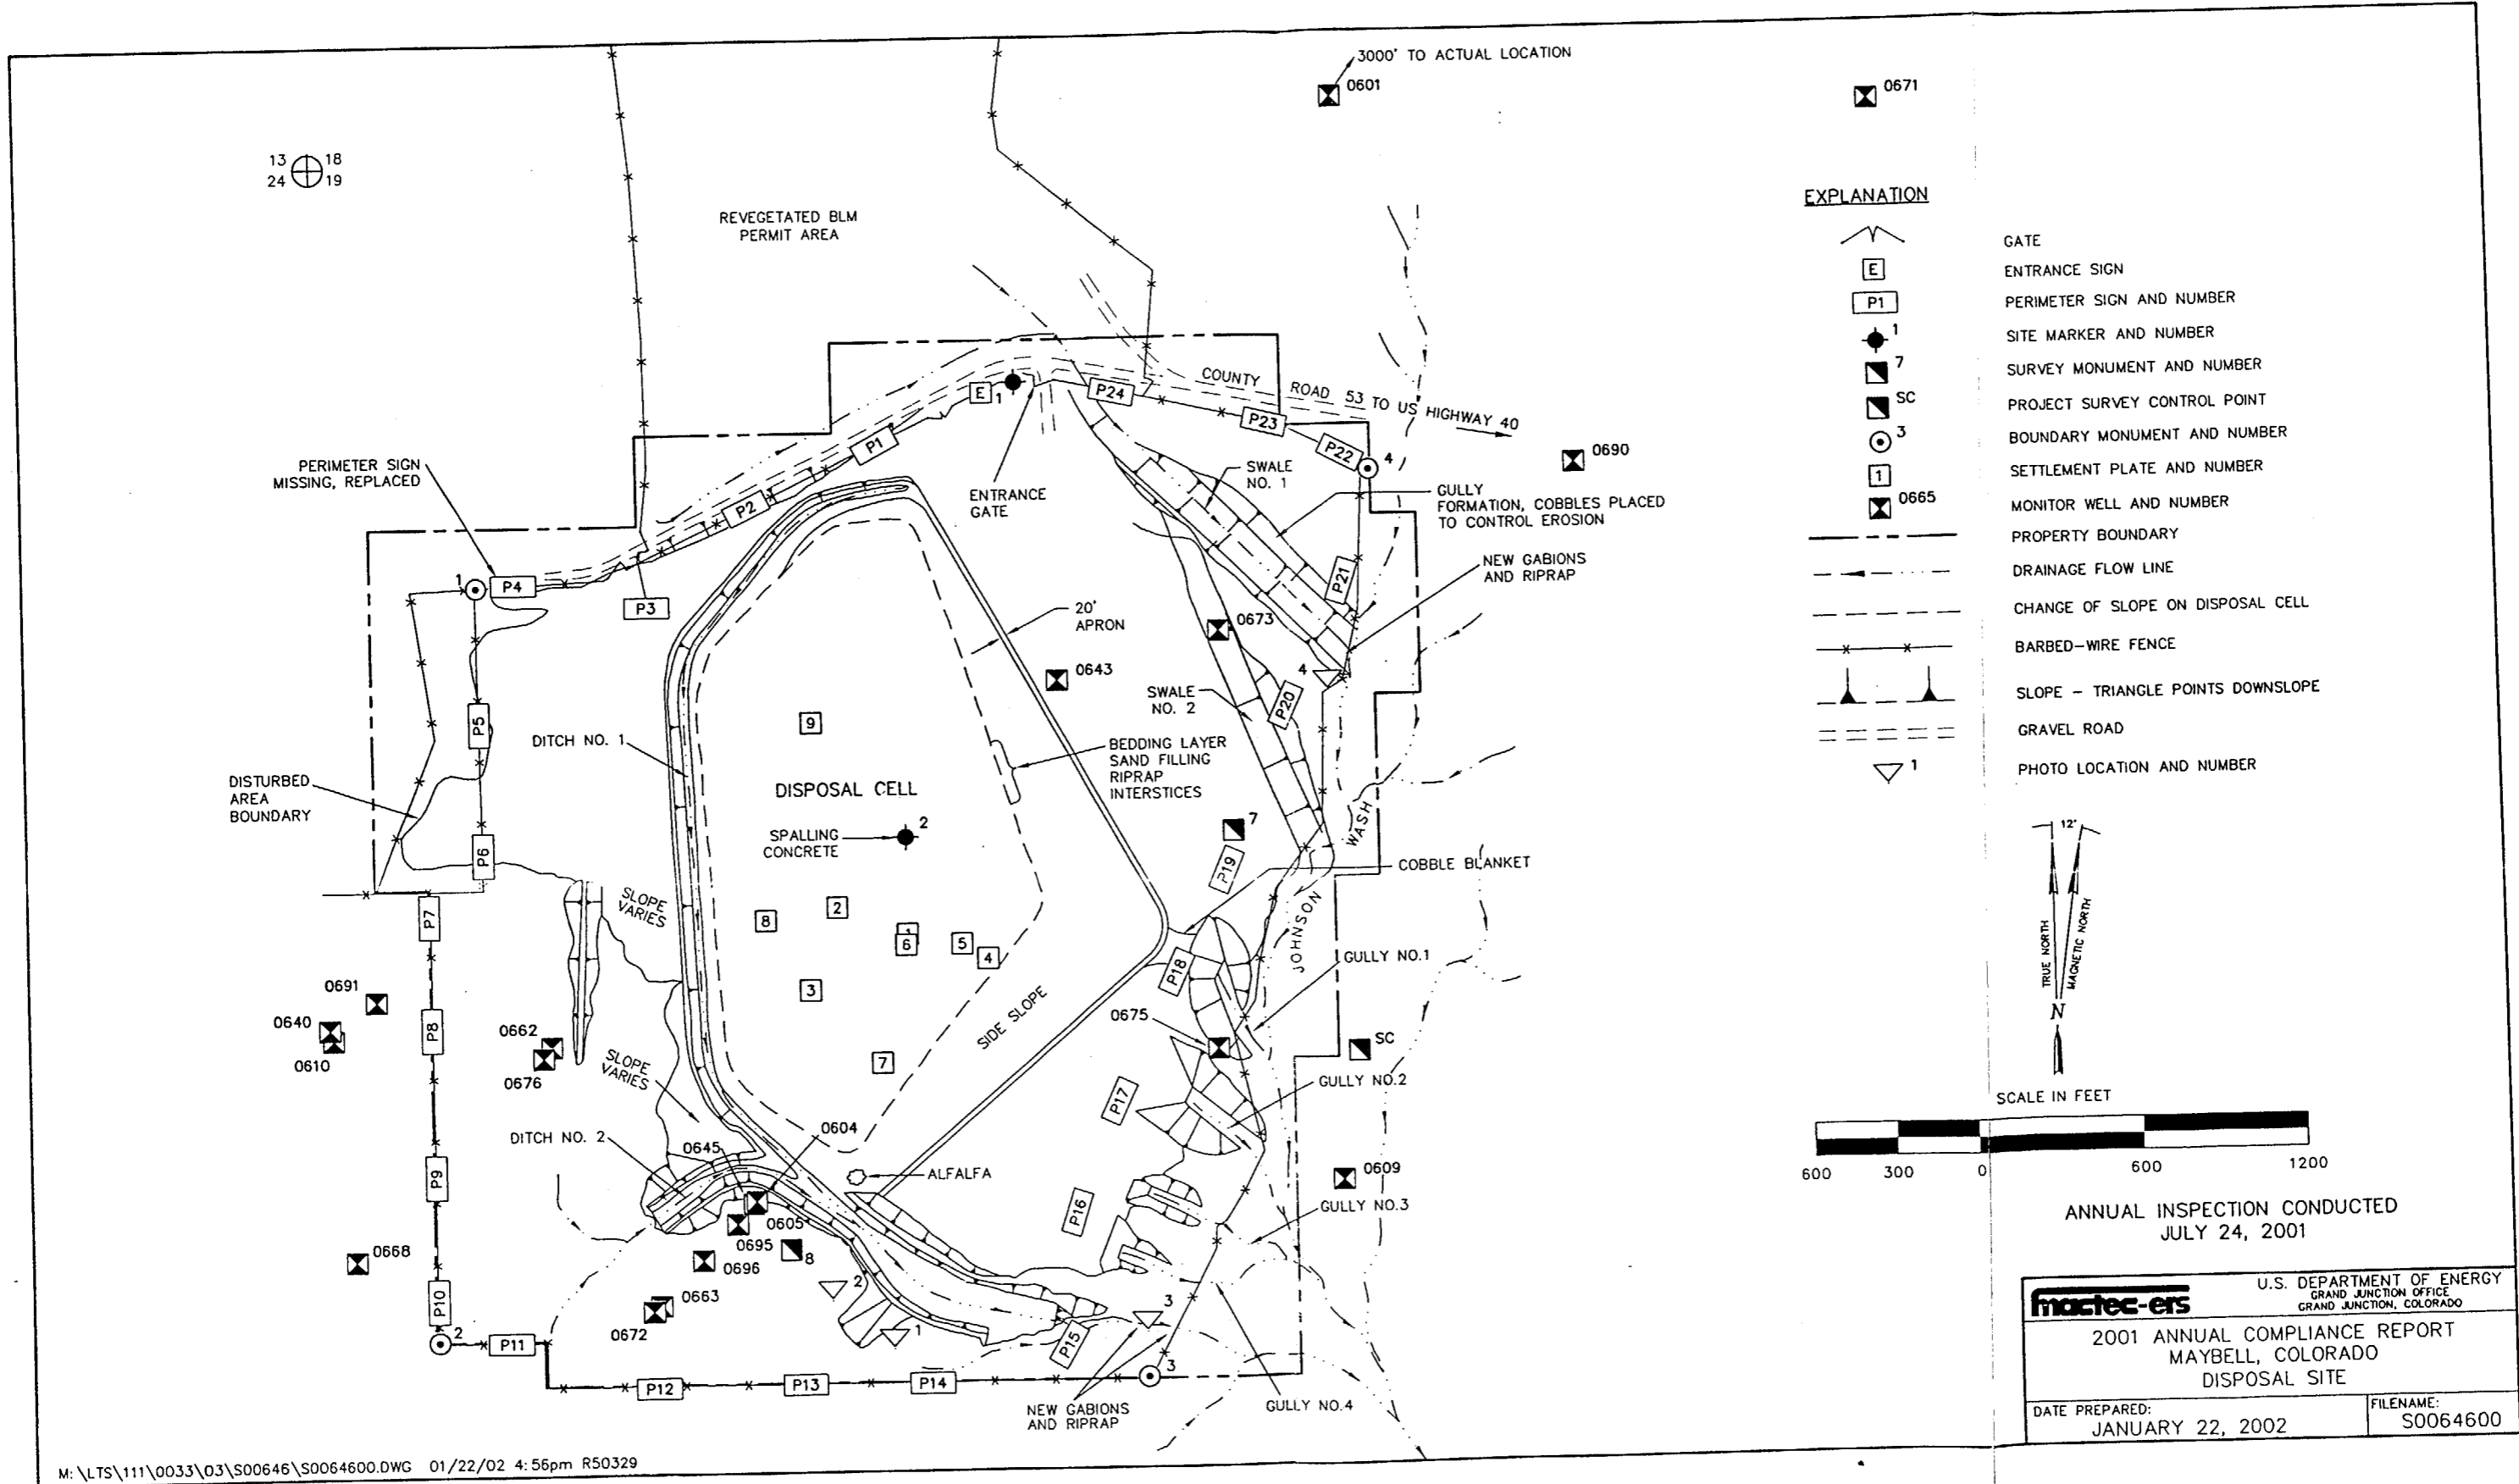
Figure 11-1. 2001 Compliance Drawing for the Maybell, Colorado, Disposal Site

An intact standard stock fence in good condition surrounds the cell. The site fence does not coincide with the site property boundary except at the southwest corner of the site and for a distance along the southern boundary of the site. The property boundary, determined from real estate records, and the actual fence line are shown on Figure 11-1.

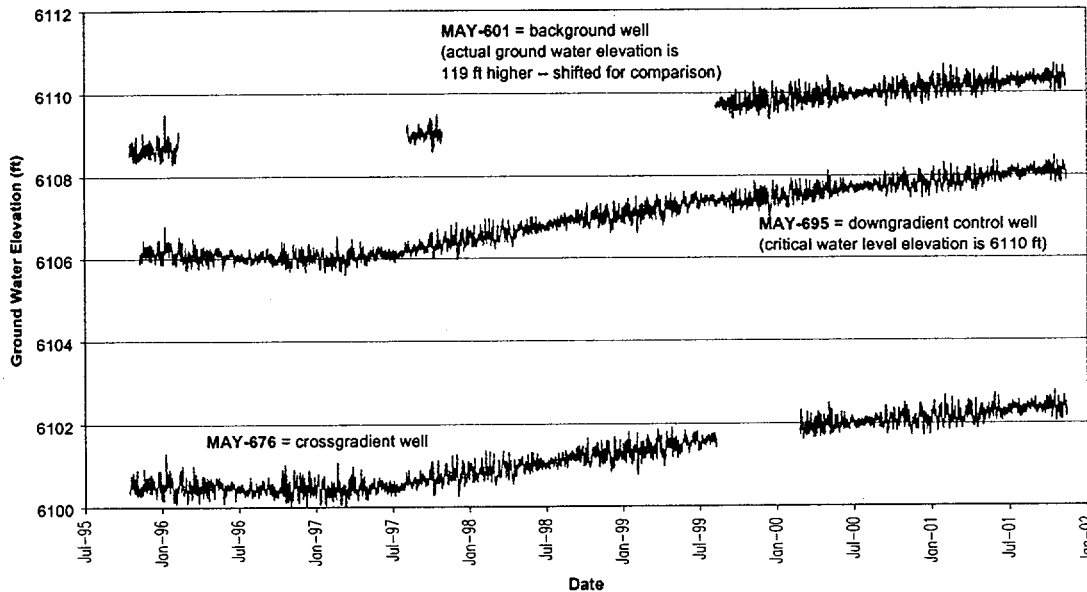
Figure 11-2. Water Level Measurements at the Maybell, Colorado, Disposal Site

Water level measurements through November 2001 are shown in Figure 11-2. Breaks in two of the hydrographs are due to data logger malfunction. Measurements are not shown for backup monitor well 0696.

- 11D Water levels continue to rise at a similar rate at all measuring stations. Slopes of the hydrographs in Figure 11-2 are remarkably parallel. Data from background well 0601 are of primary interest. They show that rising water levels are regional, at least in their major component, and cannot be related to any local effect around the disposal cell. A regional rise in water level can reasonably be attributed to long-term precipitation patterns perhaps of decadal or longer-term duration.

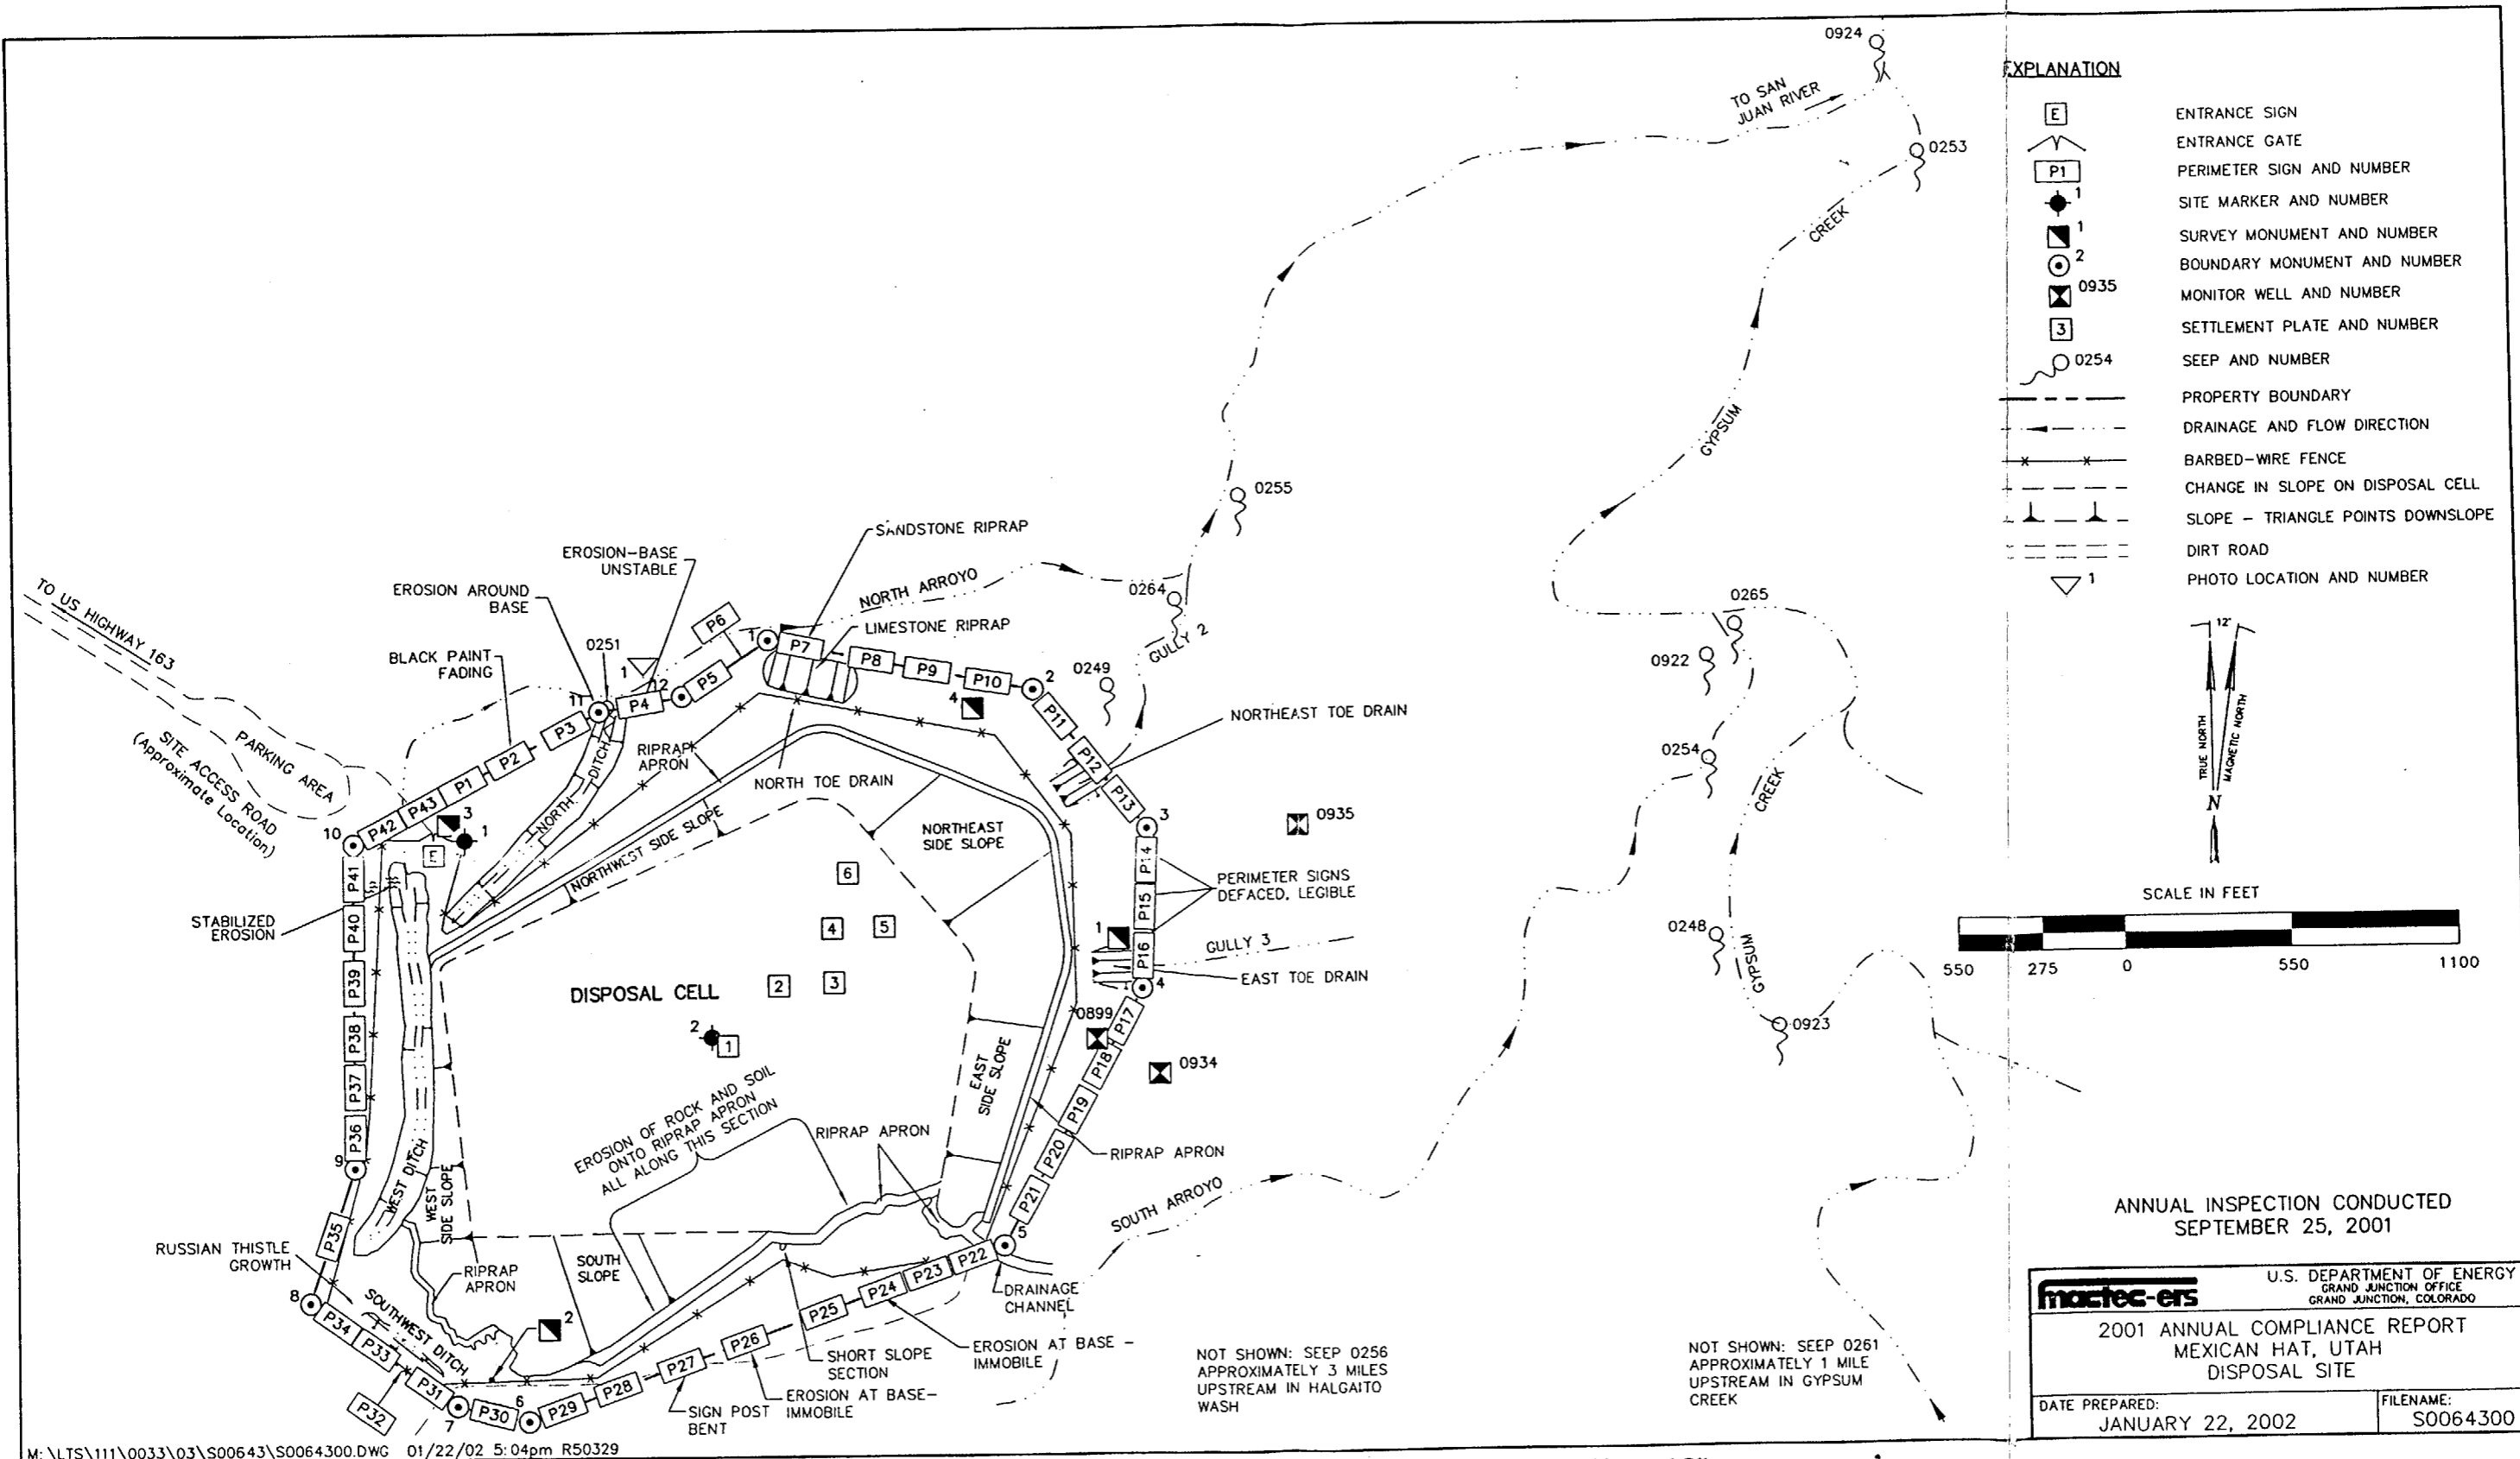
Figure 12-1. 2001 Compliance Drawing for the Mexican Hat, Utah, Disposal Site

- 12A This site has 43 perimeter signs and one entrance sign. All signs are legible. Although perimeter signs P24 and P26 have erosion at the concrete bases as noted in previous years, they remain stable. Perimeter sign P4 (PL-1) has significant erosion and is very unstable. The post holding perimeter sign P27 is bent but remains stable.

Boundary monument BM-11 is situated on a steep soil and rock slope, and soil has eroded from around the downhill side of the concrete base. This monument did not move when tested; its condition has not worsened since it was first noted three years ago.

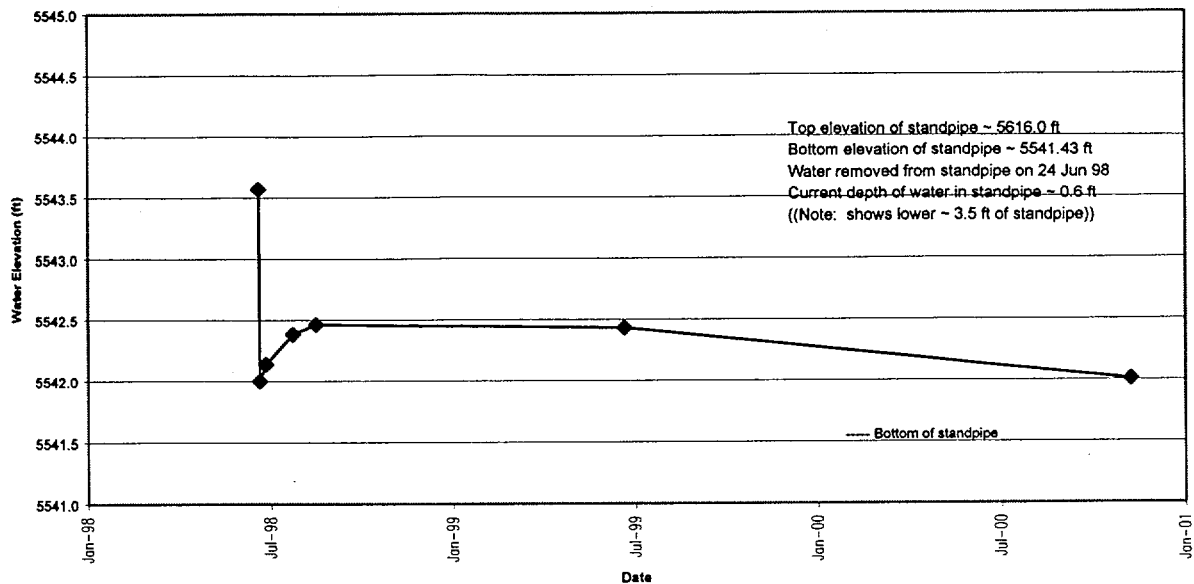
Figure 13–2. Water Elevation in Standpipe in the Naturita, Colorado, Disposal Cell

**Standpipe**—The disposal cell is designed so that transient drainage will move downward into the underlying, unsaturated sandstone and no water will accumulate or pool in the footprint of the disposal cell. A standpipe was installed in the northeastern part of the disposal cell to monitor water pooling. Water levels in this standpipe will be measured when ground water is sampled at the three monitor wells in 2002 and 2004. Results of water level measurements to date, including the measurement in November 2000, are shown on Figure 13–2.

Because the standpipe was not part of the disposal cell design and was never intended to be a permanently installed standpipe/well suitable for water-level measurements, details of the construction of the standpipe are uncertain. The bottom of the standpipe may rest in a concrete footing, and the standpipe may not be perforated all the way to the bottom of the pipe, and therefore could trap water. The standpipe was pumped dry in June 1998 to discern if the water in the standpipe was trapped or if it is an indication of the water table at the base of the cell. As Figure 13–2 shows, within a few months the water level recovered from an elevation of 5,542.5 feet to 5,543.0 feet. The water level was essentially unchanged a year later in July 1999. Since the July 1999 measurement, the water level has dropped to an elevation of 5,542.0 feet (0.6 feet of standing water) recorded in November 2000. Inspectors will continue to measure water levels in the standpipe; the next scheduled measurement is in 2002.

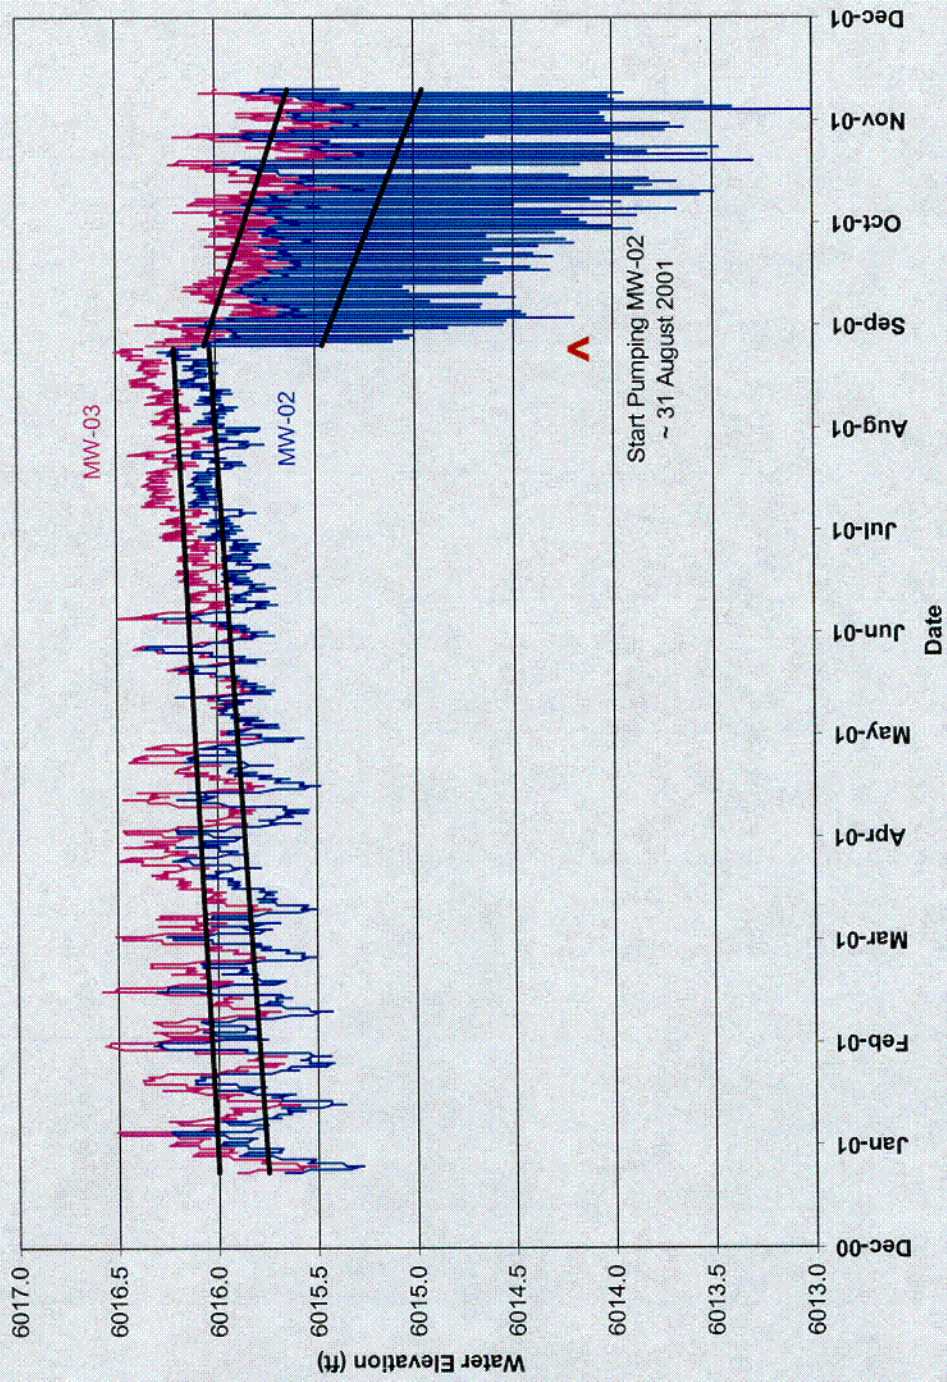
Figure 14-2. Water Levels in Standpipes MW-2 and MW-3 During 2001

When average water levels (as calculated using linear regression) in MW-2 approached the action level in August 2001, DOE installed a pump in standpipe MW-2, constructed an evaporation pond, and began pumping from the standpipe to the pond. Since then, water levels have slowly dropped 4 to 6 inches. Water level measurements for 2001 are shown on Figure 14-2. The linear regression trend line is superimposed on each hydrograph.

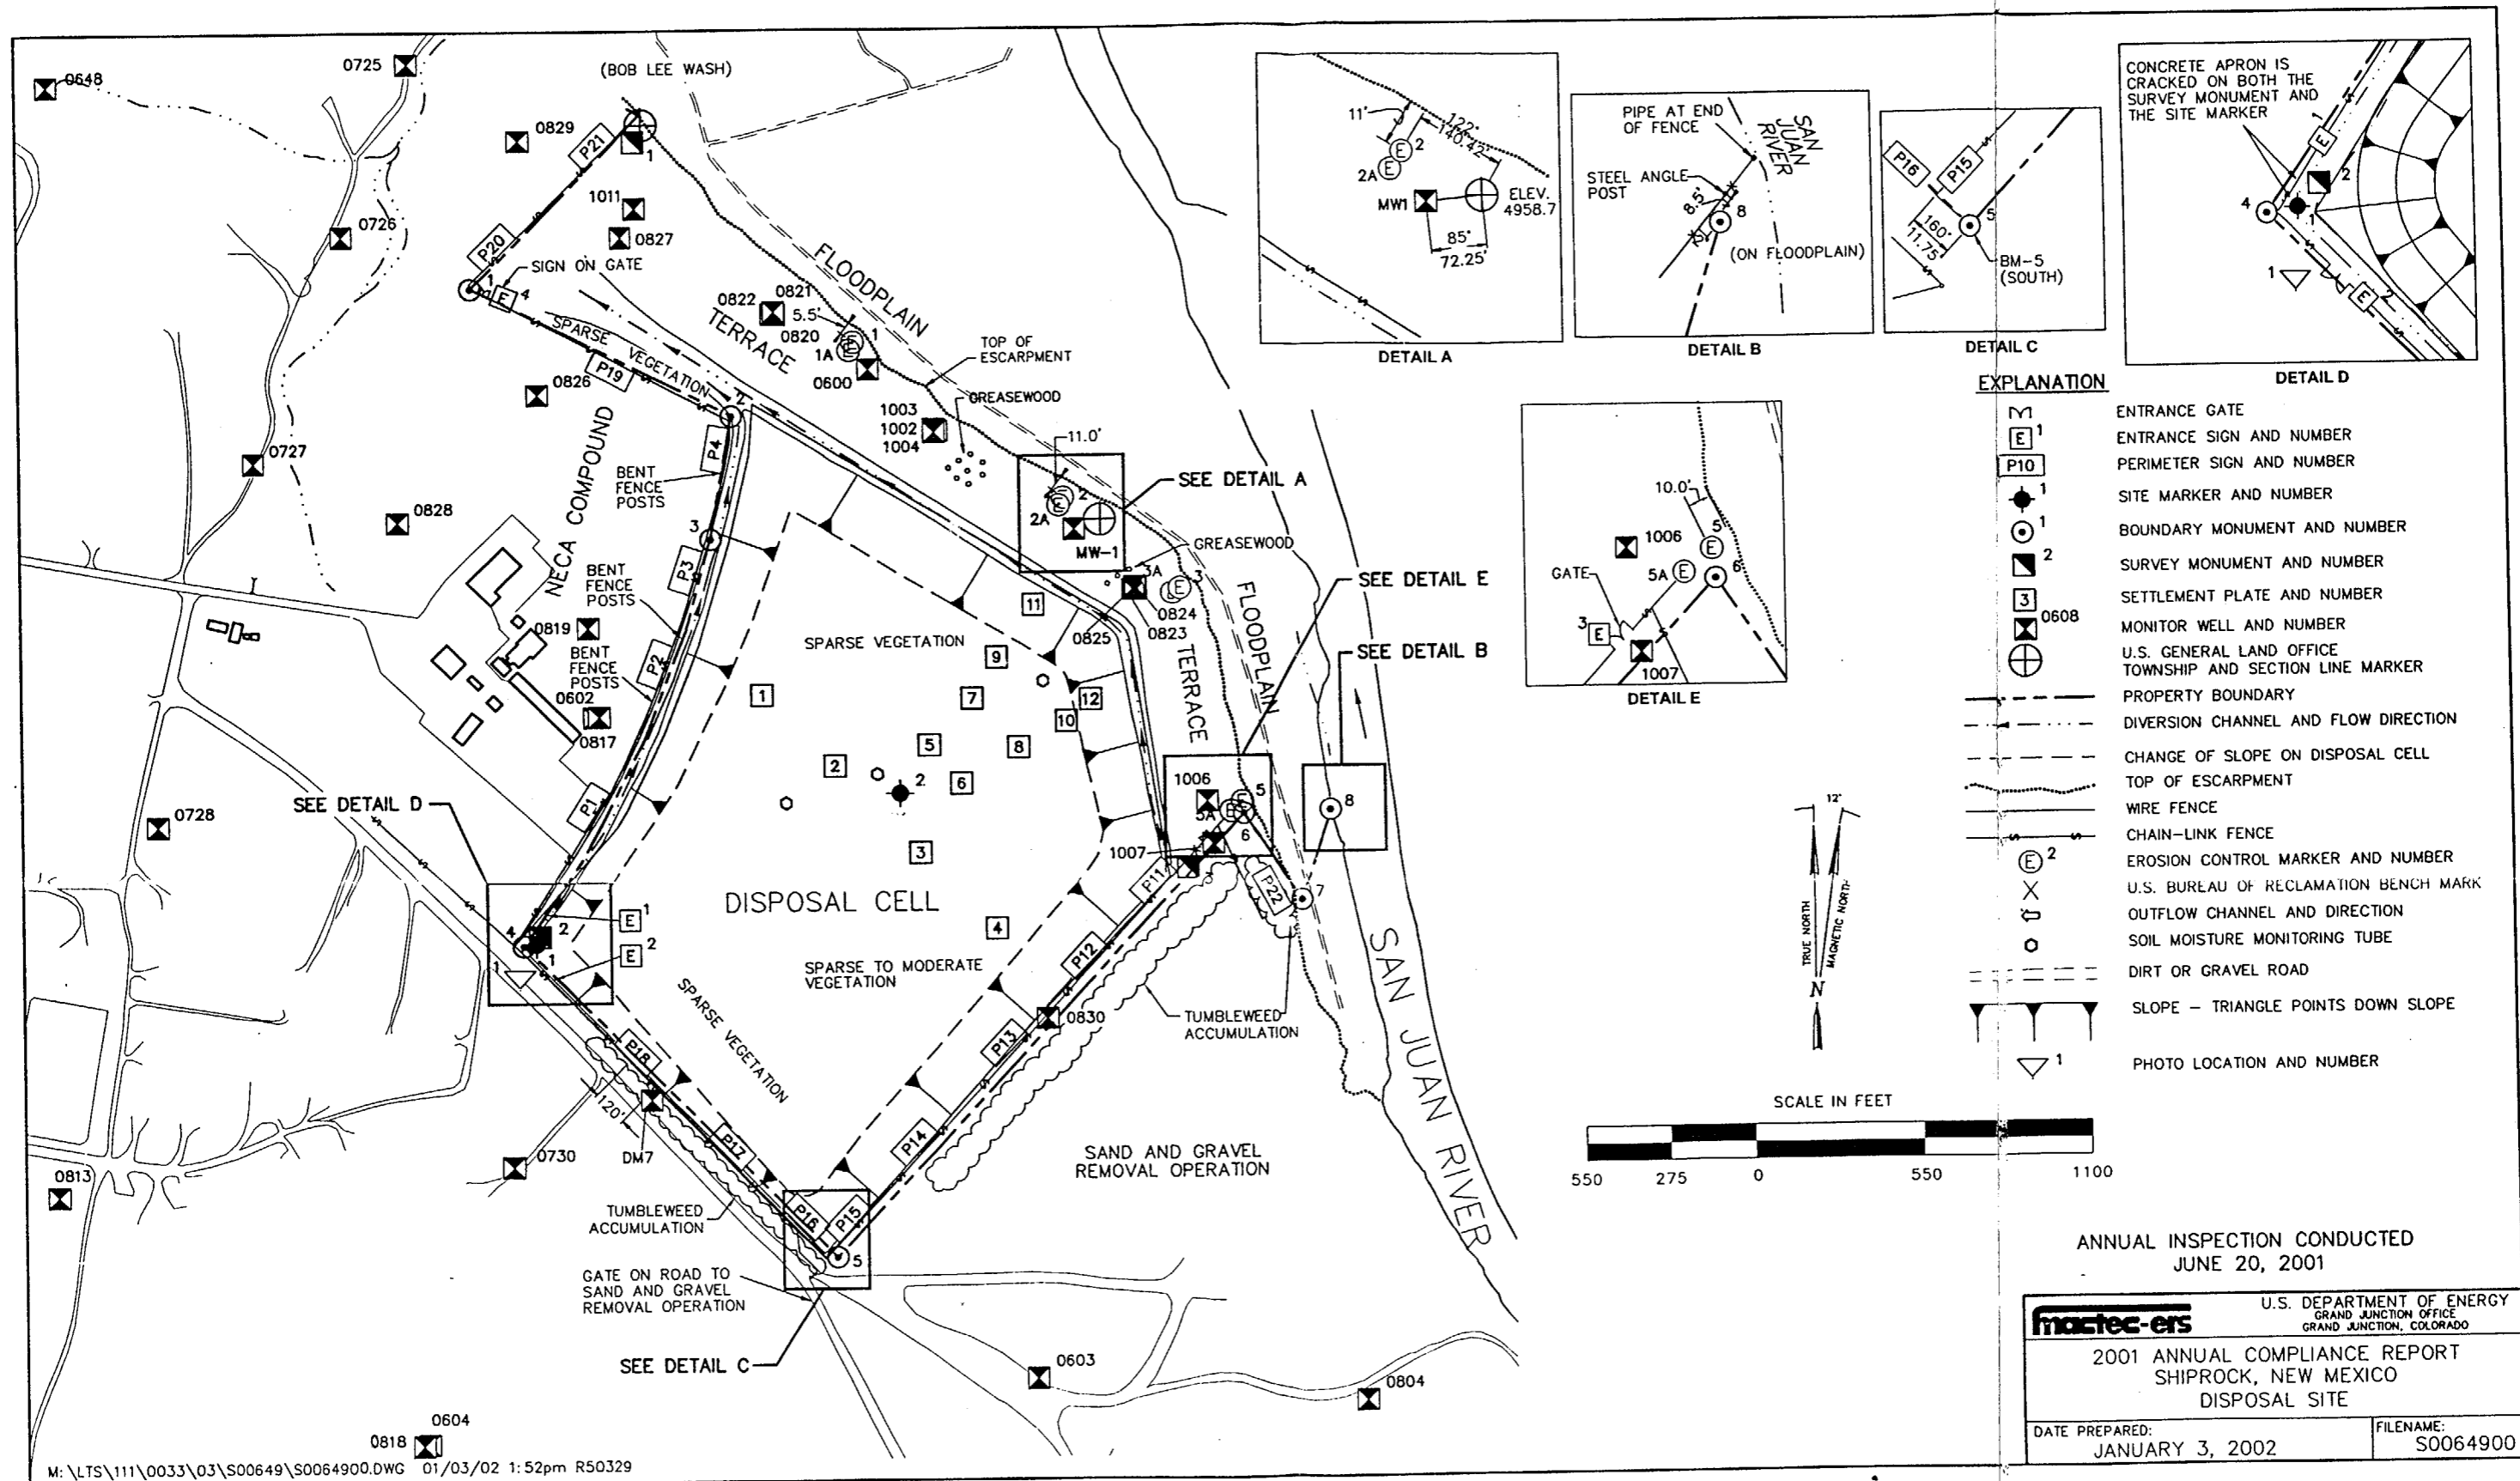
Figure 16-1. 2001 Compliance Drawing for the Shiprock, New Mexico, Disposal Site

16B Due to weed accumulations along the fence lines and the site perimeter, not all boundary monuments could be located during the 2001 inspection. There is no evidence; however, that the monuments have been disturbed or damaged. DOE will verify the locations of all boundary monuments during the 2002 site inspection. All three survey monuments were in good condition.
