Subject: 2001 Annual Site Inspection and Monitoring Compliance Report for UMTRCA  
Title I Disposal Sites

# 2001 Annual Site Inspection and Monitoring Report for Uranium Mill Tailings Radiation Control Act Title I Disposal Sites

January 2002

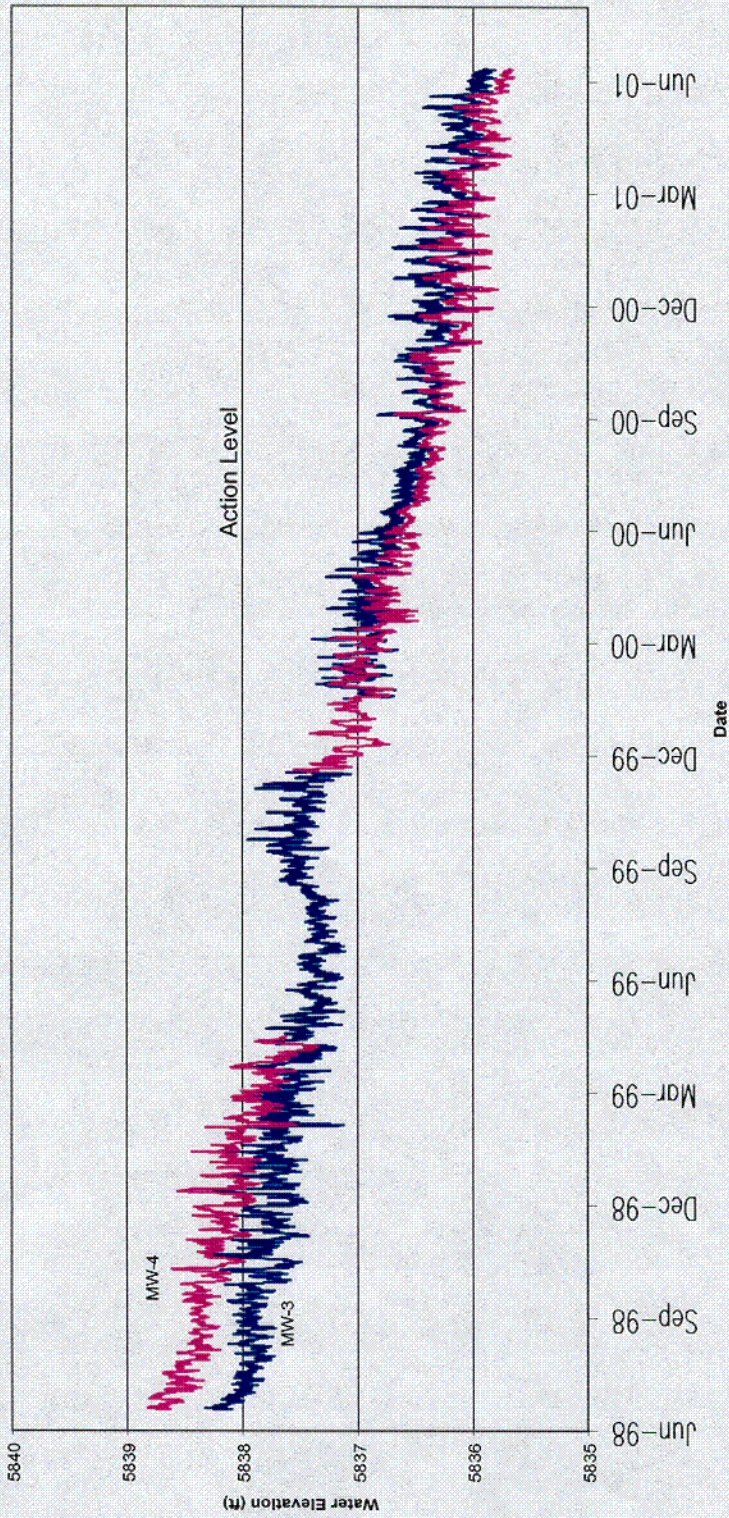
Figure 17-2. Water Levels at MW-03 and MW-04 at the Slick Rock, Colorado, Disposal Cell

Data from data loggers installed in both standpipes are downloaded quarterly. Water-level measurements began in June 1998 (Figure 17-2). At that time, water levels were less than 1 foot above the 5,838-foot datum. Since then, water levels have dropped below the 5,838-foot datum and are continuing to drop. Most recently, in July 2001, water levels in both standpipes were measured at elevations between 5,835.7 and 5,835.9 ft. (Noise or oscillations in the Figure 17-2 hydrograph result from variations in atmospheric pressure. Breaks in the hydrograph are due to malfunctioning data loggers. New equipment was installed after each failure.)

DOE's obligation, as stated in the Long-Term Surveillance Plan, is to monitor water levels until water levels in both standpipes are continuously at or below the 5,838-foot datum for three consecutive quarters. The hydrograph in Figure 17-2 clearly shows water levels in both standpipes have been below the 5,838-foot datum since April 1999. Therefore, the monitoring requirement is fulfilled, and the project is considered closed out. DOE will decommission the standpipes upon concurrence of the U.S. Nuclear Regulatory Commission.

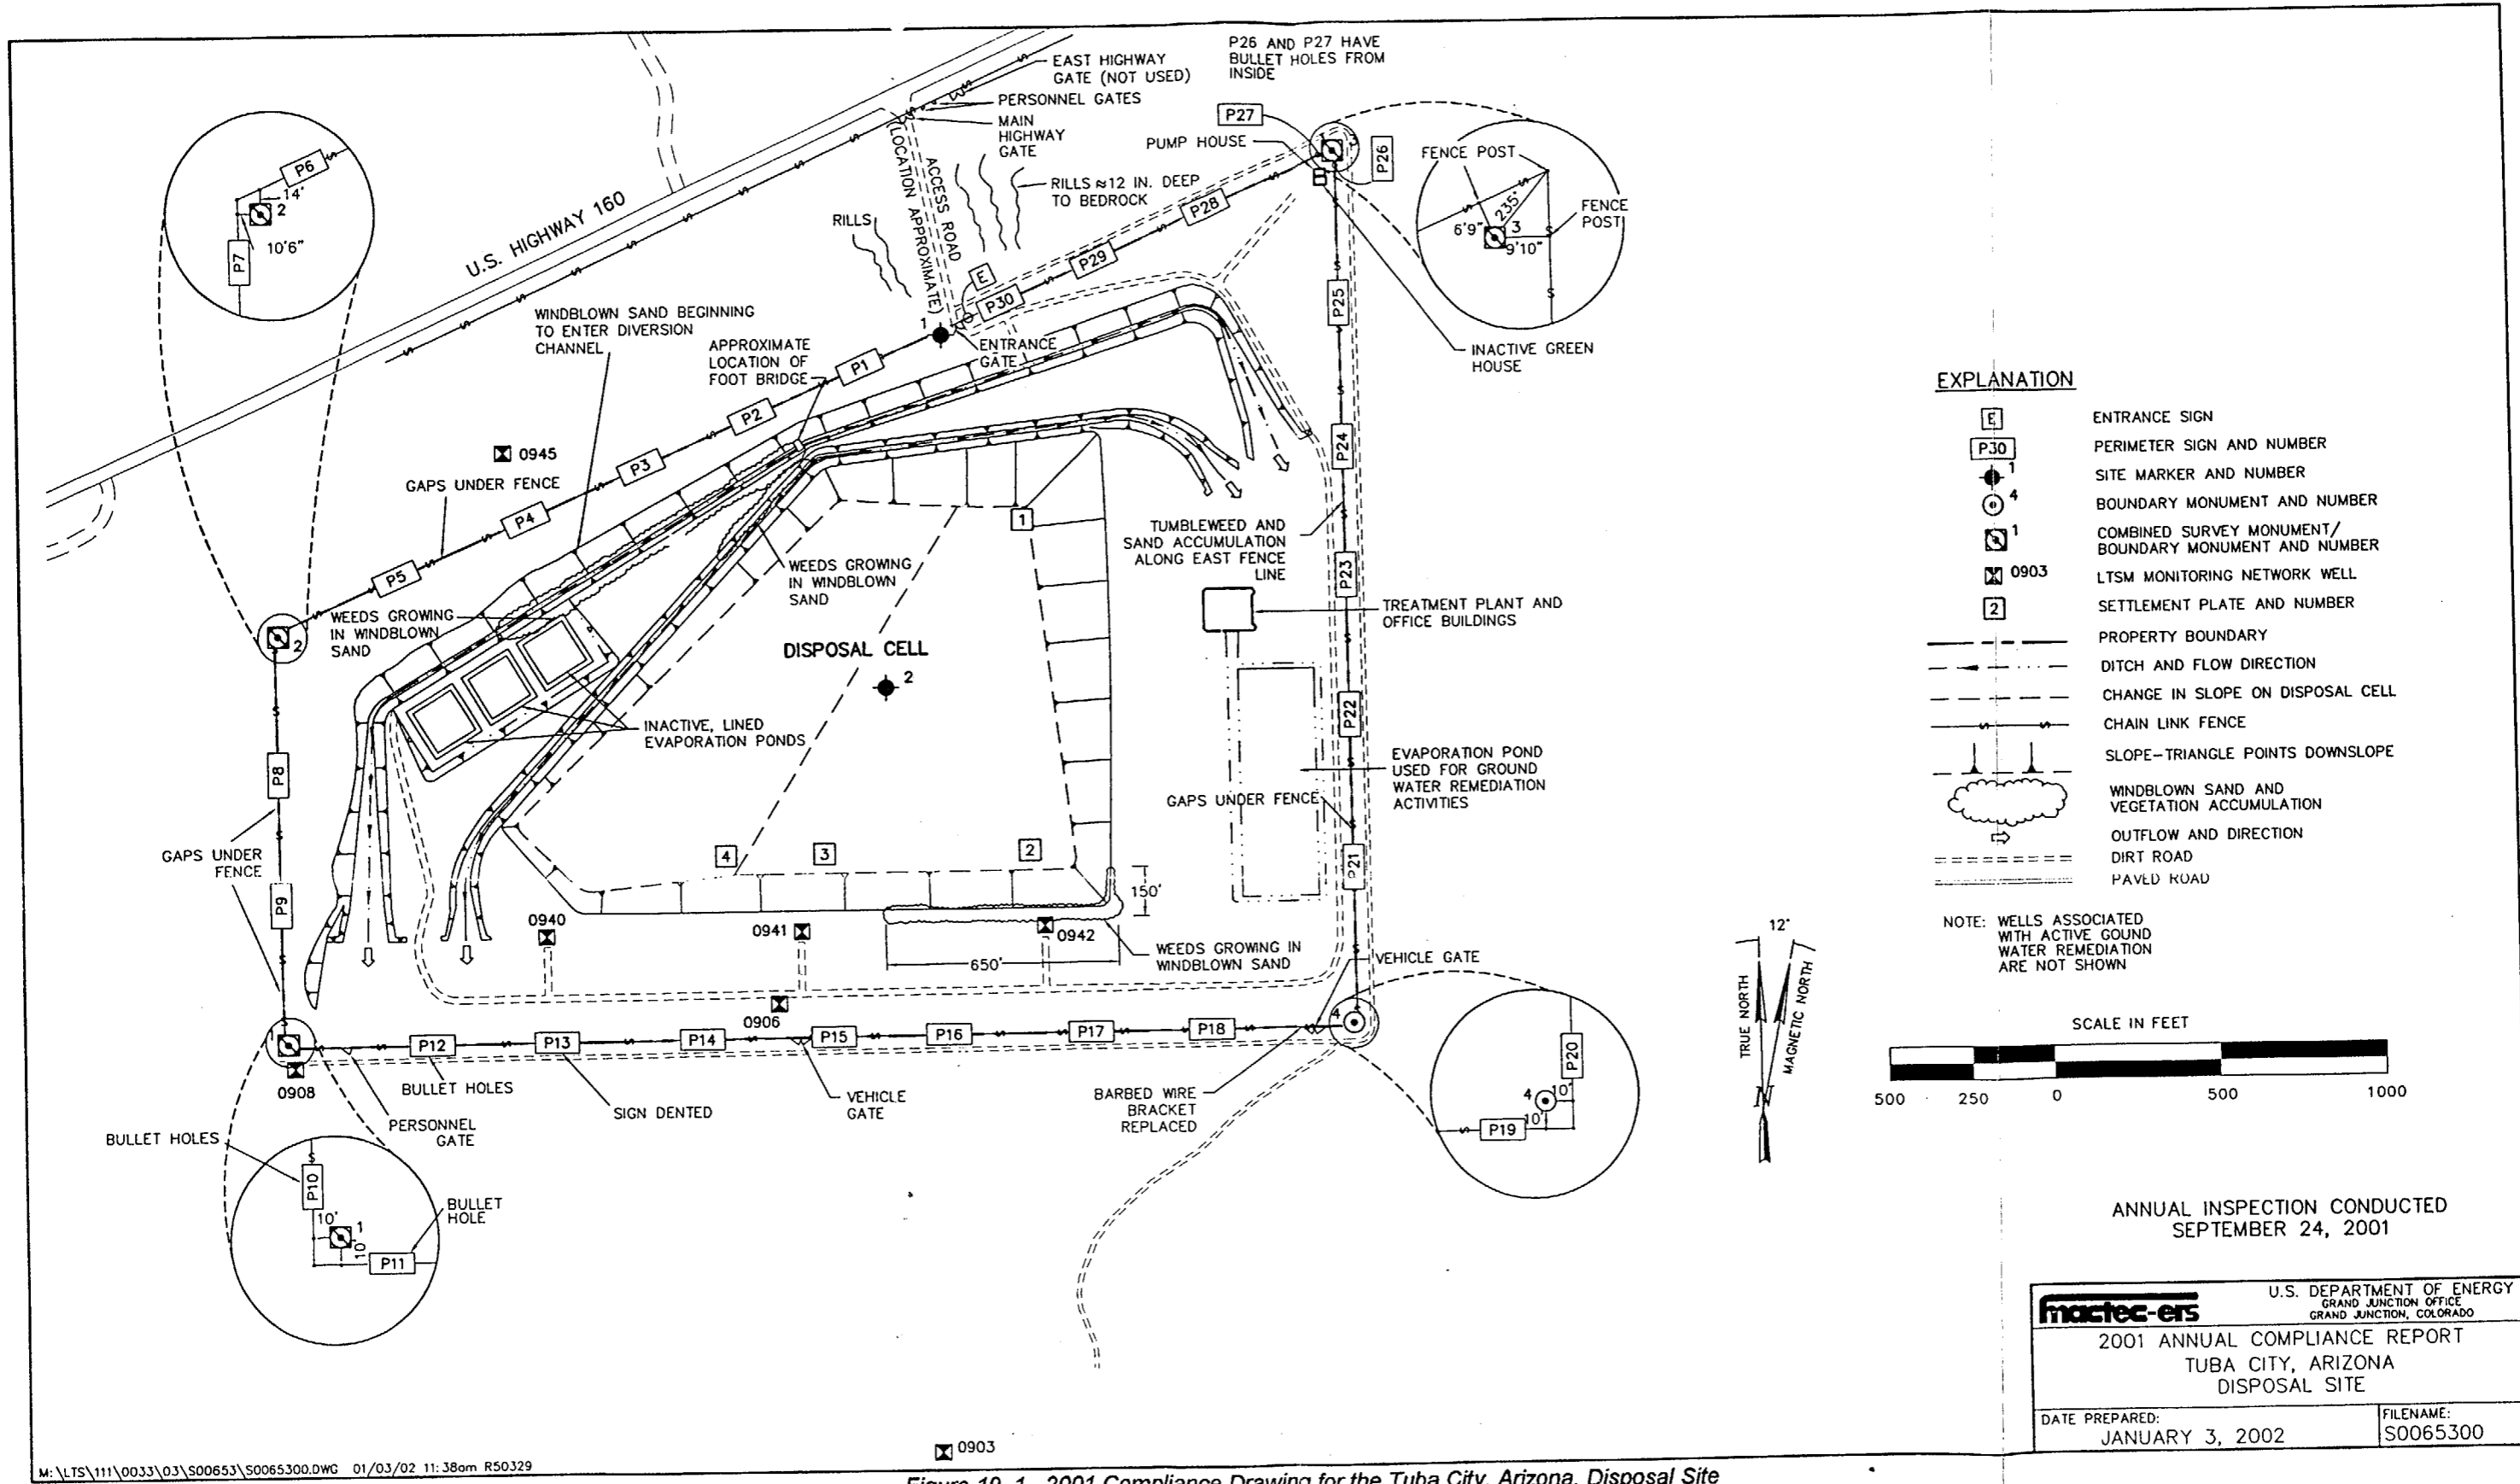
Figure 19-1. 2001 Compliance Drawing for the Tuba City, Arizona, Disposal Site

- 19C Scattered patches of kochia, Russian thistle, and other annual weeds persist on the top and south side slope of the disposal cell. Smaller and fewer patches of these weeds also remain on the west and north side slopes. The number of plants is slowly increasing, encouraged perhaps by deposition of windblown sand and soil. Inspectors continue to monitor changes in plant cover with photographs, which are taken from selected vantage points on an annual basis.
