UNITED STATES
NUCLEAR REGULATORY COMMISSION
OFFICE OF INSPECTION AND ENFORCEMENT
WASHINGTON, D.C. 20555

IE Information Notice No. 79-13

INDICATION OF LOW WATER LEVEL IN THE OYSTER CREEK REACTOR

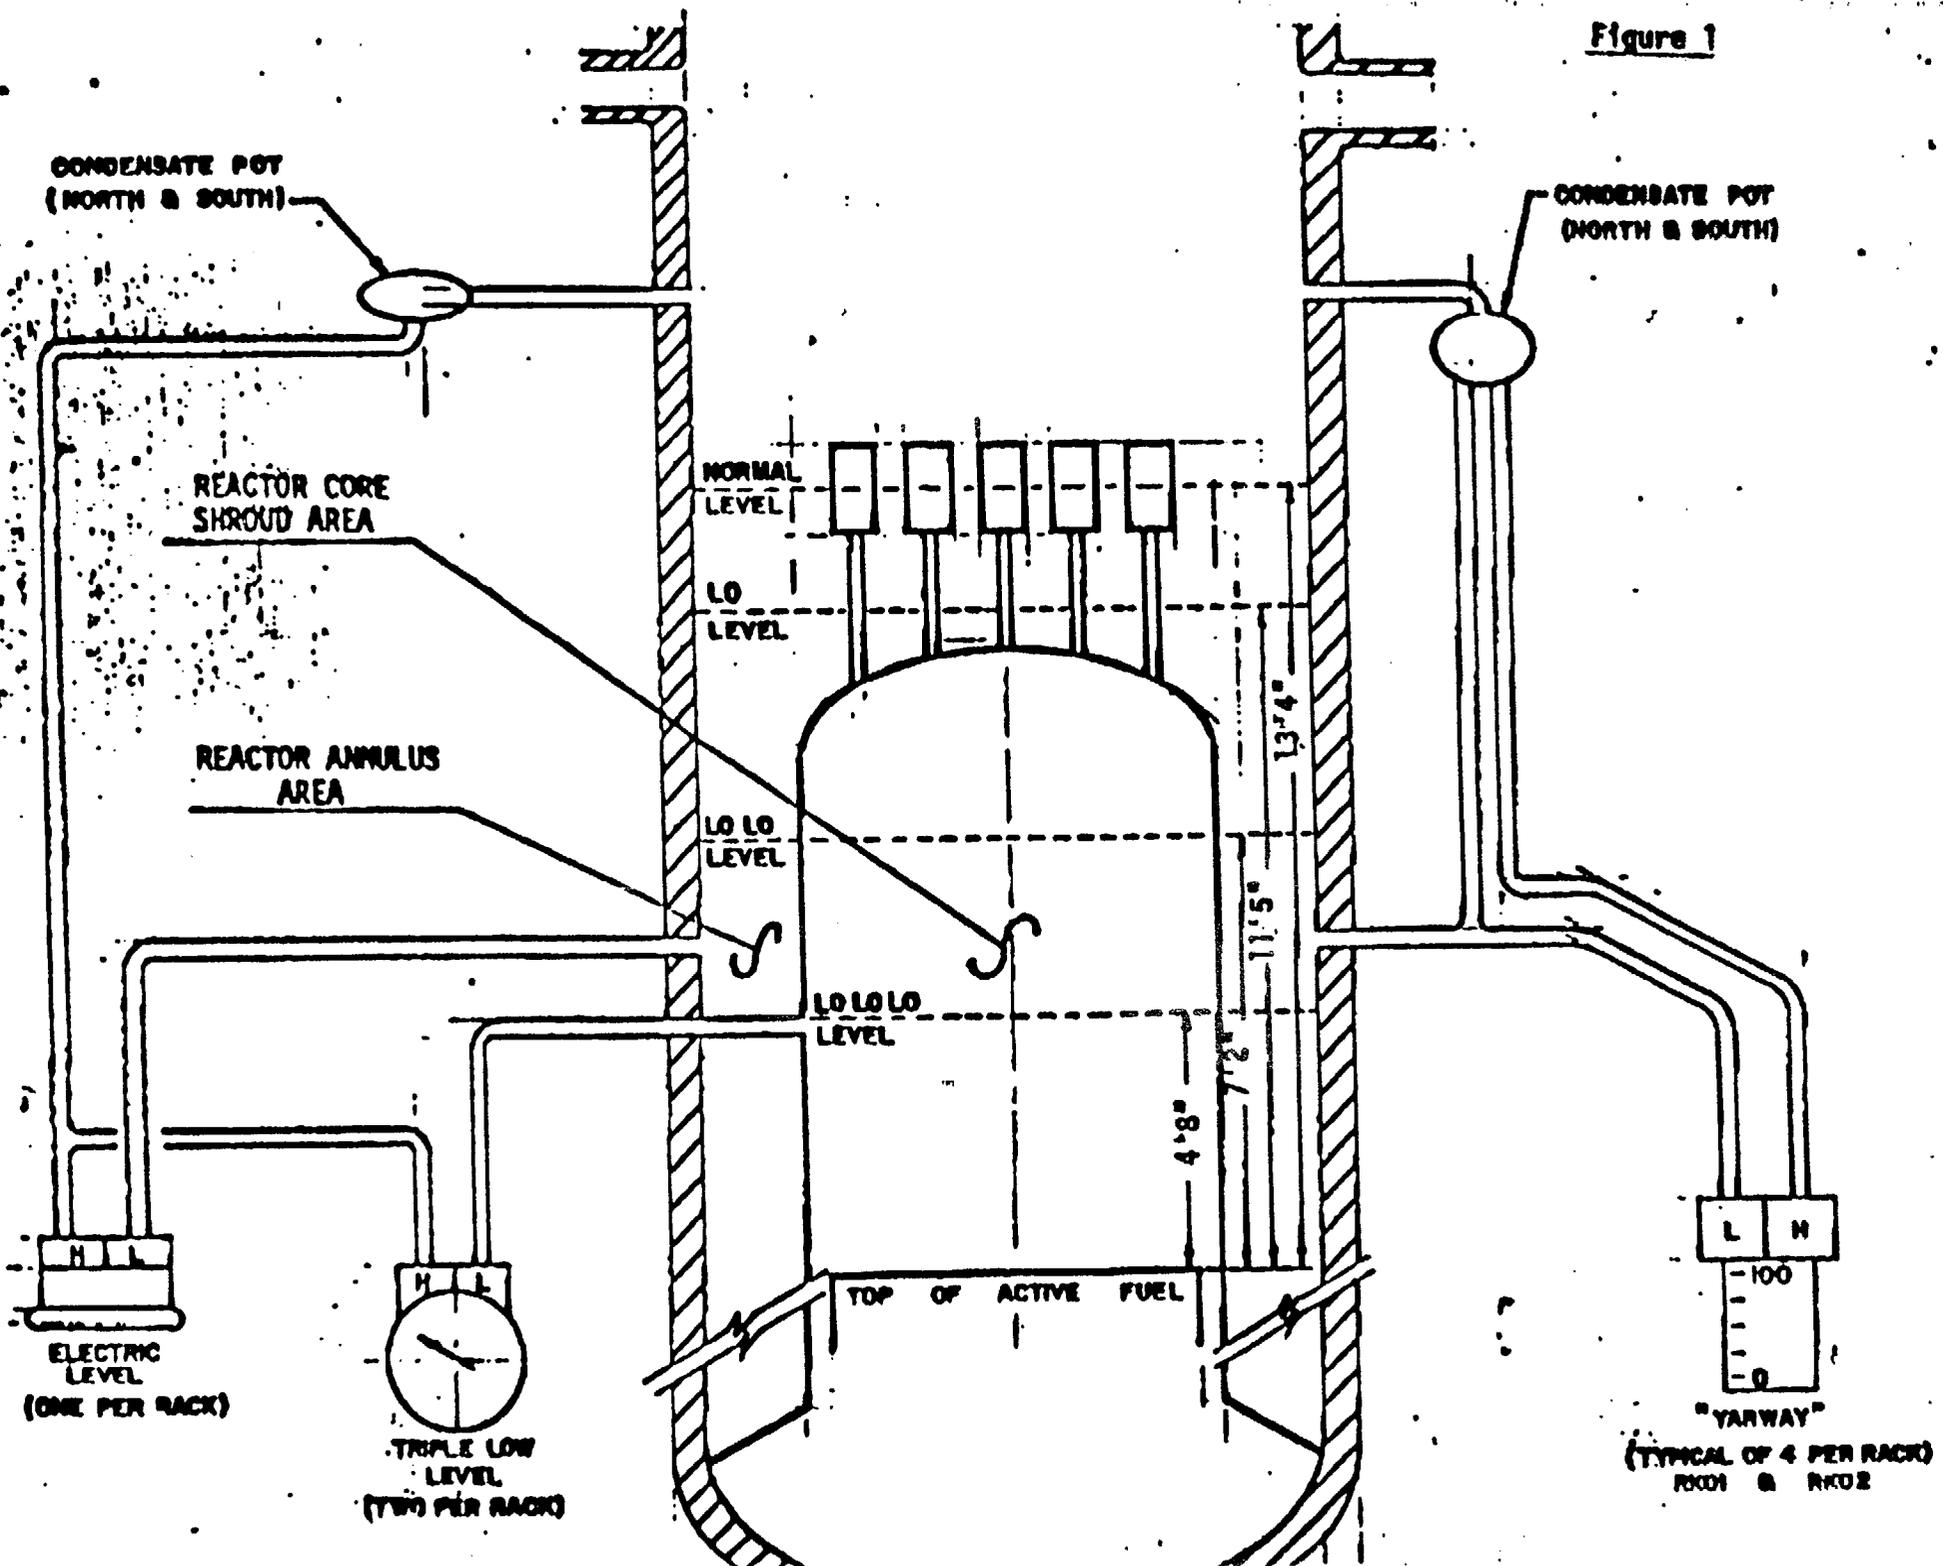
Figure 1

TIME (SEC.)	EVENT
0	REACTOR SCRAM/RECIRC. PUMP TRIP
13	TURBINE TRIP/LOSS OF FEEDWATER/CONDENSATE PUMPS
13.6	LOW WATER LEVEL SCRAM POINT
16.8	#2 RPS MOTOR GEN. SET TRIP
31	#2 DIESEL GENERATOR BREAKER CLOSED/2ND CRD PUMP STARTED
43	MSIV CLOSED*
76	B ISO. CONDENSER PLACED IN SERVICE*
90	LOW WATER LEVEL ALARM CLEARED
172	LOW LOW LOW WATER LEVEL TRIP POINT
186	RECIRC. LOOP DISCHARGE VALVES NOTED CLOSED
1914	C RECIRC. PUMP STARTED THEN TRIPPED*
2208	FEEDWATER PUMP STARTED*
2304	RECIRC. PUMP STARTED/LOW LOW LOW WATER LEVEL ALARM CLEARED
2700	RPS #2 RESTARTED/SCRAM RESET*
3600	STARTUP TRANSFORMER SB RETURNED TO SERVICE
