**UNITED STATES
NUCLEAR REGULATORY COMMISSION
REGION IV
611 RYAN PLAZA DRIVE, SUITE 400
ARLINGTON, TEXAS 76011-8064**

EA-02-046

**SUBJECT: NRC AUGMENTED INSPECTION TEAM (AIT) REPORT 50-483/02-07 AND
PRELIMINARY WHITE FINDING - CALLAWAY PLANT**

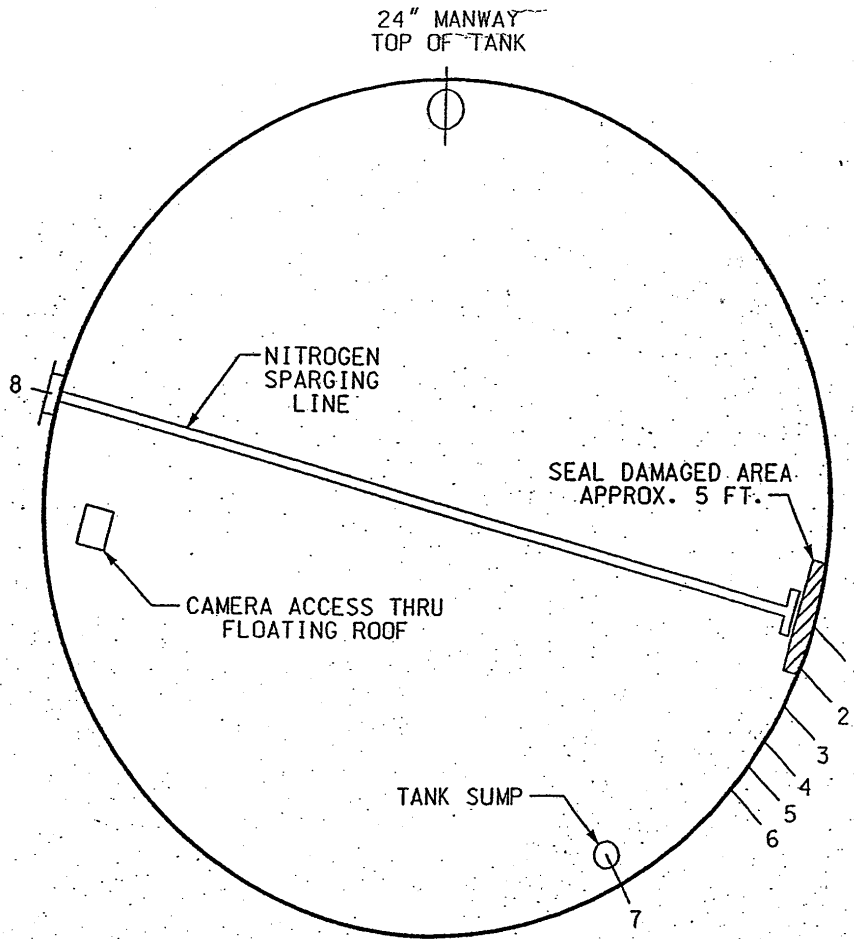
Figure 4

The team determined that the degradation of the seal was limited to a 71-inch circumferential section of the diaphragm. The degraded portion of the diaphragm seal was located above the single suction source of the AFW system (See Figure 4). The following table provides a listing of the missing foam portions of the seal.
