VIRGINIA ELECTRIC AND POWER COMPANY
NORTH ANNA POWER STATION UNIT 2
SUPPLEMENTAL INFORMATION - NRC BULLETIN 2001-01 CIRCUMFERENTIAL
CRACKING OF REACTOR VESSEL HEAD PENETRATION NOZZLES
RESULTS OF METALLURGICAL INVESTIGATION OF ALLOY 82/182 CRACKING

**WCAP-15777, "Metallurgical Investigation of Cracking of the Alloy 82/182
J-Groove Weld of the Reactor Vessel Head Penetration Joint at North Anna Unit 2
Station"**

**Virginia Electric and Power Company
(Dominion)
North Anna Unit 2**

Metallurgical Investigation of Cracking of the Alloy 82/182 J-Groove Weld of the Reactor Vessel Head Penetration Joint at North Anna Unit 2 Station

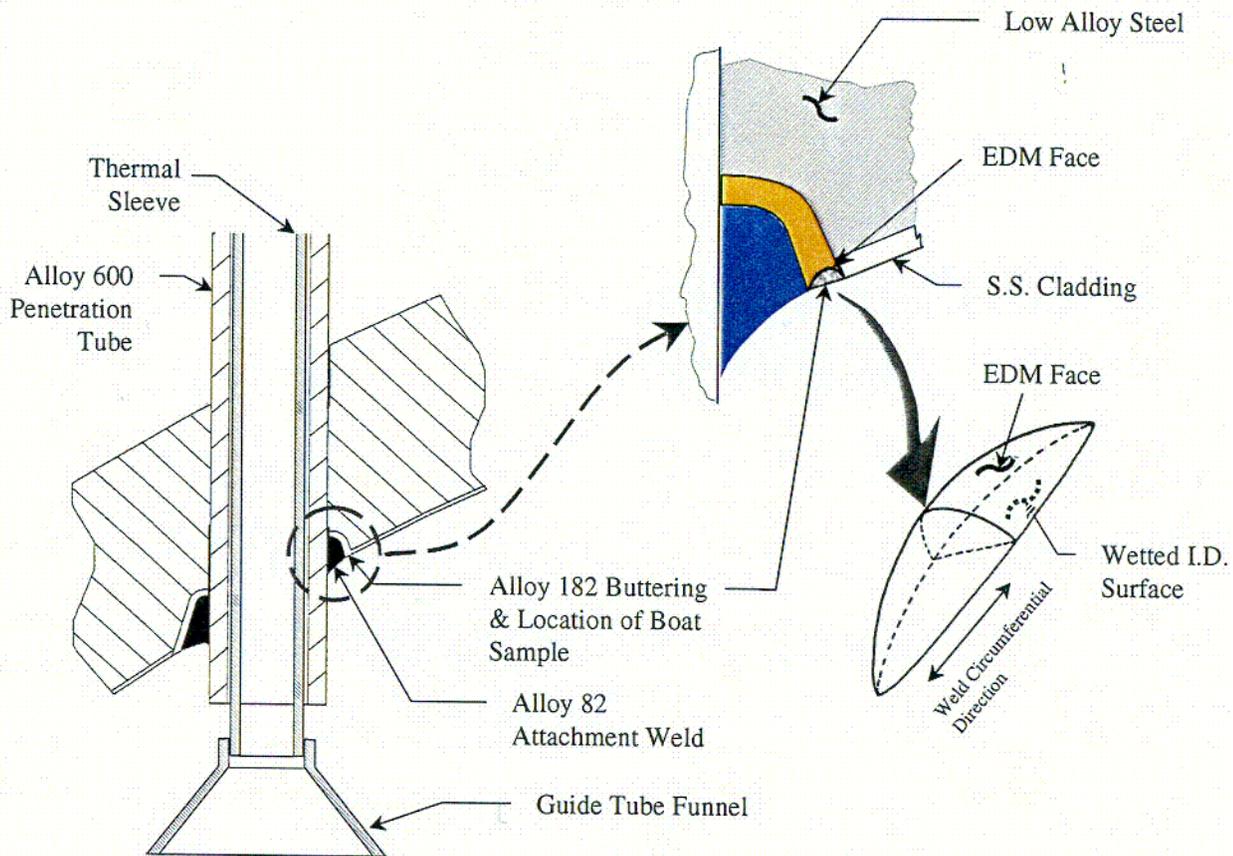
Figure 2 Schematic representation of the reactor vessel head penetration J-groove weld geometry illustrating the boat sample location at the low alloy steel to butter/clad interface. Note that the long transverse axis of the boat is oriented parallel to the 182/S.S. cladding interface, whereas the short longitudinal axis is in the radial direction with respect to the J-groove weld
