Subject: Confirmatory Action Letter Response - Root Cause Analysis Report

Root Cause Analysis Report

Significant Degradation of the Reactor Pressure
Vessel Head

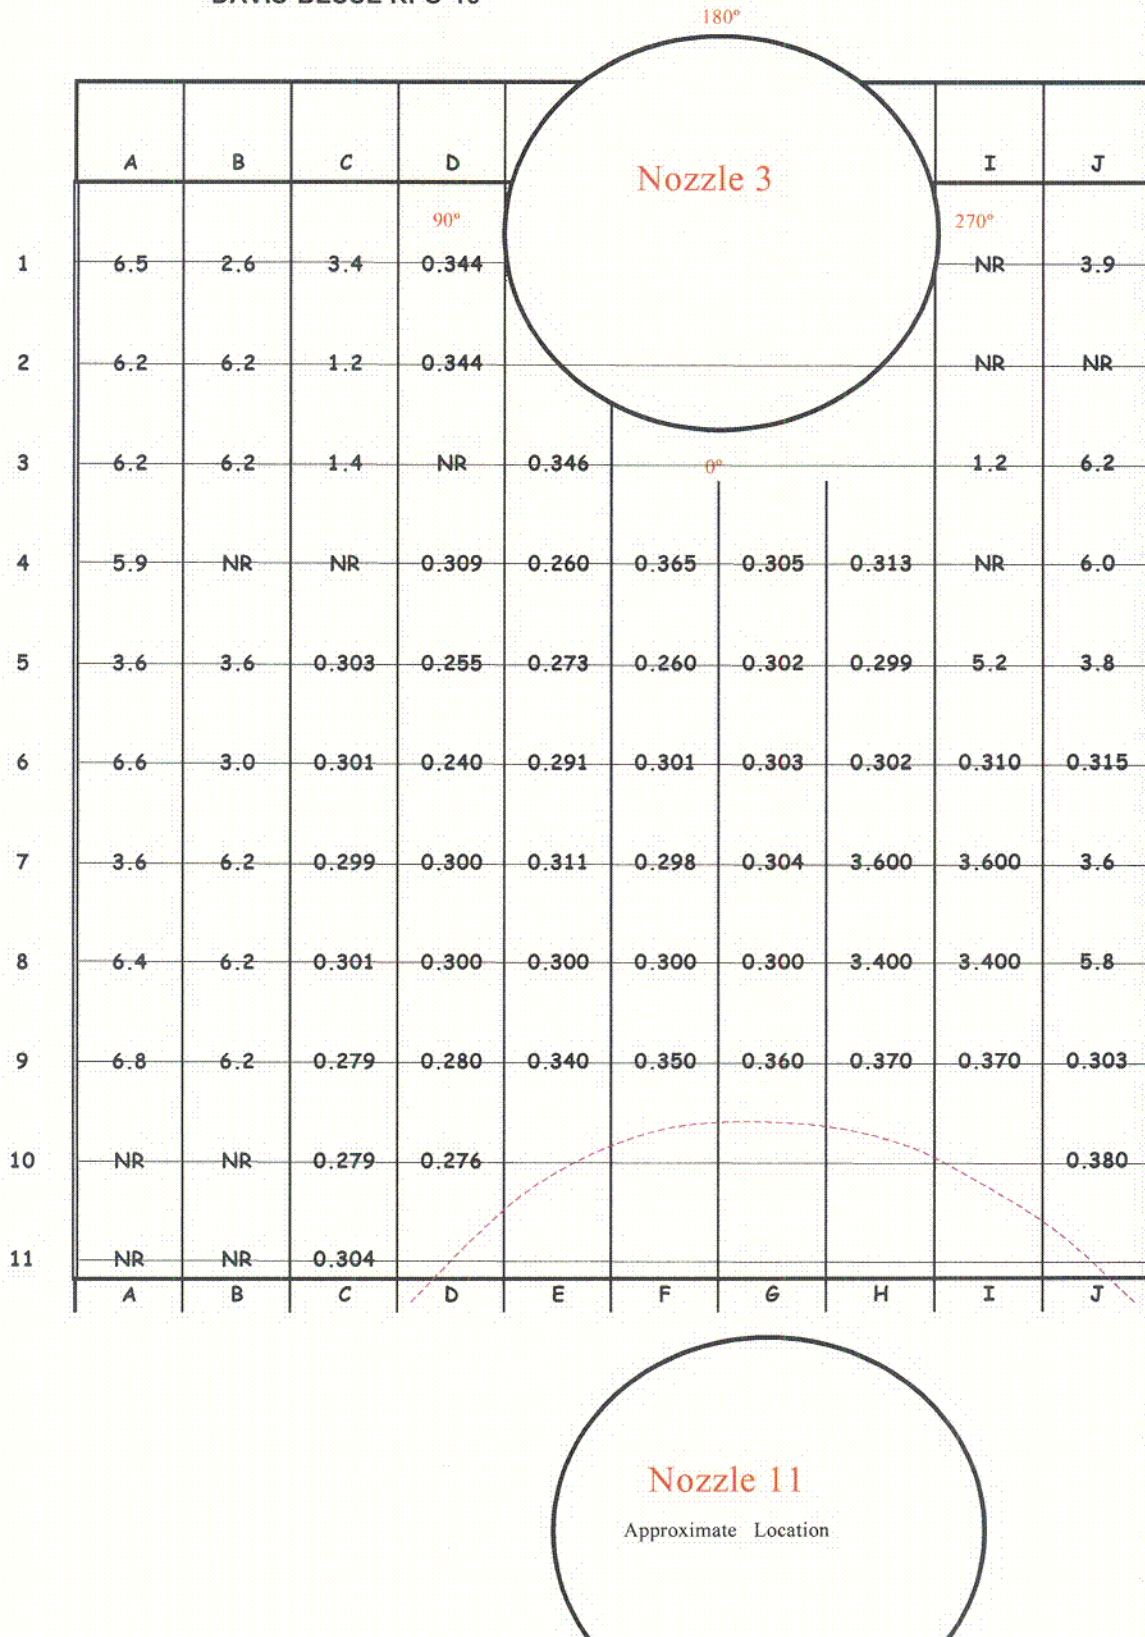
Figure 14. Nozzle 3 Clad Thickness Measurements

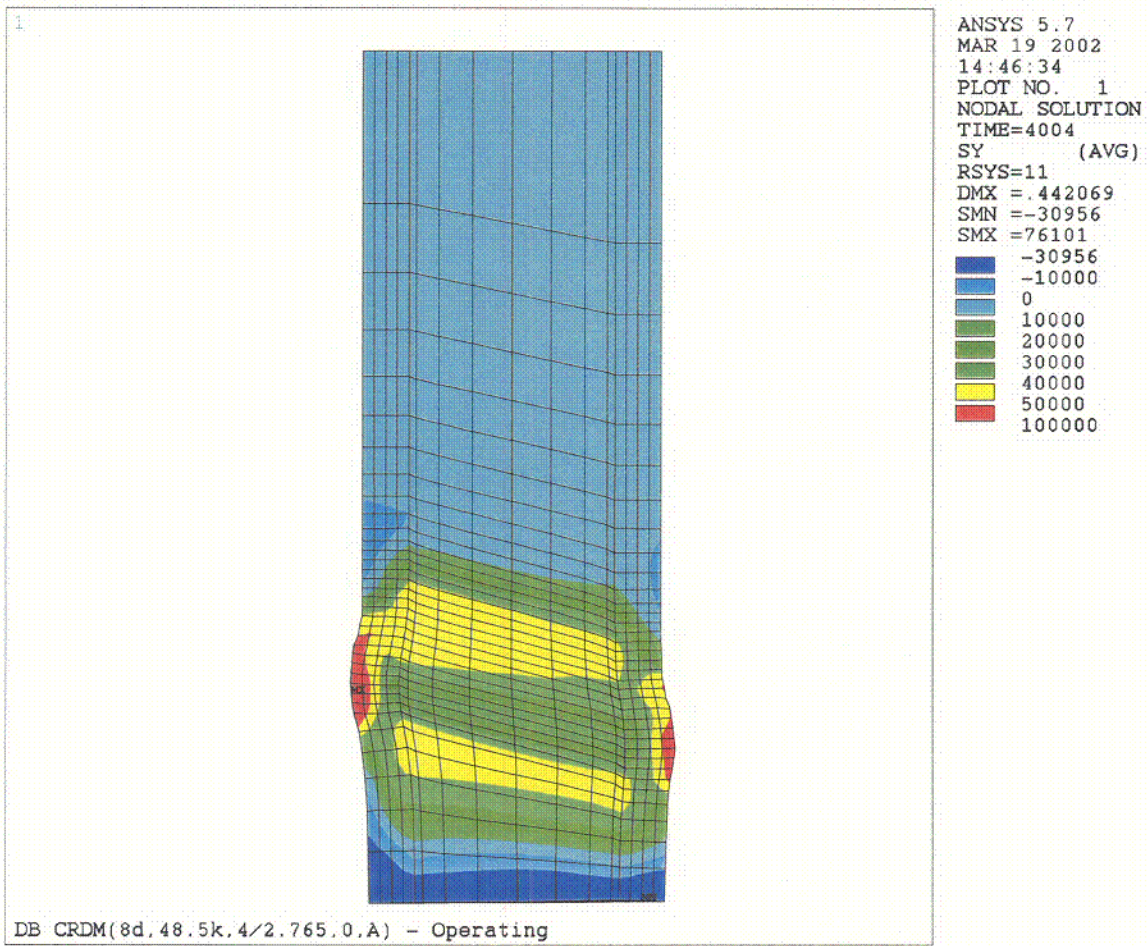
High stresses are induced into the nozzle by the J-groove weld. Since the RPV head is stiff relative to the nozzle wall, shrinkage of the J-groove weld during cooling pulls the nozzle wall radially outward causing high tensile hoop stresses as shown in Figure 15 (the deflections in Figure 15 are exaggerated to illustrate the welding induced distortion). If the nozzle is machined prior to welding, higher stresses can be induced in the cold worked machined surface.

Figure 15. Hoop Stresses and Operating Condition Deflections in CRDM Nozzles 2-5

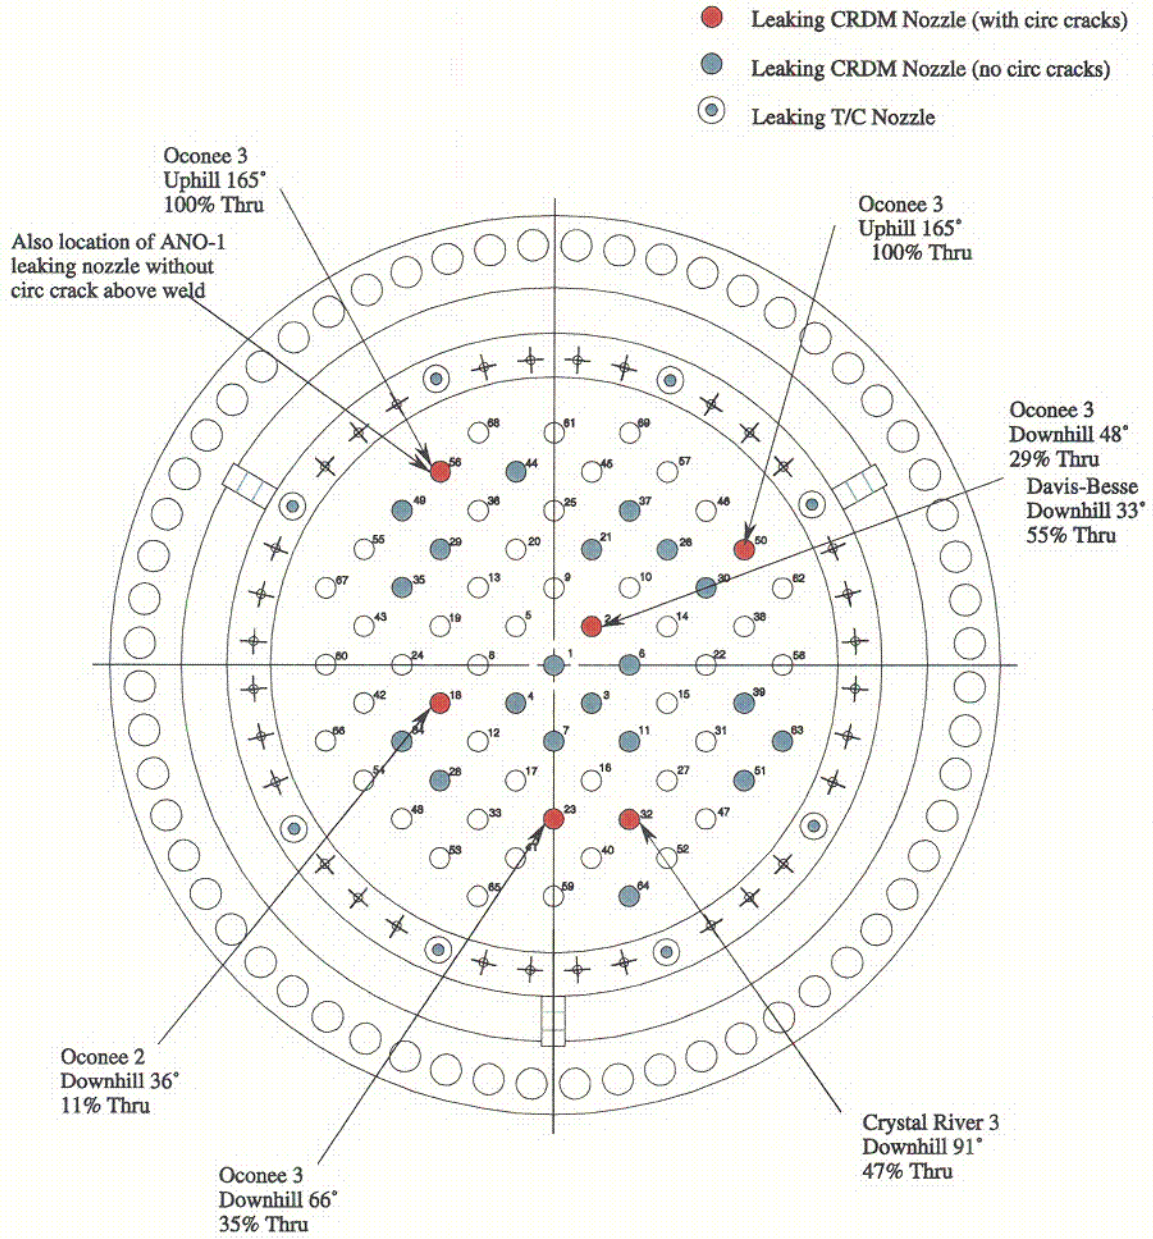
Figure 16 shows the locations of the leaking nozzles in the B&W design plants. It should be noted that the leaking nozzles are distributed across the RPV head. Figure 17 provides further information regarding the distribution of leaking nozzles. This figure shows the fraction of all of the nozzles at each row that have leaked and whether the cracks are purely axial or axial with circumferential cracks above the J-groove weld elevation.

Figure 16. Location of Leaking Nozzles in B&W Design Plants

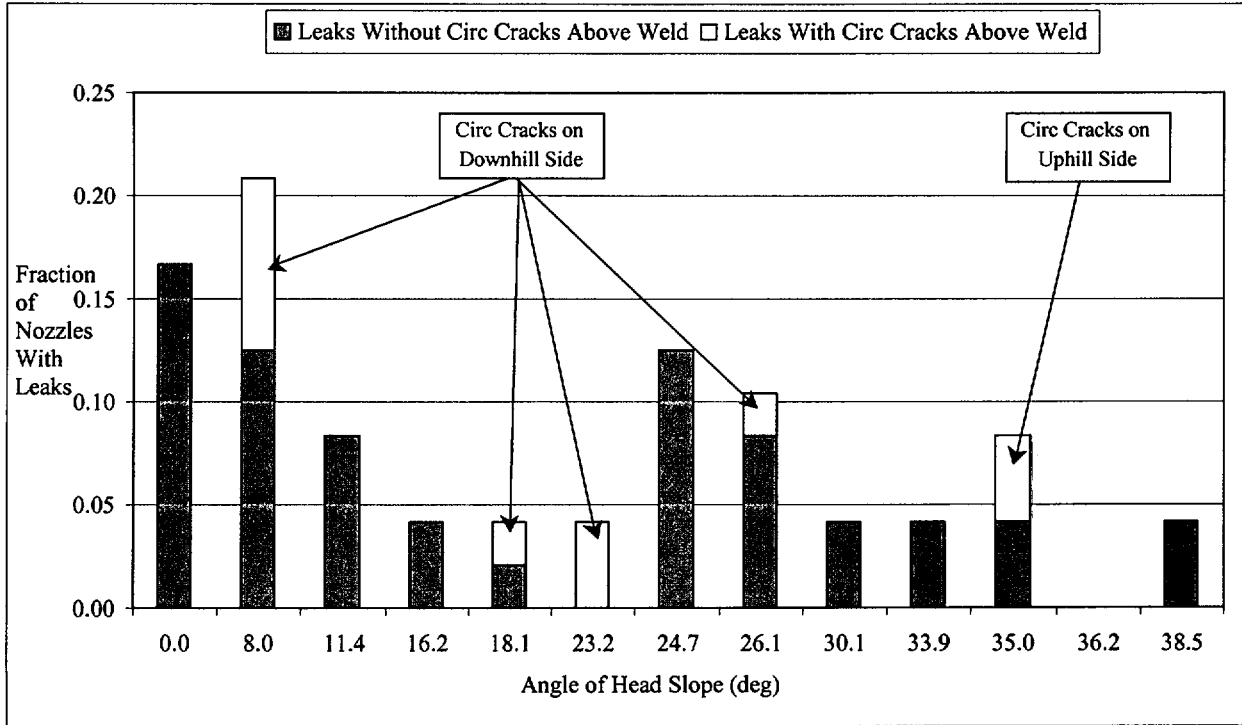
Figure 17. Distribution of Leaking Nozzles in B&W Design Plants

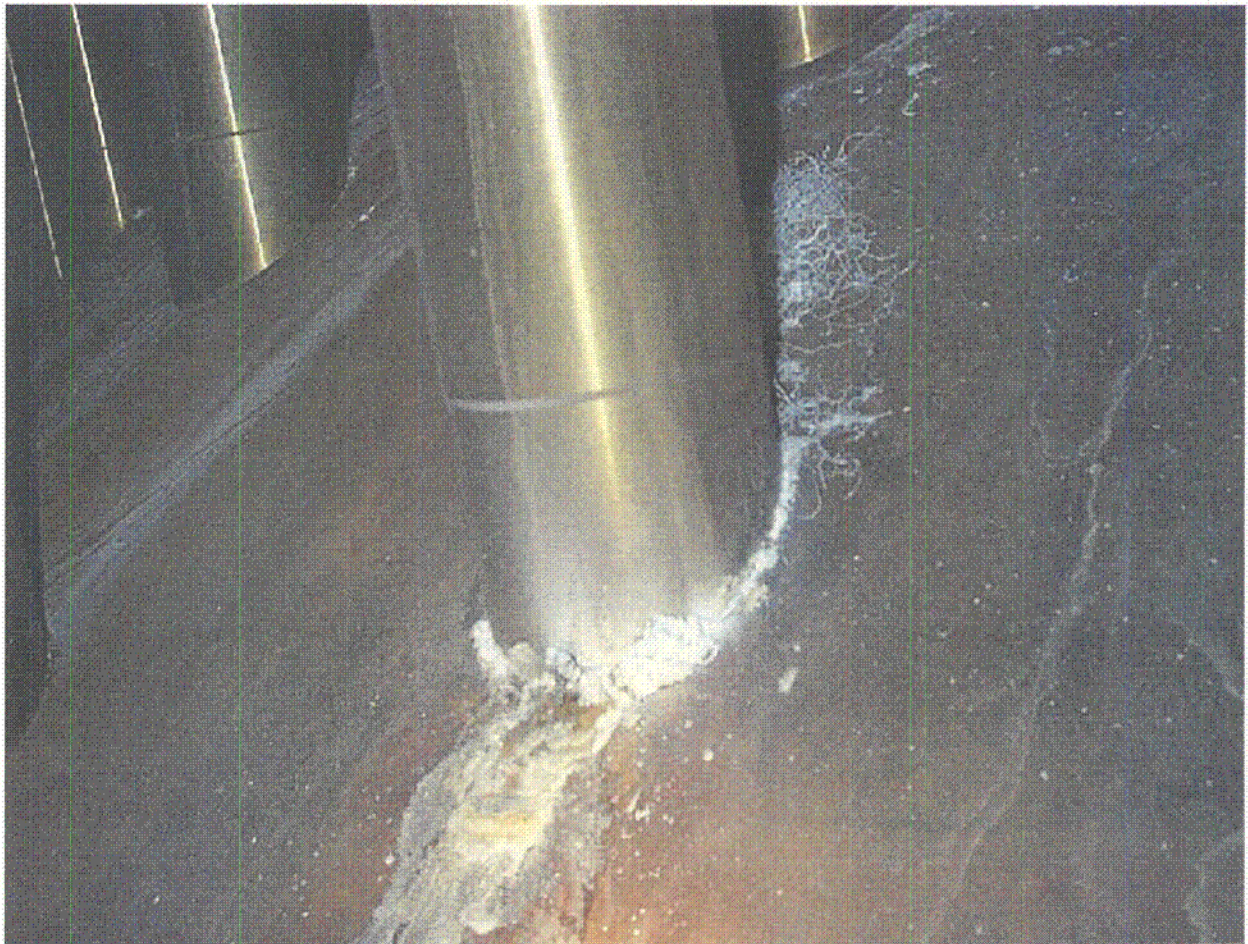
Figure 18. CRDM Nozzle Leakage Observed at Oconee 3

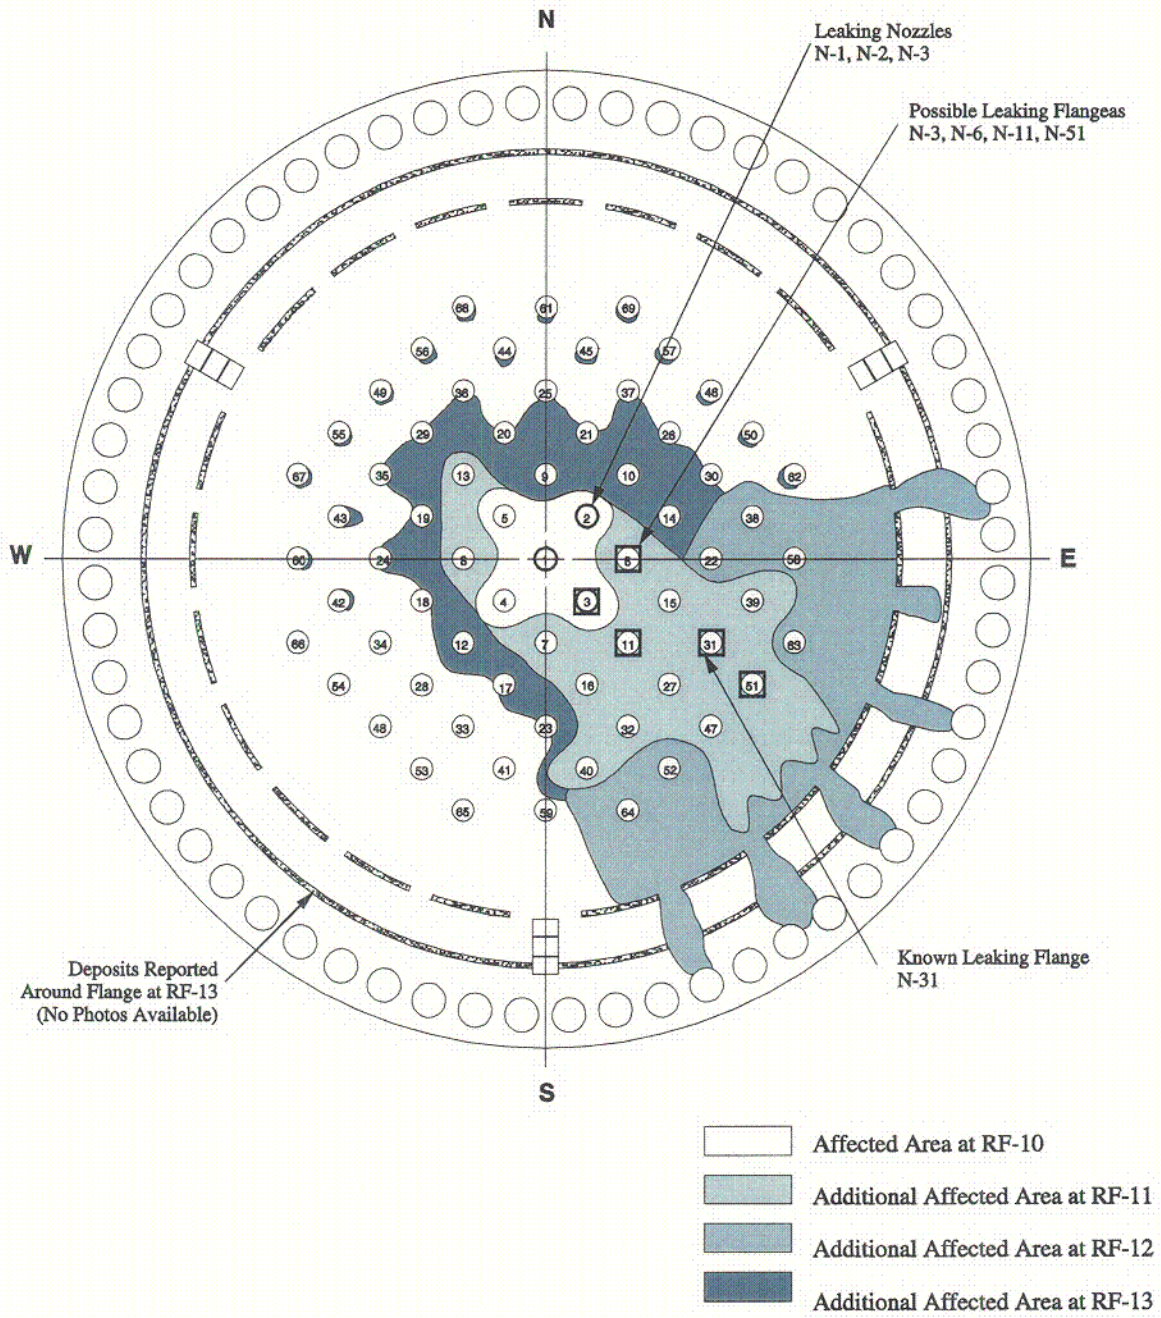
Figure 20 provides an overview of the boric acid deposits on the RPV head from 10RFO to 13RFO.

Figure 20. As Found Locations of Boric Acid Deposits on Davis-Besse Vessel Head (10RFO to 13RFO)

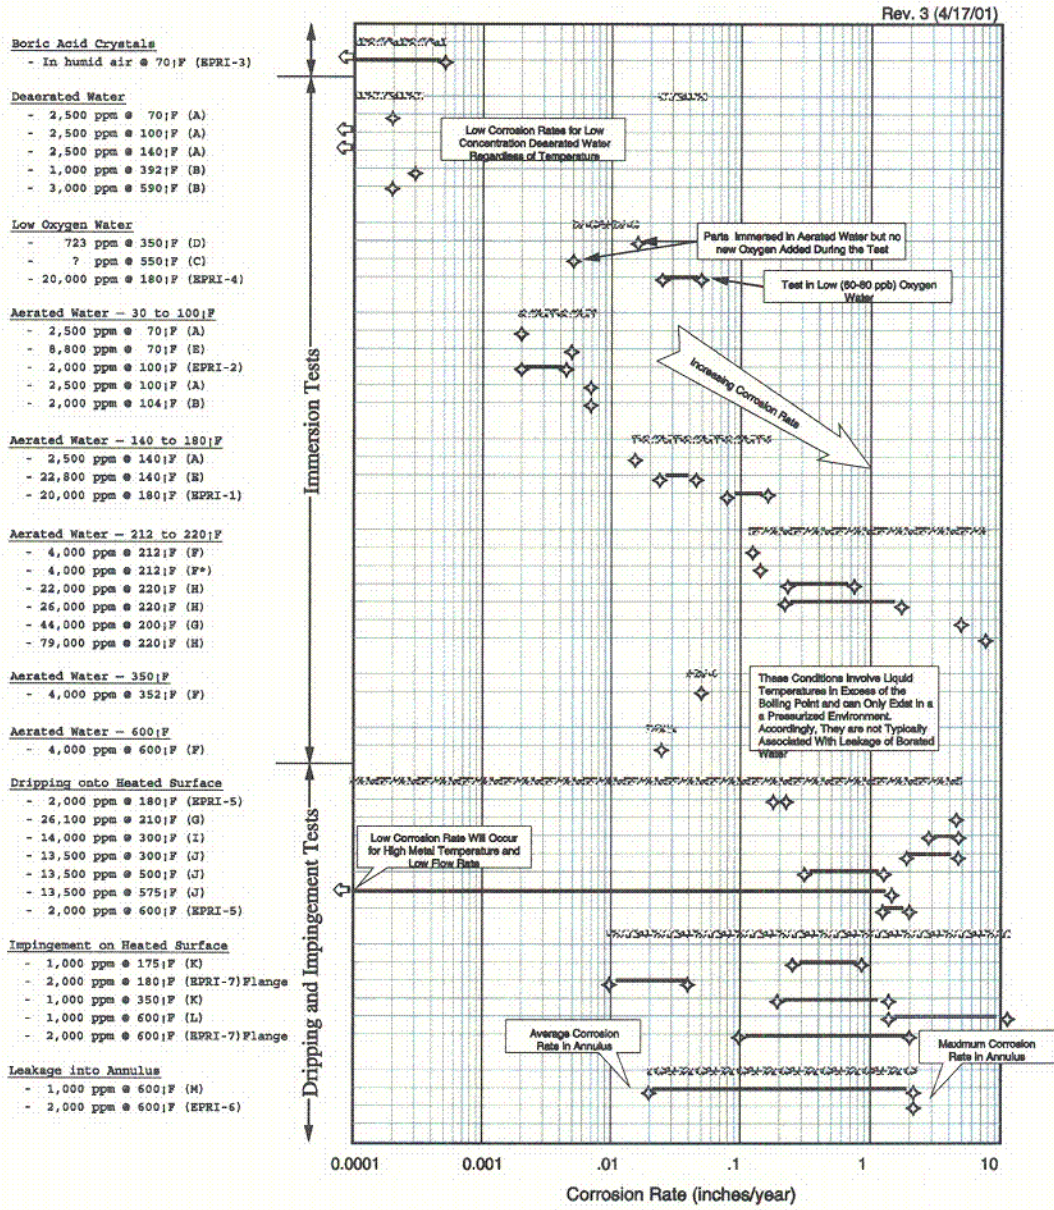
Figure 25 from the Boric Acid Corrosion Guidebook, Revision 1 (reference 5.3) summarizes the available test data regarding boric acid corrosion. These data show that most of the data points for borated water dripping onto hot metal surfaces, impinging onto hot metal surfaces, or leaking into a heated annulus, are in the range of 1.0 to 5.0 inches/year. This is consistent with the observed conditions.

Figure 25. Corrosion Rate for EPRI Experiments

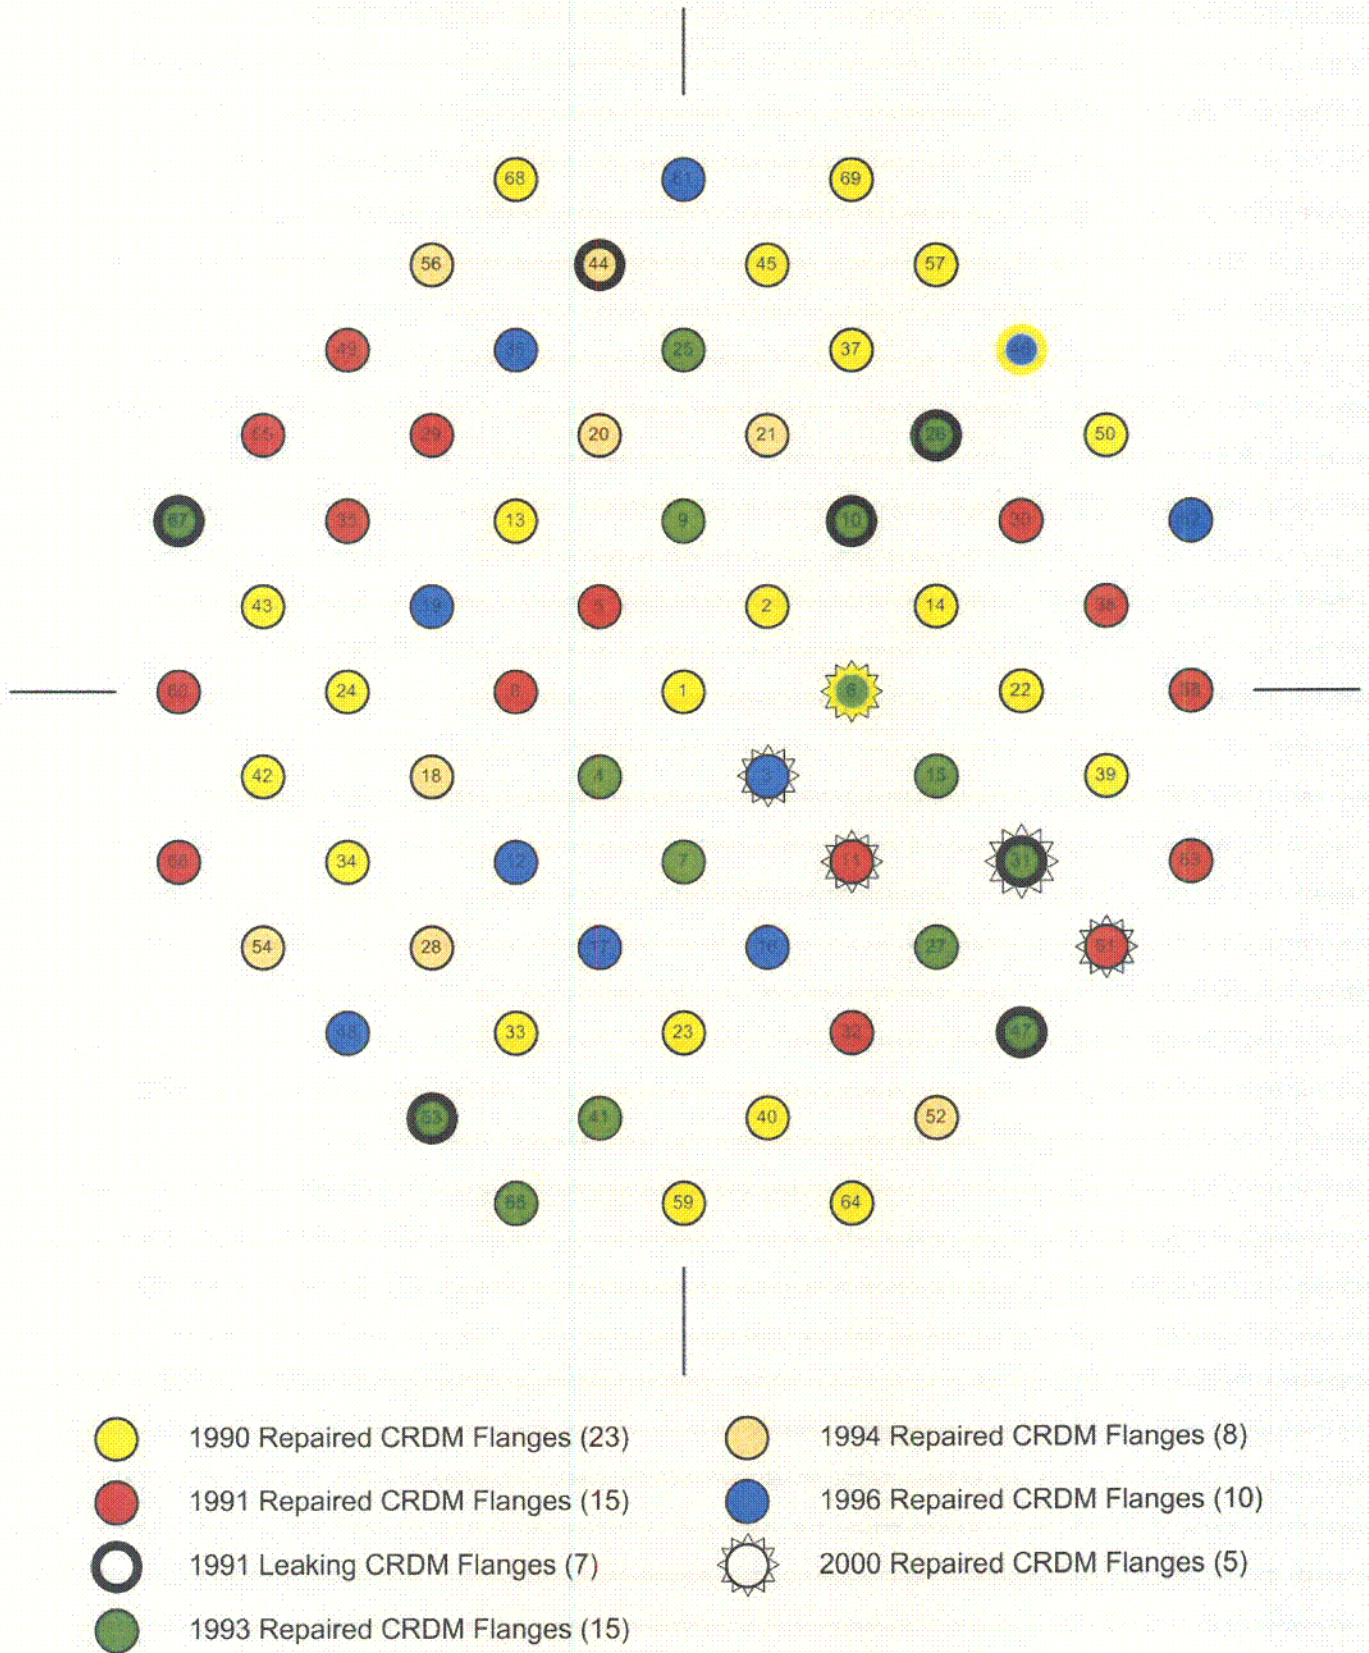
In 1990 (6RFO), gaskets were replaced in 23 CRDM flanges. Figure 28 shows the leaking flanges. There are no specific records indicating an inspection of the RPV head.

Figure 28 shows all the leaking flanges identified in 1991 and the flanges that were justified for use-as-is.

In 1994 (9RFO), the CRDM flanges were inspected; however, no records have been identified indicating a visual inspection of the RPV head was completed. Performing a video inspection of weep holes was an activity in the outage schedule. There were no boric acid deposits interference problems with inspection equipment reported. Eight CRDM flanges were identified as leaking and repaired during this outage (Figure 28)

Figure 28. Leaking Flanges Found and Repaired During Each Outage

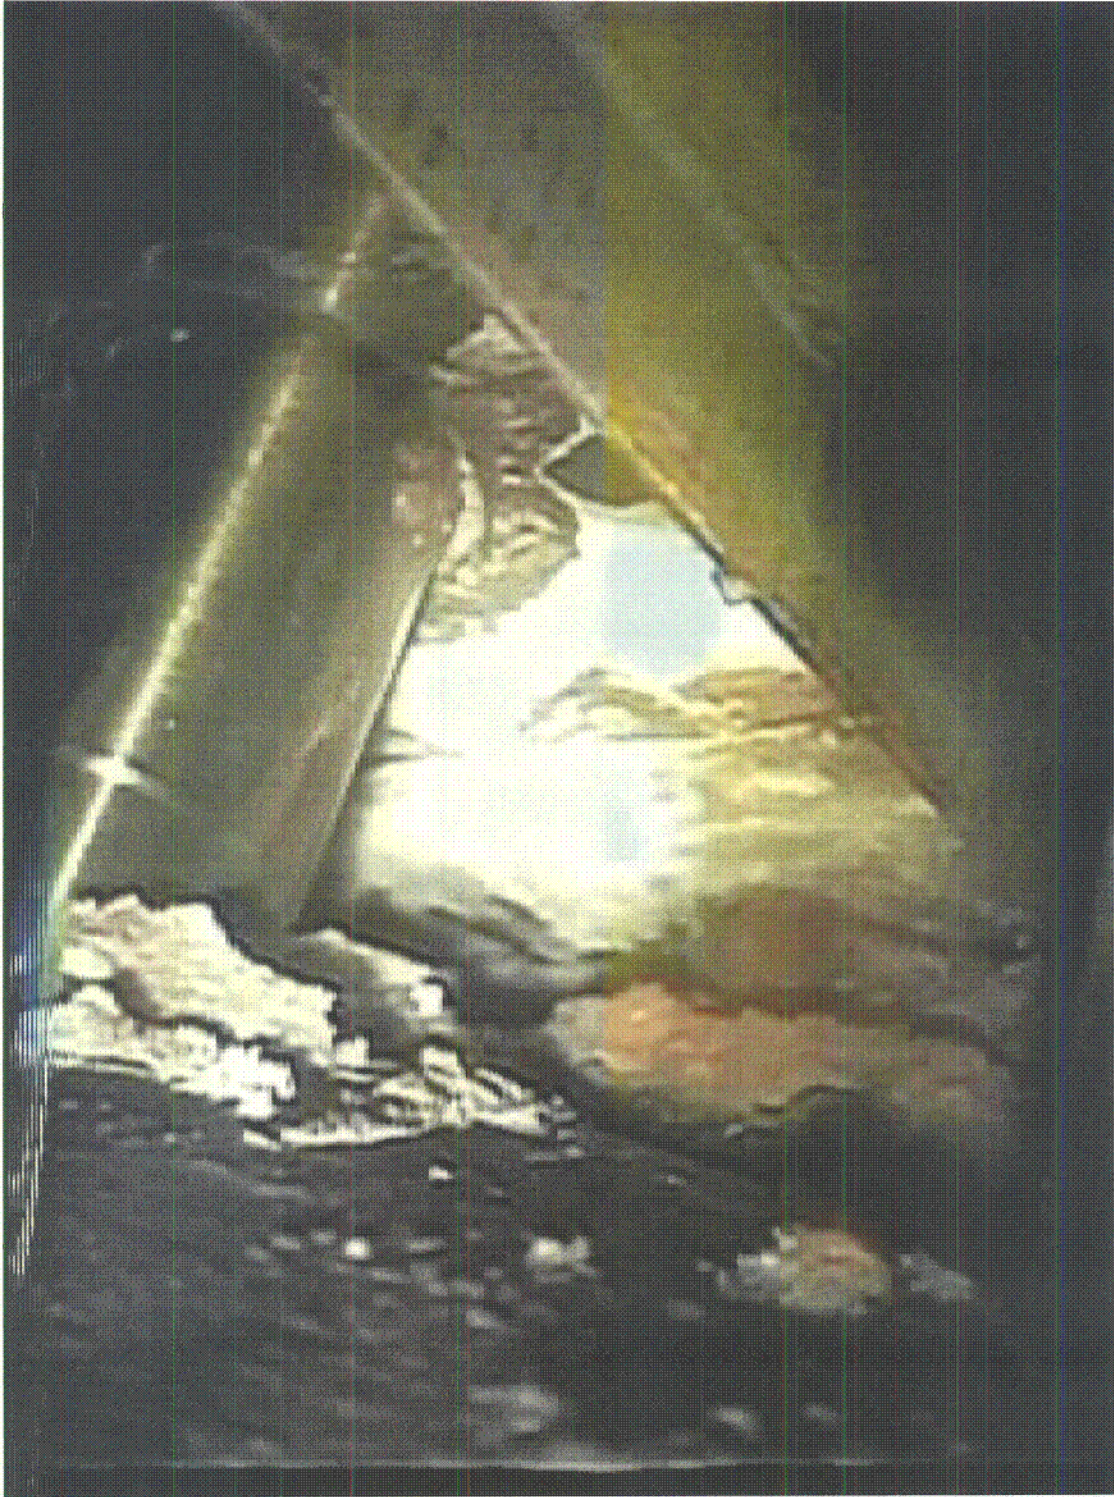
In 1993 (8RFO), an inspection of the RPV head was performed, shown in Figures 29-32. In Figure 29, the boron deposits are dripping through the gaps in the insulation forming stalactites. The boron deposits started forming stalagmites on the RPV head. Figures 30 and 31 show more boron deposits coming through gaps in the insulation and clinging to the side of the CRDM nozzles. The boron deposits in Figure 31 were reddish brown in color. The boron deposits on the RPV head in Figure 32 do not exhibit a clear picture of the source of leakage (i.e., CRDM flange or nozzle leakage).

Figure 32. Boron Deposits – Source Unclear (8RFO)

Based on the results of the head inspection, the RPV head and flange was cleaned with deionized water. The effectiveness of the cleaning could not be verified in that the RPV head had already been returned to the RPV. A cleaning effectiveness inspection was recommended as a follow-up activity for the next outage. The CRDM flange inspection revealed 15 leaking flanges as shown in Figure 28. Framatome generated a non-conformance report (NCR) that noted degradation to the flange sealing surface found during the repair of CRDM nozzle 31. The corrective action taken was to perform flange surface polishing and gasket replacement. The 1993 NCR also recommended that the flange surface be machined if further leakage occurs.

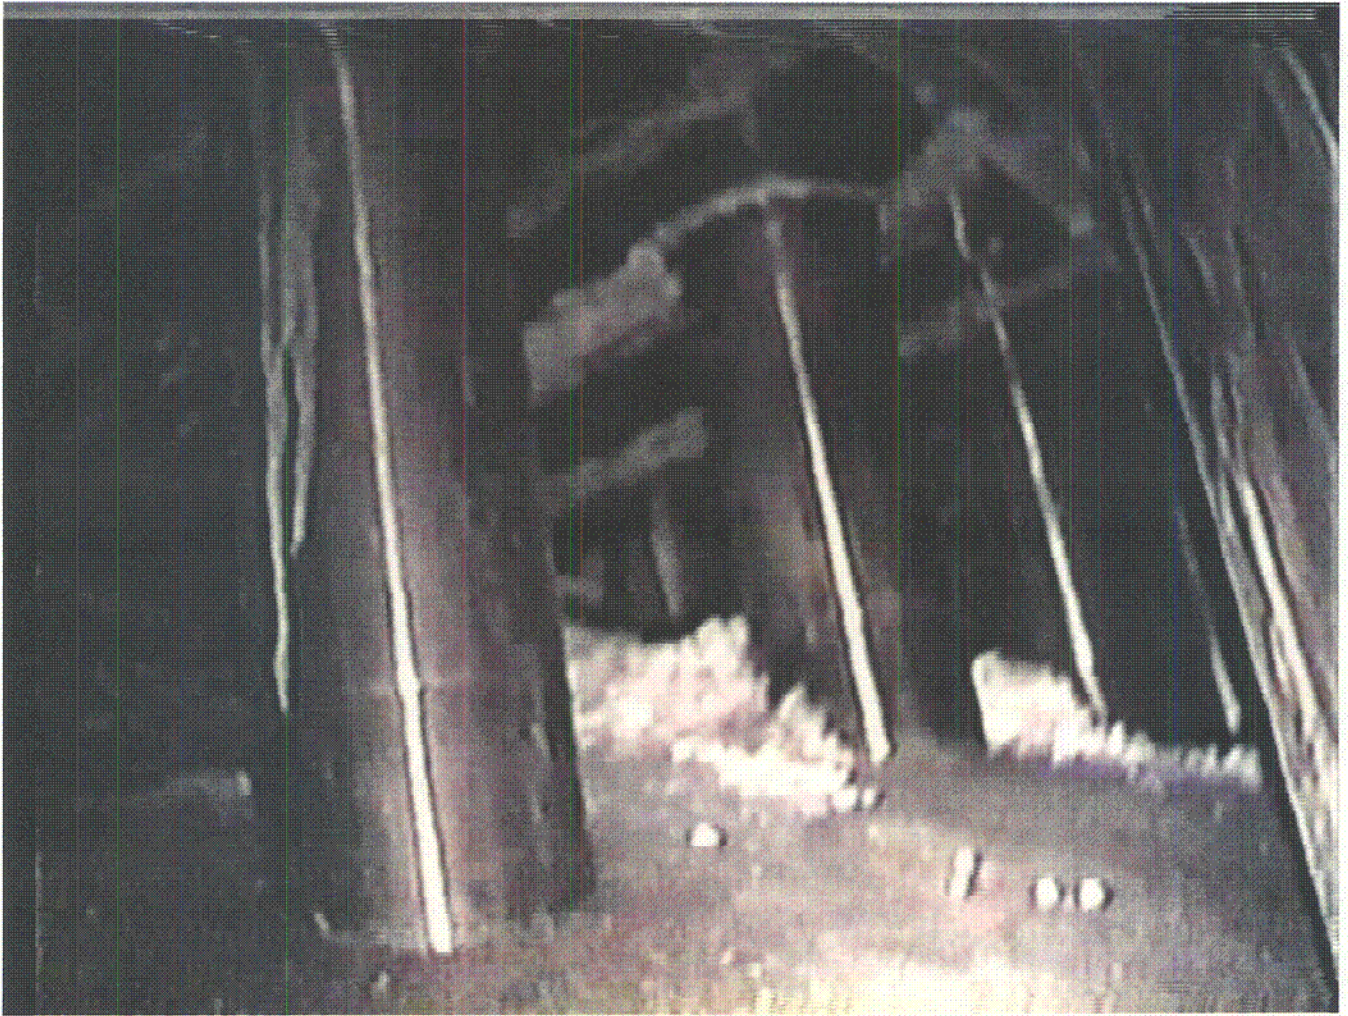
Figure 33. North Side of Reactor Vessel Head (10RFO)

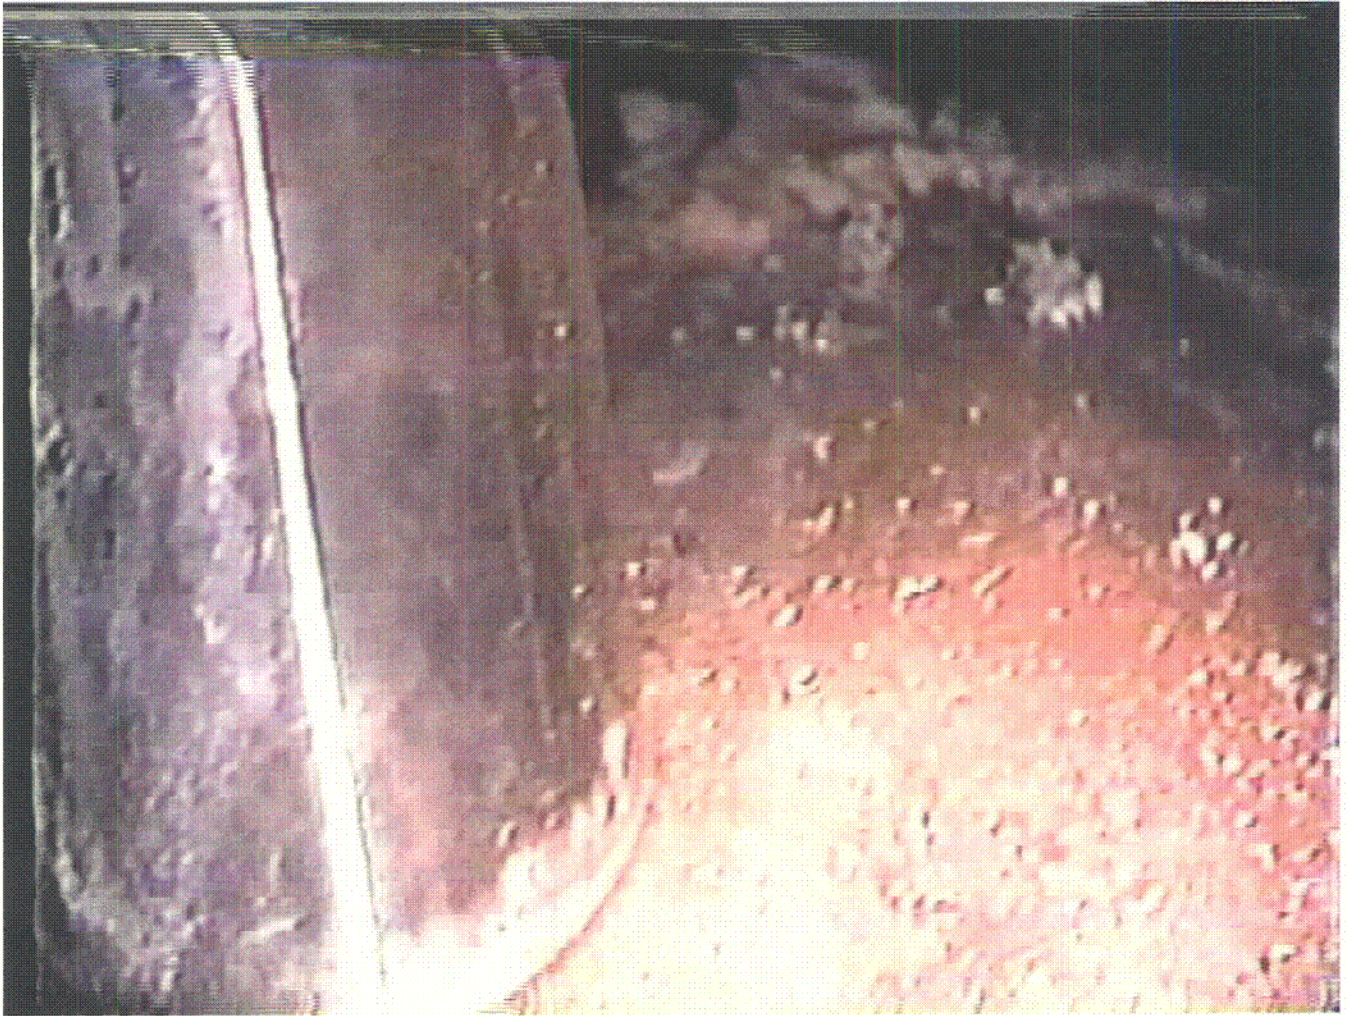
Figure 34. Boron Deposits Near Top of Reactor Vessel Head (10RFO)

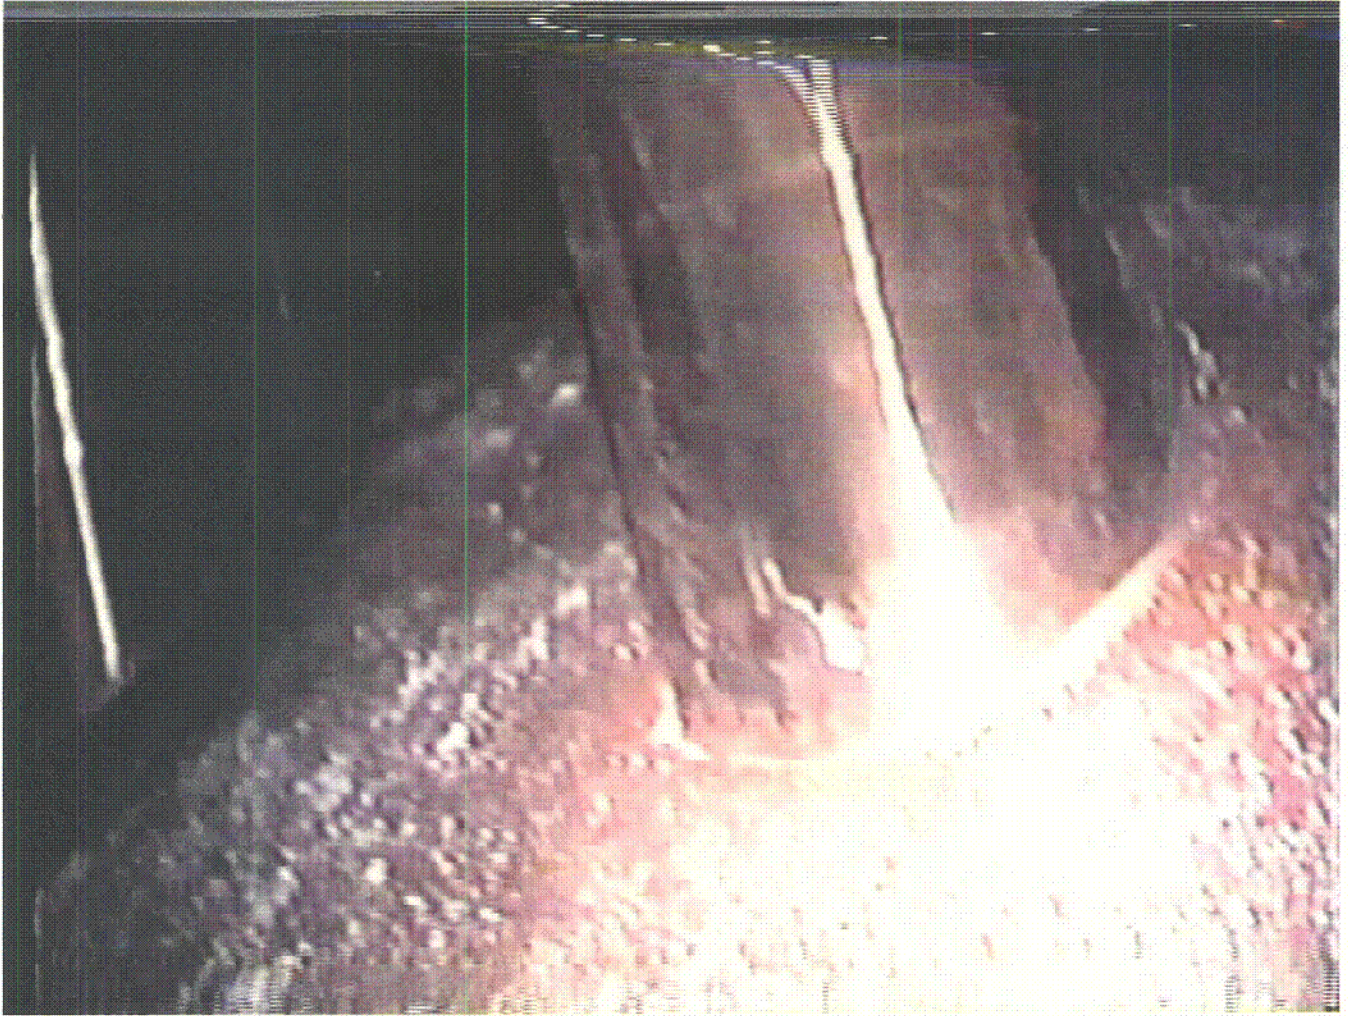
Figure 35: Typical Deposits for Periphery (10RFO)

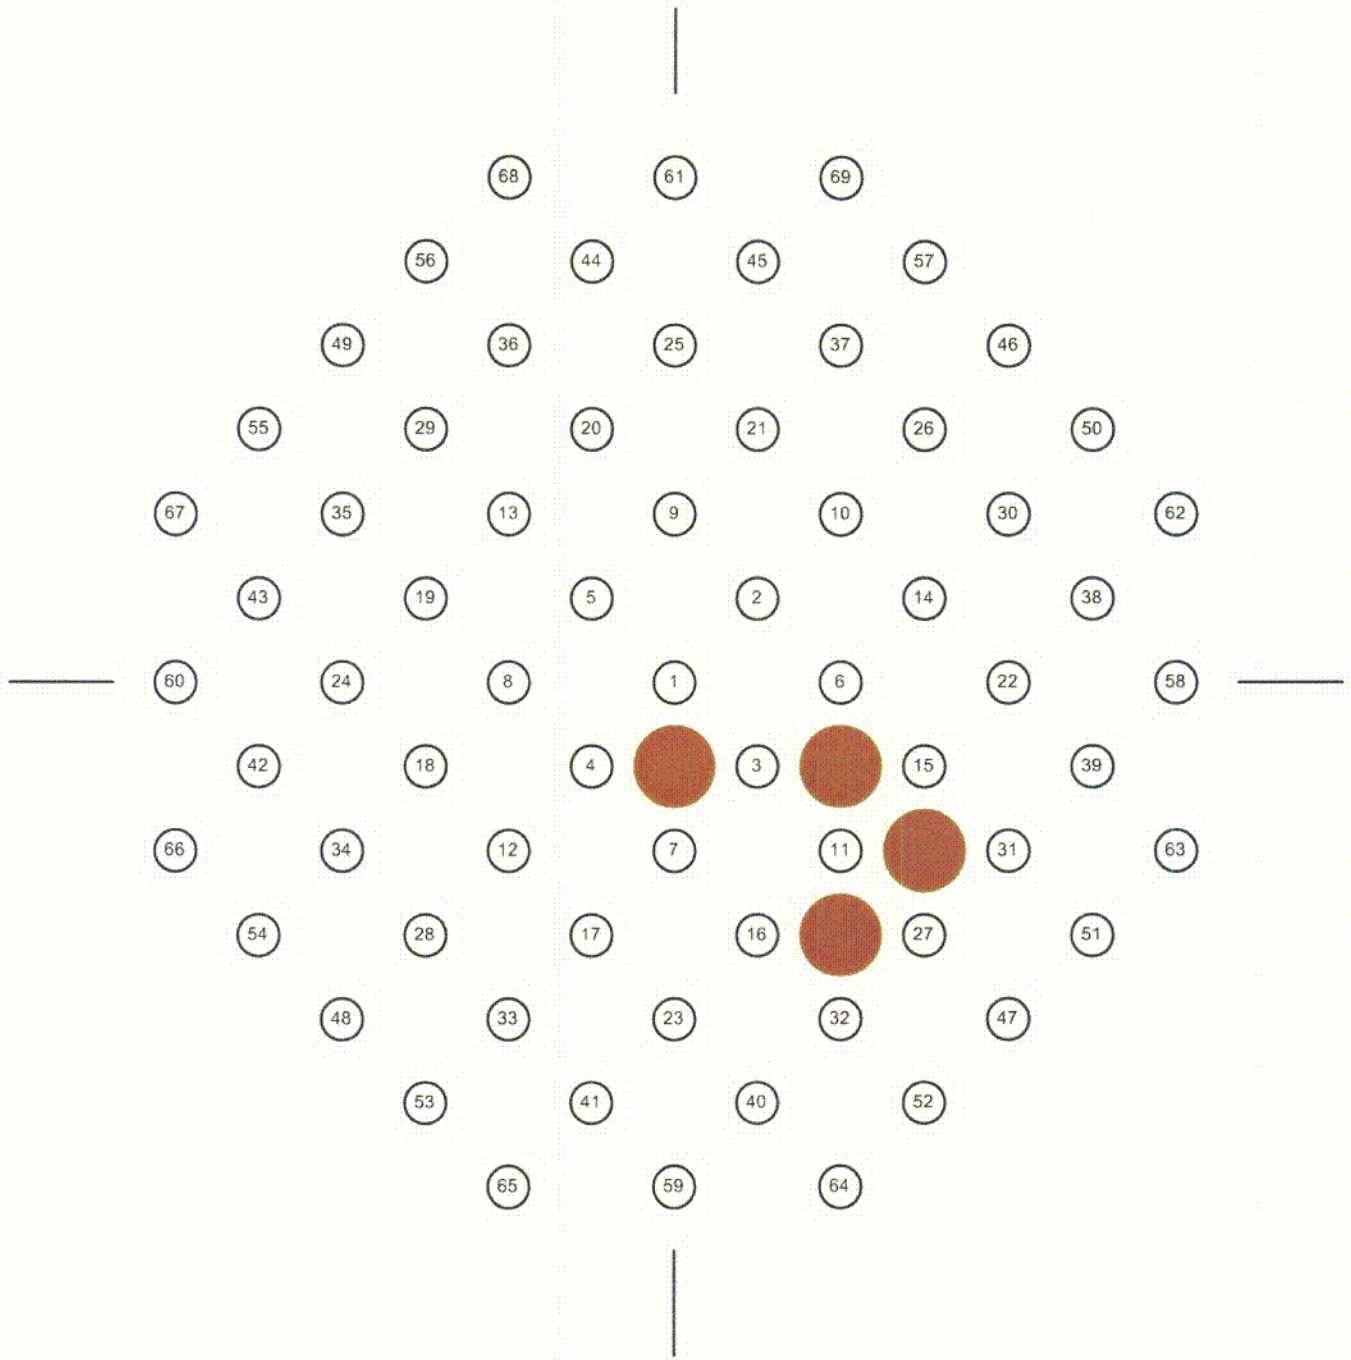
camera to see the upper flange interface. The interference locations, as shown in Figure 39, were identified in the center of the following nozzle blocks:

Figure 39. 2000 Interferences with CRDM Flange Inspection

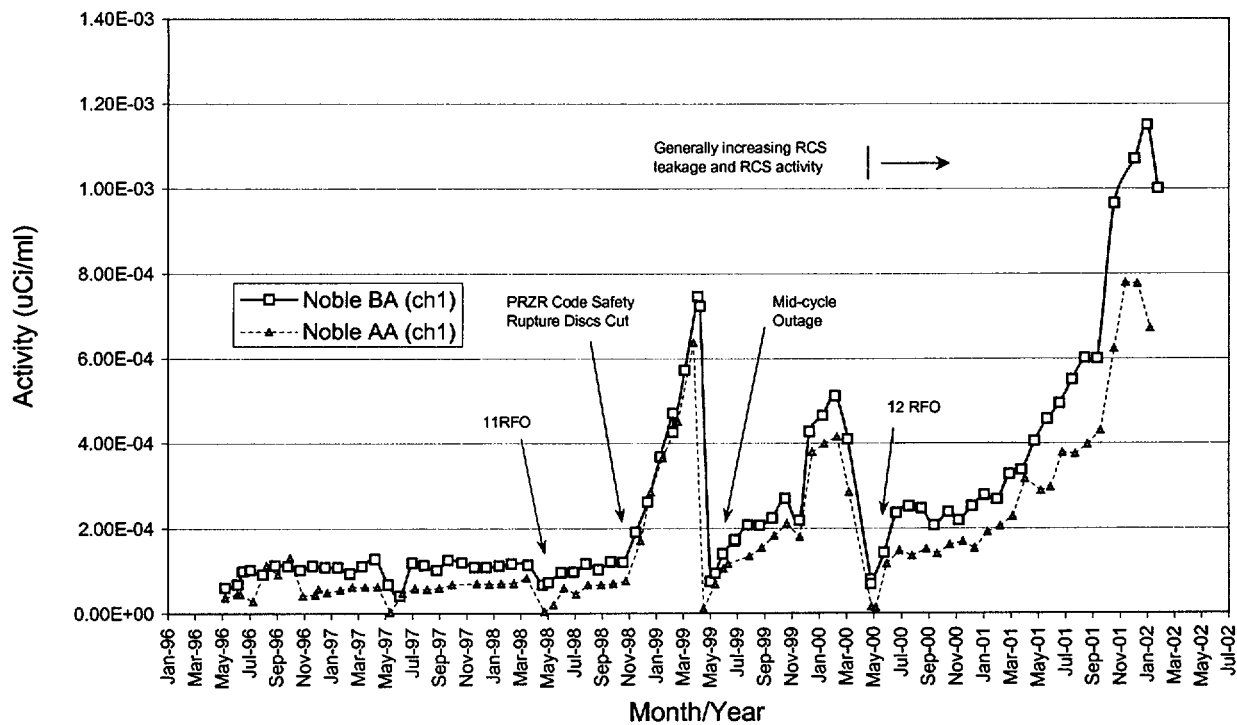
After passing through the particulate and Iodine monitors, the gas sample is finally drawn through the noble gas monitor. The monitor housing is a 4 inch 4 pi lead container. The detector is a beta detector with an internal light emitting diode (LED) check source. The output of the detector is fed to a microprocessor where the counts per minute are converted to $\mu\text{Ci/cc}$. Some of the predominant isotopes that remain to be counted by this detector are Xenon 133 and 135, with half lives of 9.2 hours to 5.2 days. For a constant RCS leakage rate and coolant activity, these isotopes will also reach a stable equilibrium value in containment and would thus theoretically provide a direct and valid indication of a slowly evolving RCS leakage trend. Trend data from these monitors is presented in Figure 42.

Figure 42. CTMT Radiation Monitors RE4597AA & BA (Both Noble Gas Channels)
