Subject: Confirmatory Action Letter Response - Root Cause Analysis Report

Root Cause Analysis Report

Significant Degradation of the Reactor Pressure
Vessel Head

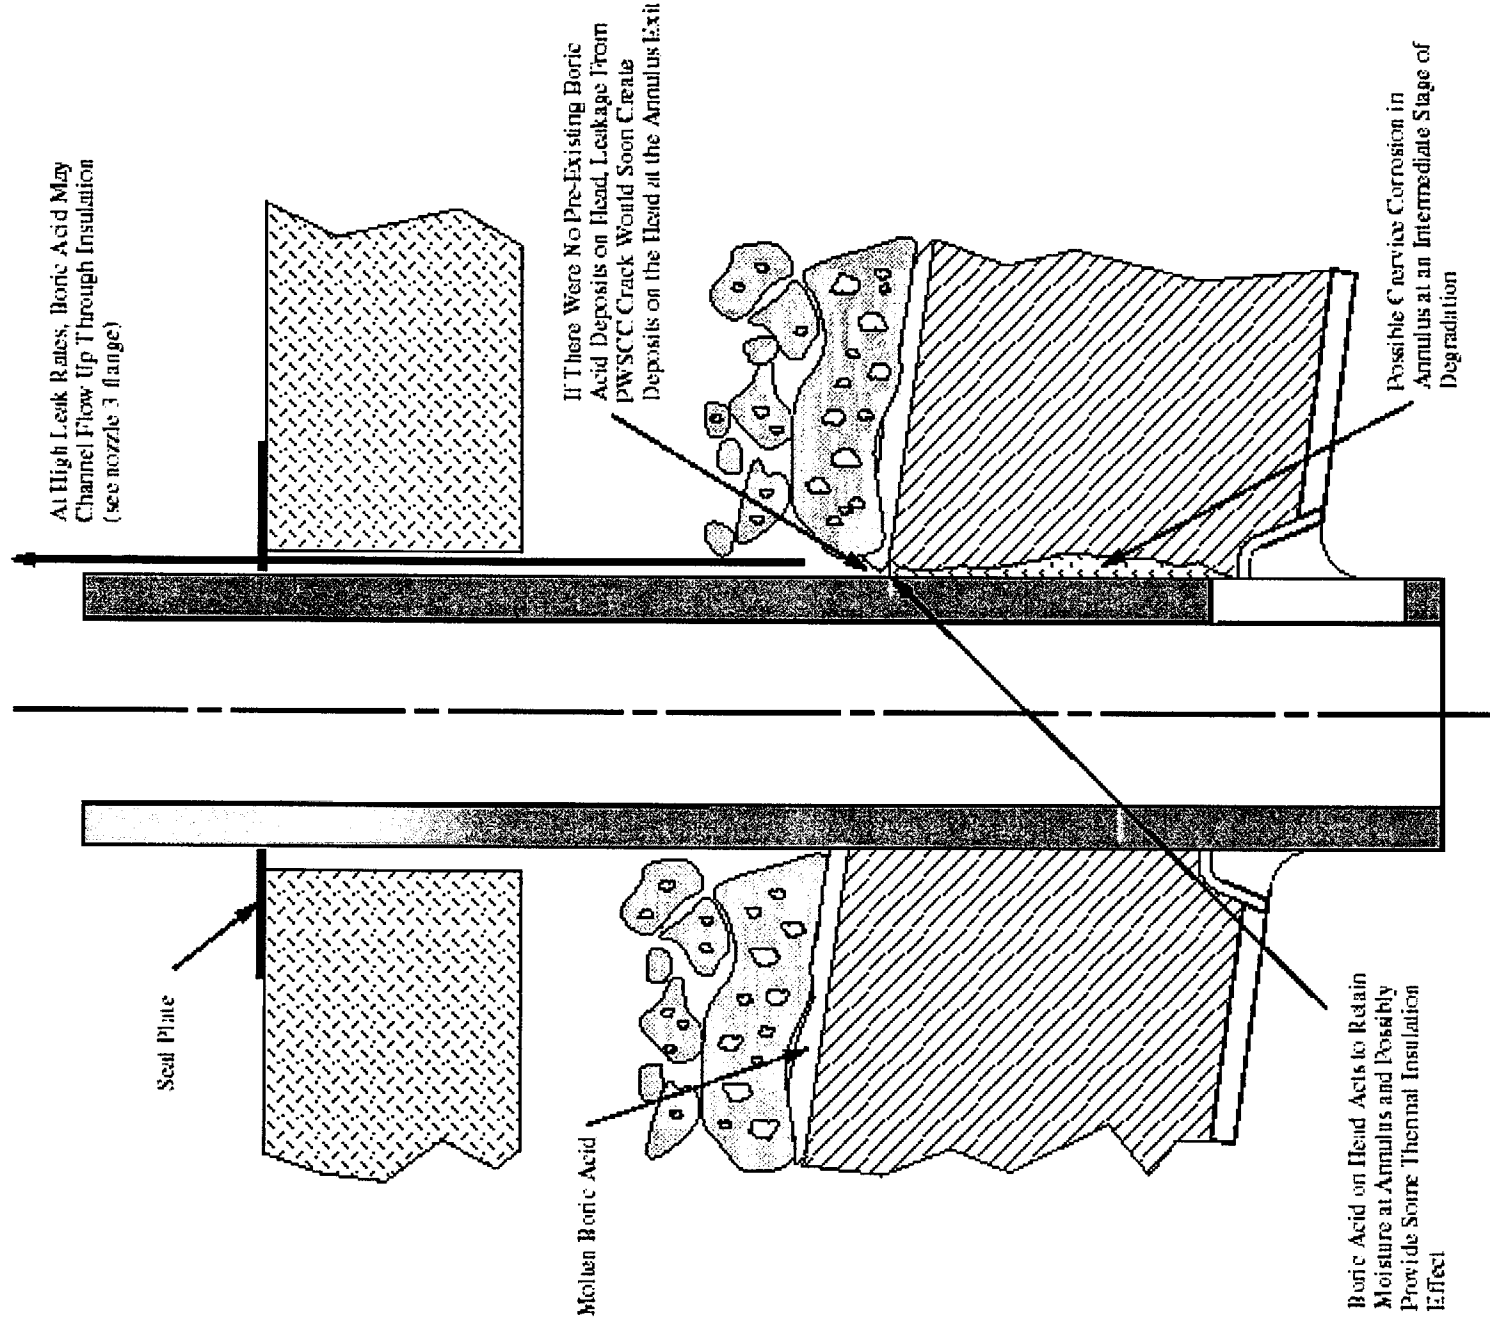
Figure 43. Potential Effects of Boric Acid Deposits on Vessel Top Head Surface.
