SUBJECT: CRDM THIMBLE RUPTURE SENSITIVITY STUDY

SUBJECT: DAVIS-BESSE NUCLEAR POWER STATION
NRC AUGMENTED INSPECTION TEAM - DEGRADATION OF THE
REACTOR PRESSURE VESSEL HEAD - REPORT NO. 50-346/02-03(DRS)

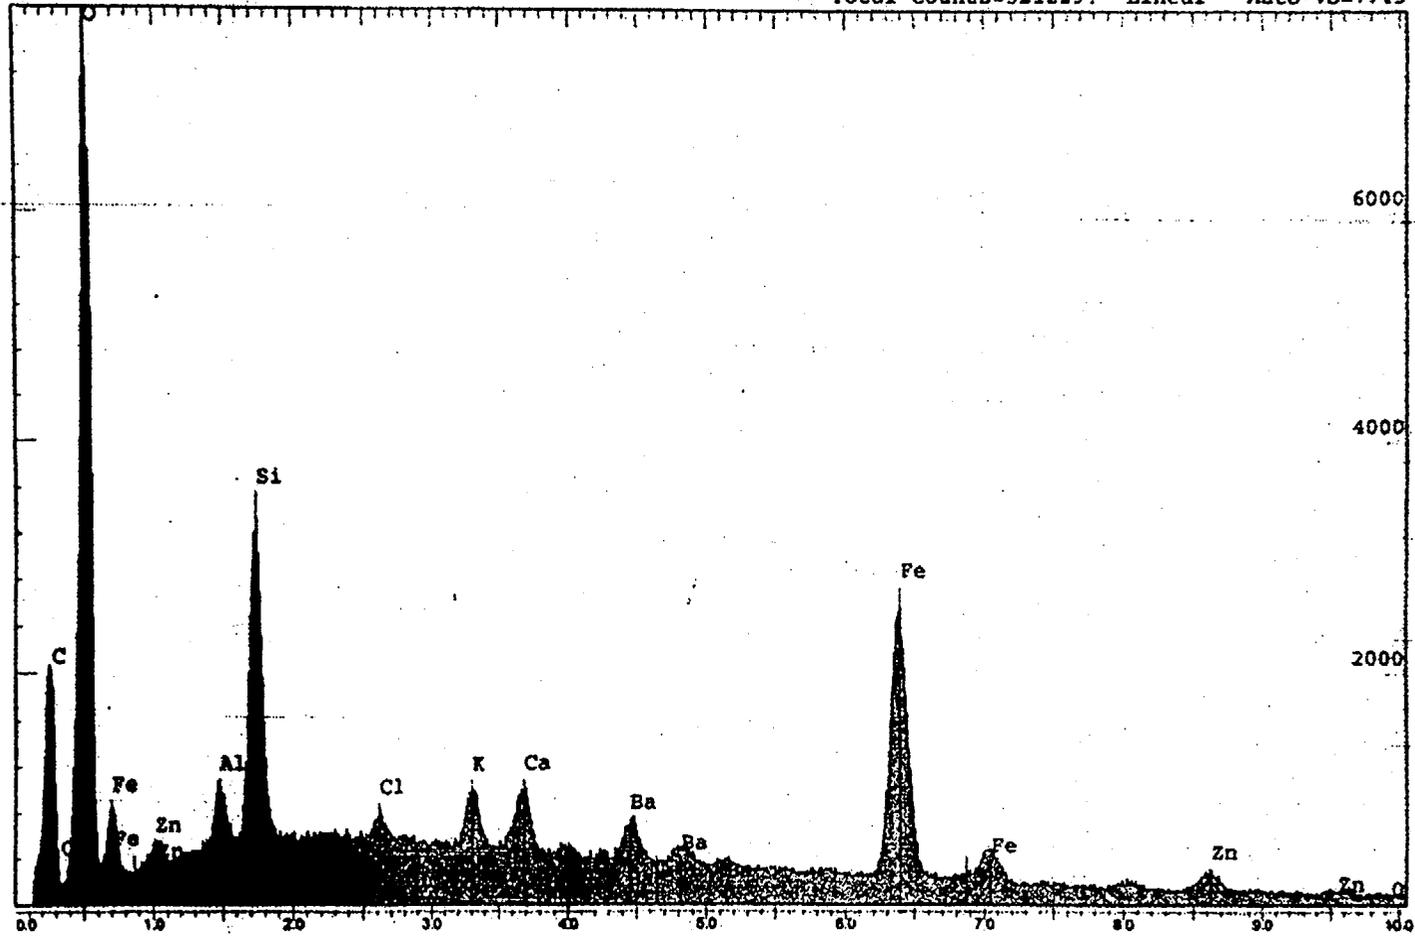
1. The uniform beige deposit that was present on the six 2¼ inch diameter filter samples was a powdery iron oxide. Small amounts of chlorine and copper were present in the deposit. ←
2. Large potassium chloride containing particles were present on one of the filters.
3. The deposits present on the 1¾ inch diameter filter were also primarily iron oxide.
4. Neither the shape nor the chemistry of the deposits is consistent with a Magnaflux powder origin. Titanium, a major constituent of the Magnaflux powder, was not detected on any of the filters examined, and the powdery morphology of the deposits was not at all similar to the larger angular Magnaflux powder.
5. The iron oxide deposits are likely corrosion products from an iron base component within the system. ←

Figure 4. EDS spectrum from an overall area of deposits on filter 4597BA 7/3/99@1400.

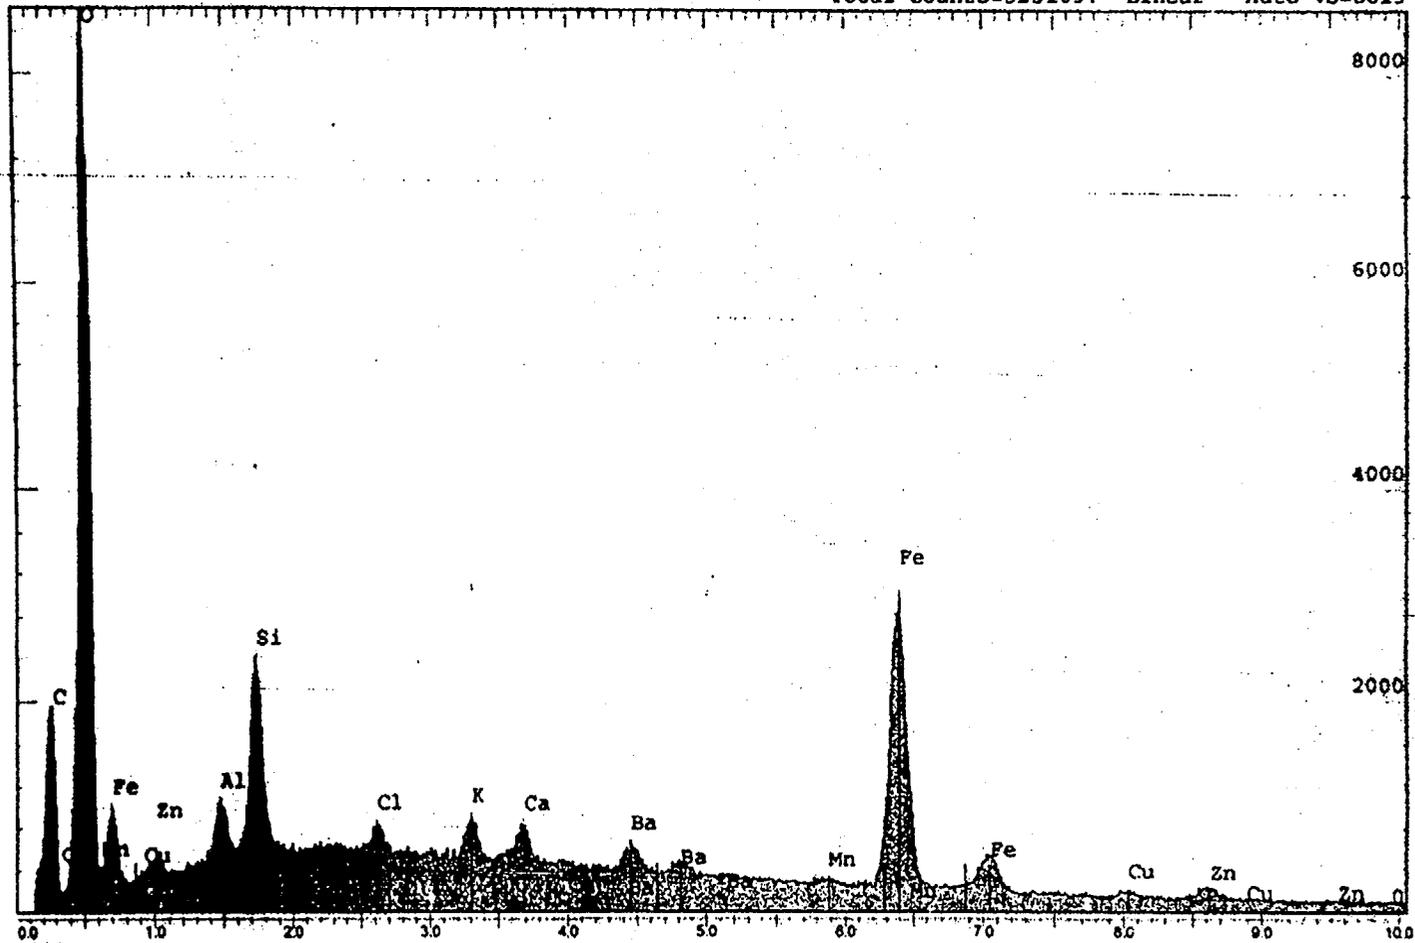
Figure 5. EDS spectrum from a second overall area of deposits on filter 4597BA 7/3/99@1400.

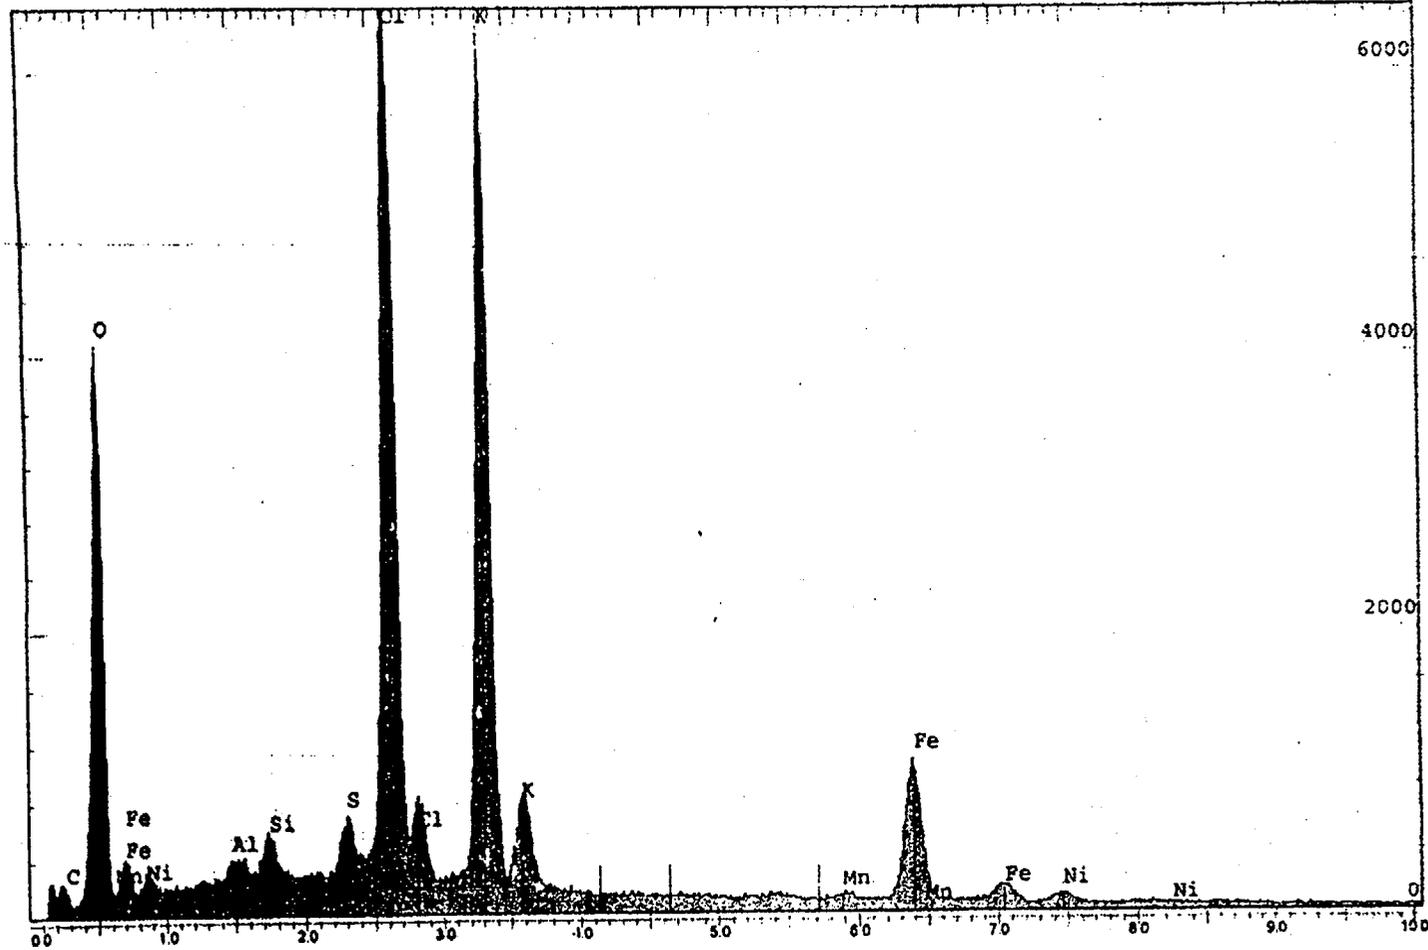
An EDS spectrum from an overall area of deposit on filter 4597BA 7/9/99@2016, Figure 6, was essentially identical to those obtained from filter 4597BA 7/3/99@1400. Spectra were also obtained from two of the dark particles on the filter, Figures 7 and 8. These particles were different from the overall deposit in that the iron peaks were reduced and high potassium and chlorine peaks were present.

Figure 7. EDS spectrum from a single dark particle on filter 4597BA 7/9/99@2016.

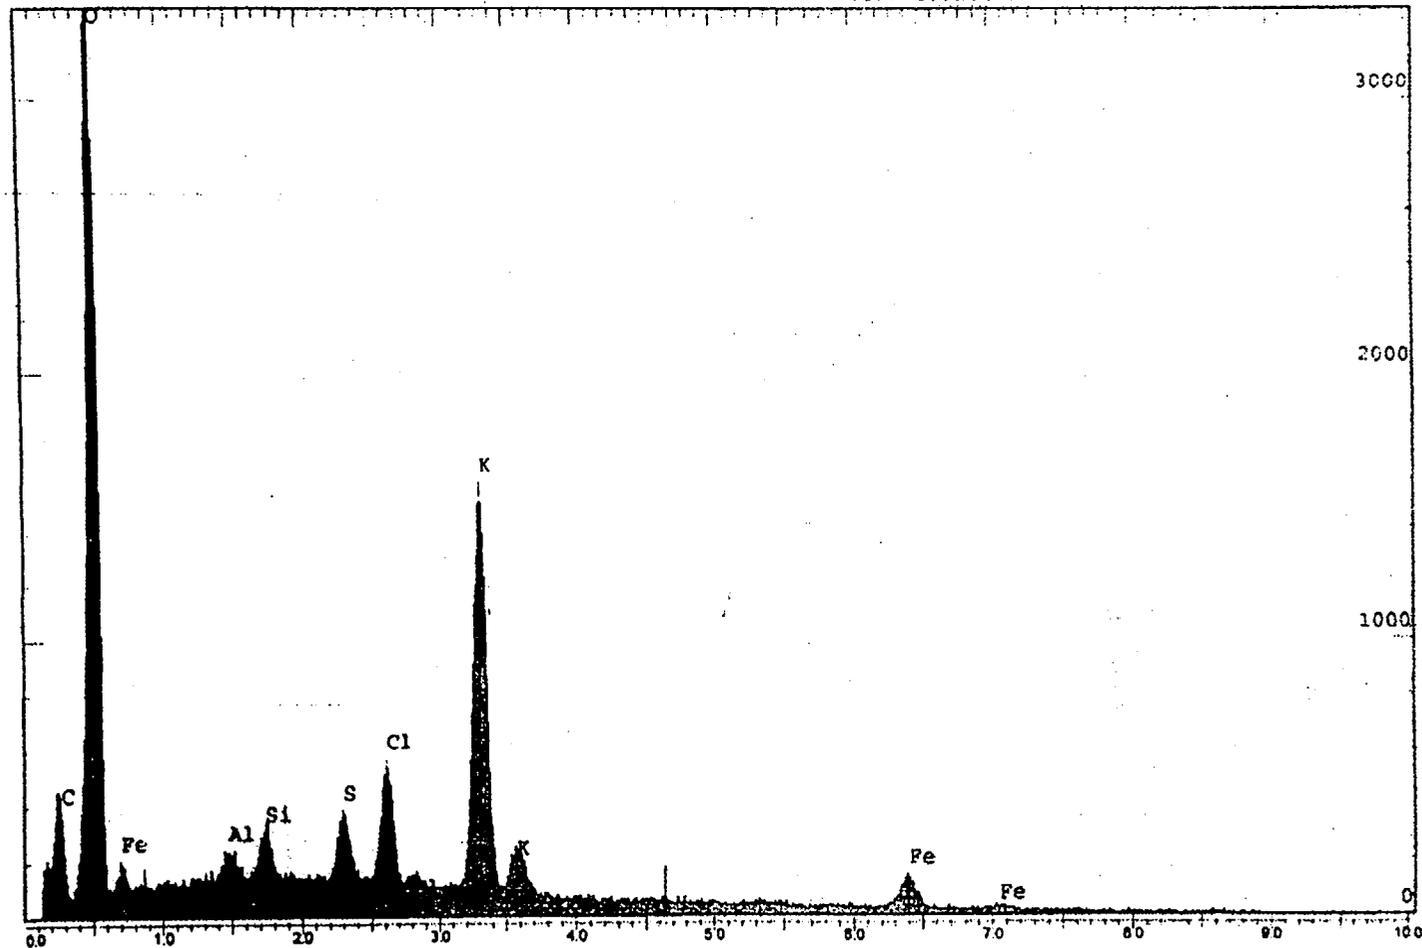
Figure 8. EDS spectrum from a second dark particle on filter 4597BA 7/9/99@2016.

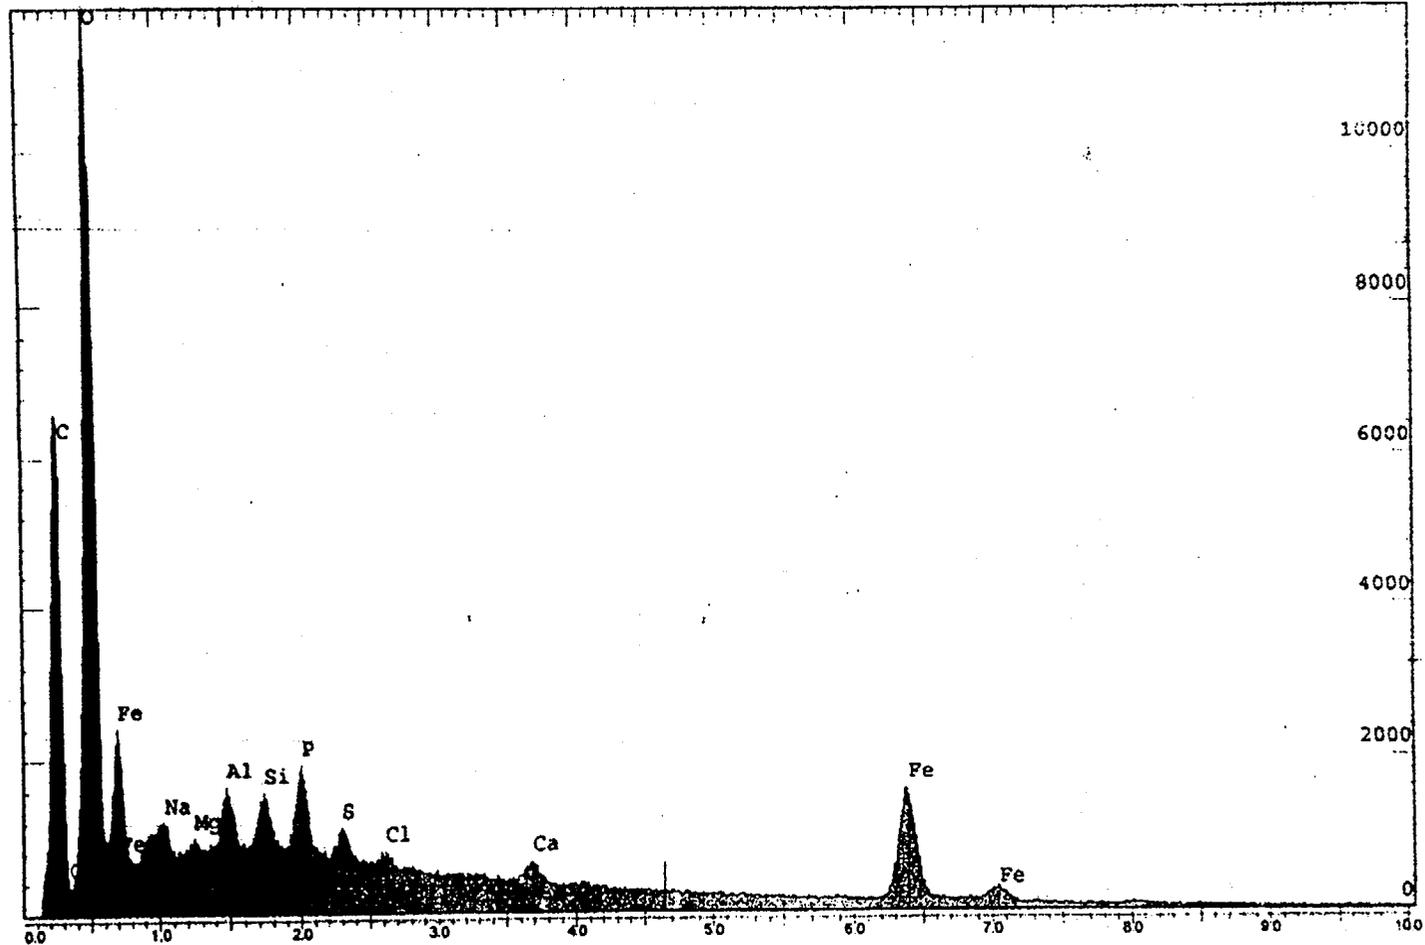
EDS spectra were also obtained from an overall area, Figure 9, and on an isolated particle Figure 10, on filter 7/16/99 White Bird. It is evident from these spectra that the deposits on the filter were also predominately iron oxide.

Figure 9. EDS spectrum from an overall area of deposits on filter 7/16/99 White Bird.

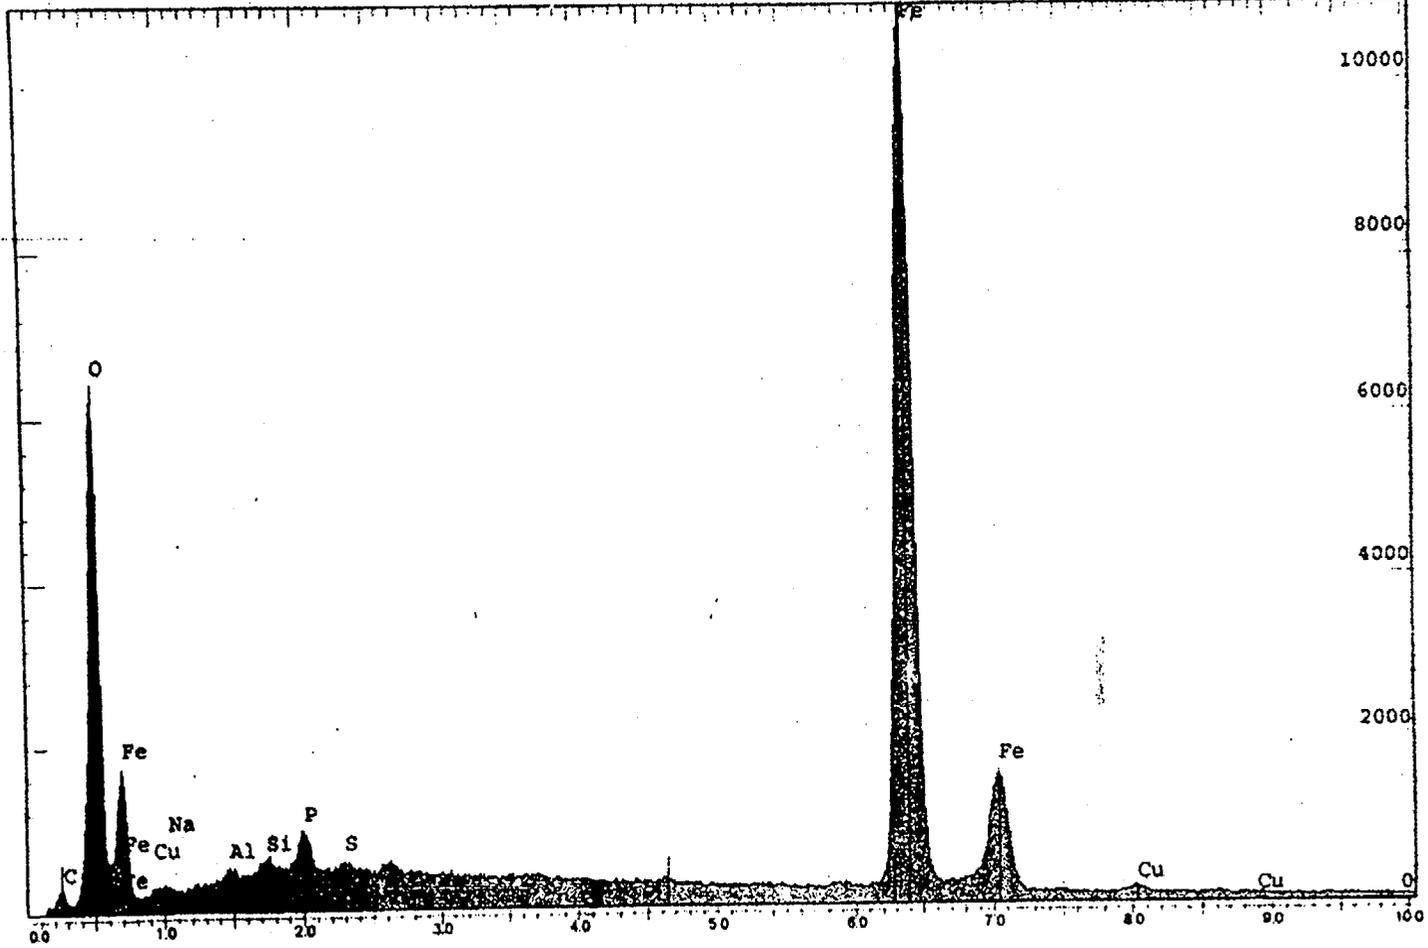
Figure 10. EDS spectrum from a single particle on filter 7/16/99 White Bird.

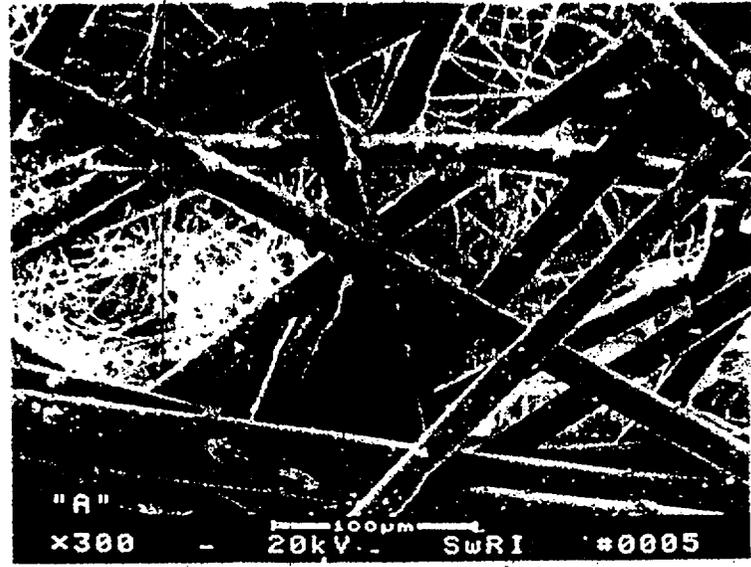
Imaging of the as-received filters in the SEM was limited by the low conductivity of the filter medium. To overcome this impediment, a gold palladium coating was applied to one of the filter samples, 4597BA 7/3/99@1400, following the EDS measurements. Electron micrographs obtained from the coated filter sample are shown in Figures 11 and 12. The deposits were generally less than 50µm in size and exhibited a very powdery appearance.
