SACRAMENTO MUNICIPAL UTILITY DISTRICT P. O. Box 15830, Sacramento CA 95852-1830, (916) 452-3211
AN ELECTRIC SYSTEM SERVING THE HEART OF CALIFORNIA

Docket No. 72-11
Rancho Seco Independent Spent Fuel Storage Installation
License No. SNM-2510
REQUEST FOR ASME CODE EXCEPTION

NONCONFORMANCE REPORT (NCR)

Subject: Flaw Evaluation of Potential Defects in the NUHOMS® FF DSC Stainless Steel Bottom Forging

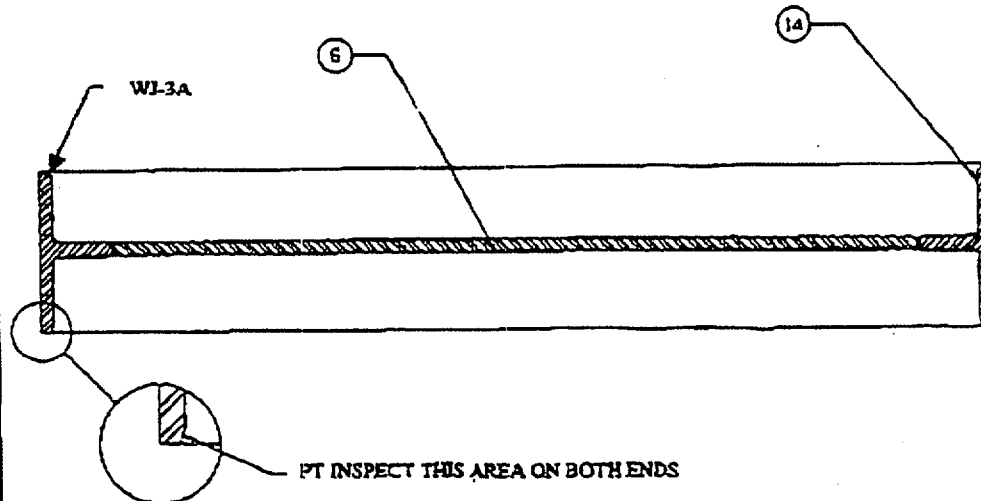
CUSTOMER: TN West (SMUD)		CUSTOMER PO: 2001-022		JOB NO.: 010267FM		LEVEL NO.: 1C		PAGE 2 CONT.-	
DESCRIPTION: FORGED CYLINDER TO INNER BOTTOM COVER, SKETCH #1, REV. 0						ACCEPTANCE CRITERIA ASME Section III NB- 5360; 1992 Ed 1893 Add		SERIAL NO.: 14-1	
LIQUID PENETRANT EXAMINATION REPORT - PROCEDURE NO. TNWFF-PT-2, REV. 0									
AREA EXAMINED: "P" - PLATE SURFACE "S" - BEVELED EDGES "O" - OTHER _____	PART NUMBER _____	WJ-4		WT-7 Removal & Polished		WJ-3A BEVELED EDGE		BOTTOM PLUG BEVEL	
SURFACE CONDITION: "S" - ACTUAL SURFACE "G" - GROUND "M" - MACHINED	NOE EXAMINER LEVEL DATE	APK -III 11-22-01		PA II 11-22-01		PA II 11-22-01		PA II 11-22-01	
	CUSTOMER QUALITY REP. DATE	309 TAM 11-27-01							
Record Area Examined		F		P		B		B	
Record Surface Condition		M		G		M		M	
Liquid Penetrant Indications		0		0		0		0	
Indications Repaired by Grinding		0		0		0		0	
Indications Repaired by Welding		0		0		0		0

Total Accumulated Length of Indications		0"		0"		0"		0"	
Liquid Penetrant Indications After Repair		0		0		0		0	
Final Weld Joint Acceptance:		Accept		Accept		Accept		Accept	
Liquid Penetrant Material:		MET-L-CHEK VP-31A		MET-L-CHEK D-70		MET-L-CHEK E-59			
Batch Numbers:		Penetrant: 3944		Developer: 1202		Cleaner: 4880			
Location Sketch (as applicable)

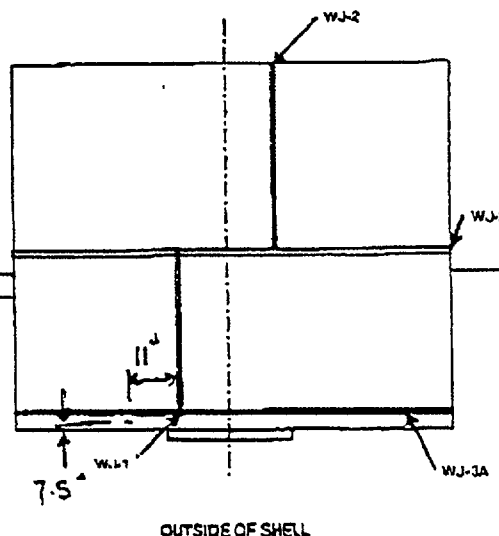
LAYOUT FOR ULTRASONIC THICKNESS INSPECTION:			
Surface Condition to be Inspected:	<input type="checkbox"/> As-Welded <input type="checkbox"/> Plate	<input checked="" type="checkbox"/> Ground	<input type="checkbox"/> Machined
Inspection Temperature:	Calibration Block <u>68</u> °F	Component <u>68</u> °F	Couplant Used: <u>UT-GEAR</u>
Inspection Requirements:	Material Thickness: .825 +.05; -.01 in.	High Level Alarm: .575 in.	Low Level Alarm: .515 in.

ACCEPT
