June 2, 1975

Docket No. 50-278

RELATING TO
CHANNEL BOX WEAR
IN THE
VERMONT YANKEE NUCLEAR POWER STATION
(Docket 50-271)
AND THE
PILGRIM NUCLEAR POWER STATION
(Docket 50-293)

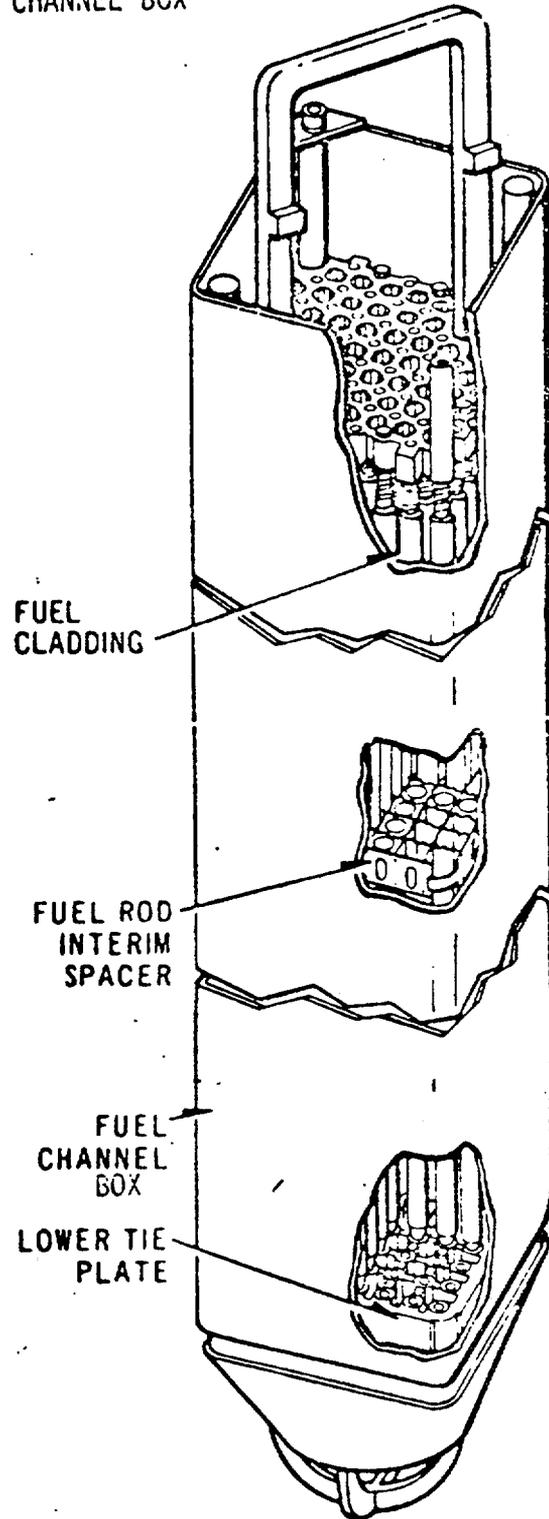
FUEL CHANNEL BOX

The fuel bundles of boiling water reactors are encased in square Zircaloy-4 tubes known as channel boxes (Fig. 1) which separate parallel coolant flow paths in the core, provide guide surfaces for the motion of control rods, and protect fuel bundles during handling. Each channel box slides over the surface (lower tie plate surface, Fig. 1) of a fitting which rests on the core support plate. The zone between the channel box assemblies is referred to as the bypass region and, in all boiling water reactors, contains the control rods and in-core instrumentation. In some facilities, the bypass region also contains temporary control curtains (Fig. 2), which are removed after initial operation of the first core and are used to provide supplemental control.
