Re: Highland Reclamation Project
Source Materials License SUA-1139
Docket No. 40-8102.
As-Built and Construction Quality Assurance Report
Converse County, WY

**AS-BUILT AND CONSTRUCTION QUALITY
ASSURANCE REPORT FOR THE URANIUM
TAILINGS BASIN AT THE HIGHLAND
RECLAMATION PROJECT**

Prepared By:
Shepherd Miller
3801 Automation Way, Suite 100
Fort Collins, Colorado 80525

May 31, 2002

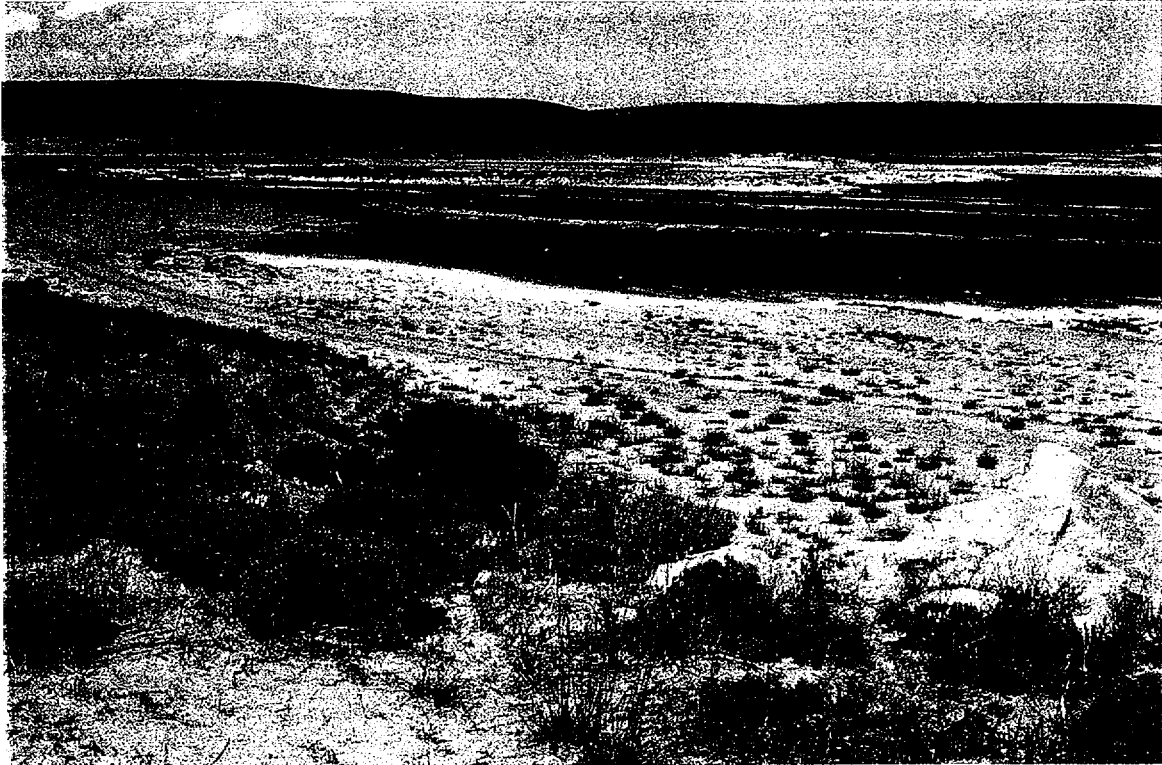
Photo A.2.1 Southwest corner of tailings basin with evaporation ponds and spray system.
Future wick area is on the right side of the photo. (Oct 1986)

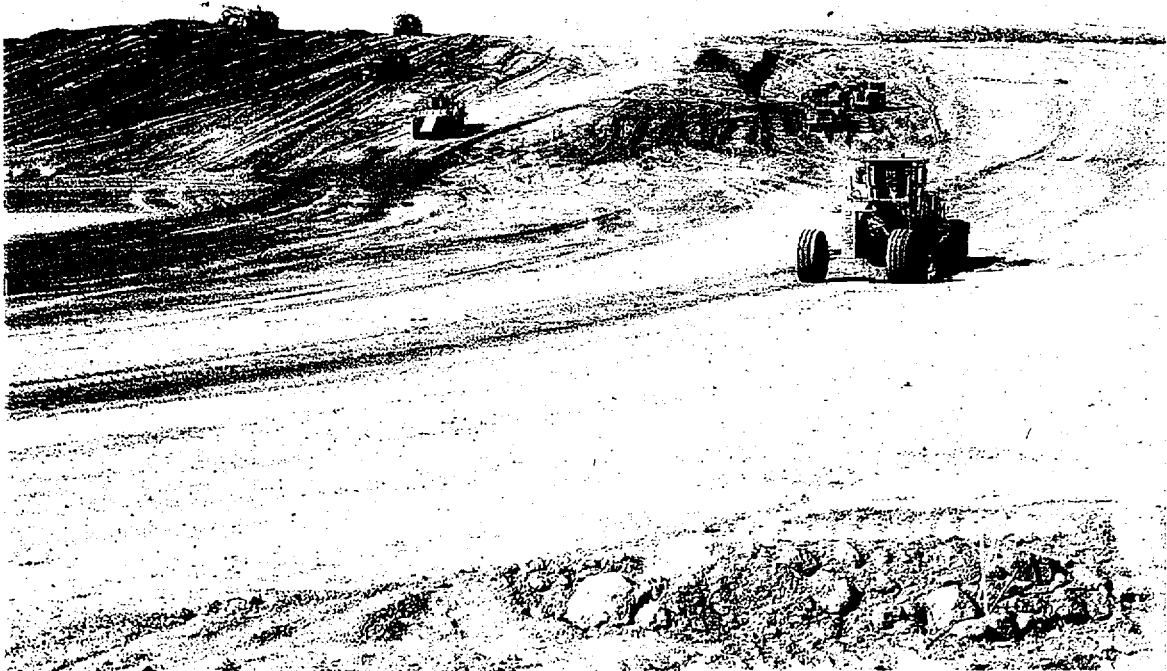
Photo A.3.1 Radon barrier material excavated from Middle Dump during 1989 construction. (Jul 1989)

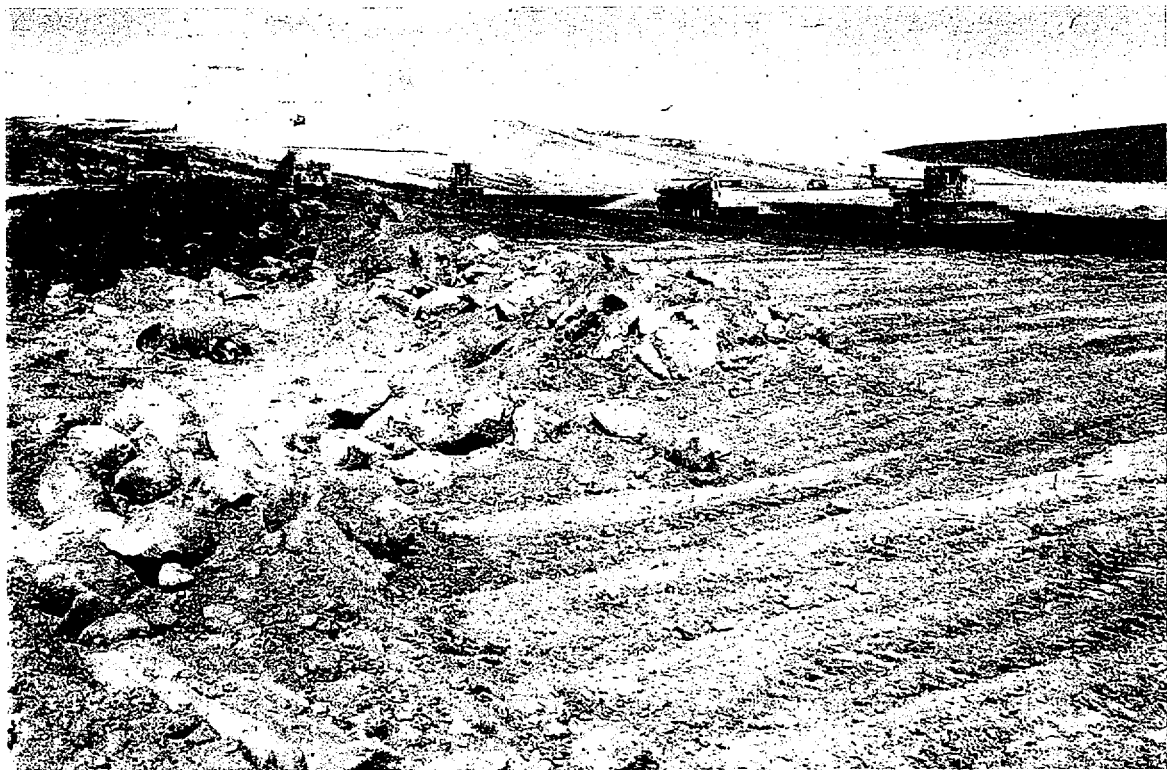
Photo A.3.2 Random fill placement (at left) and radon barrier placement (at right) during 1989 construction. The Middle Dump borrow area is in the distant center of the photo. (Jul 1989)

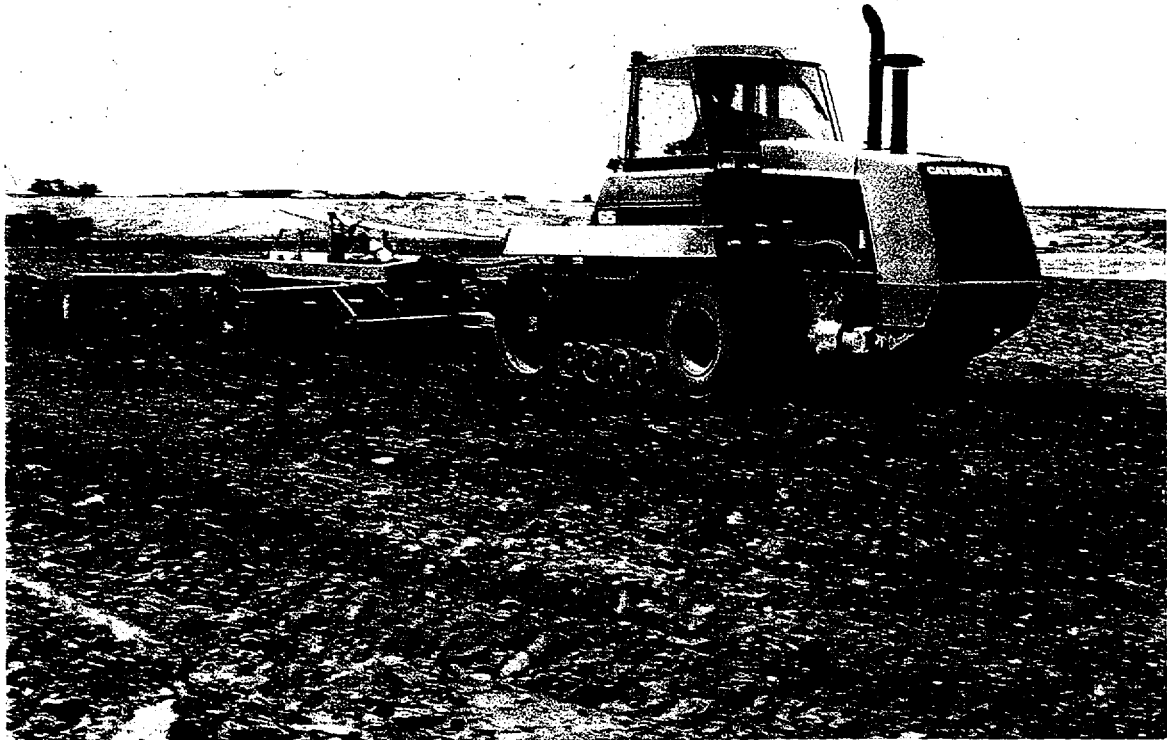
Photo A.4.1 Moisture conditioning of radon barrier material during 1989 construction.

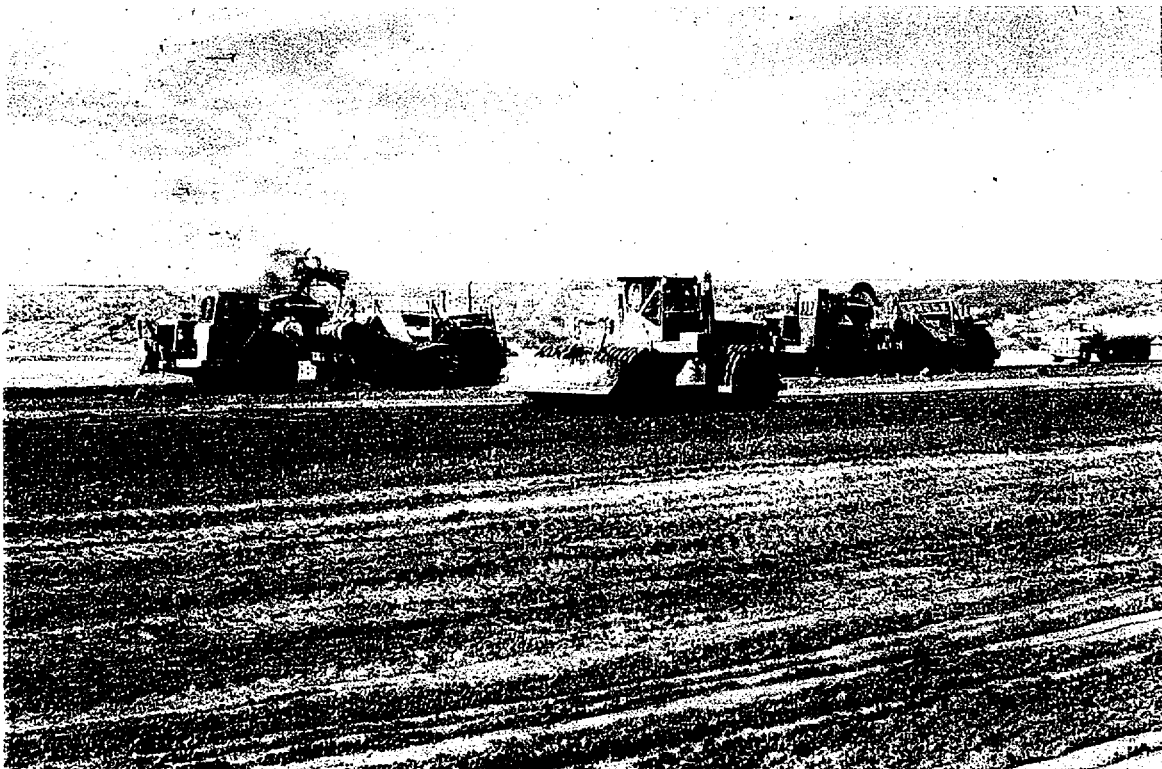
Photo A.4.2 Compaction of radon barrier material during 1989 construction.

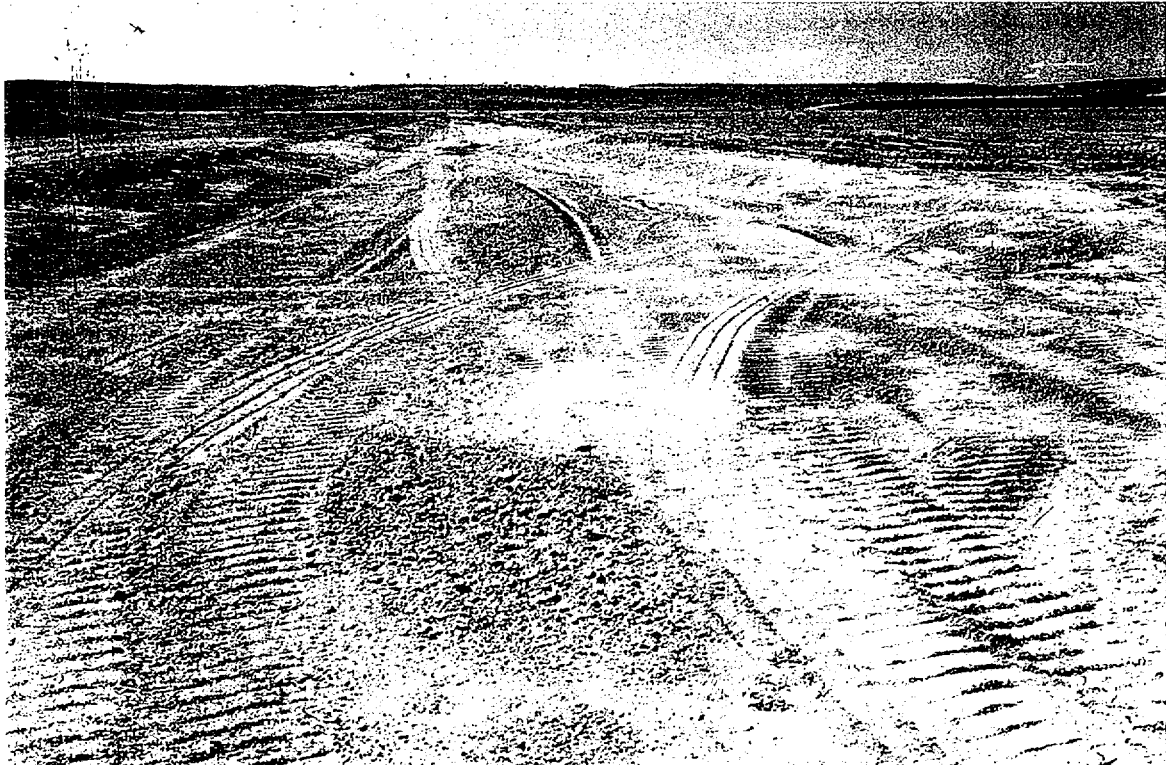
Photo A.5.1 Looking southward up the south low-flow channel from junction with west low-flow channel. Channels have been shaped and topsoil placed to edge of channel prior to rock placement. One of the cover soil stockpiles is on the right side of the photo. (Sep 1989)

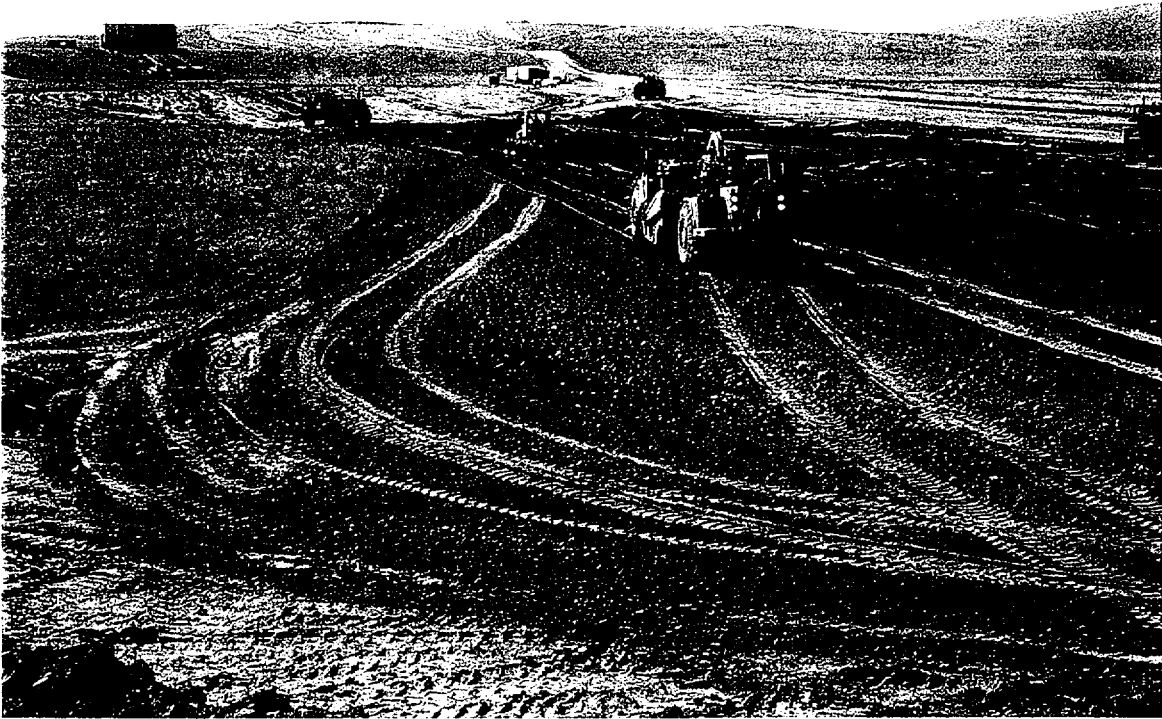
Photo A.6.1 Radon barrier placement during 2000-2001 construction. Water storage tanks are at left and the Middle Dump borrow area is in the distance. (Apr 2001)

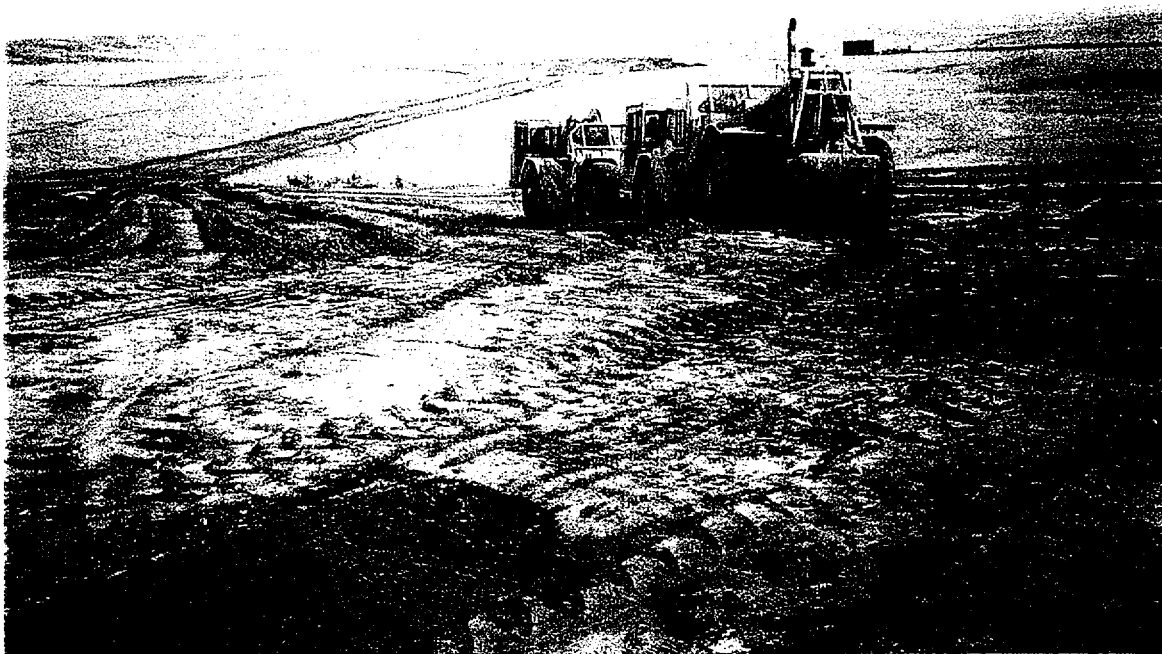
Photo A.6.2 Looking toward fill placement area from Middle Dump borrow area during 2000-2001 construction. Typical Middle Dump materials are in the foreground. (Nov. 2000)

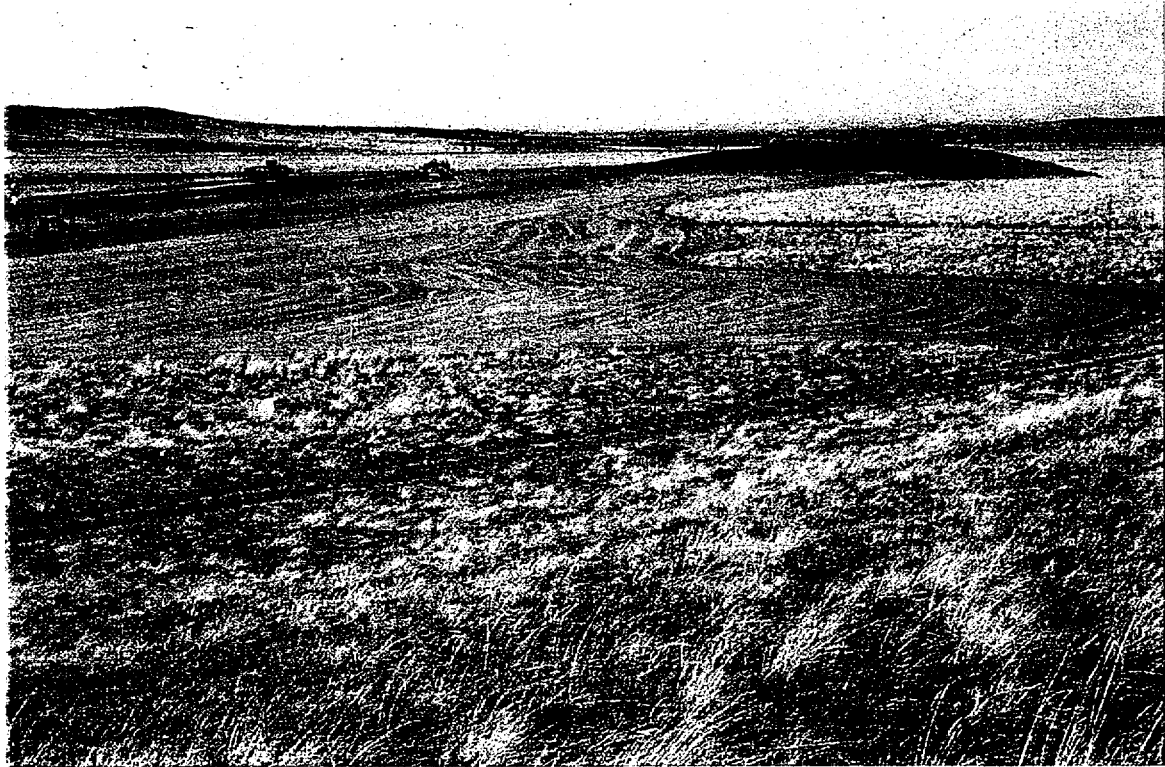
Photo A.7.1 Random fill placement during 2000-2001 construction at left side of photo.
Temporary topsoil stockpile is at right side of photo. (Apr 2001)

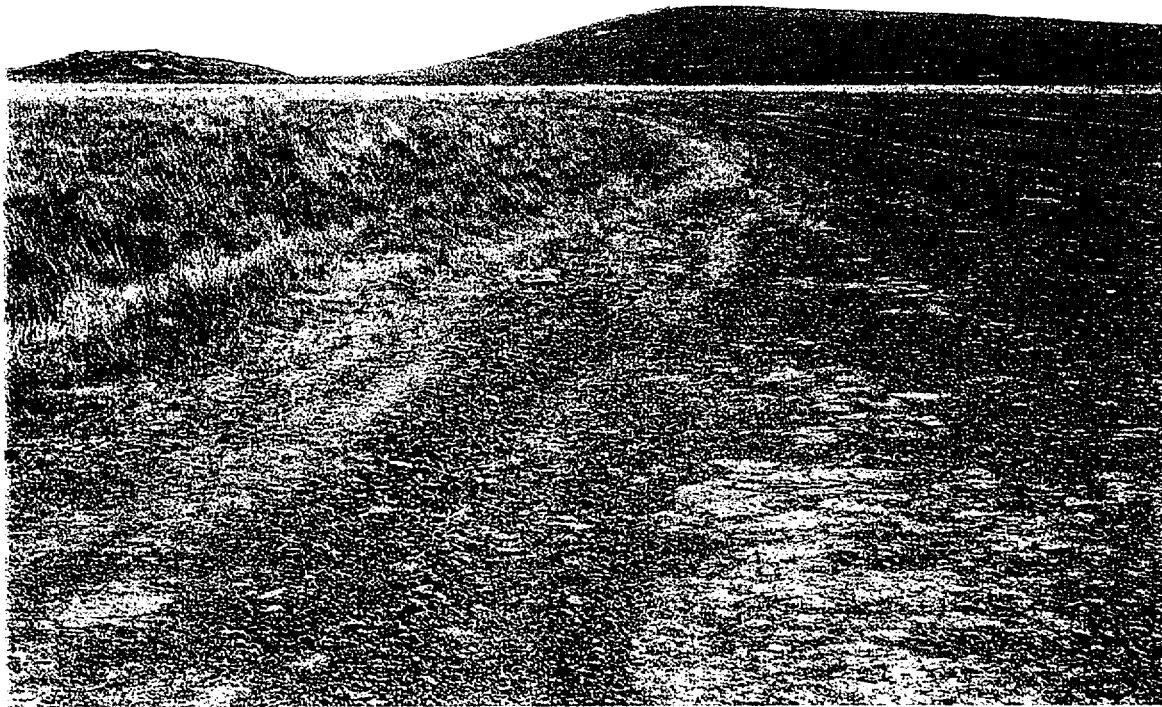
Photo A.7.2 Looking south along eastern side of fill placement area in 2001, showing transition
between existing vegetated cover and new topsoil. Part of the slope setback area can
be seen in the distance. (Jun 2001)

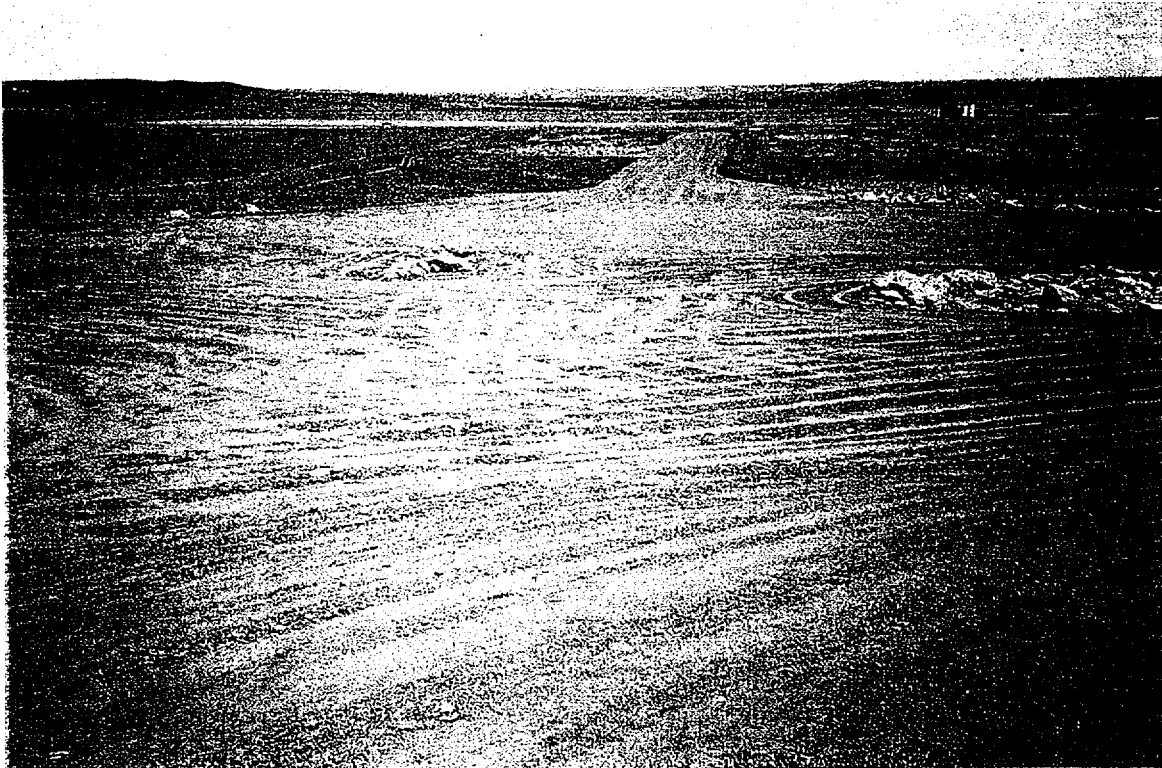
Photo A.8.1 Regraded Middle Dump borrow area and haul road after 2000-2001 construction. Fill placement area and water storage tanks are in the distance. (Jun 2001)

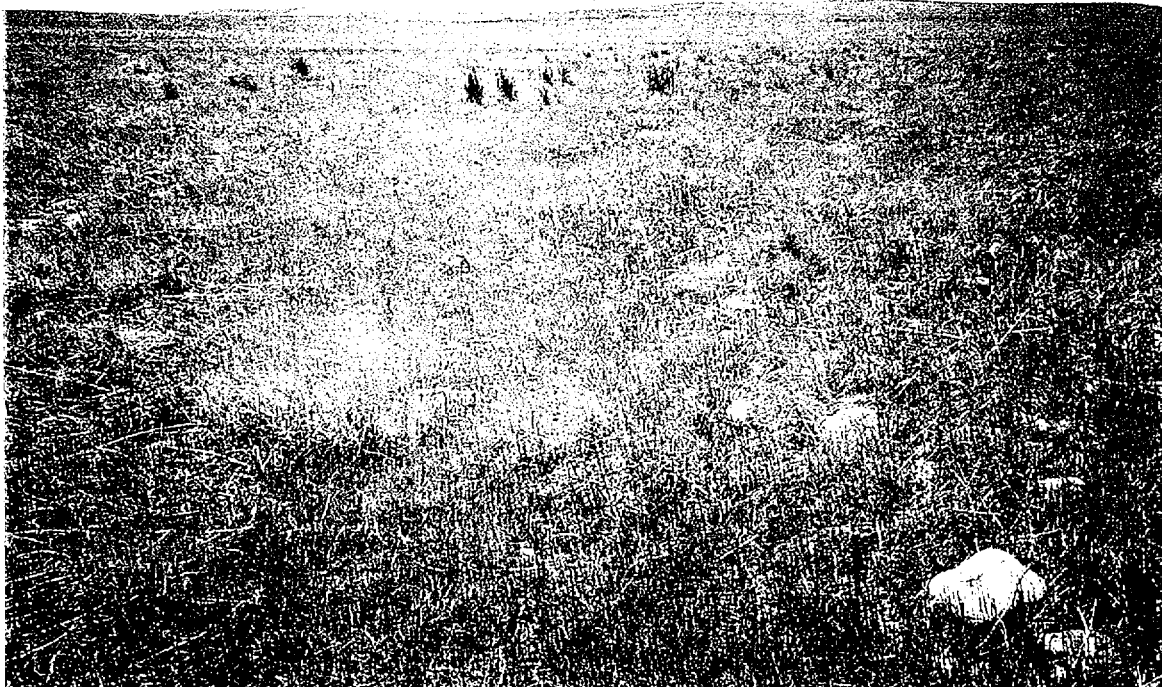
Photo A.8.2 Looking up west low-flow channel toward western limb and reclaimed Middle Dump borrow area after 2000-2001 construction. (Jun 2001)

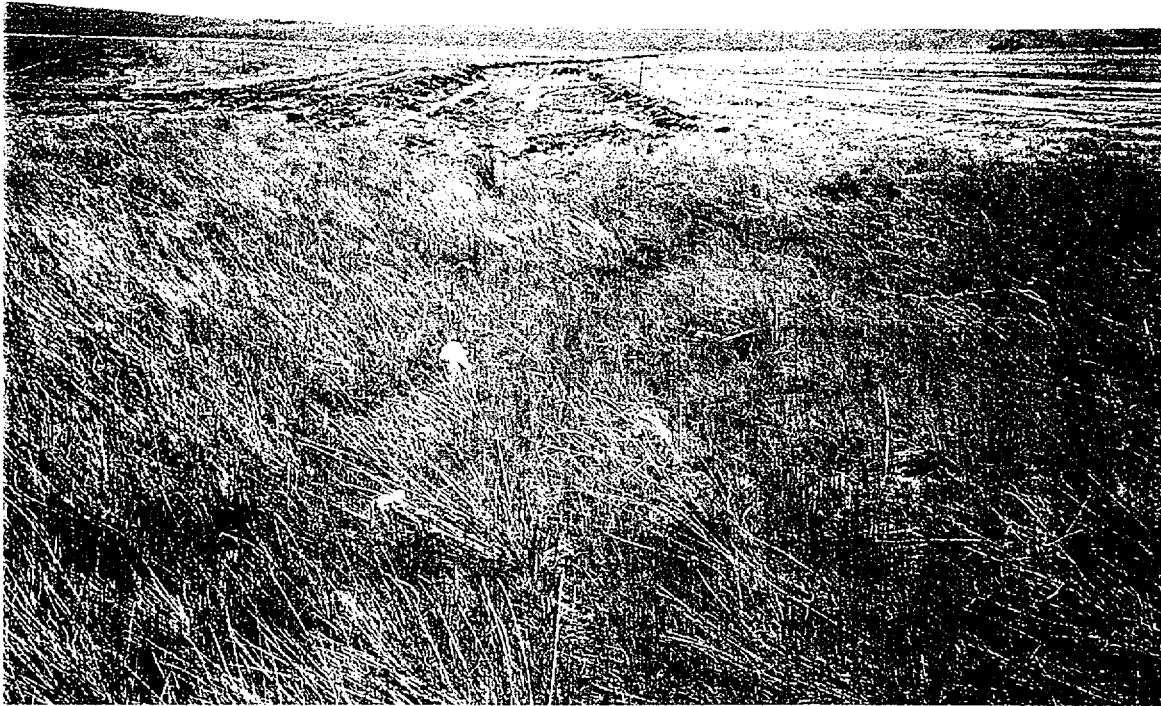
Photo A.9.1 Looking up south low-flow channel across fill placement area after 2000-2001 construction. Old portion of south low-flow channel is in foreground. (Jun 2001)

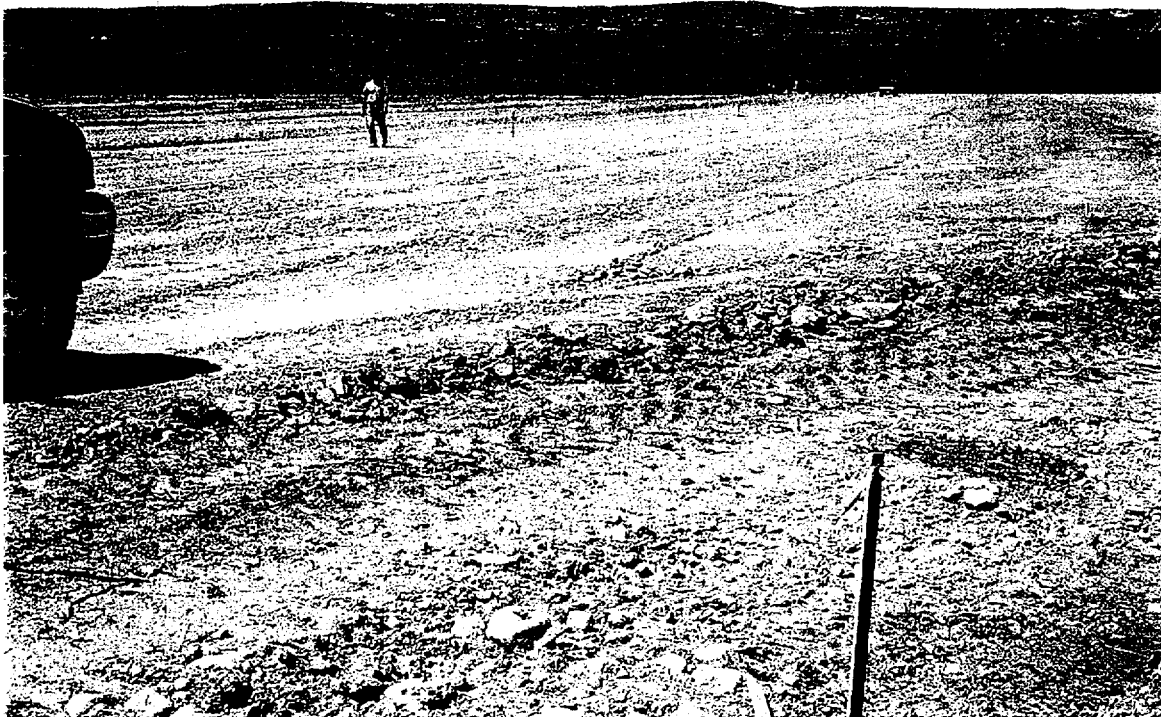
Photo A.9.2 Looking northwest across fill placement area after 2000-2001 construction. Final grading of topsoil is taking place. The first lift of rock in the south low-flow channel is in the foreground. (Jun 2001)

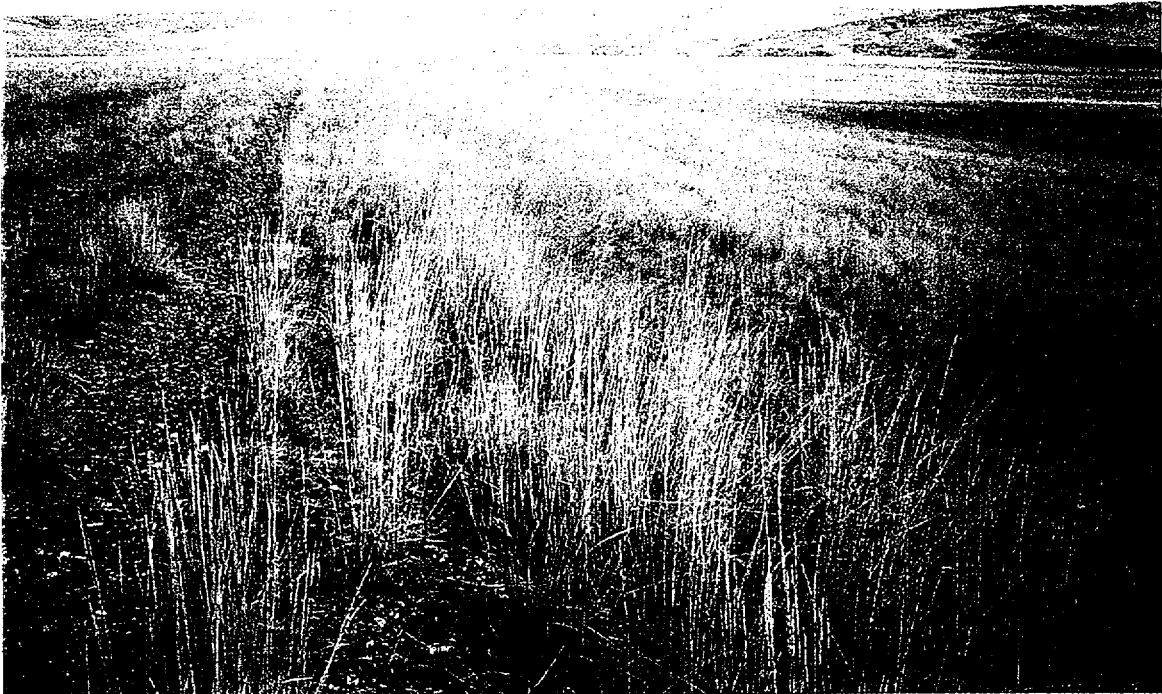
Photo A.10.1 Reclaimed embankment (looking north), with rock-covered crest on left and downstream slope on right. (Oct 2000)

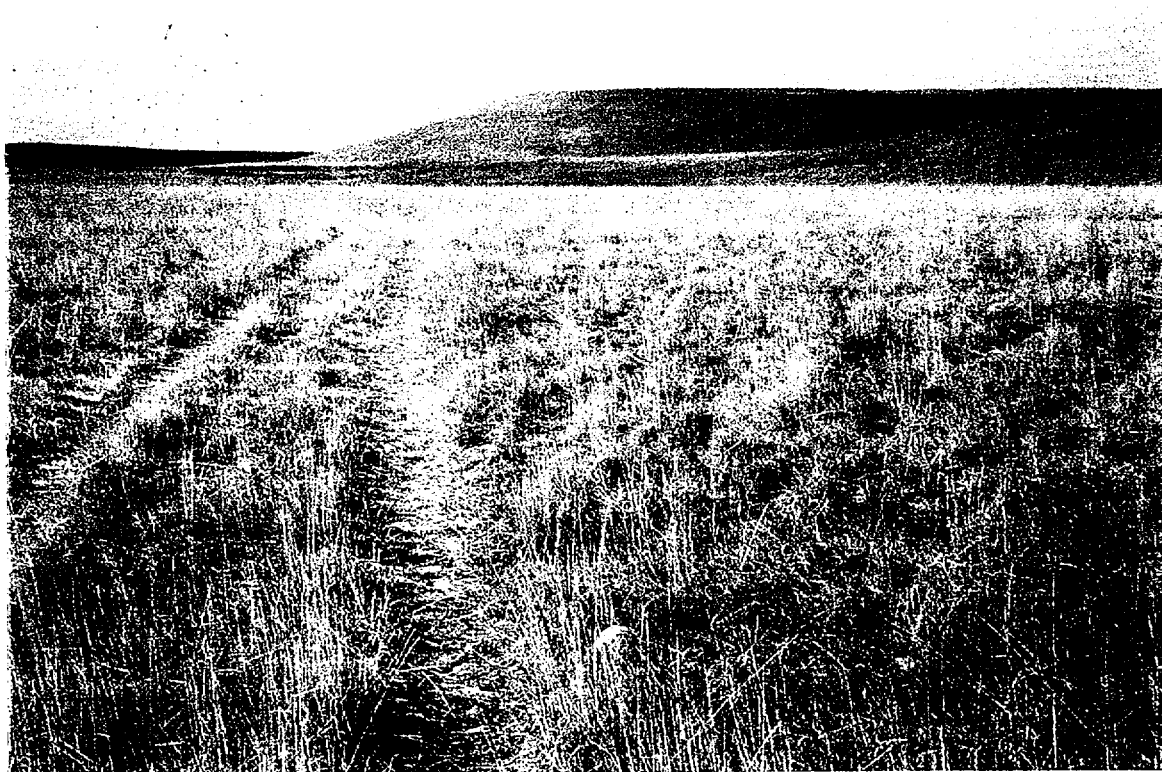
Photo A.10.2 Reclaimed tailings basin looking northwest, with North Dump and North Diversion Channel in the distance. (Oct 2000)
