July 11, 1960

**REPORT ON
WTR FUEL ELEMENT
FAILURE APRIL 3, 1960**
JULY 7, 1960

REPORT ON WTR FUEL ELEMENT FAILURE APRIL 3, 1960

FUEL ELEMENT FAILURE
IN THE
WESTINGHOUSE TESTING REACTOR

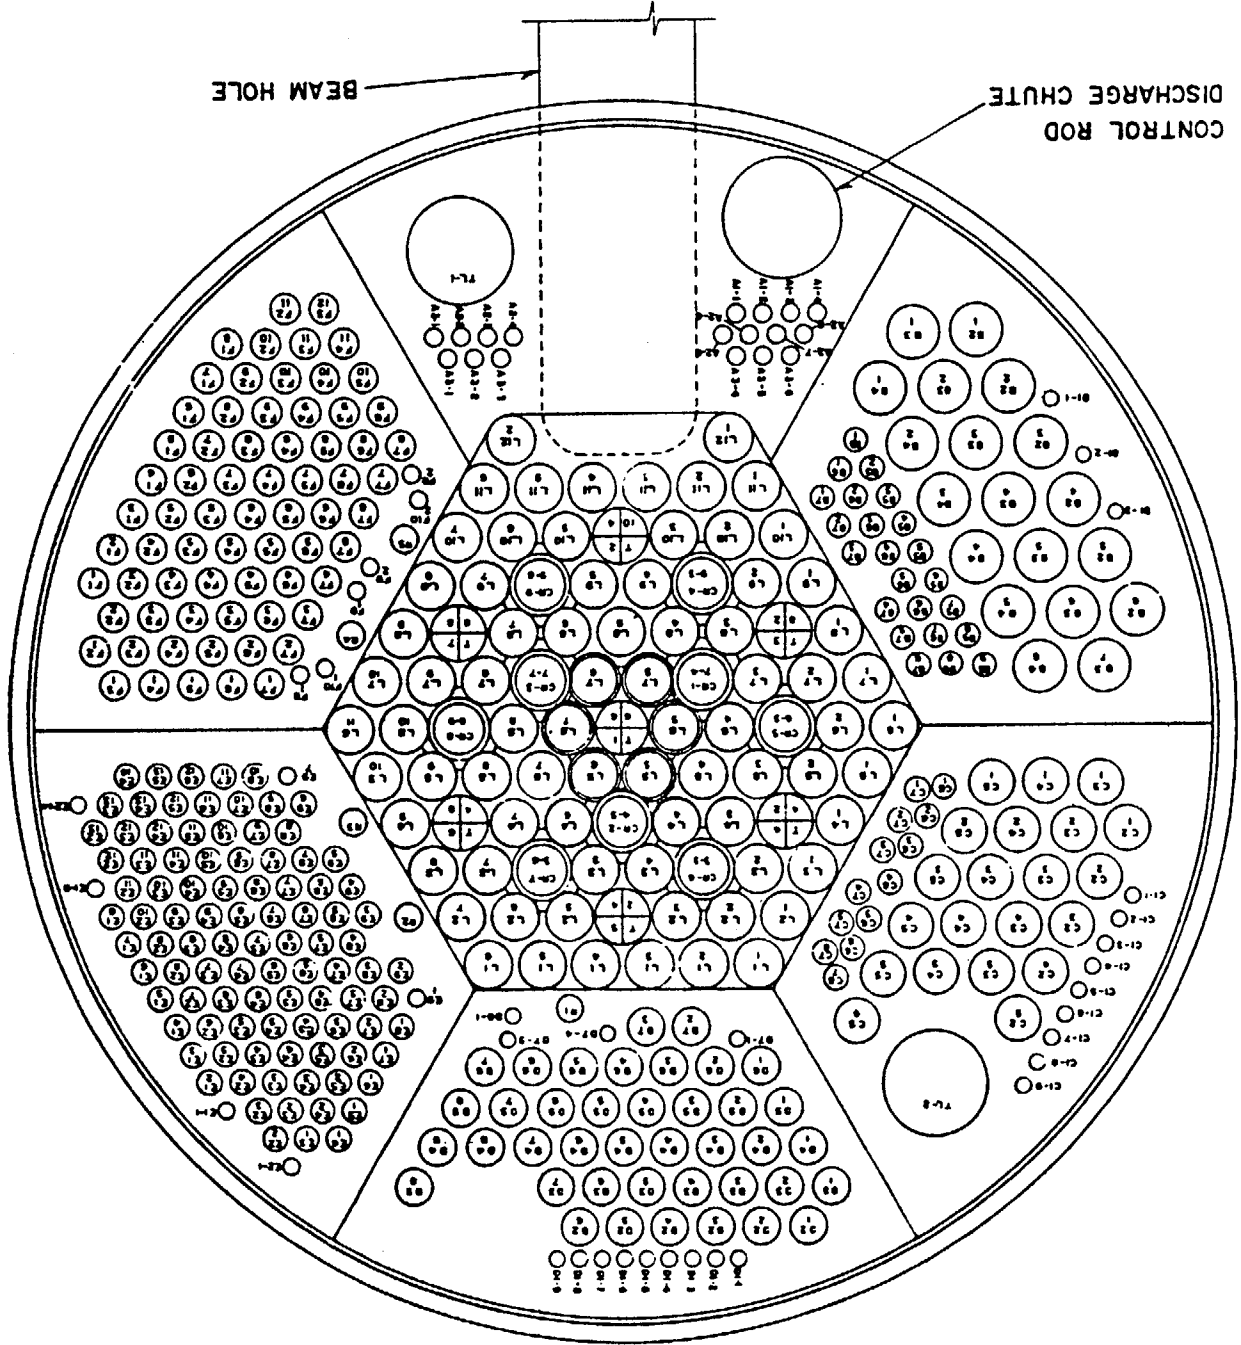
FIGURE 3.
CORE POSITION INDEX.

To measure this temperature, a fuel element was initially instrumented with three aluminum clad fiber glass insulated chromel-alumel thermocouples projecting into the nozzle space below the element. These thermocouples were connected to a printing data-logger which was used to record the temperatures. The fuel element was placed in core position L-7-6, shown in Figure 3.

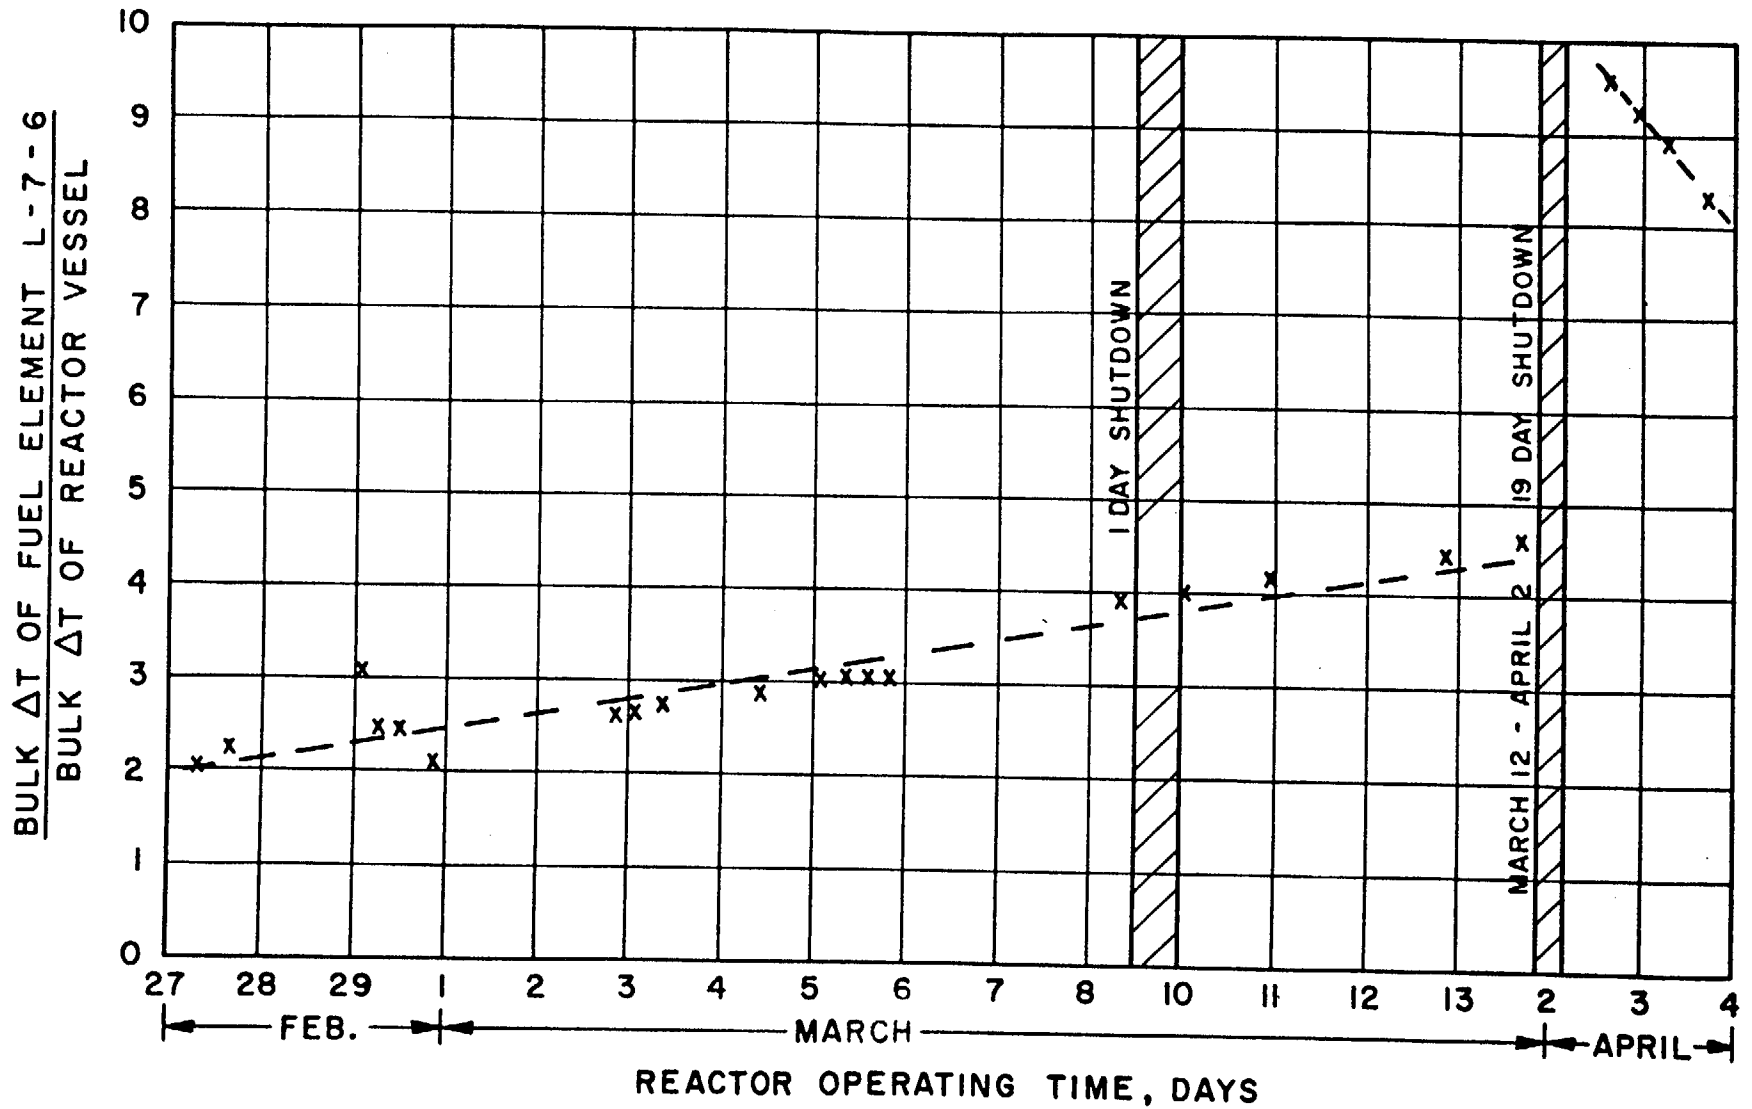
FIGURE 4

With time the second set of thermocouples exhibited a similar drift and eventually indicated in excess of 220°F. Figure 4 shows this effect by plotting the increase in the ratio of the temperature rise across the instrumented fuel element to the temperature rise across the reactor vessel as a function of time. This ratio should remain constant independent of the reactor power and the coolant flow rates, and for the calculated conditions should be 1.95.

INCREASE IN THE RATIO OF BULK COOLANT TEMPERATURE
RISE ACROSS LATTICE POSITION ON L-7-6 TO BULK COOLANT
TEMPERATURE RISE ACROSS REACTOR VESSEL WITH IRRADIATION

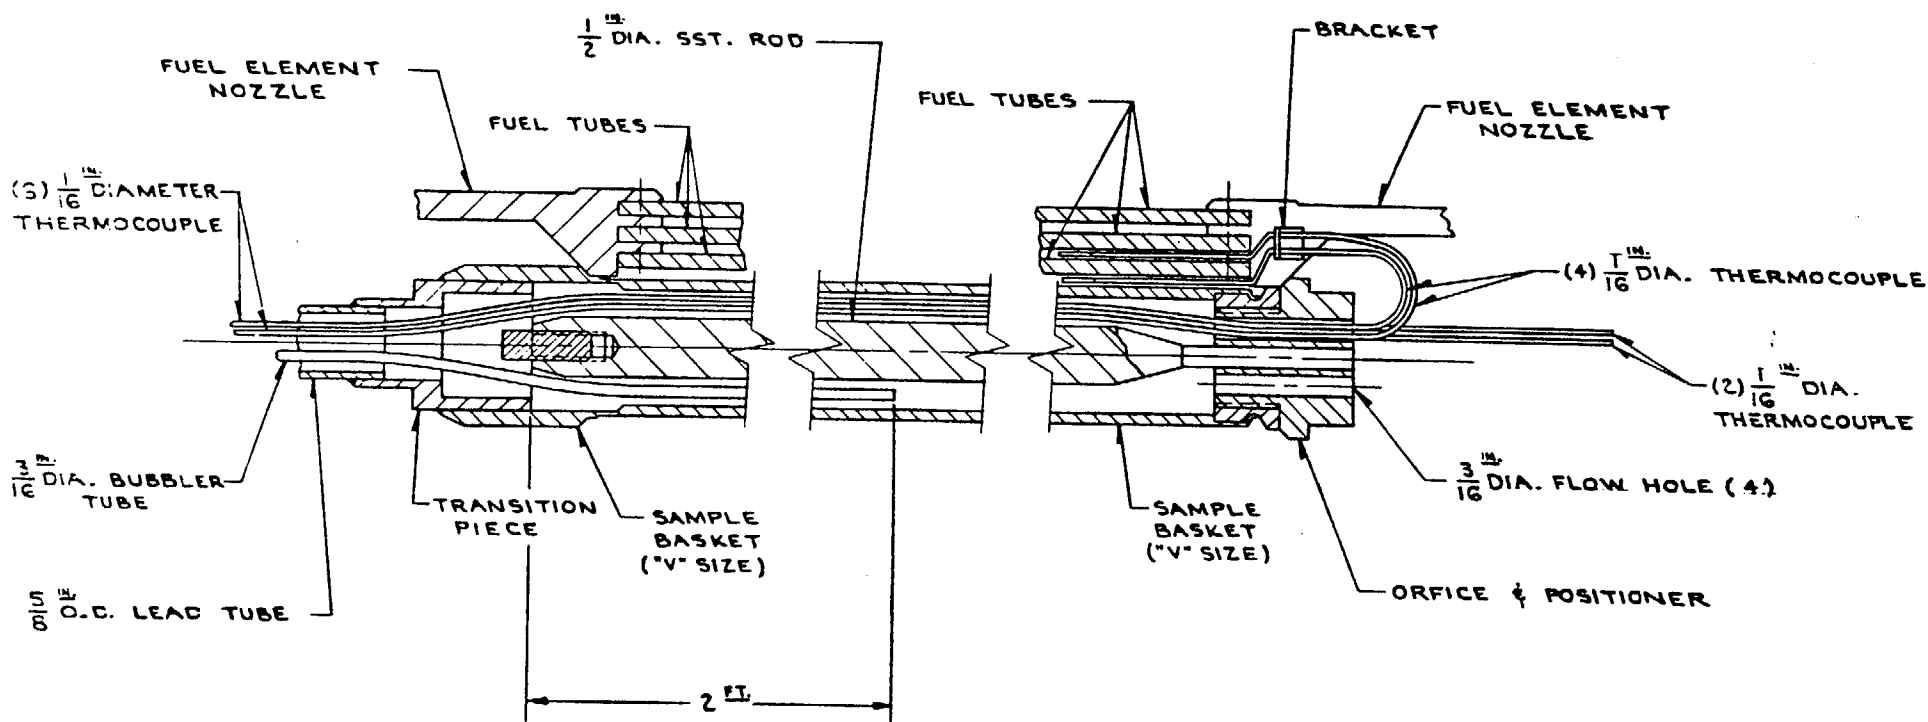
FIGURE 5

Power escalation was again interrupted and a third instrumented fuel element was constructed using stainless steel clad, magnesium oxide insulated thermocouples. These thermocouples were mounted as shown in Figure 5 with two thermocouples reading the bulk exit water temperatures, two reading the discharge water temperature in the channel between the sample basket and the first fuel tube, and the third pair reading the water discharge temperature between the inner and middle fuel tubes. This instrumented fuel element was inserted in reactor core position L-5-6. Although the second set of aluminum sheathed thermocouples were considered defective, they were not removed from the core and their

FUEL ELEMENT INSTRUMENTED WITH SIX STAINLESS STEEL THERMOCOUPLES

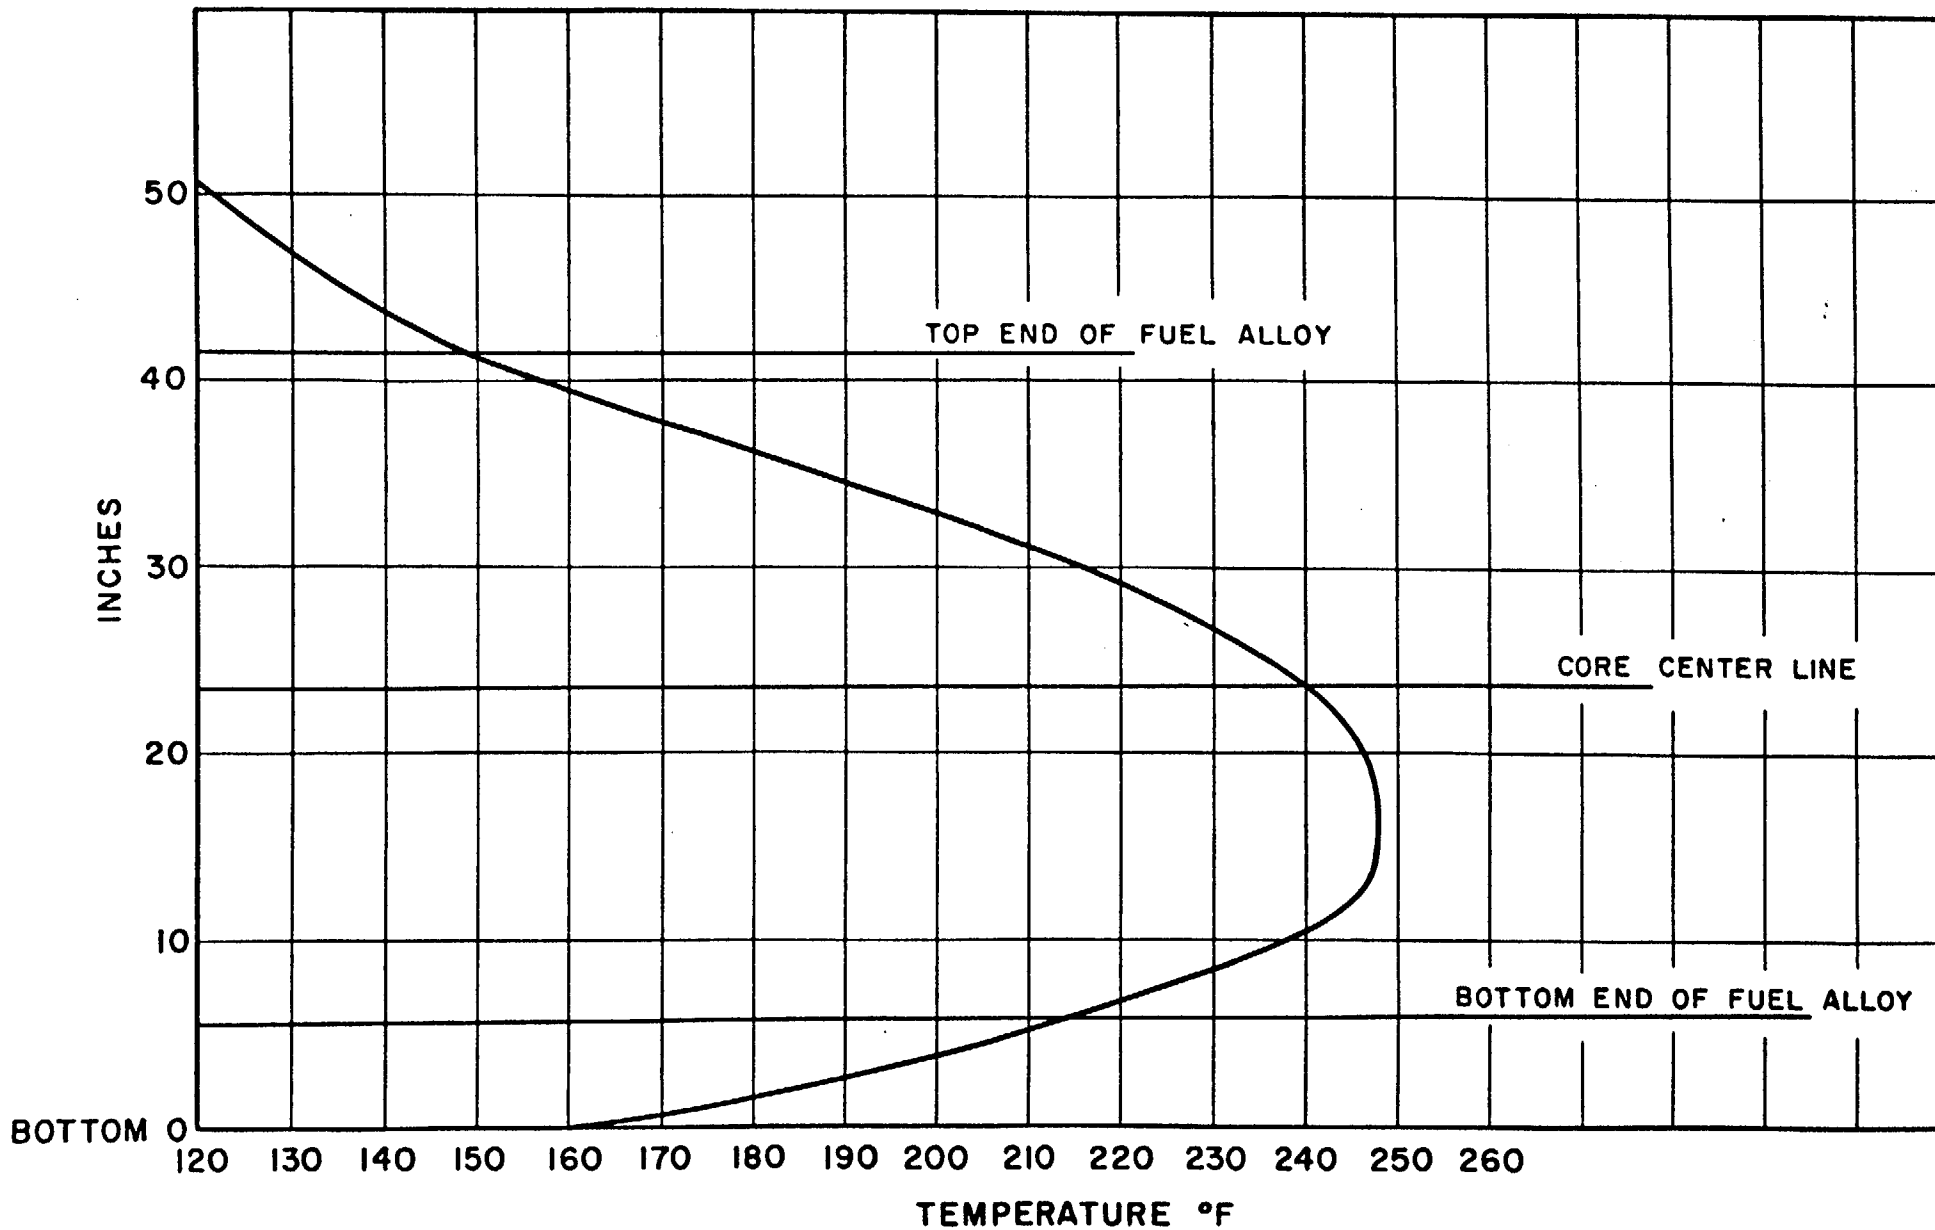
FIGURE 10

Boiling in the access tube in position L-5-8 was substantiated by traversing a thermocouple axially along the tube from the bottom to the top of the core region and observing the temperature. The resulting temperature versus position curve is shown as Figure 10. A maximum temperature of 248°F was measured in the region of maximum power production in the reactor. Saturation temperature of water under atmospheric pressure and 22 feet of head is 240°F. Consequently boiling in this tube took place over several inches of length.

TEMPERATURE PROFILE L5-8
ACCESS TUBE 40MW 11000 GPM

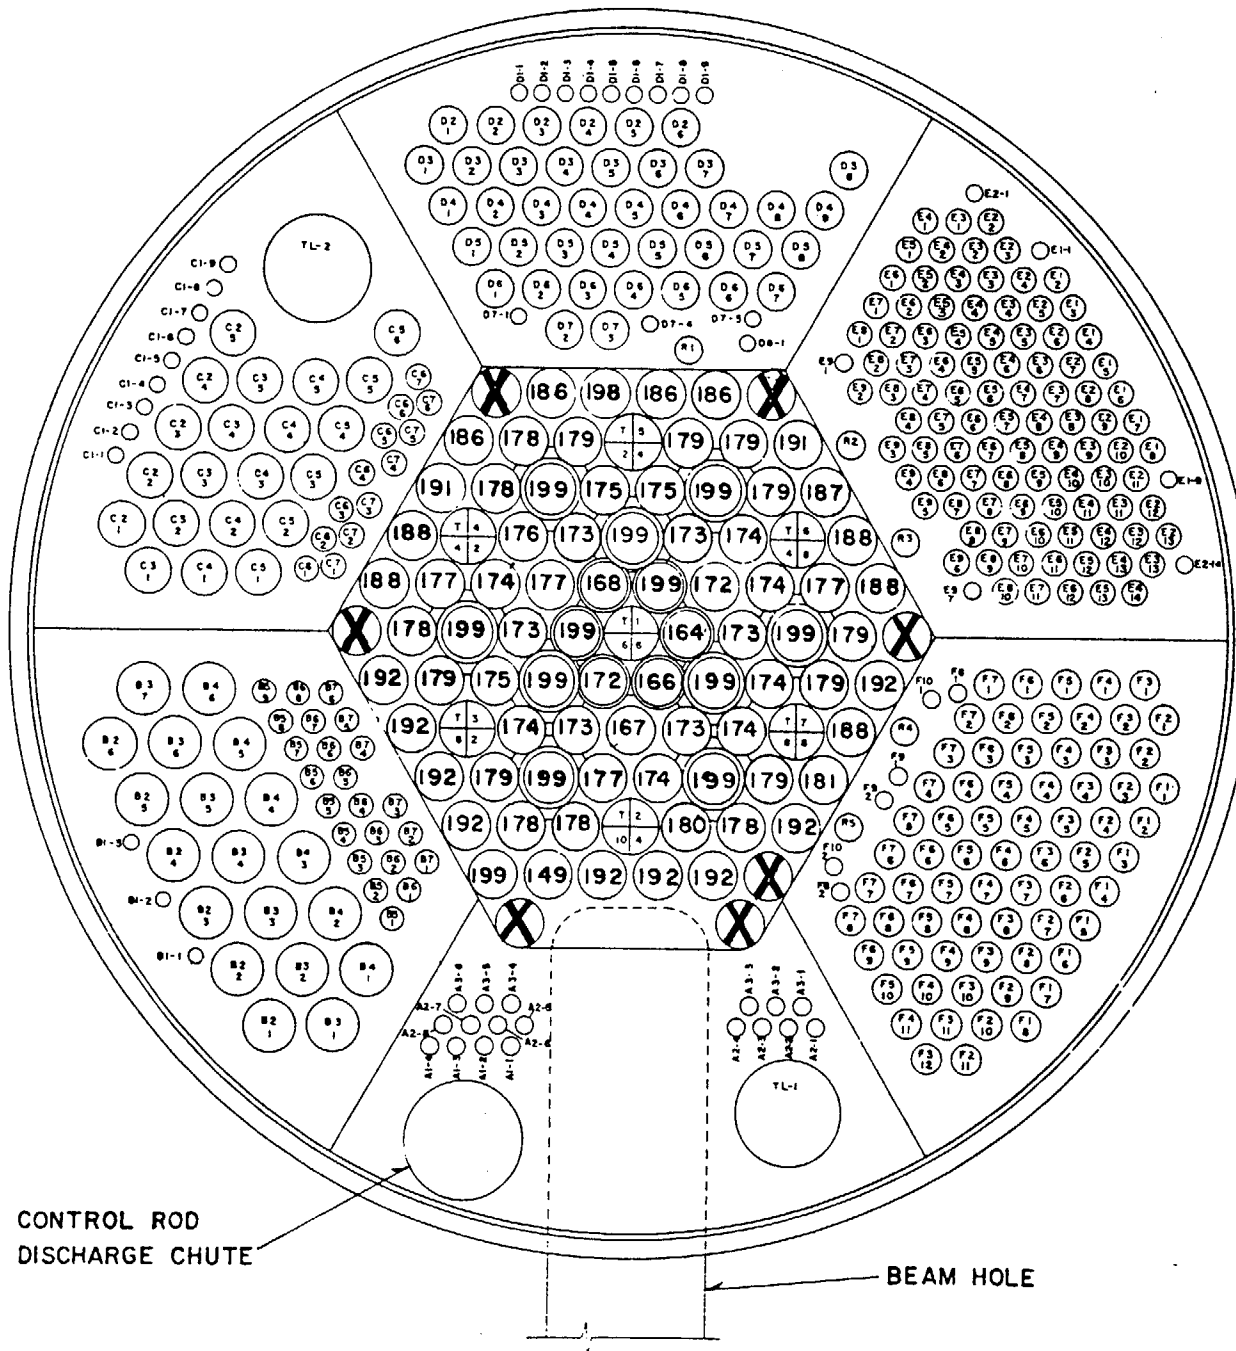
FIGURE 15
U-235 CONTENT OF FUEL
ELEMENTS(GRAMS)

For this two-day run the reactor core loading in grams of fuel in each fuel element and the contents of the irradiation volume of each fuel element are shown as Figures 15 and 16. The fuel element which subsequently failed was in core position L-6-5, and contained 199 grams of fuel, indicating that it was a new element.

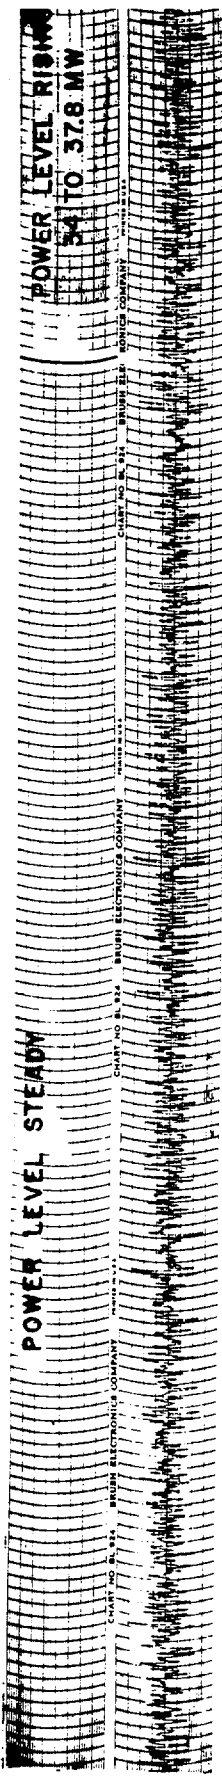
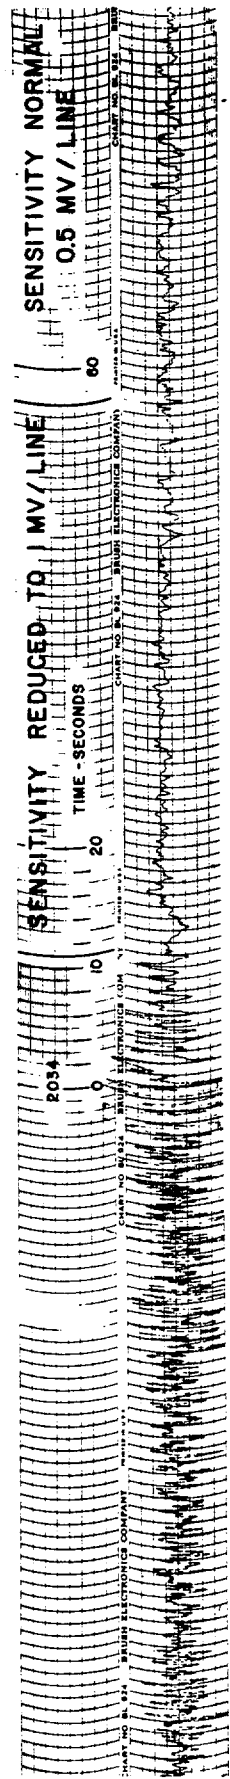
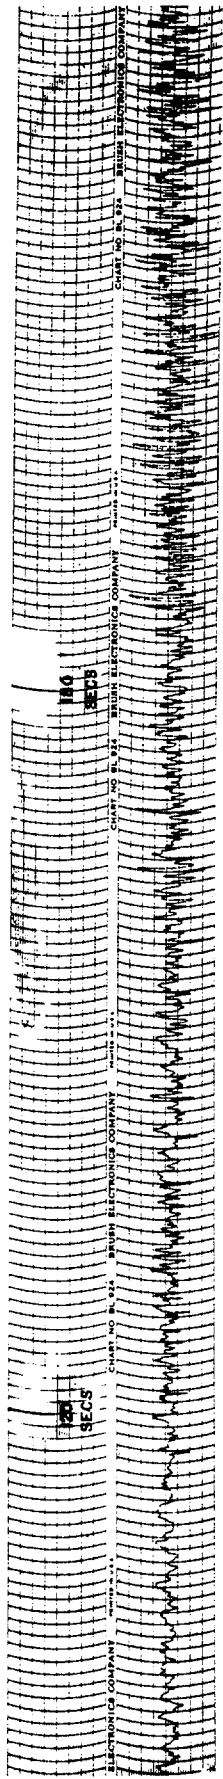
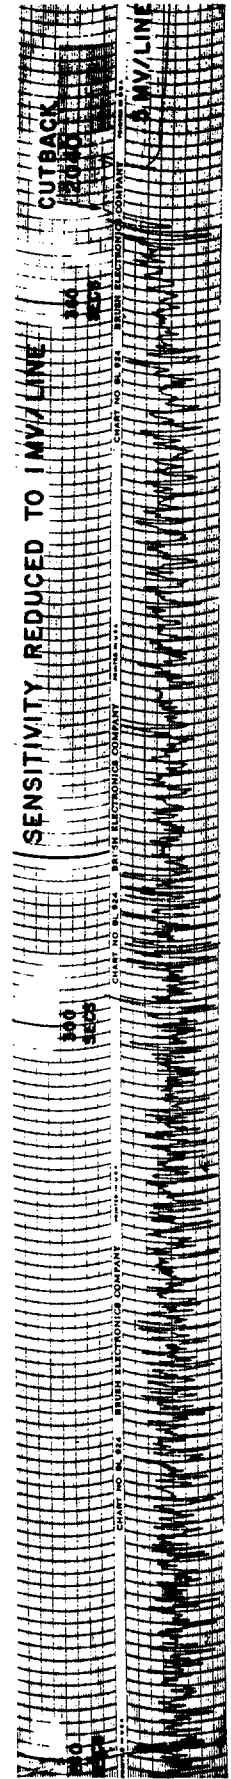
Figure 21 is a reproduction of the boiling detector Brush Recorder trace during the time interval under discussion. If time zero is taken at 20:34 corresponding to the first peak in power level of Figure 19, then the reduction in power level caused by the failure and voiding appears to have occurred in about eleven seconds. That a permanent block was established can be seen in that over the next three minutes the noise level remained approximately constant. Then as rod motion forced the power level back up, the boiling noise pattern increased in amplitude, but didn't quite return to the before failure amplitude when the cutback was initiated. An independent observation indicated that an alarm on top of the reactor, actuated by the radiation from the head tank went off at approximately 240 seconds on Figure 21. This further confirms the other deduction that the element failed at about 20:34 at the first power peak rather than at 20:40 the second peak in power.

FIG. 21
BOILING DETECTOR RECORD OF APRIL 3, 1960 DURING FUEL ELEMENT FAILURE

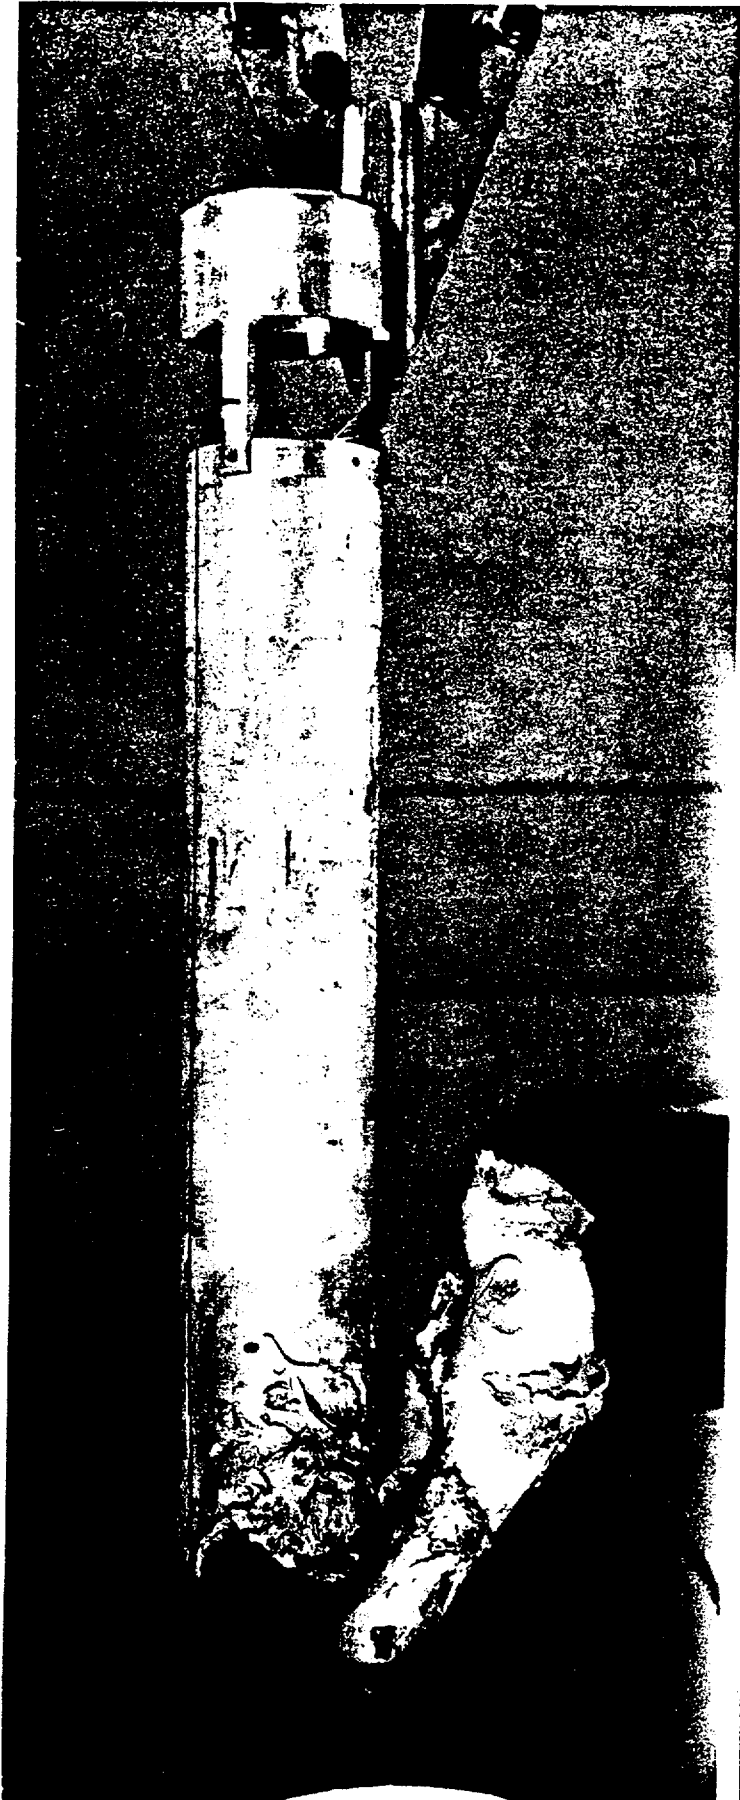
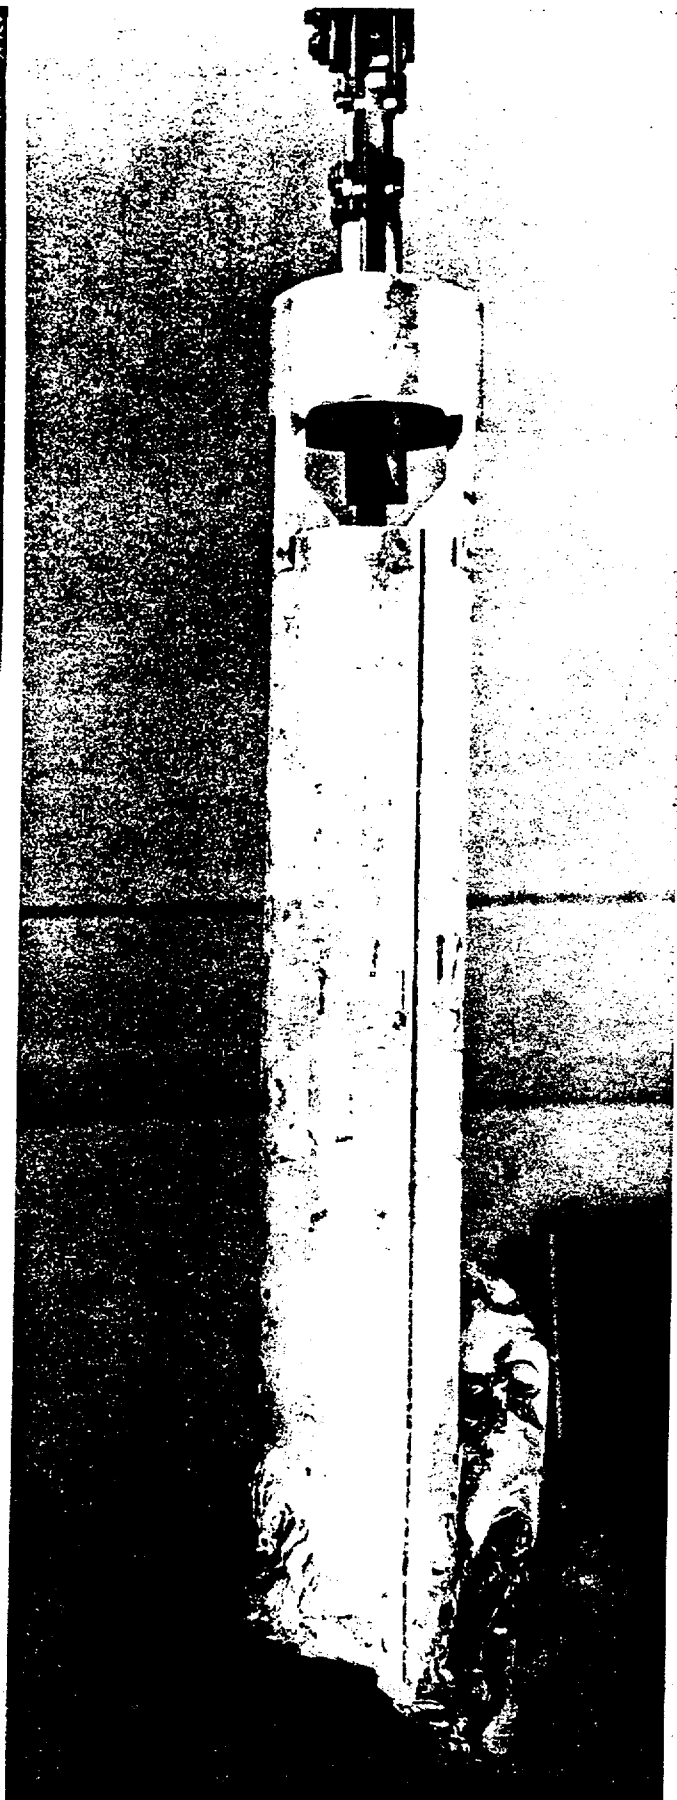
FIGURE 28

Both the upper and lower portion of the failed element were removed to the hot cells. Photographs were taken through the cell windows and through a stereomicroscope. Some of the photographs are shown in Figures 26 to 32. The appearance of the fragments is indicative of the violence and suddenness with which the melting took place. Some evidence of poor bonding between the aluminum cladding and the meat is suggested in many of the photographs, particularly in Figure 31.

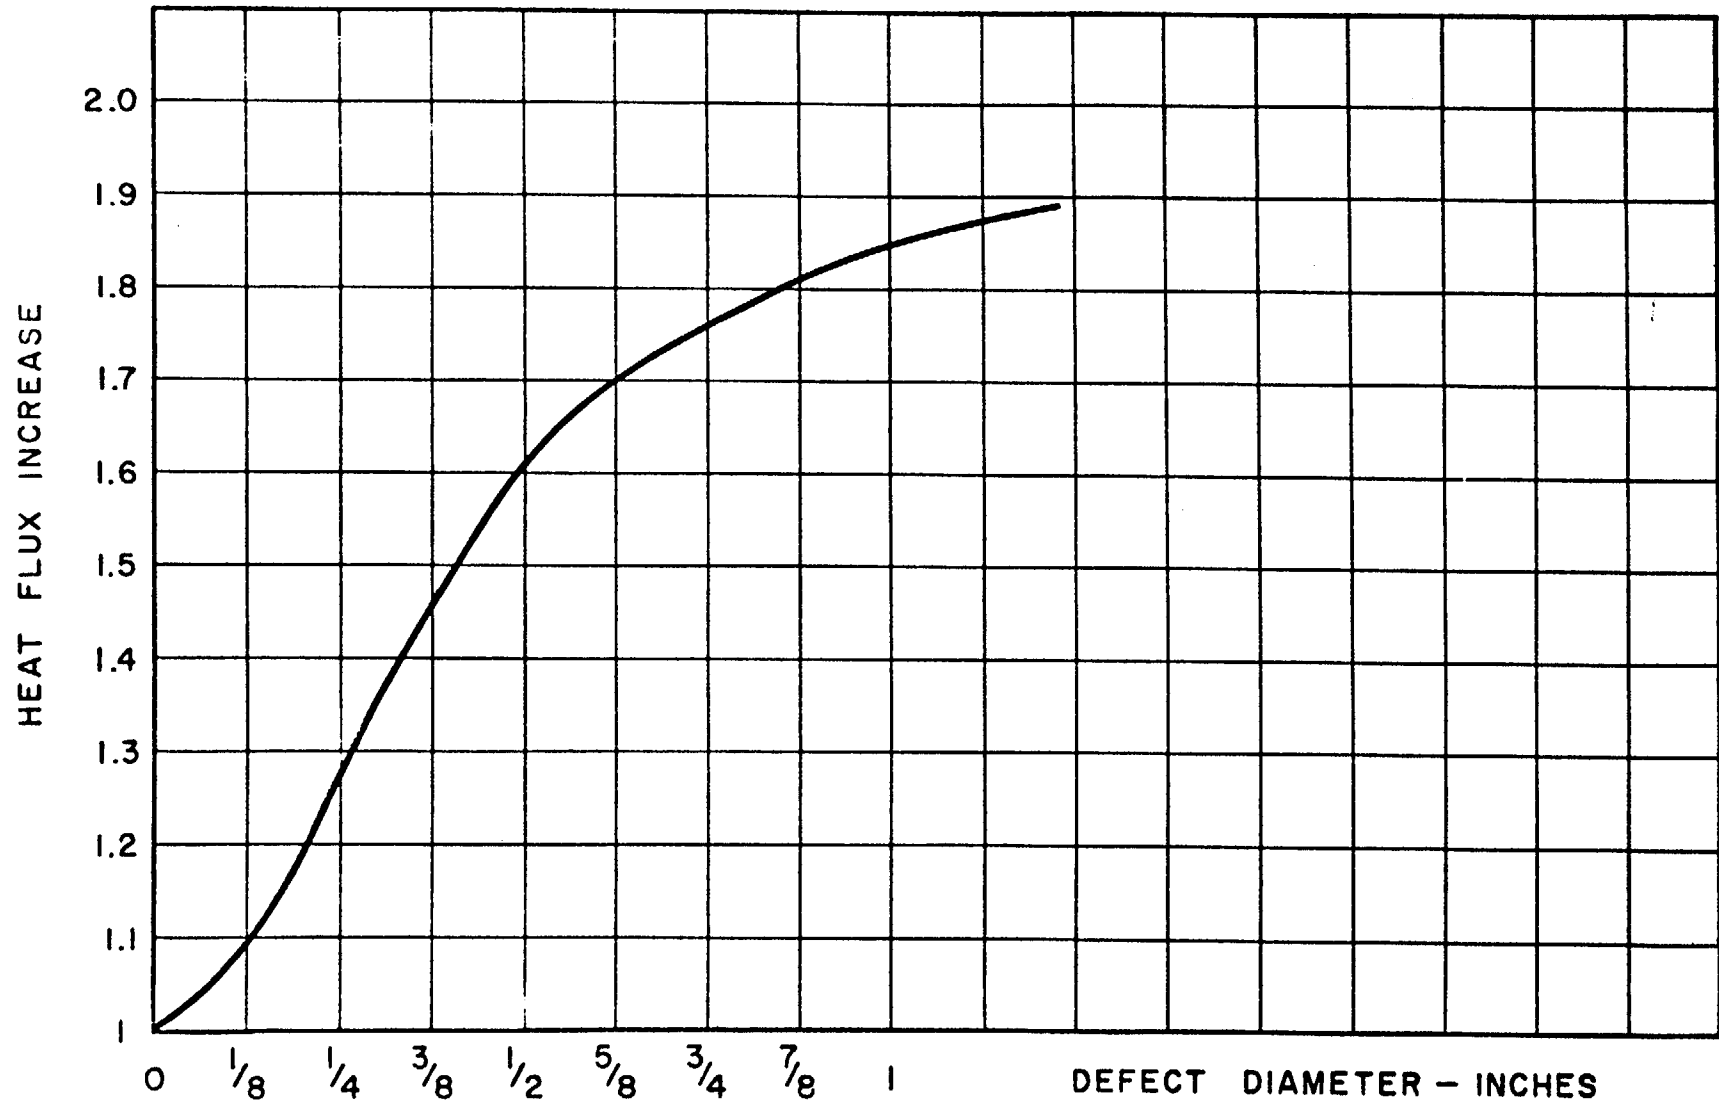
FIGURE 39

In an effort to determine what size defect might be acceptable, new heat transfer calculations were made by computing machine. The problem that was set up provided a temperature profile of an element section that contained thermal insulating voids of various sizes at the boundary of the meat and the cladding. The heat flux could then be obtained over any given surface area. The results of these calculations are shown in Figure 39 which indicates the relative increase in heat flux as a function of defect size. Illustratively, a 1/4-inch defect would create a hot spot increase of 28% and a 1/2-inch defect of 61%. It will be recognized that an infinite

DEFECT HOT CHANNEL FACTOR INCREASE
AS A FUNCTION OF DEFECT SIZE

defect in bonding on one side will produce a 100% increase in heat flux through the other side. Thus, for practical purposes, a 1-inch diameter defect may be regarded as infinite. Specifications for future new fuel will call for no defects greater than approximately 1/8-inch as determined by ultrasonic methods and thus providing only an approximate 10% increase in heat flux.

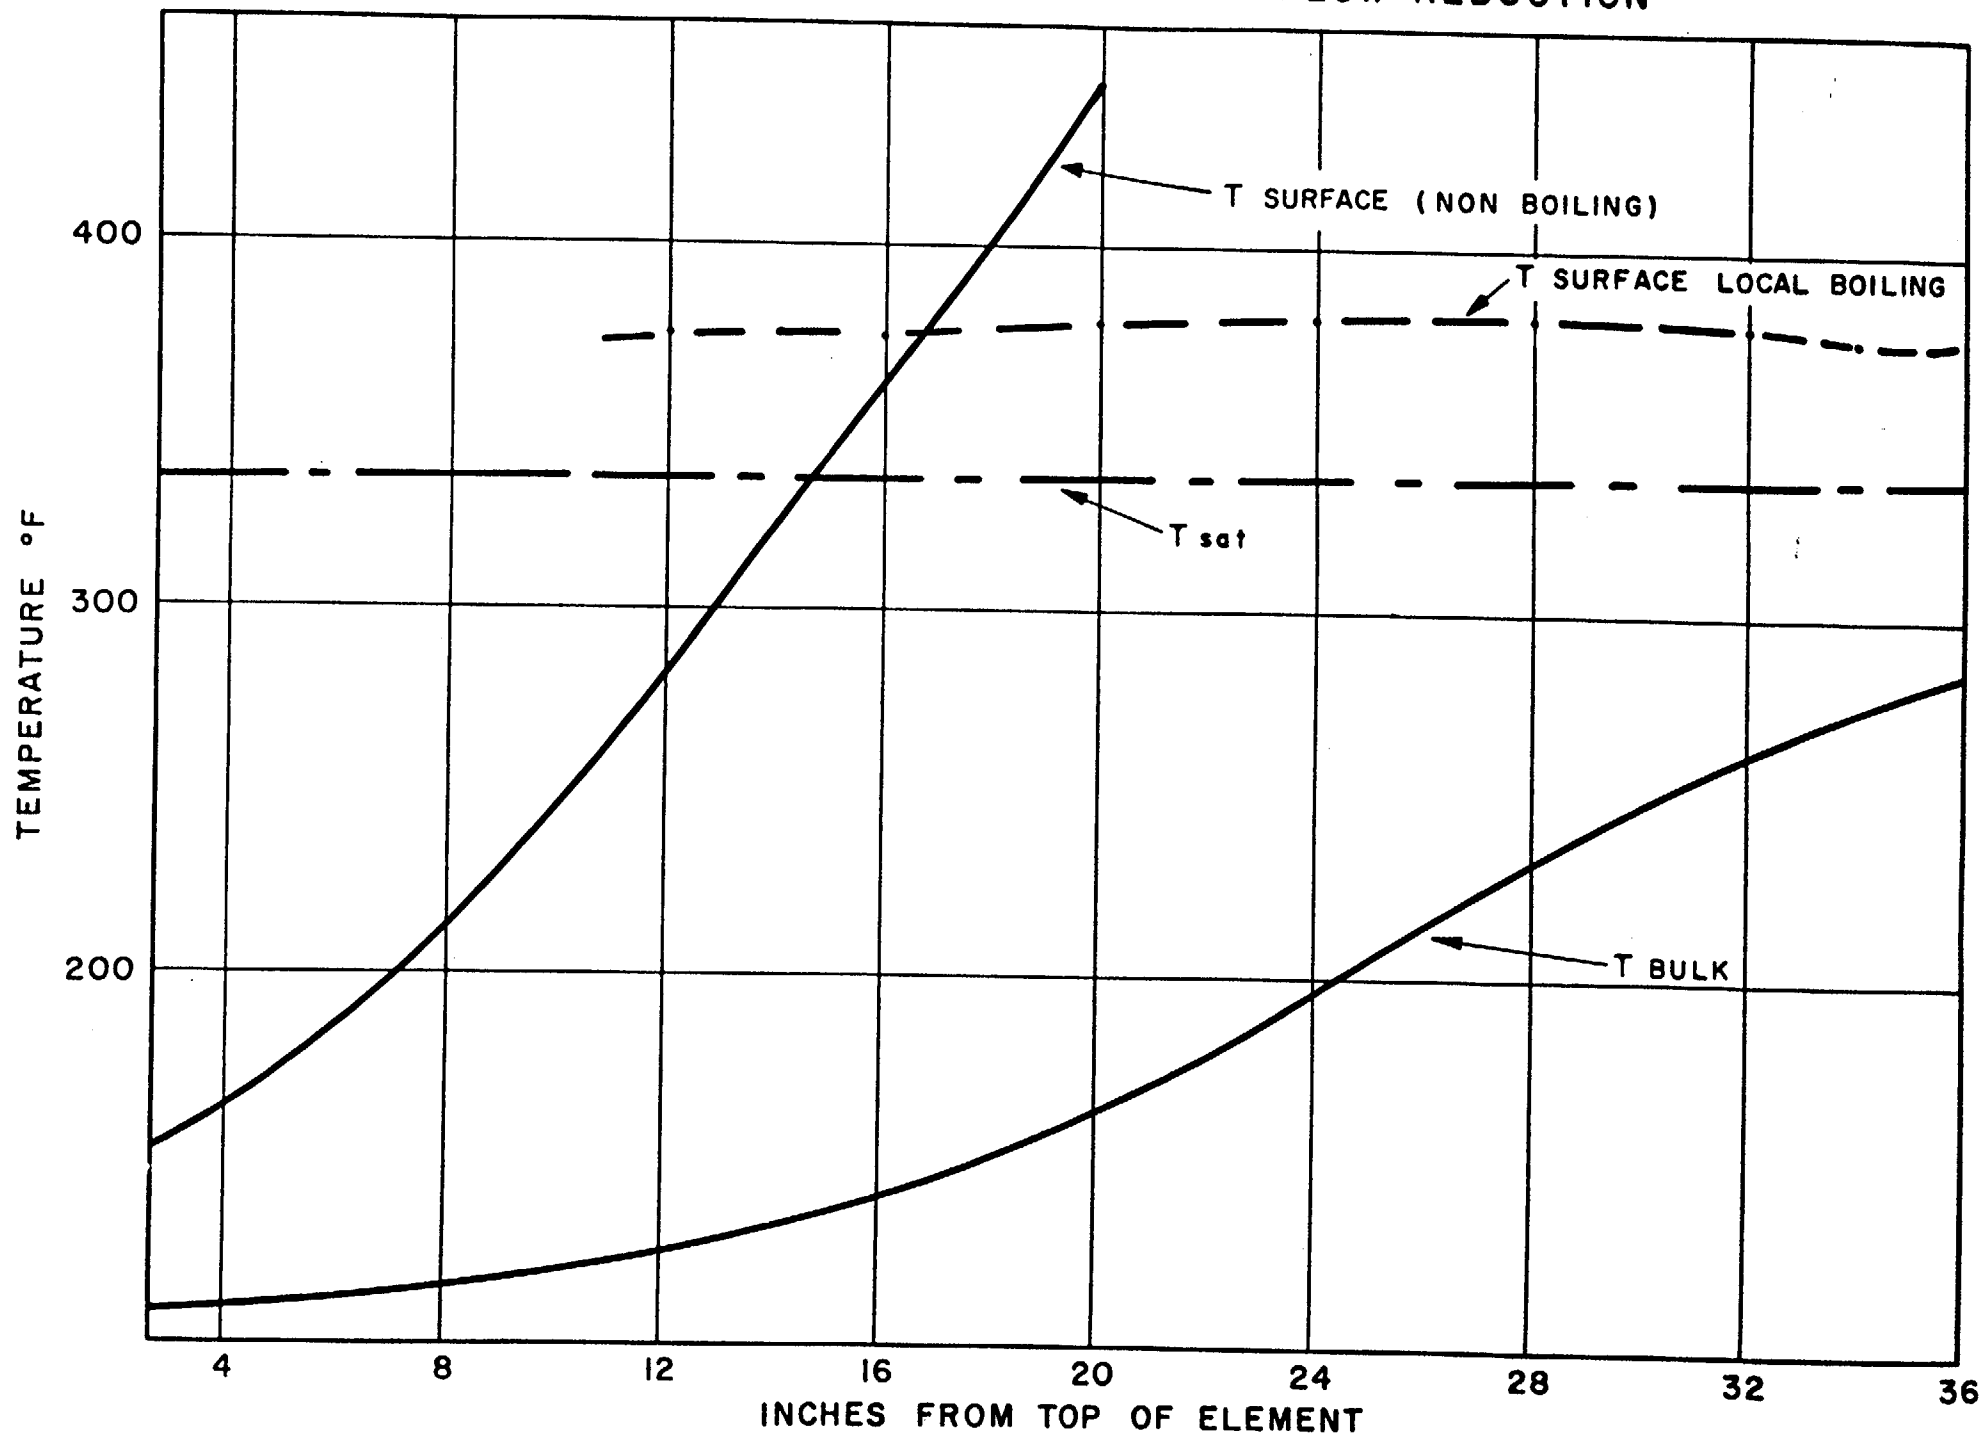
FIGURE 41

Figure 41 indicates the bulk coolant temperature and the fuel surface temperature for the hot channel with an assumed 15% additional

LOCAL BOILING ZONE WITH 15% FLOW REDUCTION

reduction of flow. The bulk coolant temperature rise increases to 170°F and the discharge temperature to 278°F. The hot channel factor for film temperature rise increases by 1.12.

Comparing Figure 41 with Figure 40 local boiling occurs over a greater length of the fuel element with the reduced flow. This creates an increase pressure drop whose effect is not considered significant. Using the data reported by J. B. Reynolds in ANL-5178, it can be shown that the increased pressure drop caused by local boiling is not adequate to account for even the assumed 15% reduction in flow. Additional flow restrictions must be postulated to produce a dangerous condition.
