Docket No. 50-331

Enclosed is a signed original of the "Order for Modification of License" issued by the Commission on May 21, 1975, for the Duane Arnold Energy Center. The Order added a provision to License No. DPR-49 stating that you shall not operate the facility at core power levels exceeding 50% of rated power or core flow rates exceeding 50% of design flow rate without prior written approval by the Director, Office of Nuclear Reactor Regulation. A copy of the Order is being filed with the Office of the Federal Register for publication.

RELATING TO
CHANNEL BOX WEAR
IN THE
VERMONT YANKEE NUCLEAR POWER STATION
(Docket 50-271)

AND THE
PILGRIM NUCLEAR POWER STATION
(Docket 50-293)

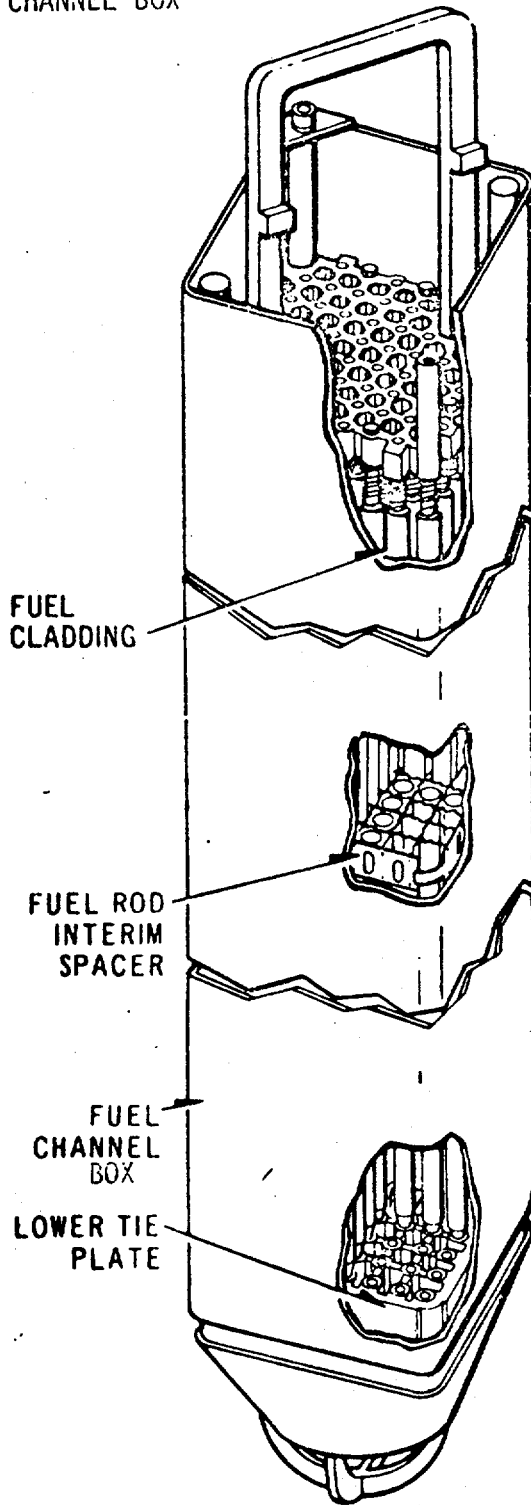
FUEL CHANNEL BOX

The fuel bundles of boiling water reactors are encased in square Zircaloy-4 tubes known as channel boxes (Fig. 1) which separate parallel coolant flow paths in the core, provide guide surfaces for the motion of control rods, and protect fuel bundles during handling. Each channel box slides over the surface (lower tie plate surface, Fig. 1) of a fitting which rests on the core support plate. The zone between the channel box assemblies is referred to as the bypass region and, in all boiling water reactors, contains the control rods and in-core instrumentation. In some facilities, the bypass region also contains temporary control curtains (Fig. 2), which are removed after initial operation of the first core and are used to provide supplemental control.
