## Insulation Resistance Measurement Results

NRC FORM 335 (2-89) NRCM 1102, 3201, 3202	U.S. NUCLEAR REGULATORY COMMISSION	<b>1. REPORT NUMBER</b> (Assigned by NRC, Add Vol., Supp. Rev., and Addendum Numbers, if any) <b>NUREG/CR- 6776</b> <b>SAND2002-0447P</b>				
<b>2. TITLE AND SUBTITLE</b>  <b>Cable Insulation Resistance Measurements Made During Cable Fire Tests</b>		<b>3. DATE REPORT PUBLISHED</b>				
		<table border="1" style="width: 100%;"> <tr> <td style="width: 50%;">MONTH</td> <td style="width: 50%;">YEAR</td> </tr> <tr> <td>June</td> <td>2002</td> </tr> </table>	MONTH	YEAR	June	2002
		MONTH	YEAR			
June	2002					
<b>4. FIN OR GRANT NUMBER</b>  <b>Y6037</b>						
<b>5. AUTHOR(S)</b>  <b>Francis J. Wyant</b> <b>Steven P. Nowlen</b>	<b>6. TYPE OF REPORT</b>  <b>Technical</b>					
	<b>7. PERIOD COVERED (inclusive Dates)</b>					
<b>8. PERFORMING ORGANIZATION -- NAME AND ADDRESS</b> (If NRC, provide Division, Office or Region, U.S. Nuclear Regulatory Commission, and mailing address, if contractor, provide name and mailing address)  <b>Sandia National Laboratories</b> <b>P.O. Box 5800</b> <b>Albuquerque, NM 87185-0744</b>						
<b>9. SPONSORING ORGANIZATION -- NAME AND ADDRESS<

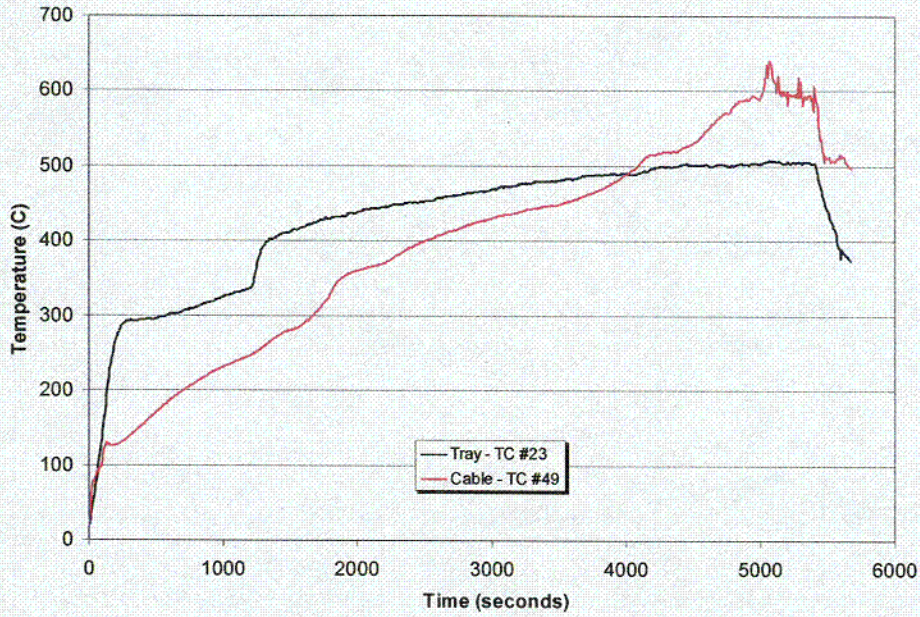
Figure 5-39 shows the time-temperature plots for two of the thermocouples monitored during the test. TC #23 was mounted on a tray rung at the top of the tray, and TC #49 was located at 15 cm (6 in.) from the bottom of the instrumented cable TC-4. These two thermocouples were chosen because they showed the worst-case temperature exposure conditions (highest recorded temperatures) for the air near the IR bundle and for the instrumented cable closest to the IR bundle. The peak tray temperature recorded was 508°C (946°F), whereas the peak cable temperature indication reached as high as 641°C (1186°F) at one point during the test.

Figure 5-39. Representative tray and TC-4 cable temperatures recorded during Test 10.

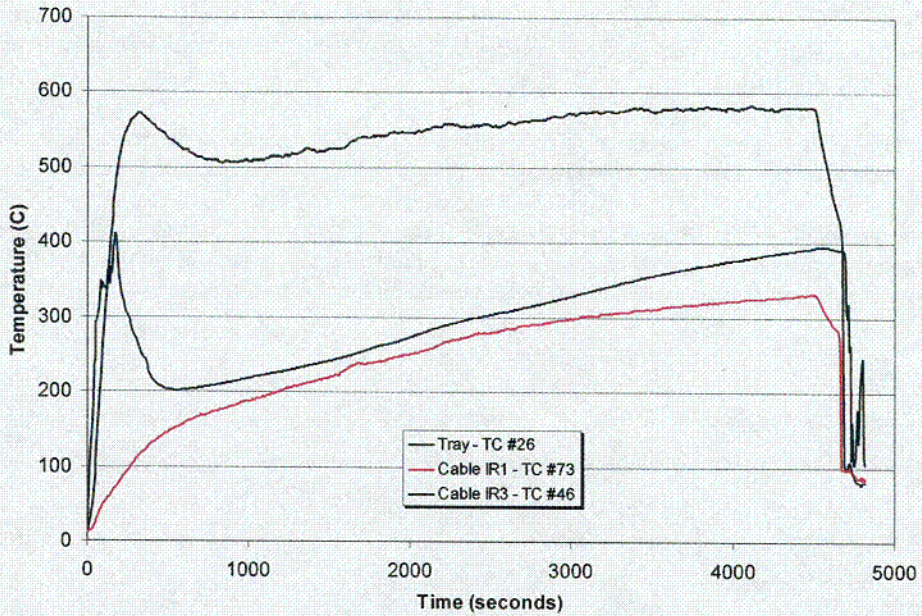
Figure 5-42 shows the time-temperature plots for three of the thermocouples monitored during the test. TC #26 was mounted on a tray rung at the corner of the tray, TC #73 was located about the mid-position on the instrumented cable TC-4, and TC #46 was located about the mid-position on the instrumented cable TC-1. These

Figure 5-42. Representative tray and cable (TC-1 and TC-4) temperatures recorded during Test 11.

thermocouples were chosen because they showed the worst-case temperature exposure conditions (highest recorded temperatures) for the air near the IR bundle and for the instrumented cable closest to the IR bundle. Peak tray temperature was 584°C (1083°F), peak TC-1 cable temperature was 412°C (774°F), and the peak TC-4 cable temperature was 333°C (631°F).

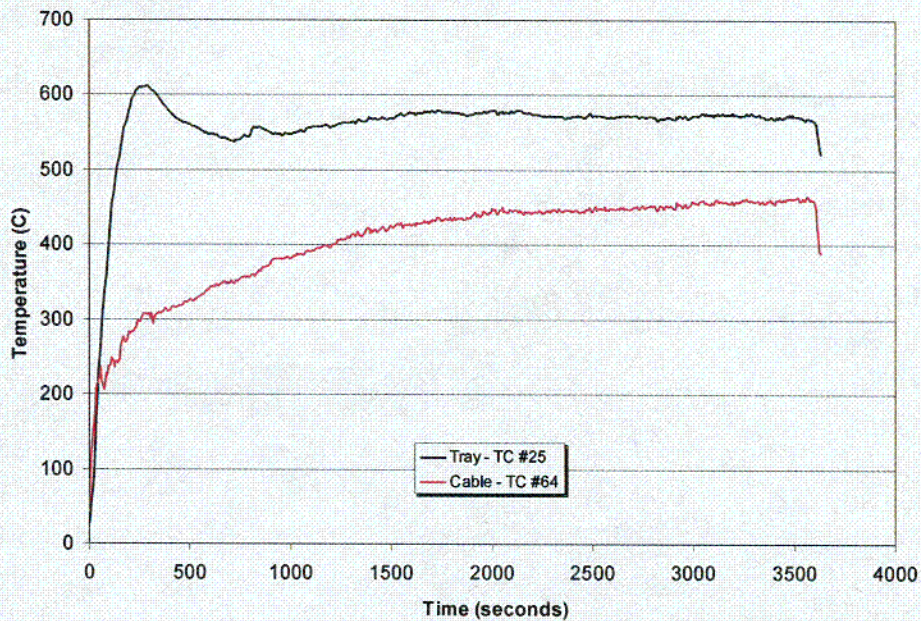
Figure 5-46 shows the time-temperature plots for two of the thermocouples monitored during the test. These two thermocouples were chosen because they showed the worst-case temperature exposure conditions (highest recorded temperatures) for the air near the IR bundle and for the instrumented cable closest to the IR bundle. TC #25 was mounted on a rung of the tray near the corner, and TC #64 was located about mid-way along the instrumented cable TC-3. The peak tray temperature was 611°C (1132°F) and then dropped and stabilized at 573°C (1063°F). The peak cable temperature was 465°C (869°F).

Figure 5-46. Representative tray and TC-3 cable temperatures recorded during Test 12

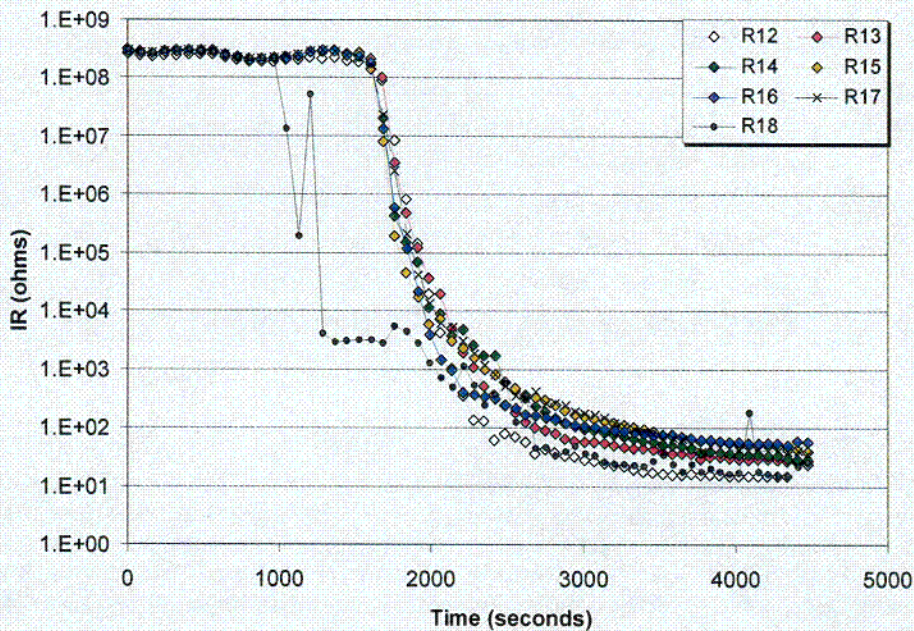
As Figure 5-47 shows, the change in IR occurring between Conductor 1 and the other conductors in the cable bundle was a fairly smooth transition from  $\sim 3 \times 10^8$  down to  $\sim 30 \Omega$  beginning at  $\sim 1700$  seconds and continuing throughout the rest of the test run. Conductor 1 was the center conductor in the seven-conductor cable and Conductors 2 through 7 surrounded Conductor 1 and were immediately adjacent to it. Conductor 8 was comprised of the ganged-together set of three single conductor cables bundled with the seven-conductor cable to make up the IR bundle.

Table 5-6 summarizes the conductor failure modes and times for Test 12. All of the initial failures observed involved the conductors shorting to ground. Initially, at about 1000 seconds, Conductor 8 (the three external conductors as a gang) shorts to ground. This short-to-ground failure is also manifested by the apparent reduction in IR between Conductor 8 and the other conductors in the cable bundle. A second ground short involving Conductor 3 is observed at about 1900 seconds. Over the period of 2200 to 3500 seconds, the rest of the conductors short to ground.

Figure 5-47. Representative conductor-to-conductor IRs obtained during Test 12. This plot shows the IR between Conductor 1 and the other seven conductors in the IR cable bundle.

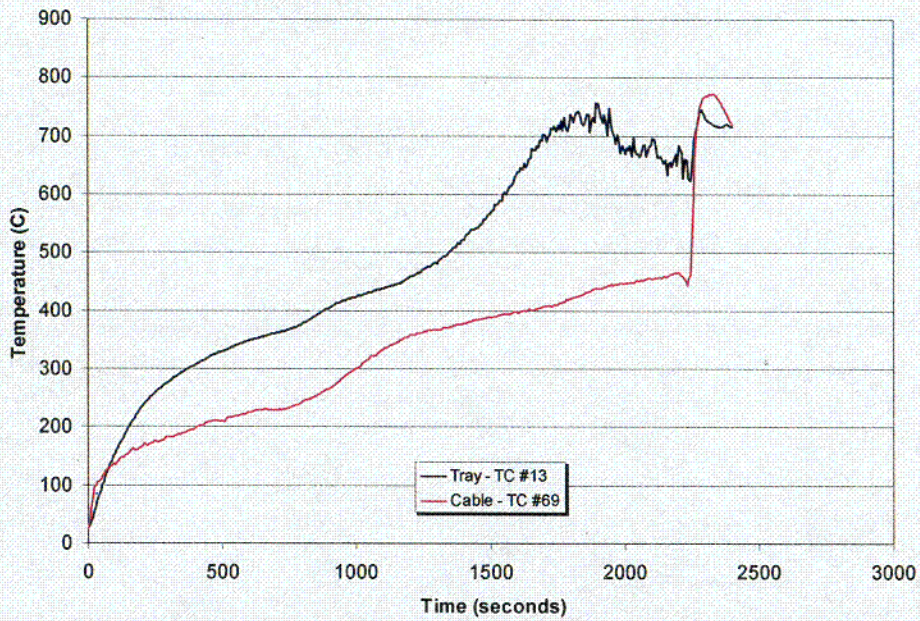
shows the time-temperature plots for two of the thermocouples monitored during the test. TC #13 was mounted on the tray's side rail about 0.6 m (2 ft) from the corner of the tray, and TC #69 was located at the test cell doorway end of the instrumented cable TC-4. These two thermocouples were chosen because they showed the worst-case temperature exposure conditions (highest recorded temperatures) for the air near the IR cable and for the instrumented cable closest to the IR bundle. The peak tray temperature recorded during this test was 756°C (1393°F) and the cable temperature peaked at 772°C (1422°F) near the end of the run.

Figure 5-50. Representative tray and TC-4 cable temperatures recorded during Test 13.

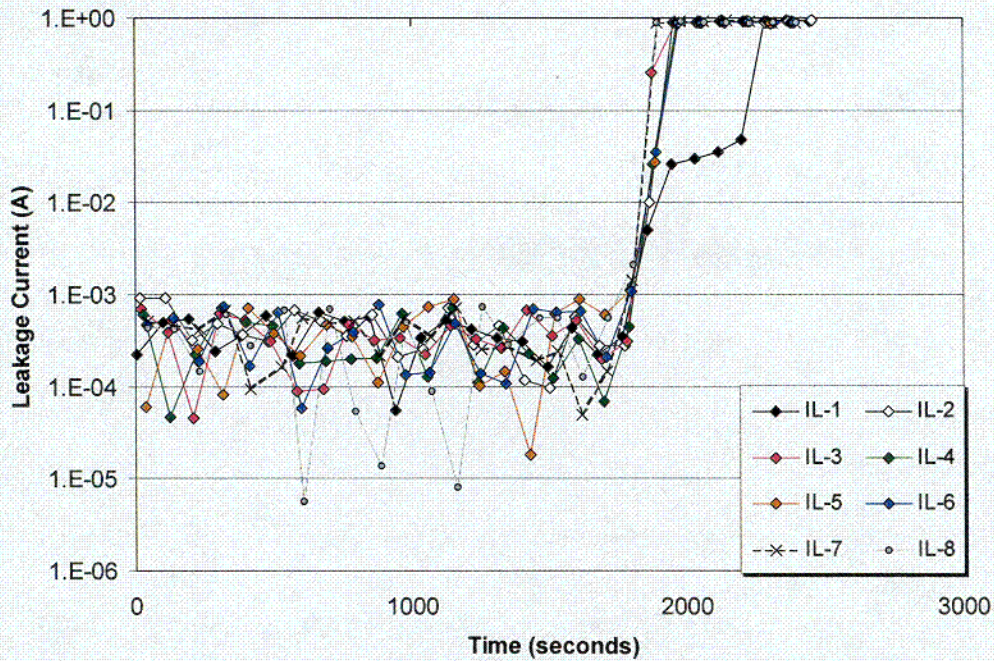
As noted previously, the IR measurement system was only capable of determining total IR to ground due to a wiring problem during Test 13. Figure 5-51 shows the time-dependent change in the total IR for each of the eight conductors in the IR cable measured during this test. The fact that the IR values fall to very low levels (<100 Ω) beginning at about 1900 seconds indicates that conductor failures have occurred. Figure 5-52 shows the associated leakage currents.

Figure 5-52. Total leakage currents resulting from IR changes for each conductor during Test 13.

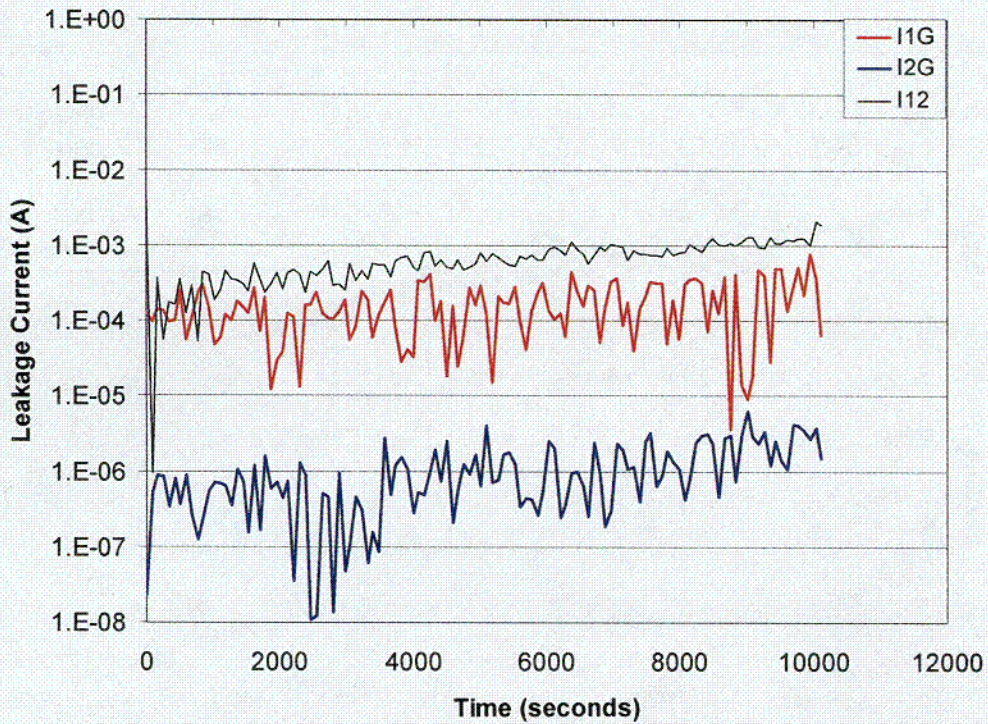
Figure 5-54 shows the values of IR between each of the IR cable conductors to ground recorded during Test 14. This figure also shows that the IRs to ground decreased very slightly during the test. Figure 5-55 presents the change in leakage current for Conductors 1 and 2 occurring during Test 14.

Based solely on the results of the IR measurements made during Test 14, it appears that the IR cable experienced virtually no damage and would not have caused any device actuation or blown fuses.

Figure 5-55. Leakage currents resulting from IR changes in Conductors 1 and 2 during Test 14.

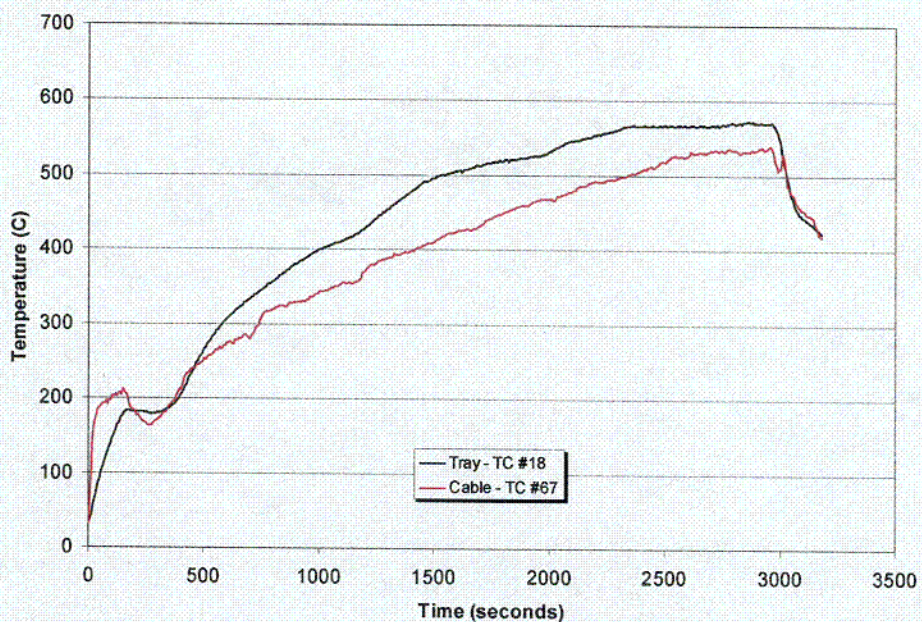
Figure 5-56 shows the time-temperature plots for two of the thermocouples monitored during the test. TC #18 was mounted on the tray's side rail about 0.6 m (2 ft) from the end of the tray closest to the doorway, and TC #67 was located 0.6 m (2 ft) from the end of the of the instrumented cable TC-3 that ran parallel to the back wall of the test cell. These two thermocouples were chosen because they showed the worst-case temperature exposure conditions (highest recorded temperatures) for the air near the IR cable and for the instrumented cable closest to the IR bundle. The peak tray temperature recorded during this test was 573°C (1063°F) and the cable temperature was 540°C (1004°F).

Figure 5-56. Representative tray and TC-3 cable temperatures recorded during Test 15.

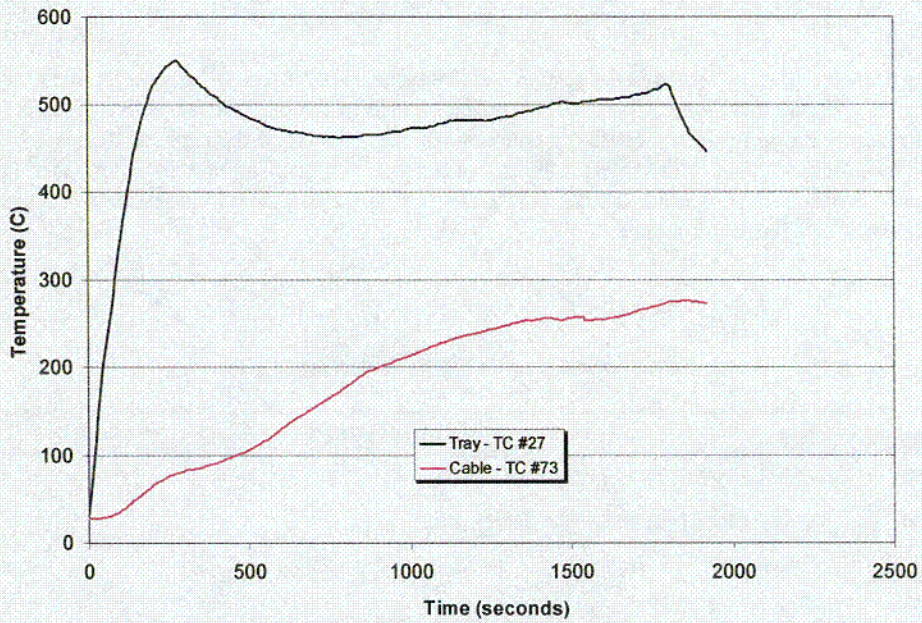
Figure 5-59 shows the time-temperature plots for two of the thermocouples monitored during the test. TC #27 was mounted on a tray rung at the corner of the tray, and TC #73 was located at the mid-point of the instrumented cable TC-4. These two thermocouples were chosen because they showed the worst-case temperature exposure conditions (highest recorded temperatures) for the air near the IR cable and for the instrumented cable closest to the IR bundle. The peak tray temperature recorded during this test was 550°C (1022°F) and the cable temperature was 276°C (529°F).

Figure 5-59. Representative tray and TC-4 cable temperatures recorded during Test 16.

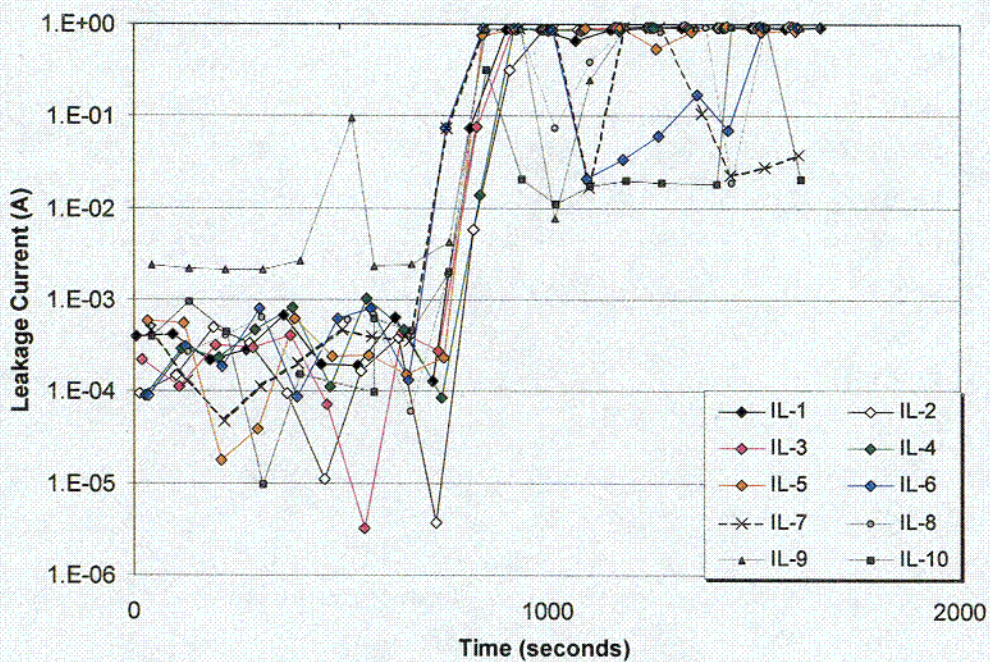
As previously mentioned, the IR measurement system was only capable of determining total IR due to a wiring problem during Test 16. Figure 5-60 shows the time-dependent change in the total IR for each of the 10 conductors in the IR cable measured during this test. Table 5-8 summarizes the behavior of the cable in the test. While some of the conductor IRs increase again (~1000  $\Omega$ ) near the end of the test, it is believed that all experienced failure and the apparent recovery was due more to noise than to real healing. Figure 5-61 shows the resulting leakage currents allowed by the change in IR for each conductor.

Figure 5-61. Total leakage currents resulting from IR changes for each conductor during Test 16.

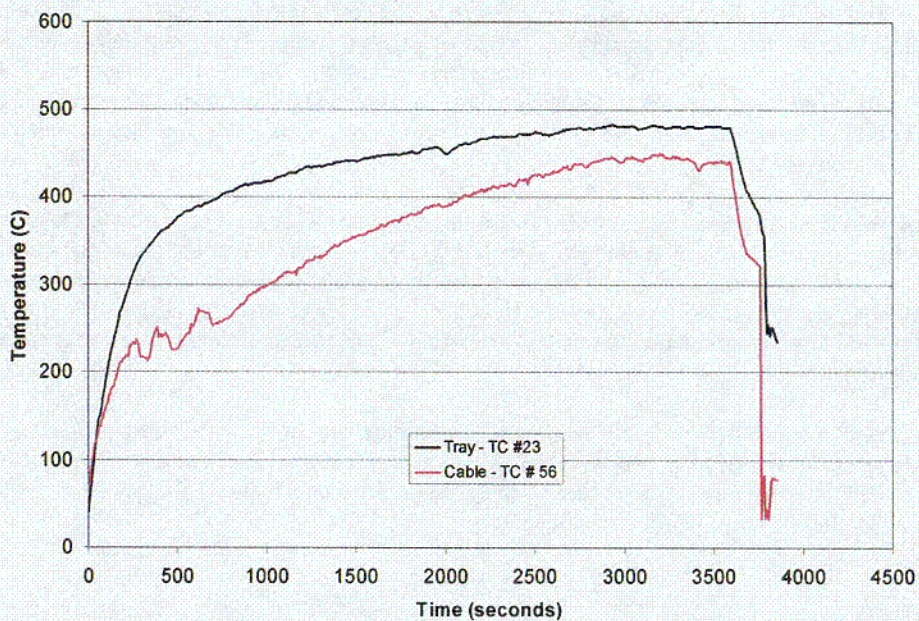
Figure 5-62 shows the time-temperature plots for two of the thermocouples monitored during the test. TC #23 was mounted on a tray rung at the top of the vertical tray, and TC #56 was located at the top of the instrumented cable TC-4. These two thermocouples were chosen because they showed the worst-case temperature exposure conditions (highest recorded temperatures) for the air near the IR cable and for the instrumented cable closest to the IR bundle. The peak tray temperature recorded during this test was 482°C (900°F) and the peak cable temperature was 449°C (840°F).

Figure 5-62. Representative tray and TC-4 cable temperatures recorded during Test 17.

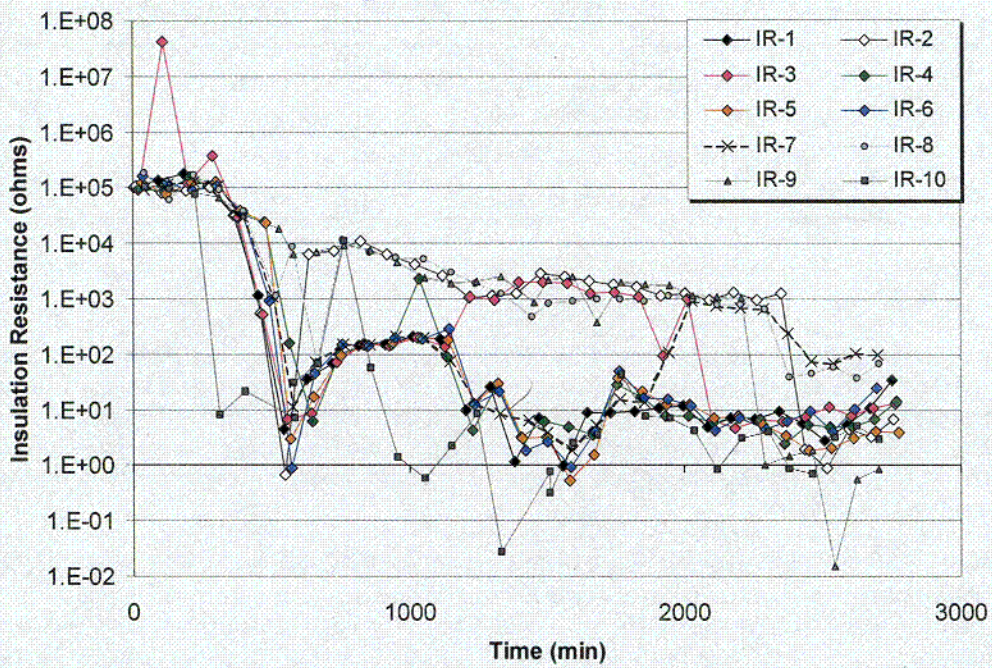
Again, the IR measurement system was only capable of determining total IR due to a wiring problem during Test 17. Figure 5-63 shows the time-dependent change in the total IR for each of the 10 conductors in the IR cable measured during this test. Table 5-9 summarizes the behavior of the cable in the test. Figure 5-64 shows the resulting leakage currents allowed by the change in IR for each conductor.

Figure 5-63. Total IR of each conductor recorded during Test 17.

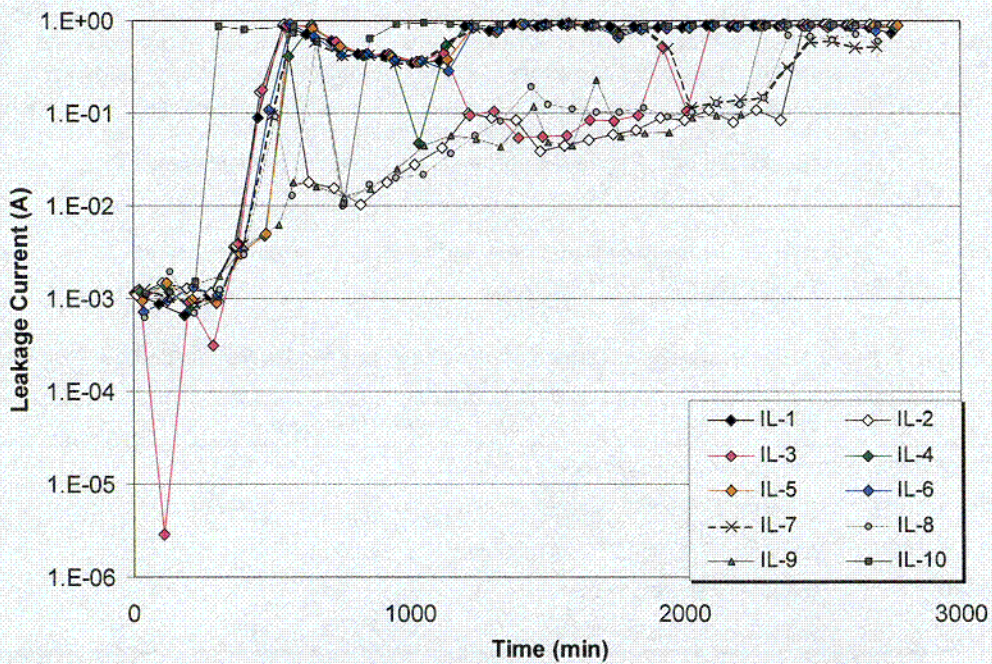
Figure 5-64. Total leakage currents resulting from IR changes for each conductor during Test 17.

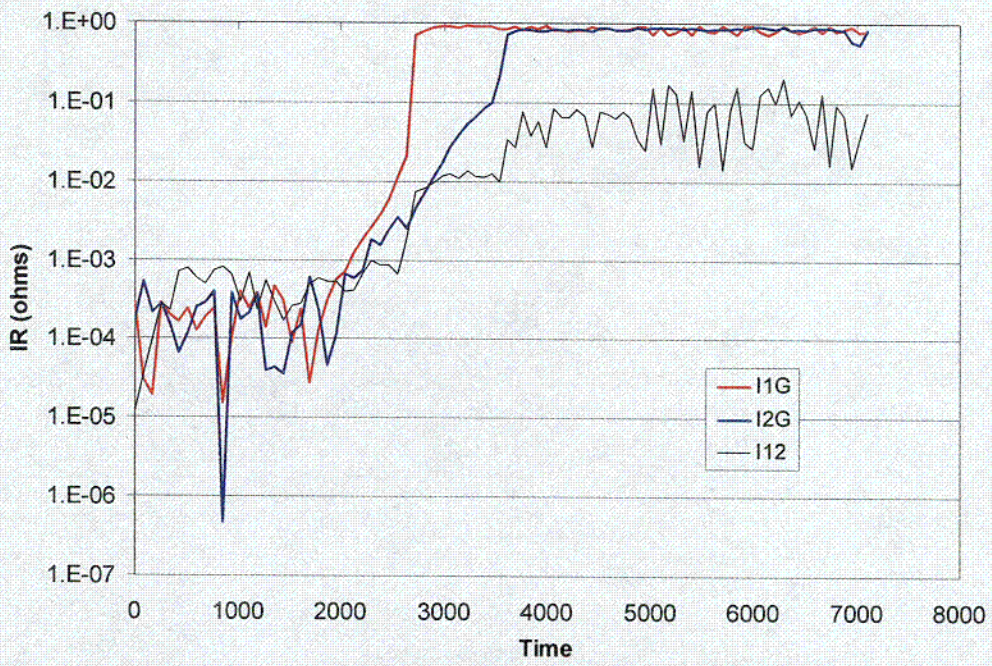
Figure 5-66 shows the IR values between each of the IR cable conductors and ground recorded during Test 18. This figure shows a relatively gradual decline in IRs to ground from ~ $10^6$  down to ~3000  $\Omega$  over the period 1500 to 2500 seconds. The almost simultaneous failure of Conductors 1, 3, and 9 followed this. The next conductor to fail was Conductor 7 at ~ 2900 seconds, then Conductors 8 and 4 failed. Conductors 5, 2, and 6 eventually failed during the course of the test. All conductors shorted to ground before interacting with any other conductor. Table 5-10 provides a summary of the conductor failures. Figure 5-67 presents the change in leakage current for Conductors 1 and 2 occurring during Test 18.

Figure 5-67. Leakage currents resulting from IR changes in Conductors 1 and 2 during Test 18.

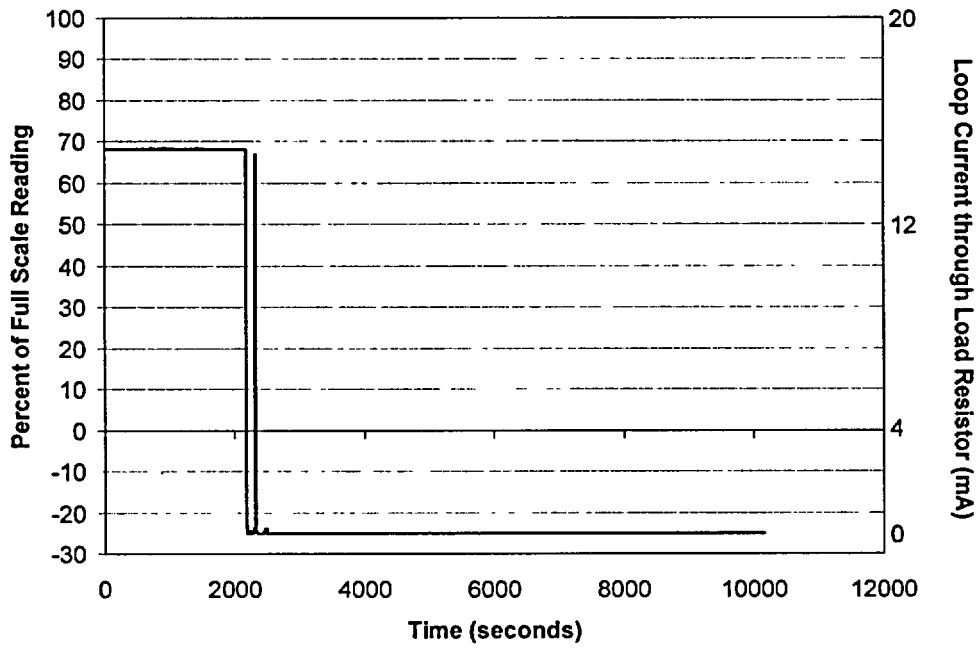
Figure 6-3 presents the current loop data obtained during Test 14. The cable used was a two-conductor thermoplastic instrumentation cable routed in conduit and exposed to the plume of a 145-kW flame. As shown in the figure, the output signal remains at 68% until ~2225 seconds, whereupon the signal is abruptly lost. The signal briefly recovers to ~67% and is lost again for the remainder of the test.

Figure 6-3. Current loop data obtained during Test 14.
