Insulation Resistance Measurement Results

5.3.2 Test 10

6. CURRENT LOOP DATA AND RESULTS

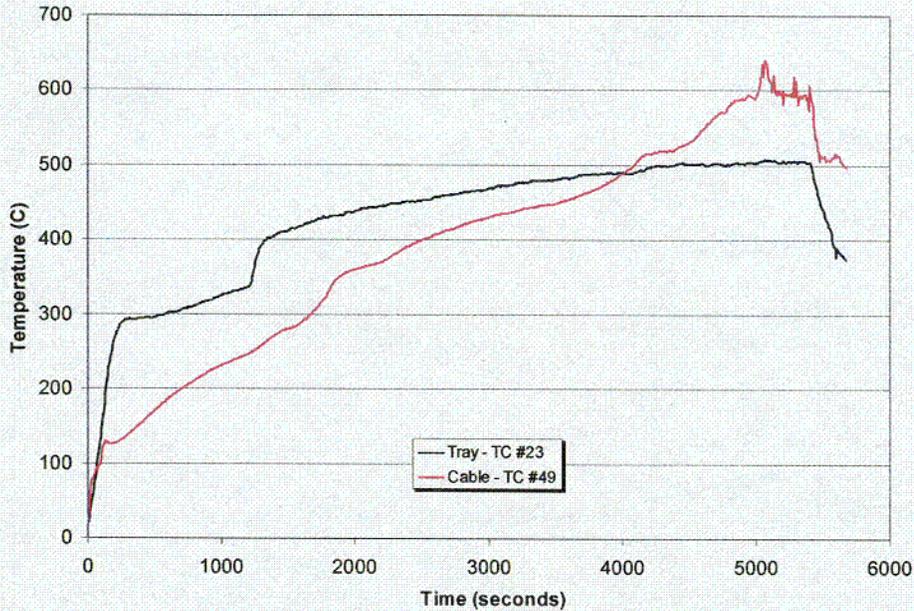
Figure 5-39 shows the time-temperature plots for two of the thermocouples monitored during the test. TC #23 was mounted on a tray rung at the top of the tray, and TC #49 was located at 15 cm (6 in.) from the bottom of the instrumented cable TC-4. These two thermocouples were chosen because they showed the worst-case temperature exposure conditions (highest recorded temperatures) for the air near the IR bundle and for the instrumented cable closest to the IR bundle. The peak tray temperature recorded was 508°C (946°F), whereas the peak cable temperature indication reached as high as 641°C (1186°F) at one point during the test.

Figure 5-39. Representative tray and TC-4 cable temperatures recorded during Test 10.

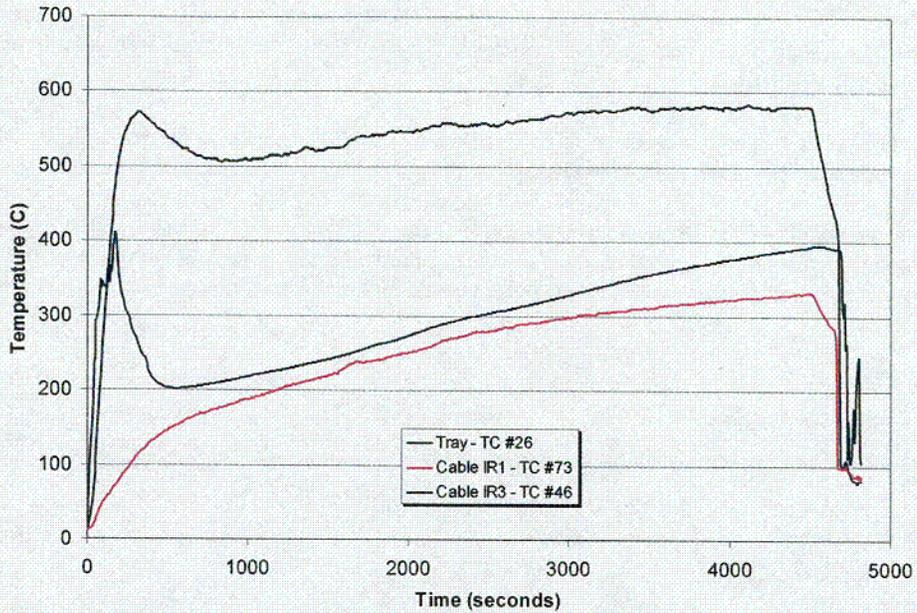
Figure 5-42 shows the time-temperature plots for three of the thermocouples monitored during the test. TC #26 was mounted on a tray rung at the corner of the tray, TC #73 was located about the mid-position on the instrumented cable TC-4, and TC #46 was located about the mid-position on the instrumented cable TC-1. These

Figure 5-42. Representative tray and cable (TC-1 and TC-4) temperatures recorded during Test 11.

thermocouples were chosen because they showed the worst-case temperature exposure conditions (highest recorded temperatures) for the air near the IR bundle and for the instrumented cable closest to the IR bundle. Peak tray temperature was 584°C (1083°F), peak TC-1 cable temperature was 412°C (774°F), and the peak TC-4 cable temperature was 333°C (631°F).

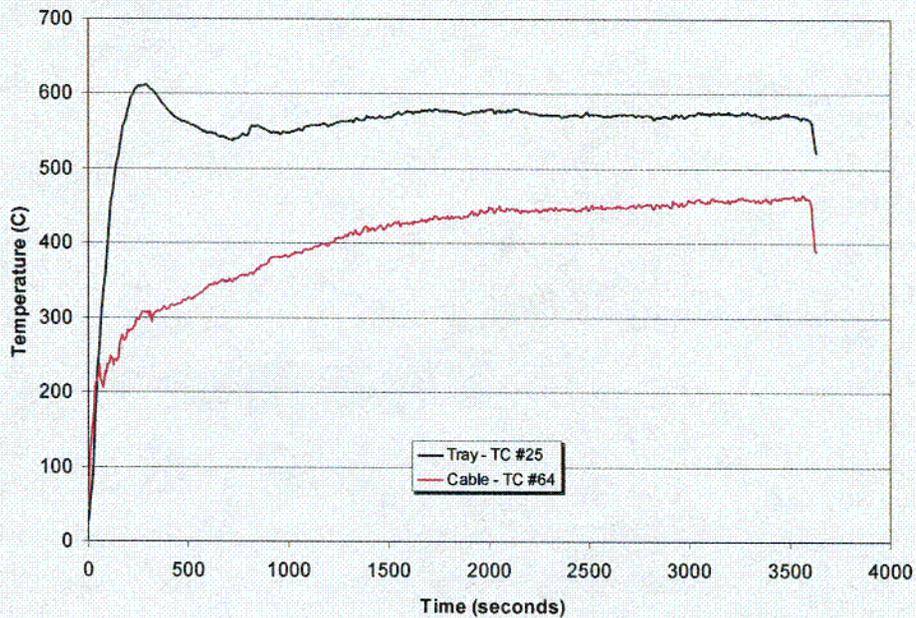
Figure 5-46 shows the time-temperature plots for two of the thermocouples monitored during the test. These two thermocouples were chosen because they showed the worst-case temperature exposure conditions (highest recorded temperatures) for the air near the IR bundle and for the instrumented cable closest to the IR bundle. TC #25 was mounted on a rung of the tray near the corner, and TC #64 was located about mid-way along the instrumented cable TC-3. The peak tray temperature was 611°C (1132°F) and then dropped and stabilized at 573°C (1063°F). The peak cable temperature was 465°C (869°F).

Figure 5-46. Representative tray and TC-3 cable temperatures recorded during Test 12

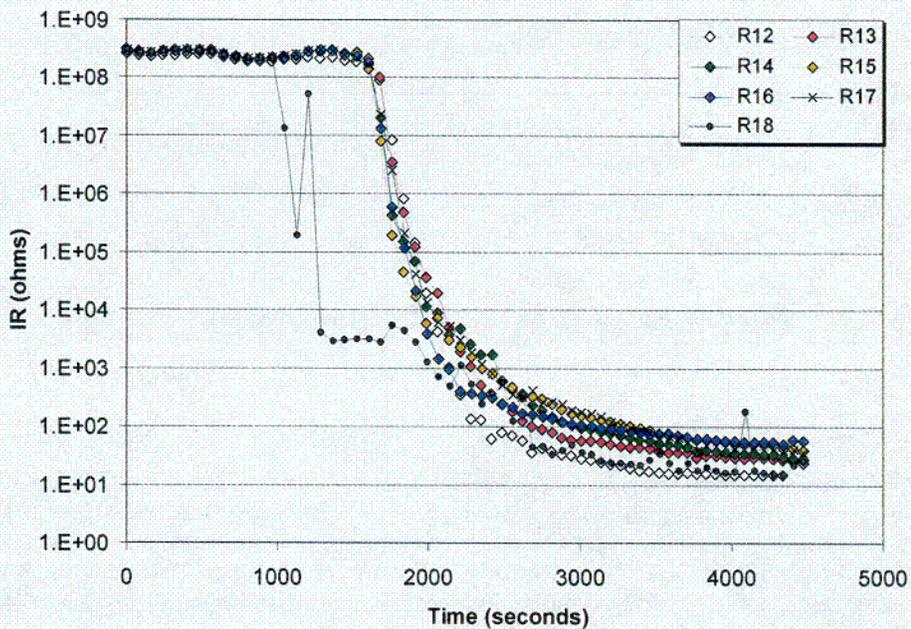
As Figure 5-47 shows, the change in IR occurring between Conductor 1 and the other conductors in the cable bundle was a fairly smooth transition from $\sim 3 \times 10^8$ down to $\sim 30 \Omega$ beginning at ~ 1700 seconds and continuing throughout the rest of the test run. Conductor 1 was the center conductor in the seven-conductor cable and Conductors 2 through 7 surrounded Conductor 1 and were immediately adjacent to it. Conductor 8 was comprised of the ganged-together set of three single conductor cables bundled with the seven-conductor cable to make up the IR bundle.

Figure 5-47. Representative conductor-to-conductor IRs obtained during Test 12. This plot shows the IR between Conductor 1 and the other seven conductors in the IR cable bundle.

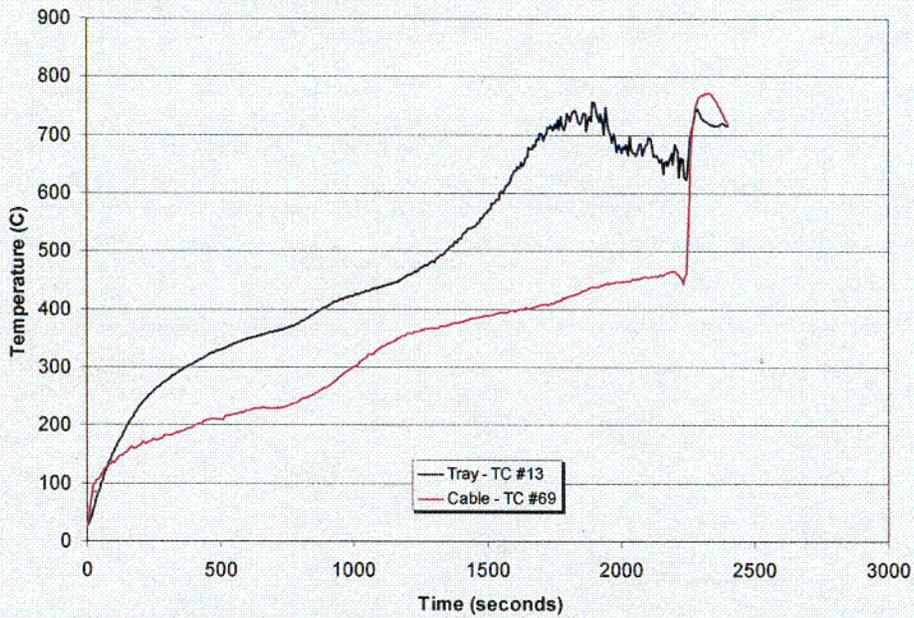
shows the time-temperature plots for two of the thermocouples monitored during the test. TC #13 was mounted on the tray's side rail about 0.6 m (2 ft) from the corner of the tray, and TC #69 was located at the test cell doorway end of the instrumented cable TC-4. These two thermocouples were chosen because they showed the worst-case temperature exposure conditions (highest recorded temperatures) for the air near the IR cable and for the instrumented cable closest to the IR bundle. The peak tray temperature recorded during this test was 756°C (1393°F) and the cable temperature peaked at 772°C (1422°F) near the end of the run.

Figure 5-50. Representative tray and TC-4 cable temperatures recorded during Test 13.

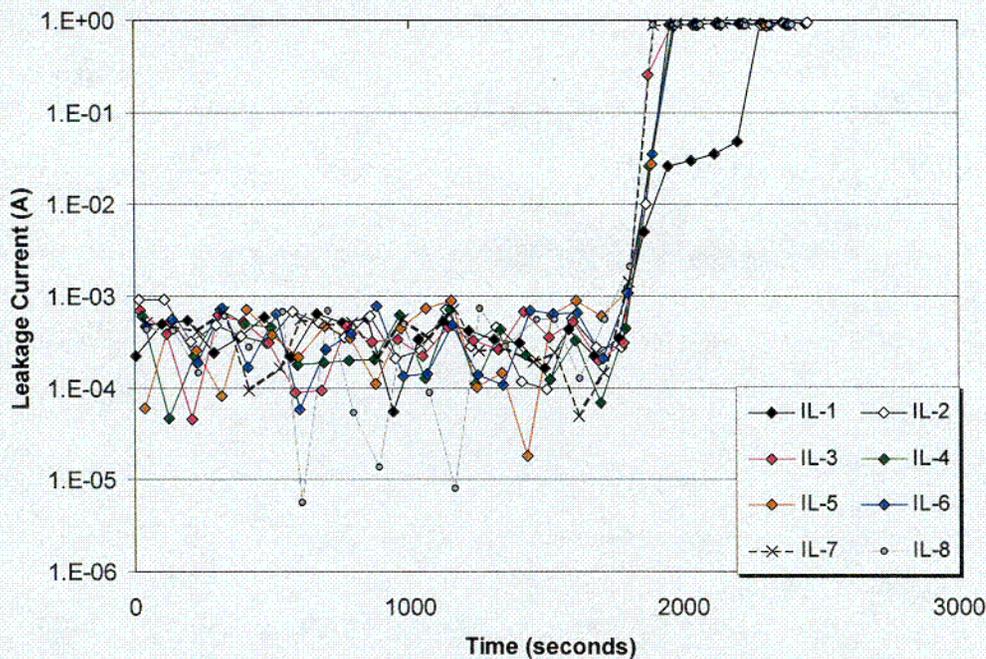
As noted previously, the IR measurement system was only capable of determining total IR to ground due to a wiring problem during Test 13. Figure 5-51 shows the time-dependent change in the total IR for each of the eight conductors in the IR cable measured during this test. The fact that the IR values fall to very low levels (<100 Ω) beginning at about 1900 seconds indicates that conductor failures have occurred. Figure 5-52 shows the associated leakage currents.

Figure 5-52. Total leakage currents resulting from IR changes for each conductor during Test 13.

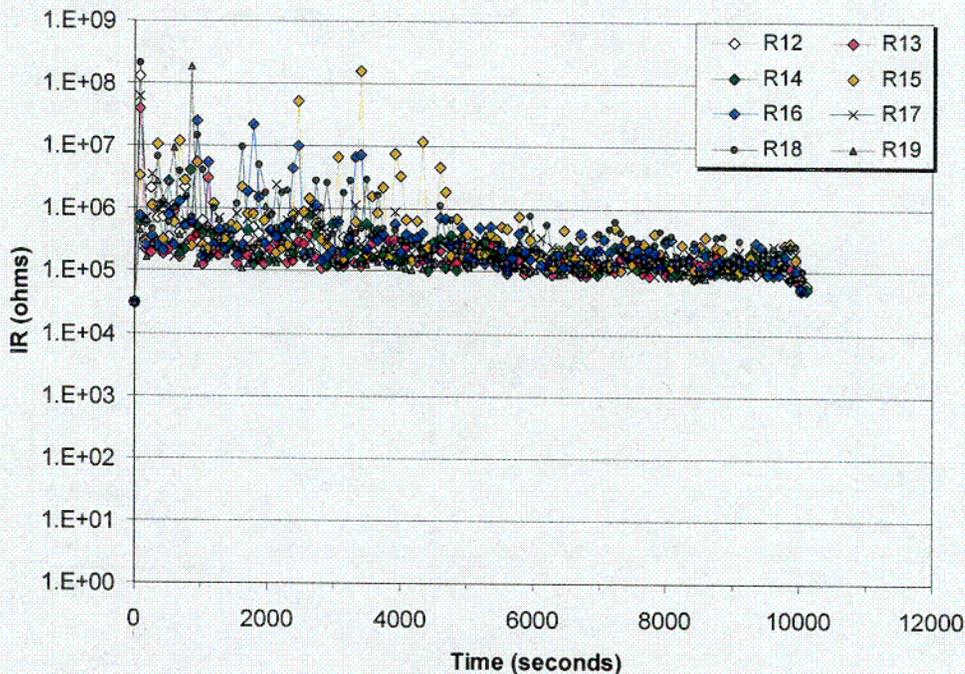
No thermocouple-instrumented cable was routed in the conduit during this test; hence, there is no cable temperature data available. In addition, no direct measure of conduit temperature was made either. However, no failures of the IR cable bundle were identified based on the results of this test. Figure 5-53 shows a plot of the IRs between Conductor 1 and the other conductors in the IR bundle. Conductors 1 through 3 were enclosed in one of the three-conductor cables of the IR bundle, Conductors 4 through 6 were in a second cable, and Conductors 7 through 9 formed the third cable. As shown in the figure, the IRs declined very little over the course of the test run.

Figure 5-53. Representative conductor-to-conductor IRs obtained during Test 14.

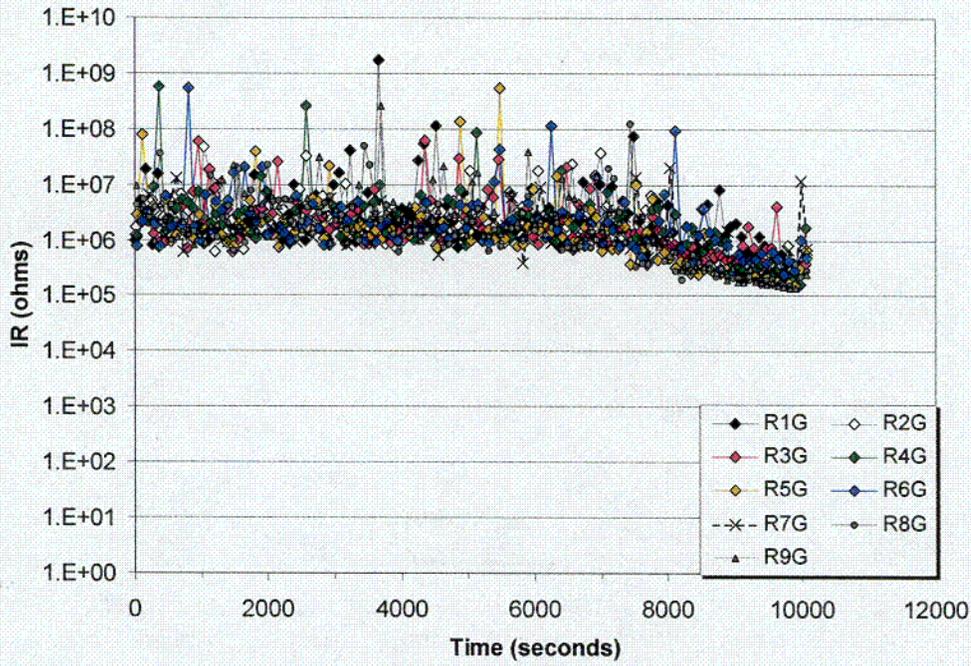
Figure 5-54 shows the values of IR between each of the IR cable conductors to ground recorded during Test 14. This figure also shows that the IRs to ground decreased very slightly during the test. Figure 5-55 presents the change in leakage current for Conductors 1 and 2 occurring during Test 14.

Figure 5-54. Conductor-to-ground IRs obtained during Test 14.

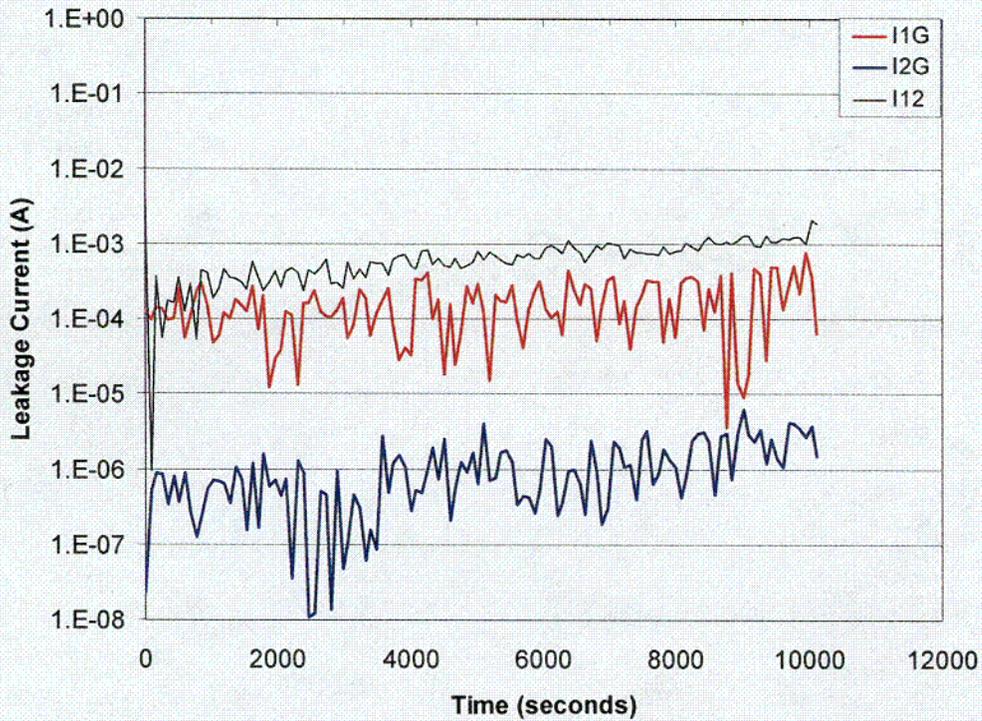
Figure 5-55. Leakage currents resulting from IR changes in Conductors 1 and 2 during Test 14.

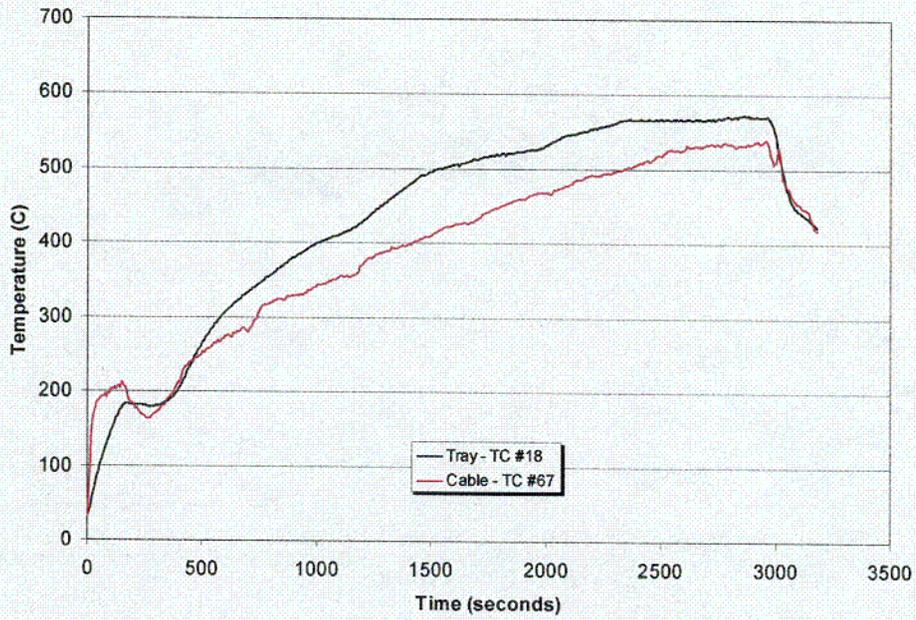
Figure 5-56 shows the time-temperature plots for two of the thermocouples monitored during the test. TC #18 was mounted on the tray's side rail about 0.6 m (2 ft) from the end of the tray closest to the doorway, and TC #67 was located 0.6 m (2 ft) from the end of the of the instrumented cable TC-3 that ran parallel to the back wall of the test cell. These two thermocouples were chosen because they showed the worst-case temperature exposure conditions (highest recorded temperatures) for the air near the IR cable and for the instrumented cable closest to the IR bundle. The peak tray temperature recorded during this test was 573°C (1063°F) and the cable temperature was 540°C (1004°F).

Figure 5-56. Representative tray and TC-3 cable temperatures recorded during Test 15.

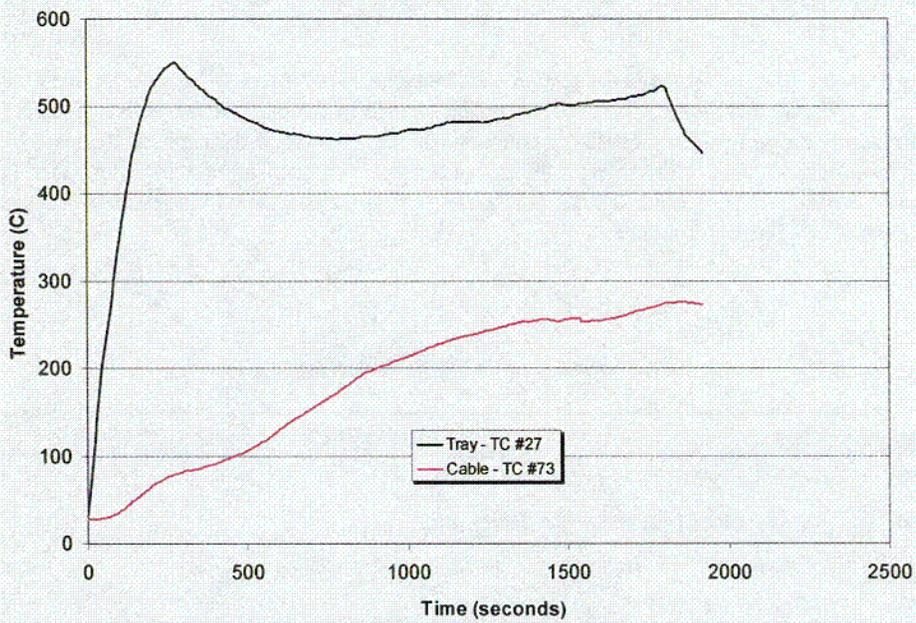
Figure 5-59 shows the time-temperature plots for two of the thermocouples monitored during the test. TC #27 was mounted on a tray rung at the corner of the tray, and TC #73 was located at the mid-point of the instrumented cable TC-4. These two thermocouples were chosen because they showed the worst-case temperature exposure conditions (highest recorded temperatures) for the air near the IR cable and for the instrumented cable closest to the IR bundle. The peak tray temperature recorded during this test was 550°C (1022°F) and the cable temperature was 276°C (529°F).

Figure 5-59. Representative tray and TC-4 cable temperatures recorded during Test 16.

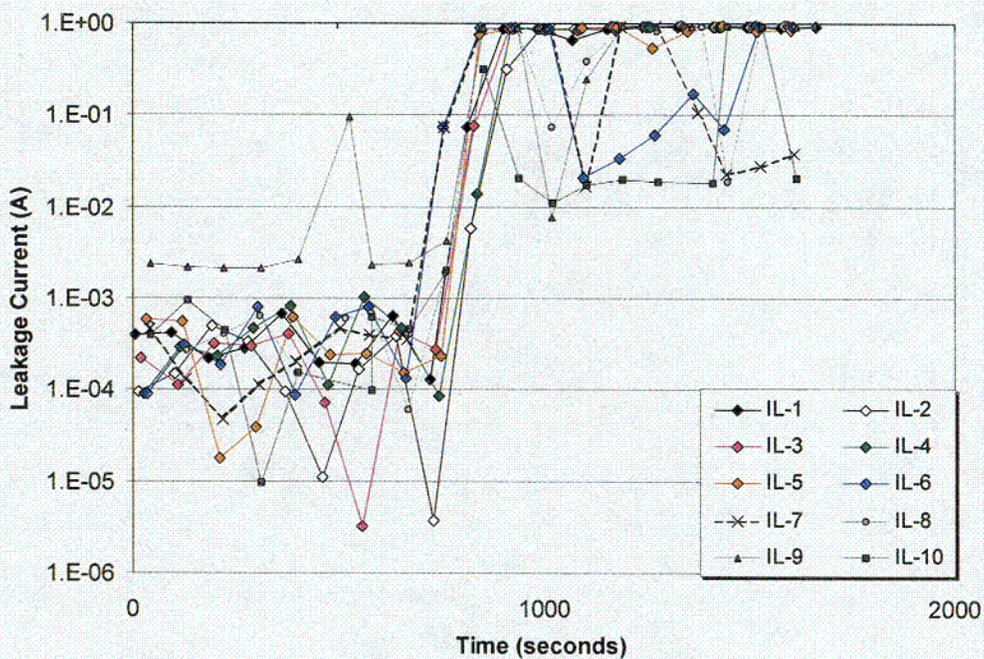
As previously mentioned, the IR measurement system was only capable of determining total IR due to a wiring problem during Test 16. Figure 5-60 shows the time-dependent change in the total IR for each of the 10 conductors in the IR cable measured during this test. Table 5-8 summarizes the behavior of the cable in the test. While some of the conductor IRs increase again (~1000 Ω) near the end of the test, it is believed that all experienced failure and the apparent recovery was due more to noise than to real healing. Figure 5-61 shows the resulting leakage currents allowed by the change in IR for each conductor.

Figure 5-61. Total leakage currents resulting from IR changes for each conductor during Test 16.

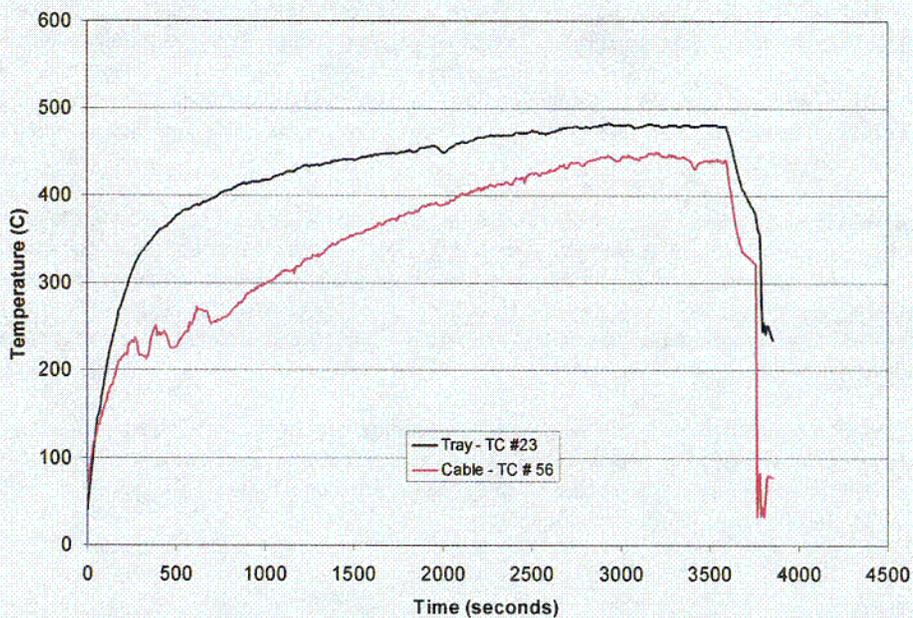
Figure 5-62 shows the time-temperature plots for two of the thermocouples monitored during the test. TC #23 was mounted on a tray rung at the top of the vertical tray, and TC #56 was located at the top of the instrumented cable TC-4. These two thermocouples were chosen because they showed the worst-case temperature exposure conditions (highest recorded temperatures) for the air near the IR cable and for the instrumented cable closest to the IR bundle. The peak tray temperature recorded during this test was 482°C (900°F) and the peak cable temperature was 449°C (840°F).

Figure 5-62. Representative tray and TC-4 cable temperatures recorded during Test 17.

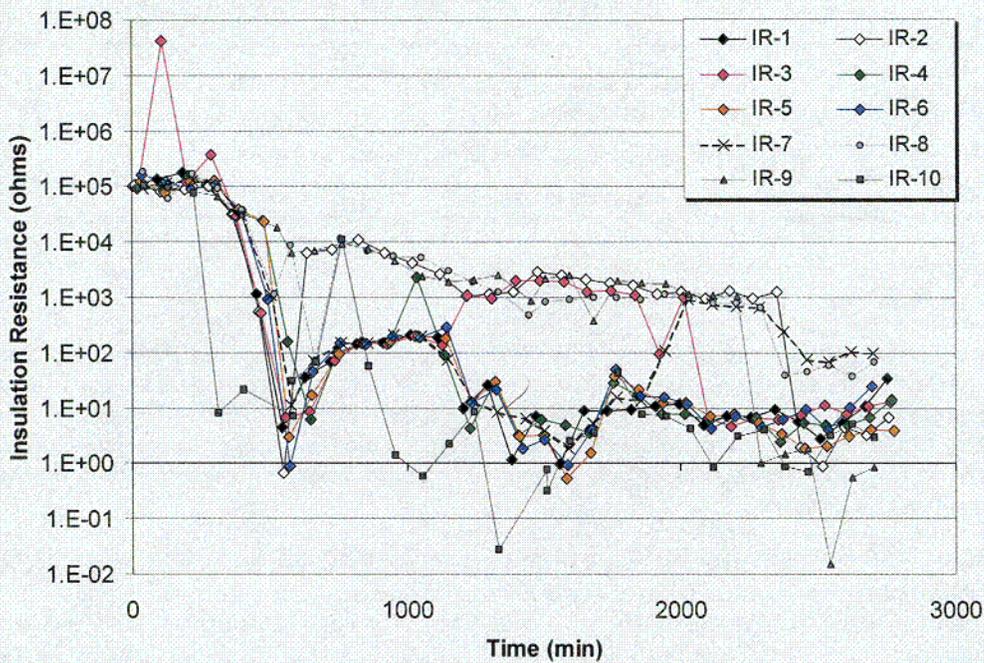
Again, the IR measurement system was only capable of determining total IR due to a wiring problem during Test 17. Figure 5-63 shows the time-dependent change in the total IR for each of the 10 conductors in the IR cable measured during this test. Table 5-9 summarizes the behavior of the cable in the test. Figure 5-64 shows the resulting leakage currents allowed by the change in IR for each conductor.

Figure 5-63. Total IR of each conductor recorded during Test 17.

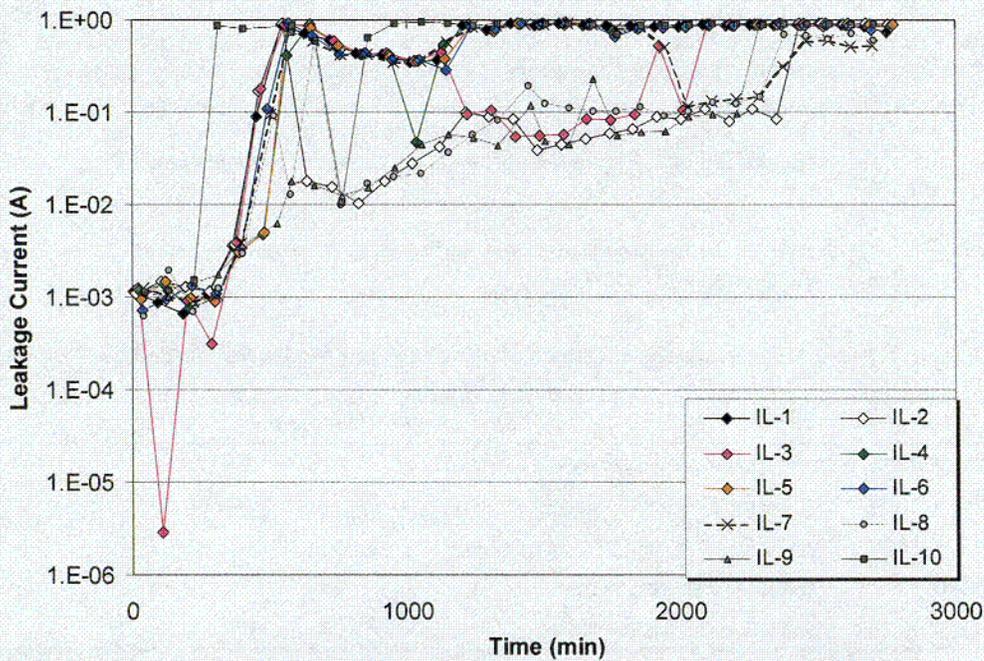
Figure 5-64. Total leakage currents resulting from IR changes for each conductor during Test 17.

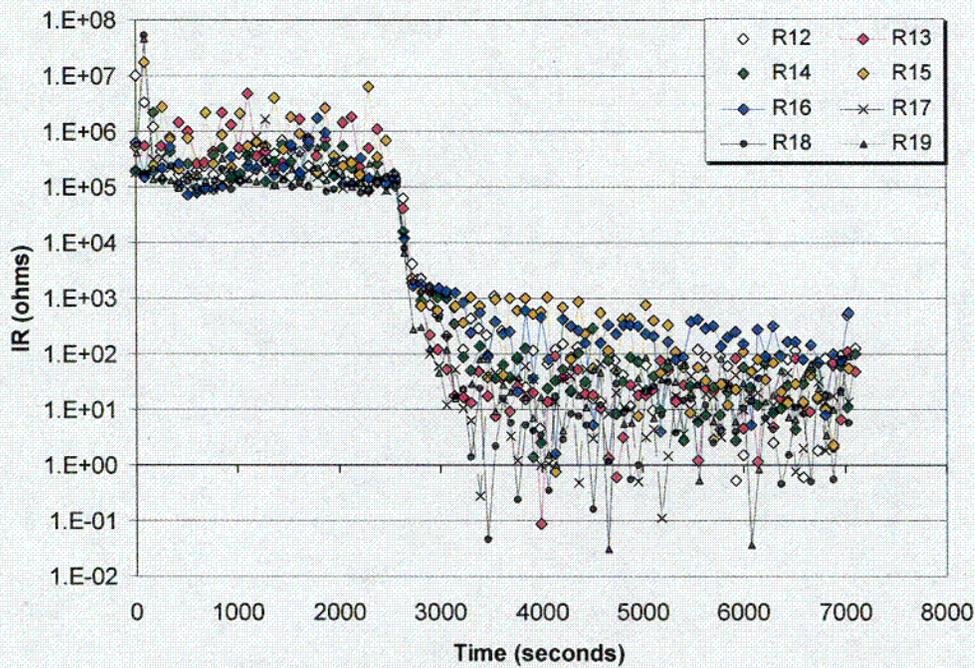
No thermocouple-instrumented cable was routed in the conduit during this test; hence, there is no cable temperature data available. In addition, no direct measure of conduit temperature was made either. Failures of the IR cable bundle were identified based on the results of this test. Figure 5-65 shows a plot of the IRs between Conductor 1 and the other conductors in the IR bundle. Conductors 1 through 3 made up one of the three-conductor cables of the IR bundle, Conductors 4 through 6 were in a second cable, and Conductors 7 through 9 formed the third cable. As shown in the figure, most of the IR values drop to < 100 Ω at ~3000 seconds.

Figure 5-65. Representative conductor-to-conductor IRs obtained during Test 18. This plot shows the IR between Conductor 1 and the other eight conductors in the IR cable bundle.

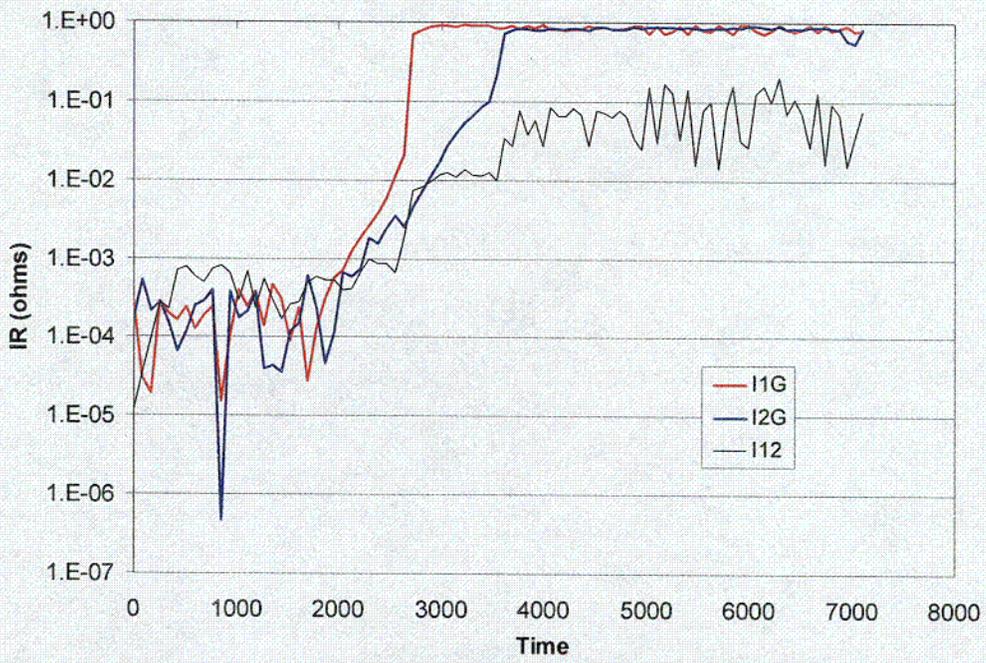
Figure 5-66 shows the IR values between each of the IR cable conductors and ground recorded during Test 18. This figure shows a relatively gradual decline in IRs to ground from ~ 10^6 down to ~3000 Ω over the period 1500 to 2500 seconds. The almost simultaneous failure of Conductors 1, 3, and 9 followed this. The next conductor to fail was Conductor 7 at ~ 2900 seconds, then Conductors 8 and 4 failed. Conductors 5, 2, and 6 eventually failed during the course of the test. All conductors shorted to ground before interacting with any other conductor. Table 5-10 provides a summary of the conductor failures. Figure 5-67 presents the change in leakage current for Conductors 1 and 2 occurring during Test 18.

Based solely on the results of the IR measurements made during Test 18, it appears that the IR cable experienced significant damage and could have caused blown fuses.

Figure 5-67. Leakage currents resulting from IR changes in Conductors 1 and 2 during Test 18.
