RE: St. Lucie Units 1 and 2
Docket Nos. 50-335 and 50-389
Request for Information
Reinitiation of ESA Section 7 Consultation

ST LUCIE PLANT SEA TURTLE INCIDENTAL LETHAL TAKES IN 2001 AND CORRECTIVE ACTIONS

5-INCH BARRIER NET IMPROVEMENTS

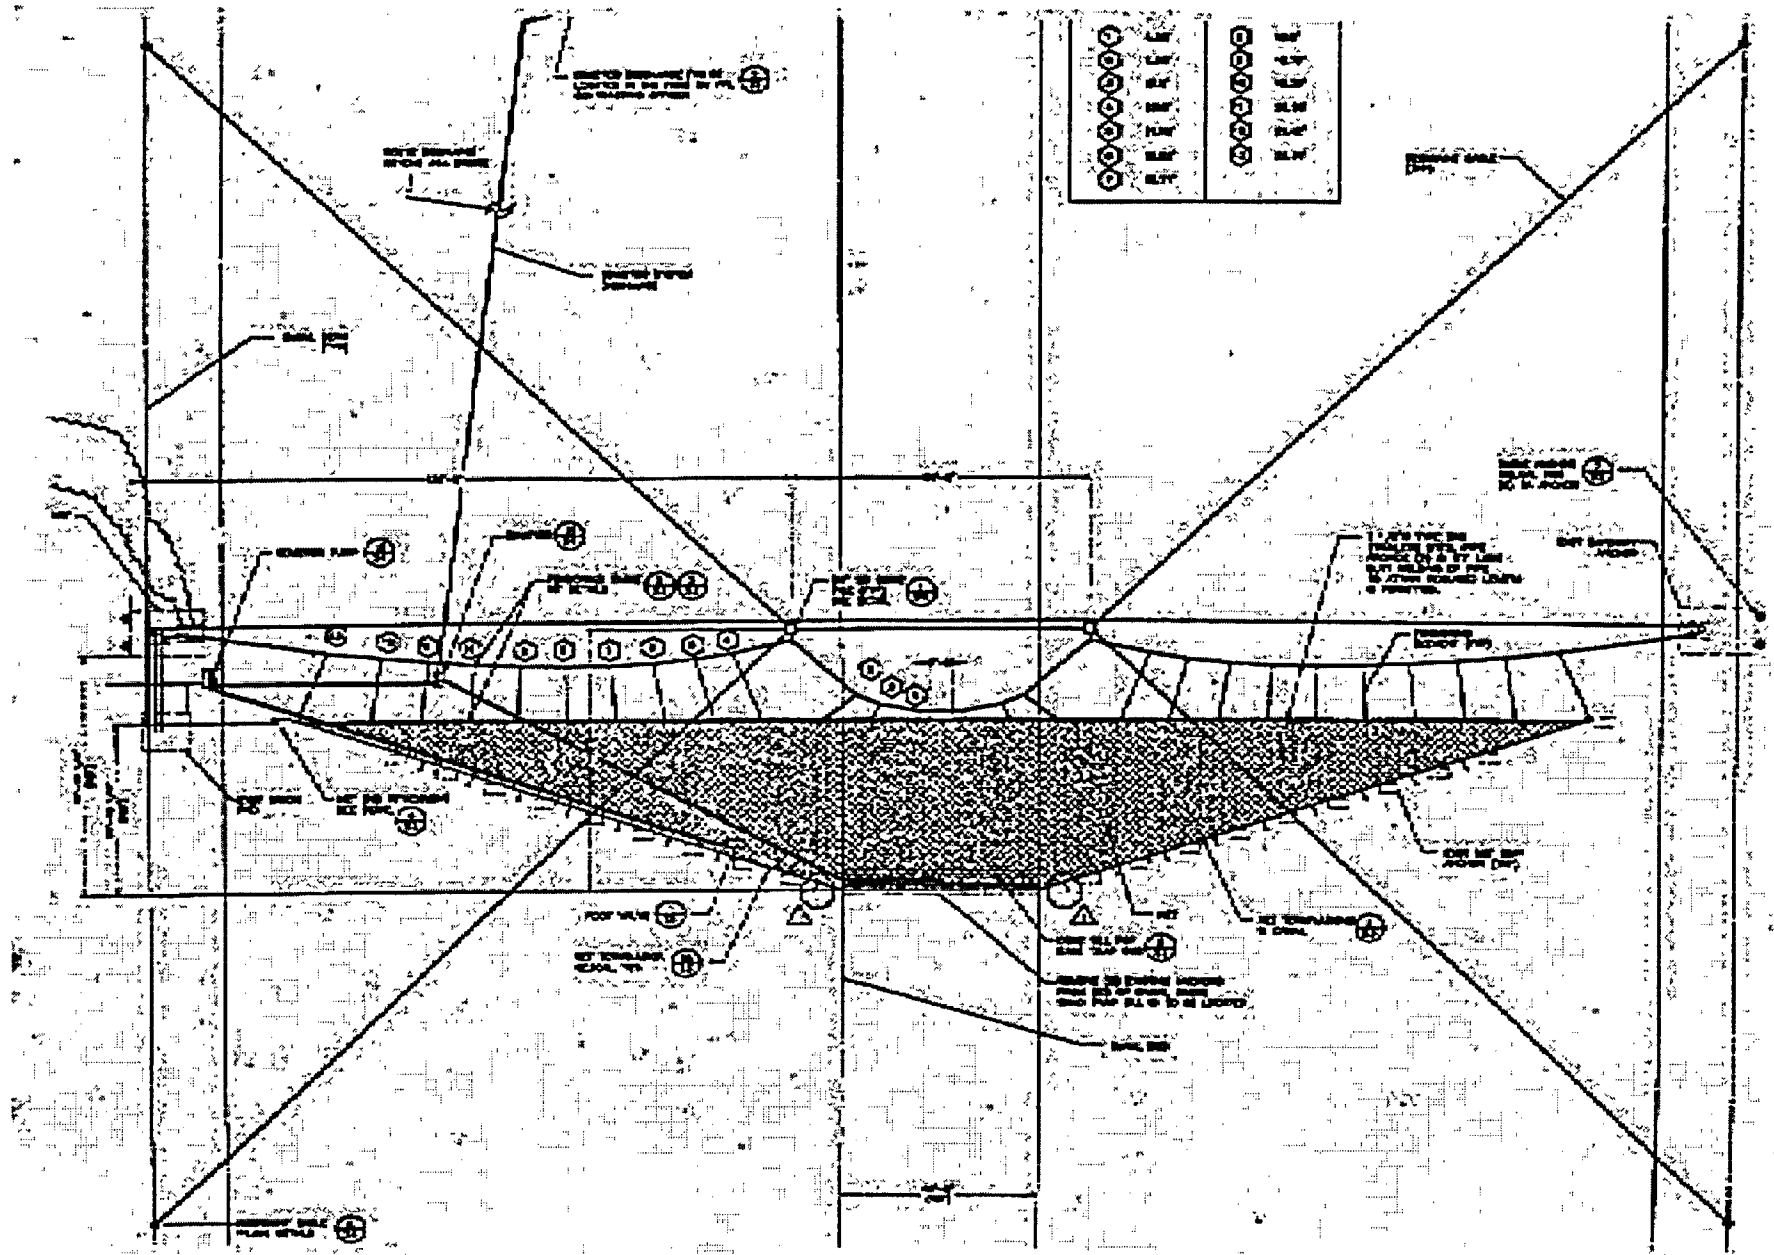
Two factors have contributed to the overstress condition that has compromised the integrity of the net and the suspension cable system; debris loading and canal sedimentation.

Episodes of heavy debris loading on the 5-inch barrier net from flotsam, seaweed, and jellyfish that become trapped and entangled in the net, impart load on the catenary cable, which is transferred to the concrete support pedestals. The induced moment applied by these overstress conditions appears to have resulted in rotational movement of the concrete support pedestals. Plumb measurements indicate that the pedestals are presently skewed. To prevent support failure, net maintenance technicians have had to lower the net during periods of heavy loading. In the lowered position, turtles can easily pass over the net, which defeats the purpose of this barrier. Furthermore, lowering the net endangers turtles because the net flagellates and billows and can trap turtles. In order to raise the net after a major debris event, divers must be used to clean the net.

A modification and retrofit to the existing net suspension cable system has been designed to remedy its compromised condition. This modification includes a renovation of the present concrete support pedestals, and the addition of several new structural elements to the system. Re-use of the existing pedestals requires a retrofit with new screw anchors to supplement its overturning resistance.

The addition of new structural elements to the existing cable system includes two new concrete pier founded, pin-connected, guyed, cable-support towers. The purpose of the guyed towers is to reduce the lateral loading that the net transfers to the cable, and the cable transfers to the concrete pedestals. Lateral loads would be transferred to new, screw anchored foundation blocks on the bank of the canal via adjustable cable guy wires. The towers also transform the vertical geometry of the net cable from a single, shallow long-span catenary to that of an inverted trapezoid. The span reductions would be greater than $\frac{1}{2}$ the current span conditions, thus affording much stiffer support for the net. Additional guy cables support the net cable in the region of the sloped sides of the canal.
