Root Cause Analysis for CR 02-08166

Evaluation Of "D" Steam Generator Tube Cracking

FPL Energy

Seabrook Station

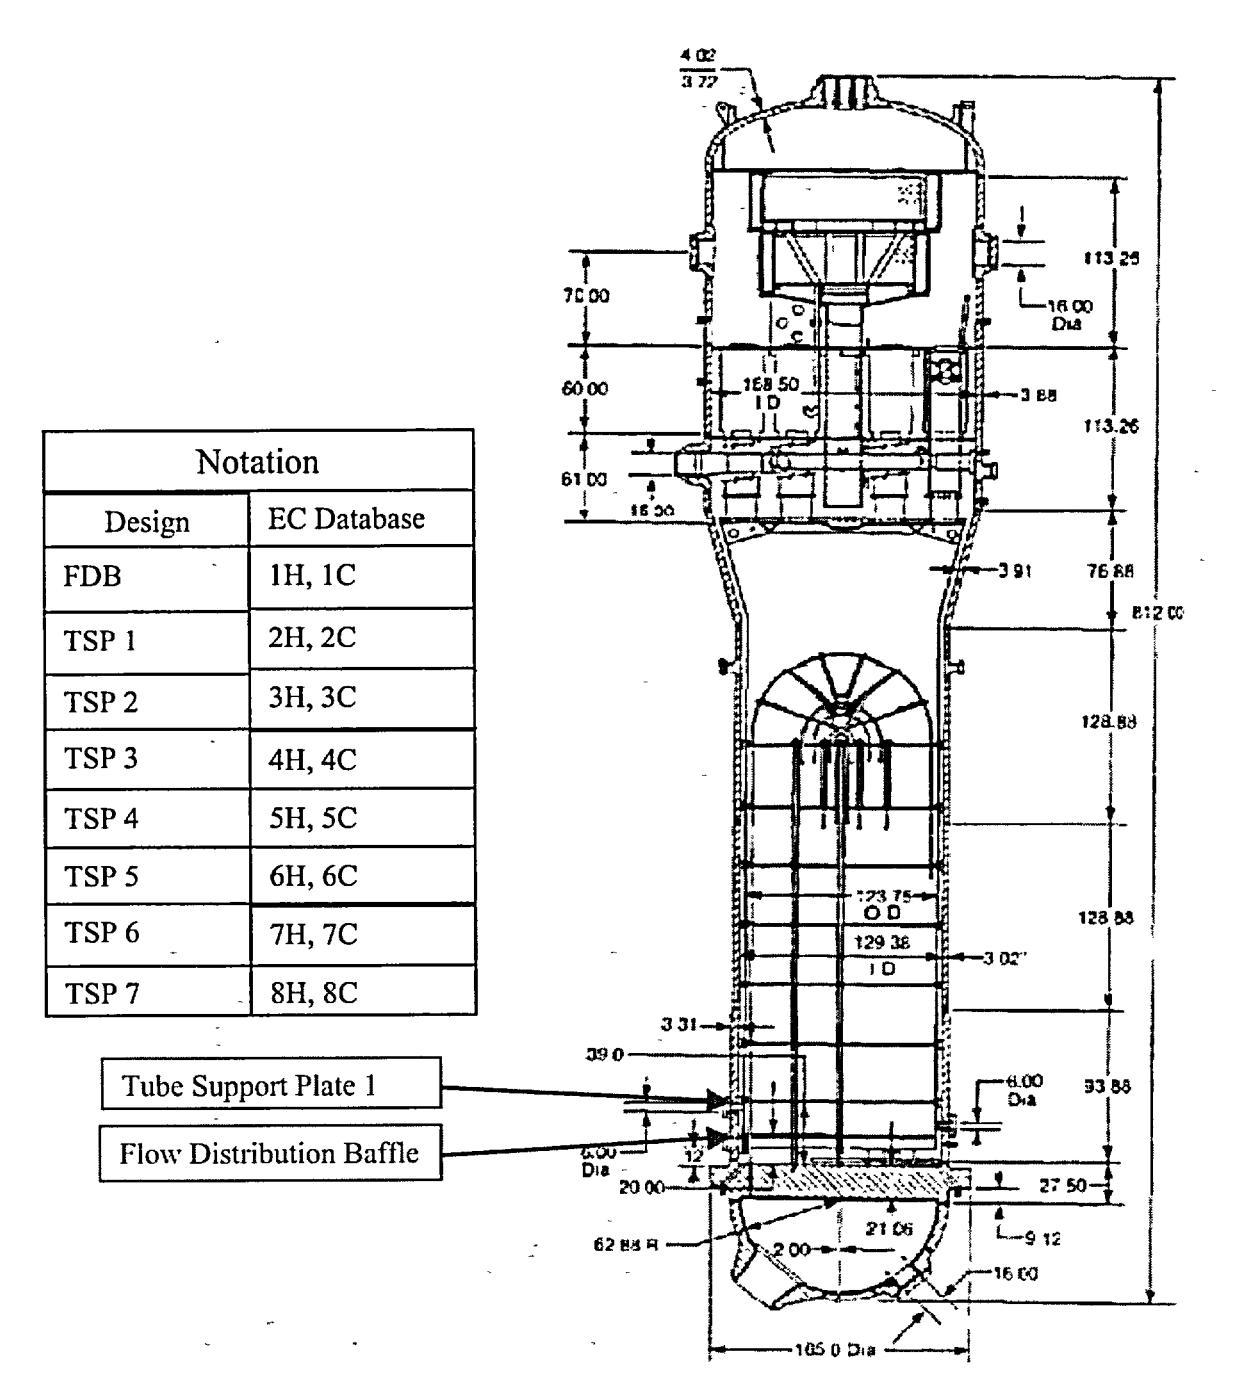
Figure 3-2 Location of Degraded Tubes

- 1. Seabrook has significantly less operating time than many of the other Model F SG plants that have not observed tube cracking; thus, these indications were unanticipated.
- 2. Indications were detected in only SG-D.
- 3. Indications were found at the TSP intersections and not at the top of the tubesheet (TTS) expansion transition where initial cracking would be expected.
- 4. Indications were reported on both the HL and CL. In all cases where a CL indication was reported, a HL indication was also reported on the same tube. CL cracking at the same time as HL cracking is unexpected due to the lower temperature on the CL.
- 5. All indications were confined to rows 4 through 9 (see Figure 3-2).

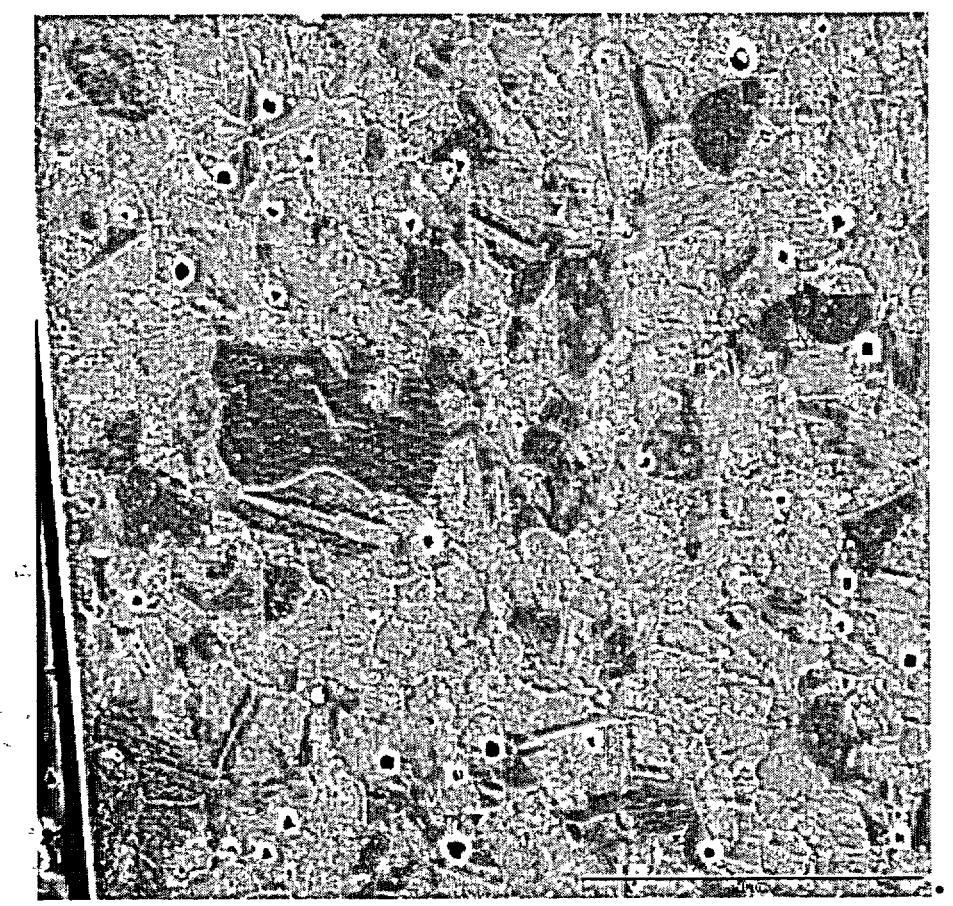
Figure 4-3 11/16" Dia. Archived Tube [Heat NX 1374] Microstructure [Lot TF6039; TT A0206D]

The two tubes that were pulled and examined exhibited a microstructure characterized by fine equiaxed grains with a significant variation in grain size as well as a non-uniform "banded" grain distribution. The microstructure was also characterized by intergranular and extensive intragranular carbide precipitation. This structure is considered to be not optimum but within the

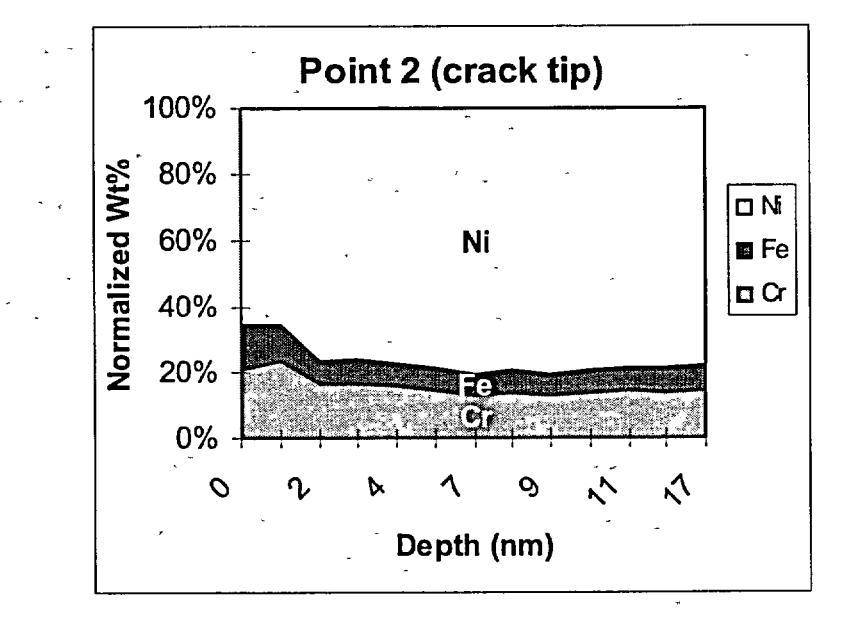
Figure 4-8. Metals Normalized AES profile on an opened crack face from the R5C62 HL 4th TSP specimen.

The crack-face oxide at the crack tip where little corrosion had taken place was slightly enriched in chromium relative to the bulk. This is consistent with a non-sensitized grain boundary condition. This is evident in the "metals normalized" profile shown in Figure 4-8.

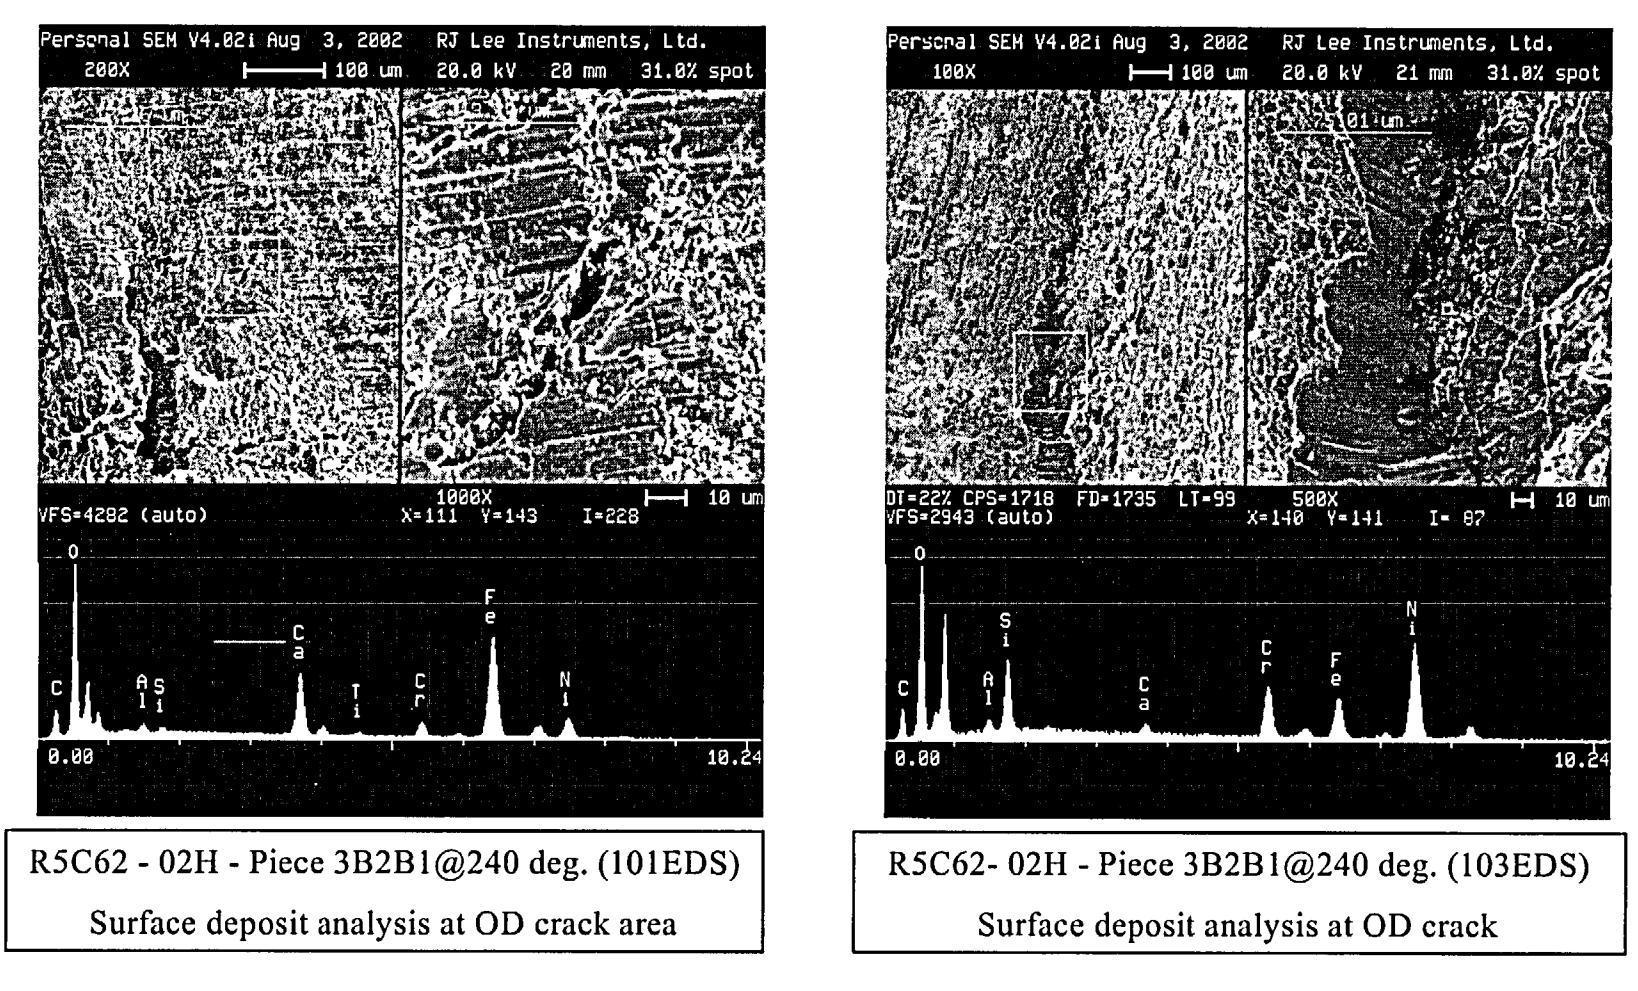
Figure 4-9

The deposits on the OD of the tubes and crack fracture faces were photographed in the SEM and were analyzed by energy dispersive X-ray spectroscopy (EDS). The EDS system used was capable of detecting elements of atomic number 11 or greater for a depth of approximately 2 micrometers below the surface. Thus, when the deposits were thin, the base metal composition strongly influenced the EDS deposit data. For the EDS analysis, regions of both relatively thick deposits and thin deposits within the OD area of interest were selected. Typical photographs and EDS analyses are shown in Figure 4-9.

EDS Deposit Analysis - R5C62 (02H)

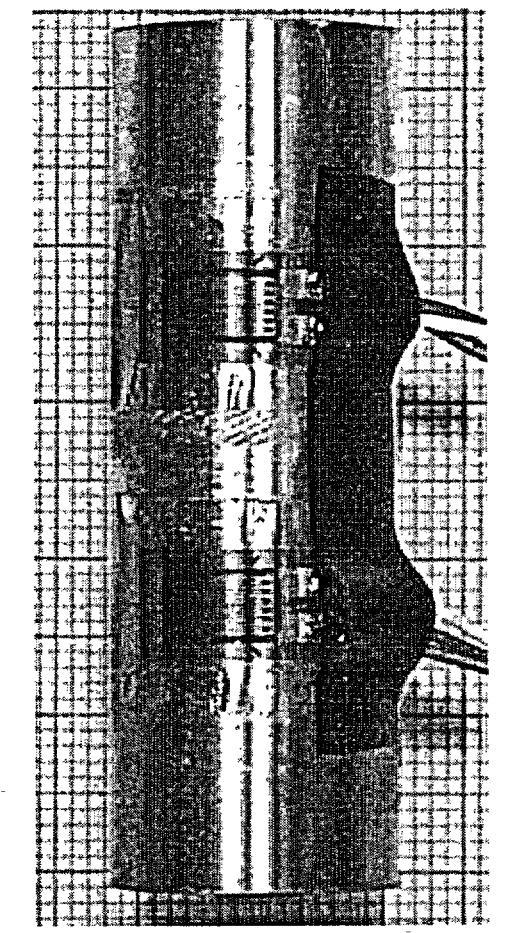
Figure 4-10 Residual Stress Test Specimen with Strain Gages Mounted

- -, -
dimensional changes. Tube samples about 2 inches long were used for these tests. Figure 4-10 shows the pre-split test sample with strain gages attached.

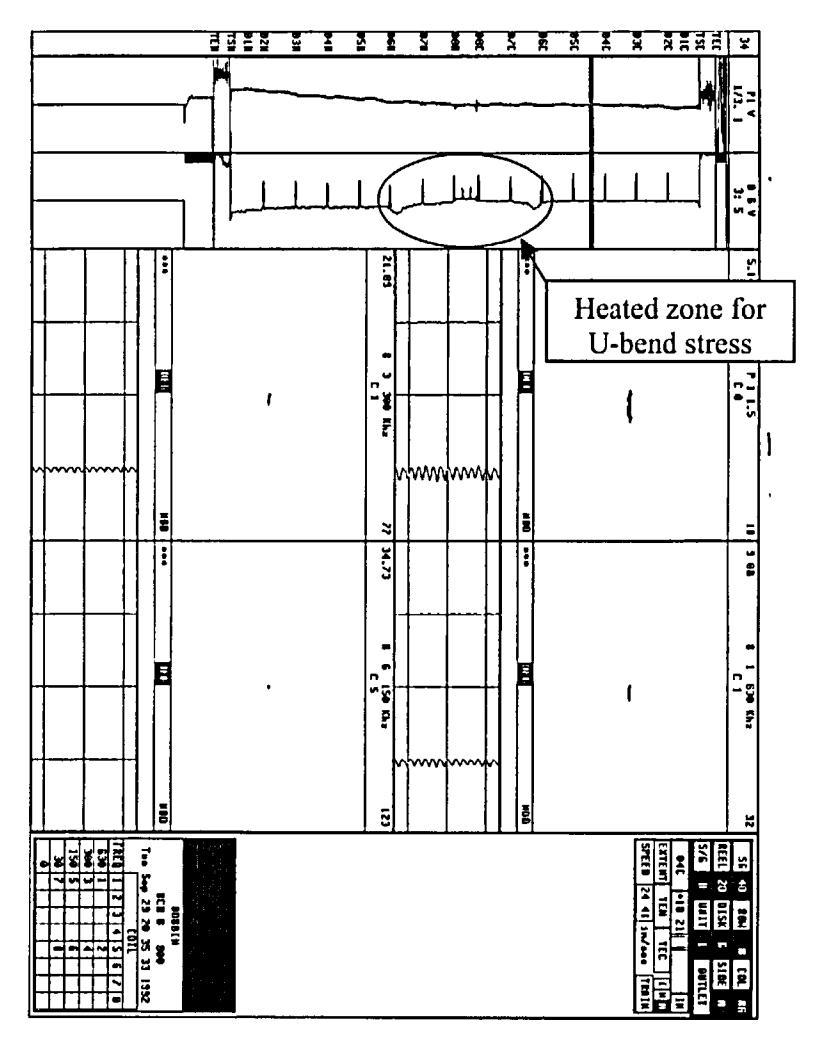
Figure 5-2 Normal EC Signal for R<11 Tube

For the rows 1 through 10 tubes, whose U-bends were stress relieved, the normal EC trace is characterized by the general absence of the U-bend signal excursion, which is replaced by a region between about 6H and 6C that is defined by entrance and exit "blips" in the signal (Figure 5-2). This region defines the heated zone for the U-bend stress relief. As noted in Section 6, stress relief is achieved by loading the low-row U-bends into the vacuum furnace apex to apex so that the U-bends are in the center of the length of the furnace, then heating the central region (of three regions) in the furnace to achieve the desired temperature in the U-bends. The "blips" in the signal define the heated region of the tube. A very small signal excursion to the left between the "blips" may indicate a stress-free state of the U-bends compared to the straight legs.

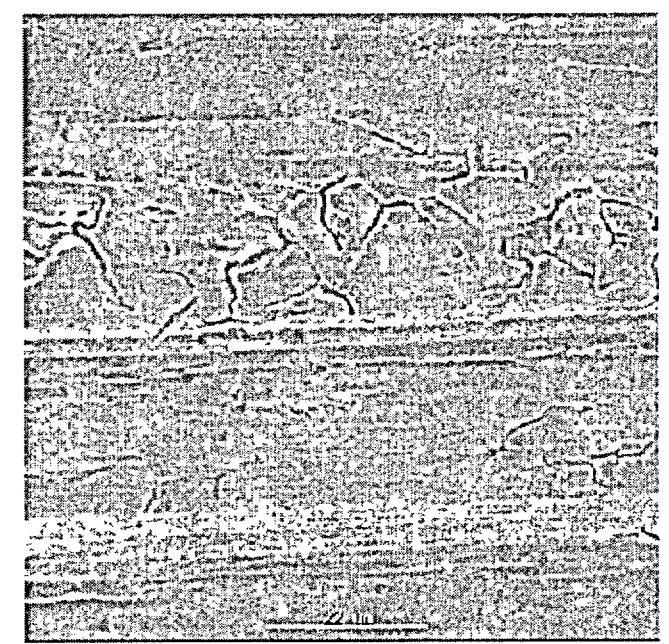
Figure 4- 4. Laboratory Thermally Treated Seabrook Service Sample R5C62 Post Modified Huey Testing

One important trend that was revealed by the 25 volume percent solution testing is that laboratory thermal treatment of the Seabrook service samples dramatically increased their corrosion resistance. Post Huey SEM images of Seabrook service R5C62 samples tested in the as received and laboratory thermal treated conditions are shown in Figures 4-3 and 4-4. The facetted surface of the as received sample clearly shows intergranular attack. Additionally, it should be noted that all of the archived Seabrook samples (TY9402 9993 B0579B and heats 1456, 1457 and 1374) performed satisfactorily in 25 volume percent solutions, as did the thermally treated and laboratory solutionized heat 96845 samples. Axially splitting the Seabrook service samples to partially relieve axial stresses prior to testing did not have a dramatic effect on their behavior.

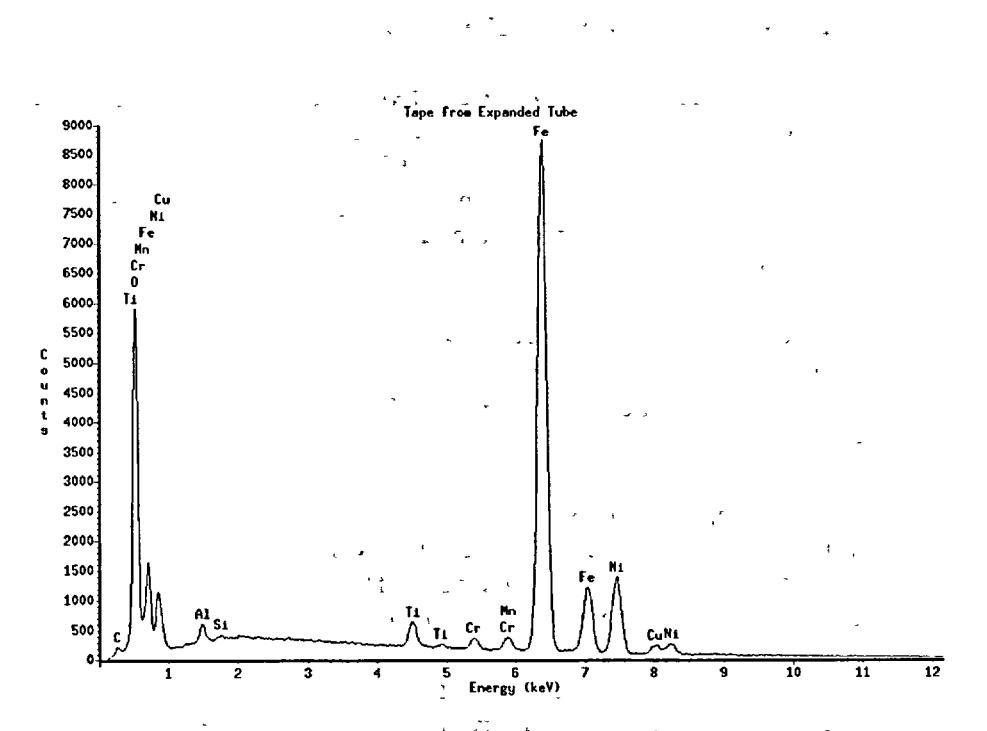
Figure 4-19. Typical EDS Spectra of the Tape Containing the Deposit.

A small section of the tape containing the deposit was chemically analyzed using EDS. A typical spectra is shown in Figure 4-19. This spectra is similar to that shown in Figure 4-18, and shows predominantly iron and oxygen peaks typical for iron oxide.
