# Seabrook Steam Generator Tube Assessment Project

November 14, 2002

*FPL* Energy Seabrook

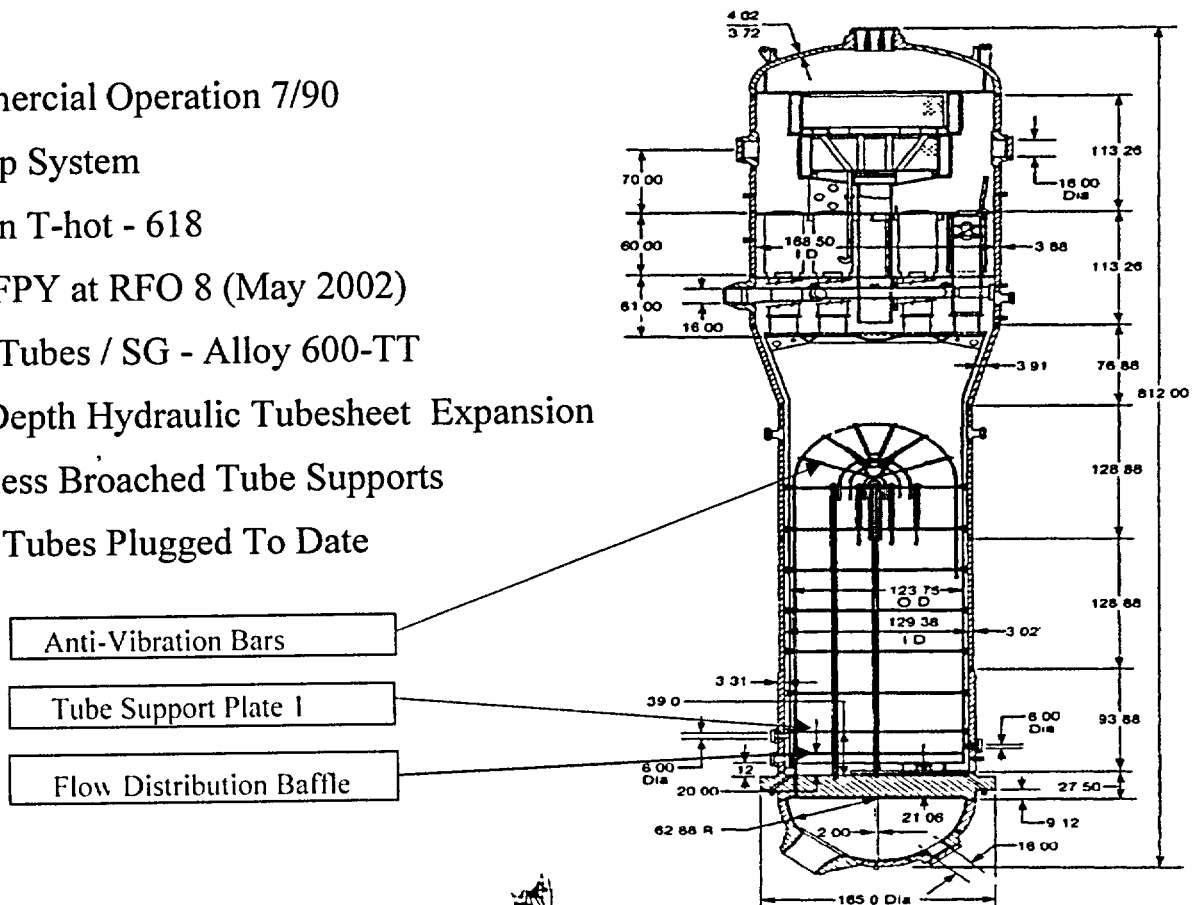
# Seabrook Model F Steam Generator

- Commercial Operation 7/90
- 4 Loop System
- Design T-hot - 618
- 9.7 EFPY at RFO 8 (May 2002)
- 5626 Tubes / SG - Alloy 600-TT
- Full Depth Hydraulic Tubesheet Expansion
- Stainless Broached Tube Supports
- 0.5% Tubes Plugged To Date

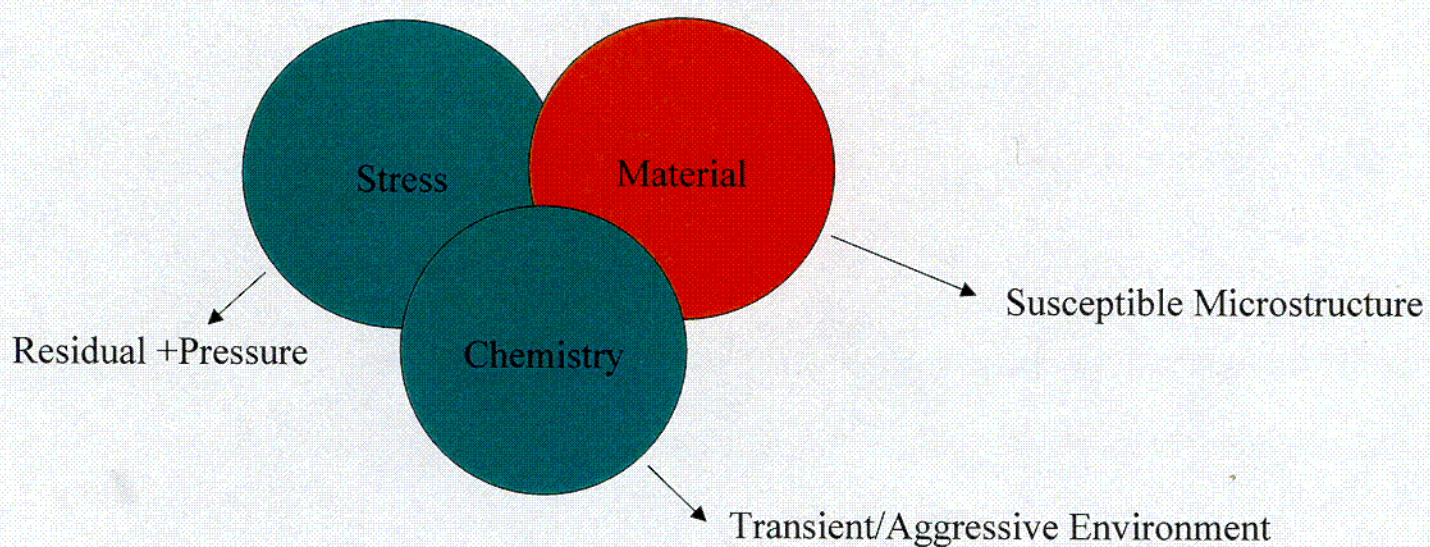
# Stress Corrosion Cracking

- Two Pulled Tubes Available For Testing (both from Heat 1374)
- Lab test confirmed field E/C data - Tubes have Micro Cracks
- Burst Test confirmed tube structural capability (i.e. Large Safety Margin)
  - ☞ Most Deeply Flawed Segment Tested To 7,000 psi- No leakage
  - ☞ Non Flawed Segments Burst Tested To 13,000 psi
- Tube Chemical and Mechanical Properties Consistent w/ spec
- Fractography Confirms Cracking Mechanism Is Stress Corrosion

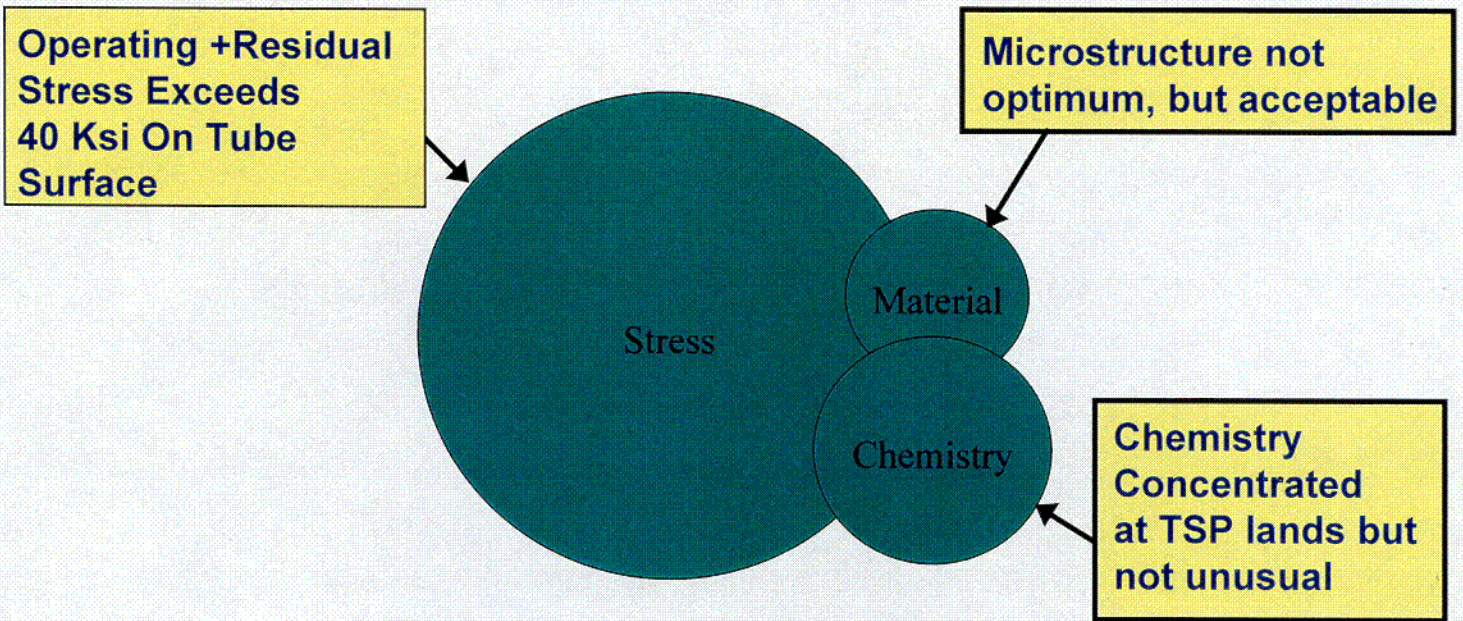
# Root Cause

- ∞ Need > 40ksi To Initiate Cracking In TT Material
- ∞ High Residual + Operating Stress Exceeds 40 ksi on Tube Surface
- ∞ Potential Sources
  - \ Cold Work After Final TT
  - \ Improper Heat Treatment Including Stress Relief

- The Root Cause Of The Tube Cracking In Seabrook Steam Generator "D" At RFO8 Is High Residual Stress In A Subset Of Tubes Caused By Manufacturing Process
- The Extent Of Condition Is Defined
- Degradation Mechanism Is Not A New Generic Issue In Thermally Treated Tubing and is not an Active Damage Mechanism at Seabrook.
