Subject: 2002 Annual Site Inspection and Monitoring Compliance Report for UMTRCA Title II Disposal Sites

2002 Annual Site Inspection and Monitoring Compliance Report for Uranium Mill Tailings Radiation Control Act Title II Disposal Sites

November 2002

Prepared by
U.S. Department of Energy
Grand Junction Office
Grand Junction, Colorado

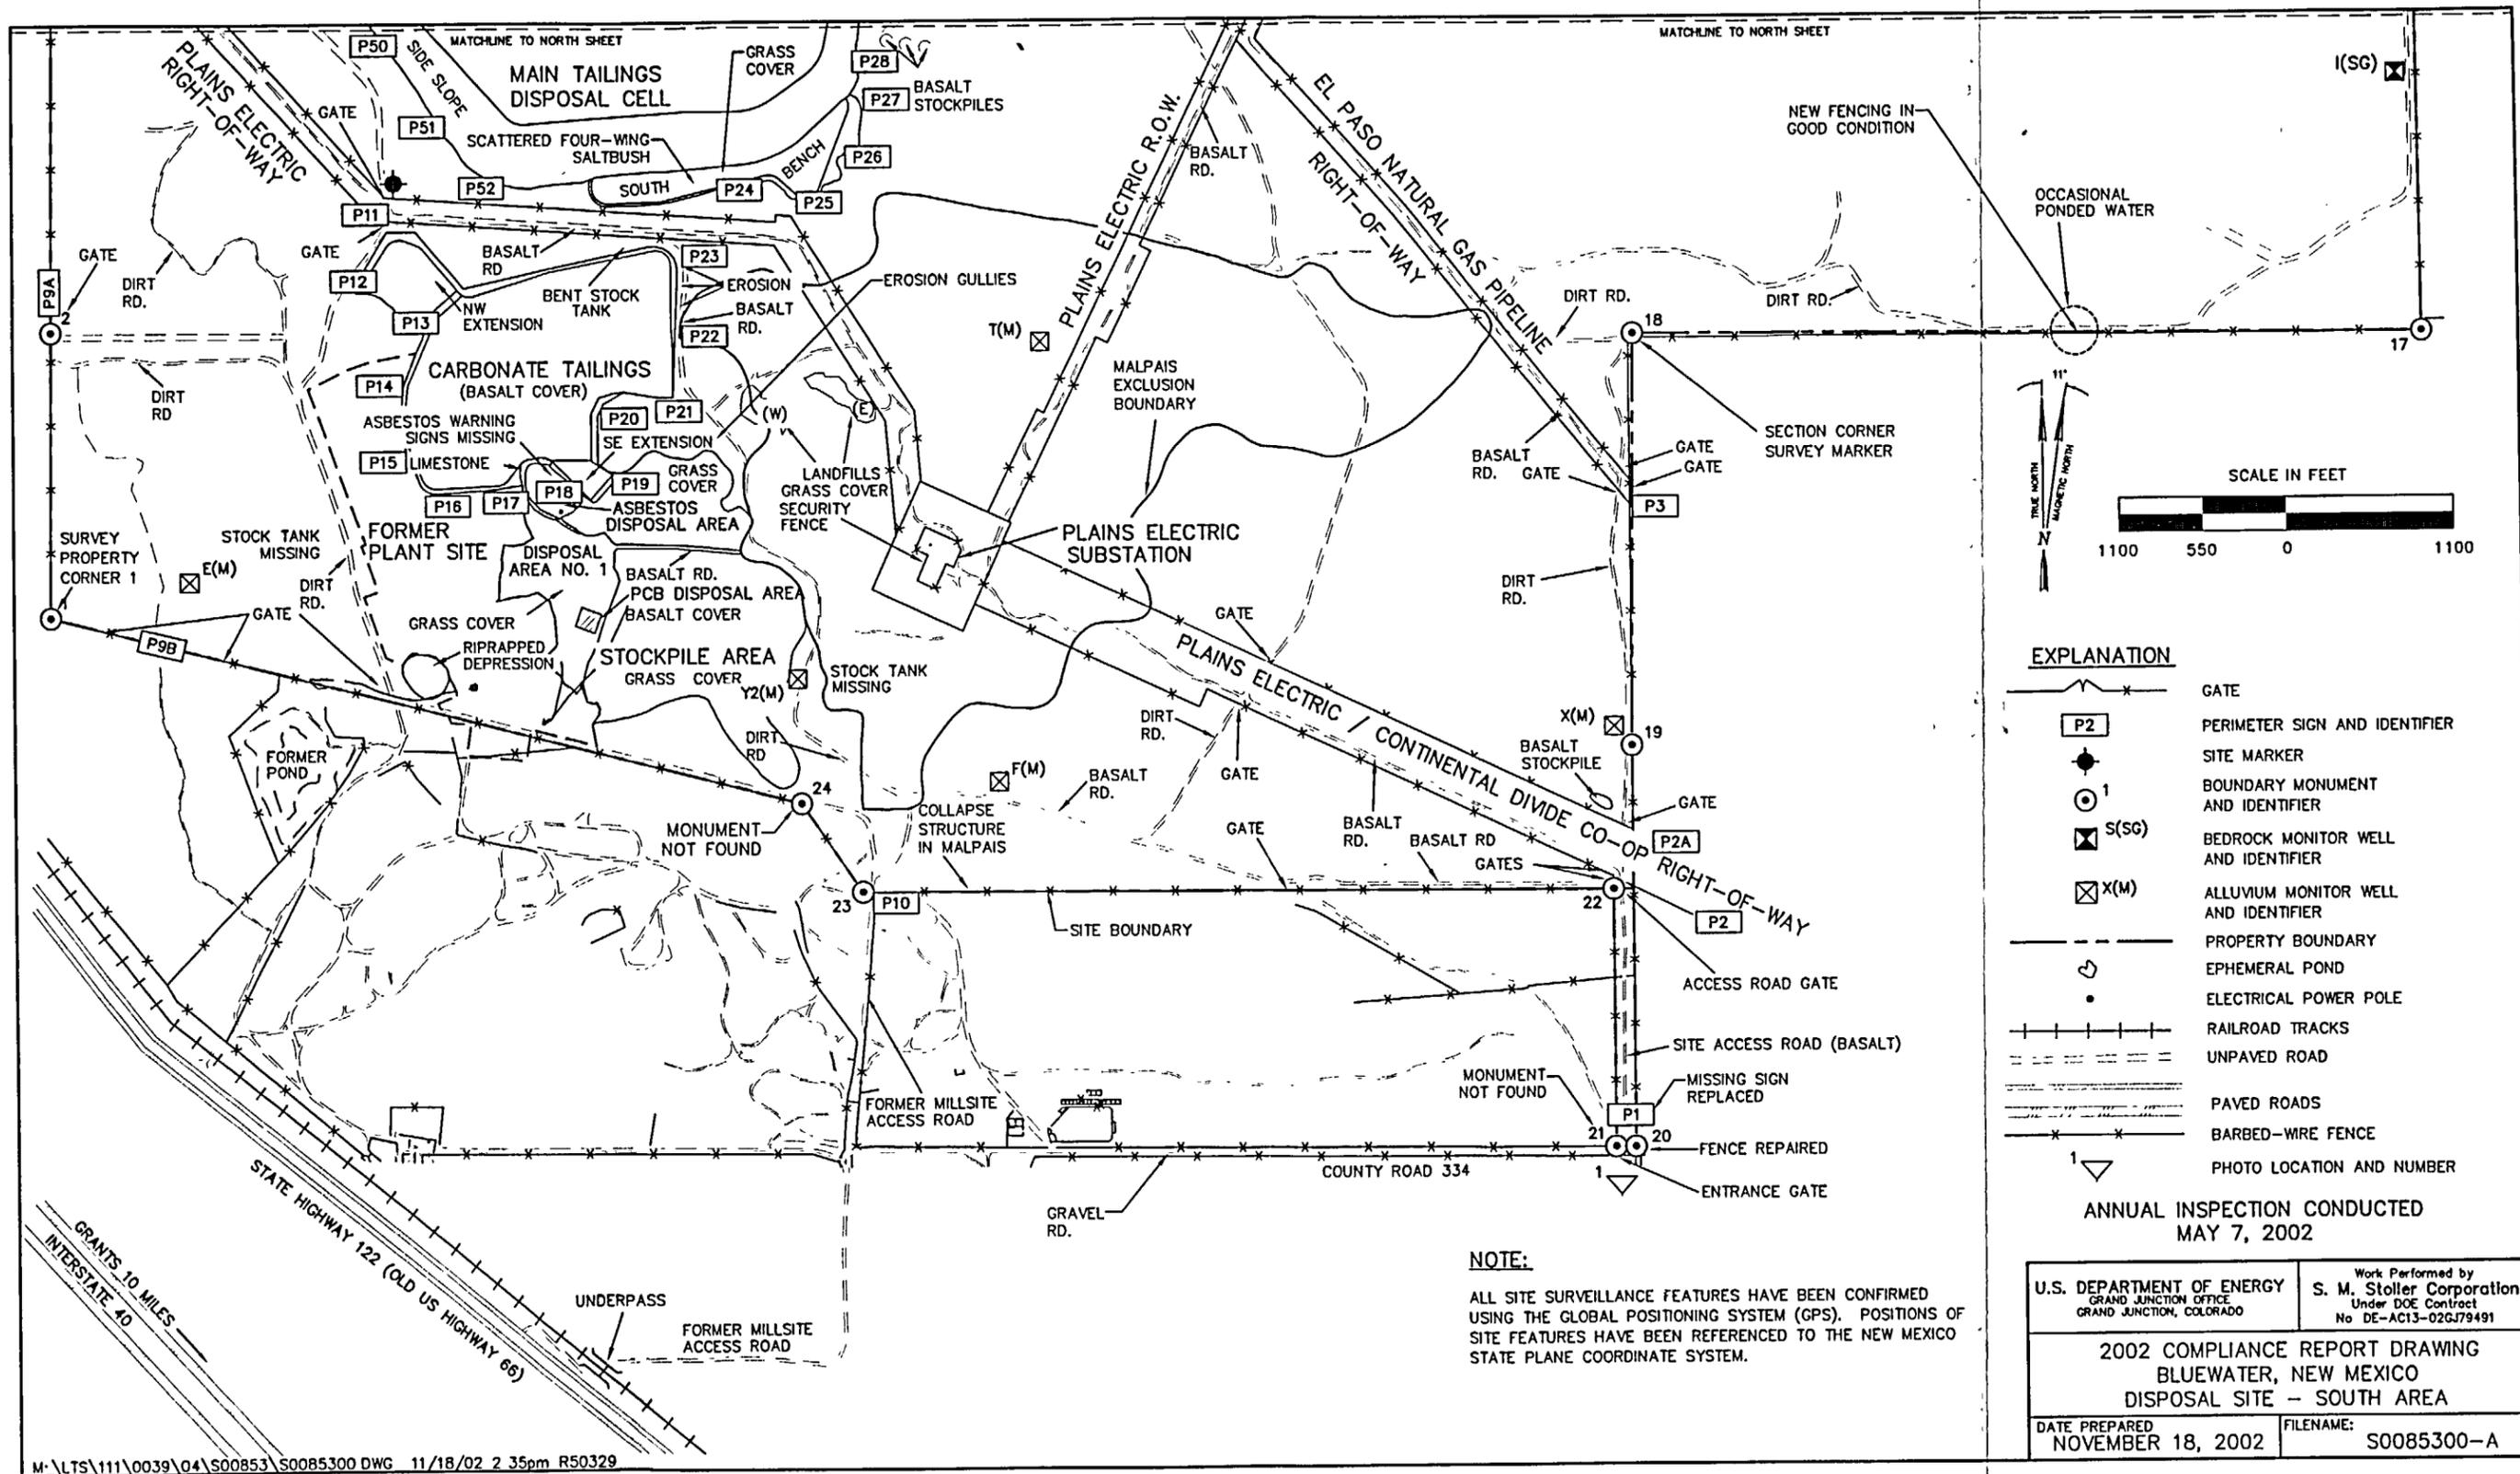
Figure 1-1. Bluewater, New Mexico, South Area, 2002

Fifty-four perimeter or warning signs, designated P1 through P52 on Figures 1-1 and 1-2 (including perimeter signs P2A, P2B, P9A, and P9B), are posted at access points along right-of-way intersections with the site boundary and around the main and carbonate tailings disposal cells. At the Bluewater site, all signs are identical and convey the information typically conveyed on entrance signs at other Long-Term Surveillance and Maintenance (LTSM) Program sites. Perimeter sign P1, located at the access gate, was missing; inspectors replaced P1 (PL-1).

Twenty-four boundary monuments define the site boundary. These monuments are typically inside the perimeter fence, several feet inside the true corner or boundary line. The boundary monuments and the general area around the monuments were inspected for signs of disturbance. No disturbance was found. Boundary monument BM-21 appears to be buried under about two feet of sand.

An unexploded blasting cap was found on the northwest edge on the top of the main tailings disposal cell. It was photographed (PL-2) so that inspectors could recognize other potential blasting caps and be cognizant of safety hazards. The blasting cap was not disturbed.

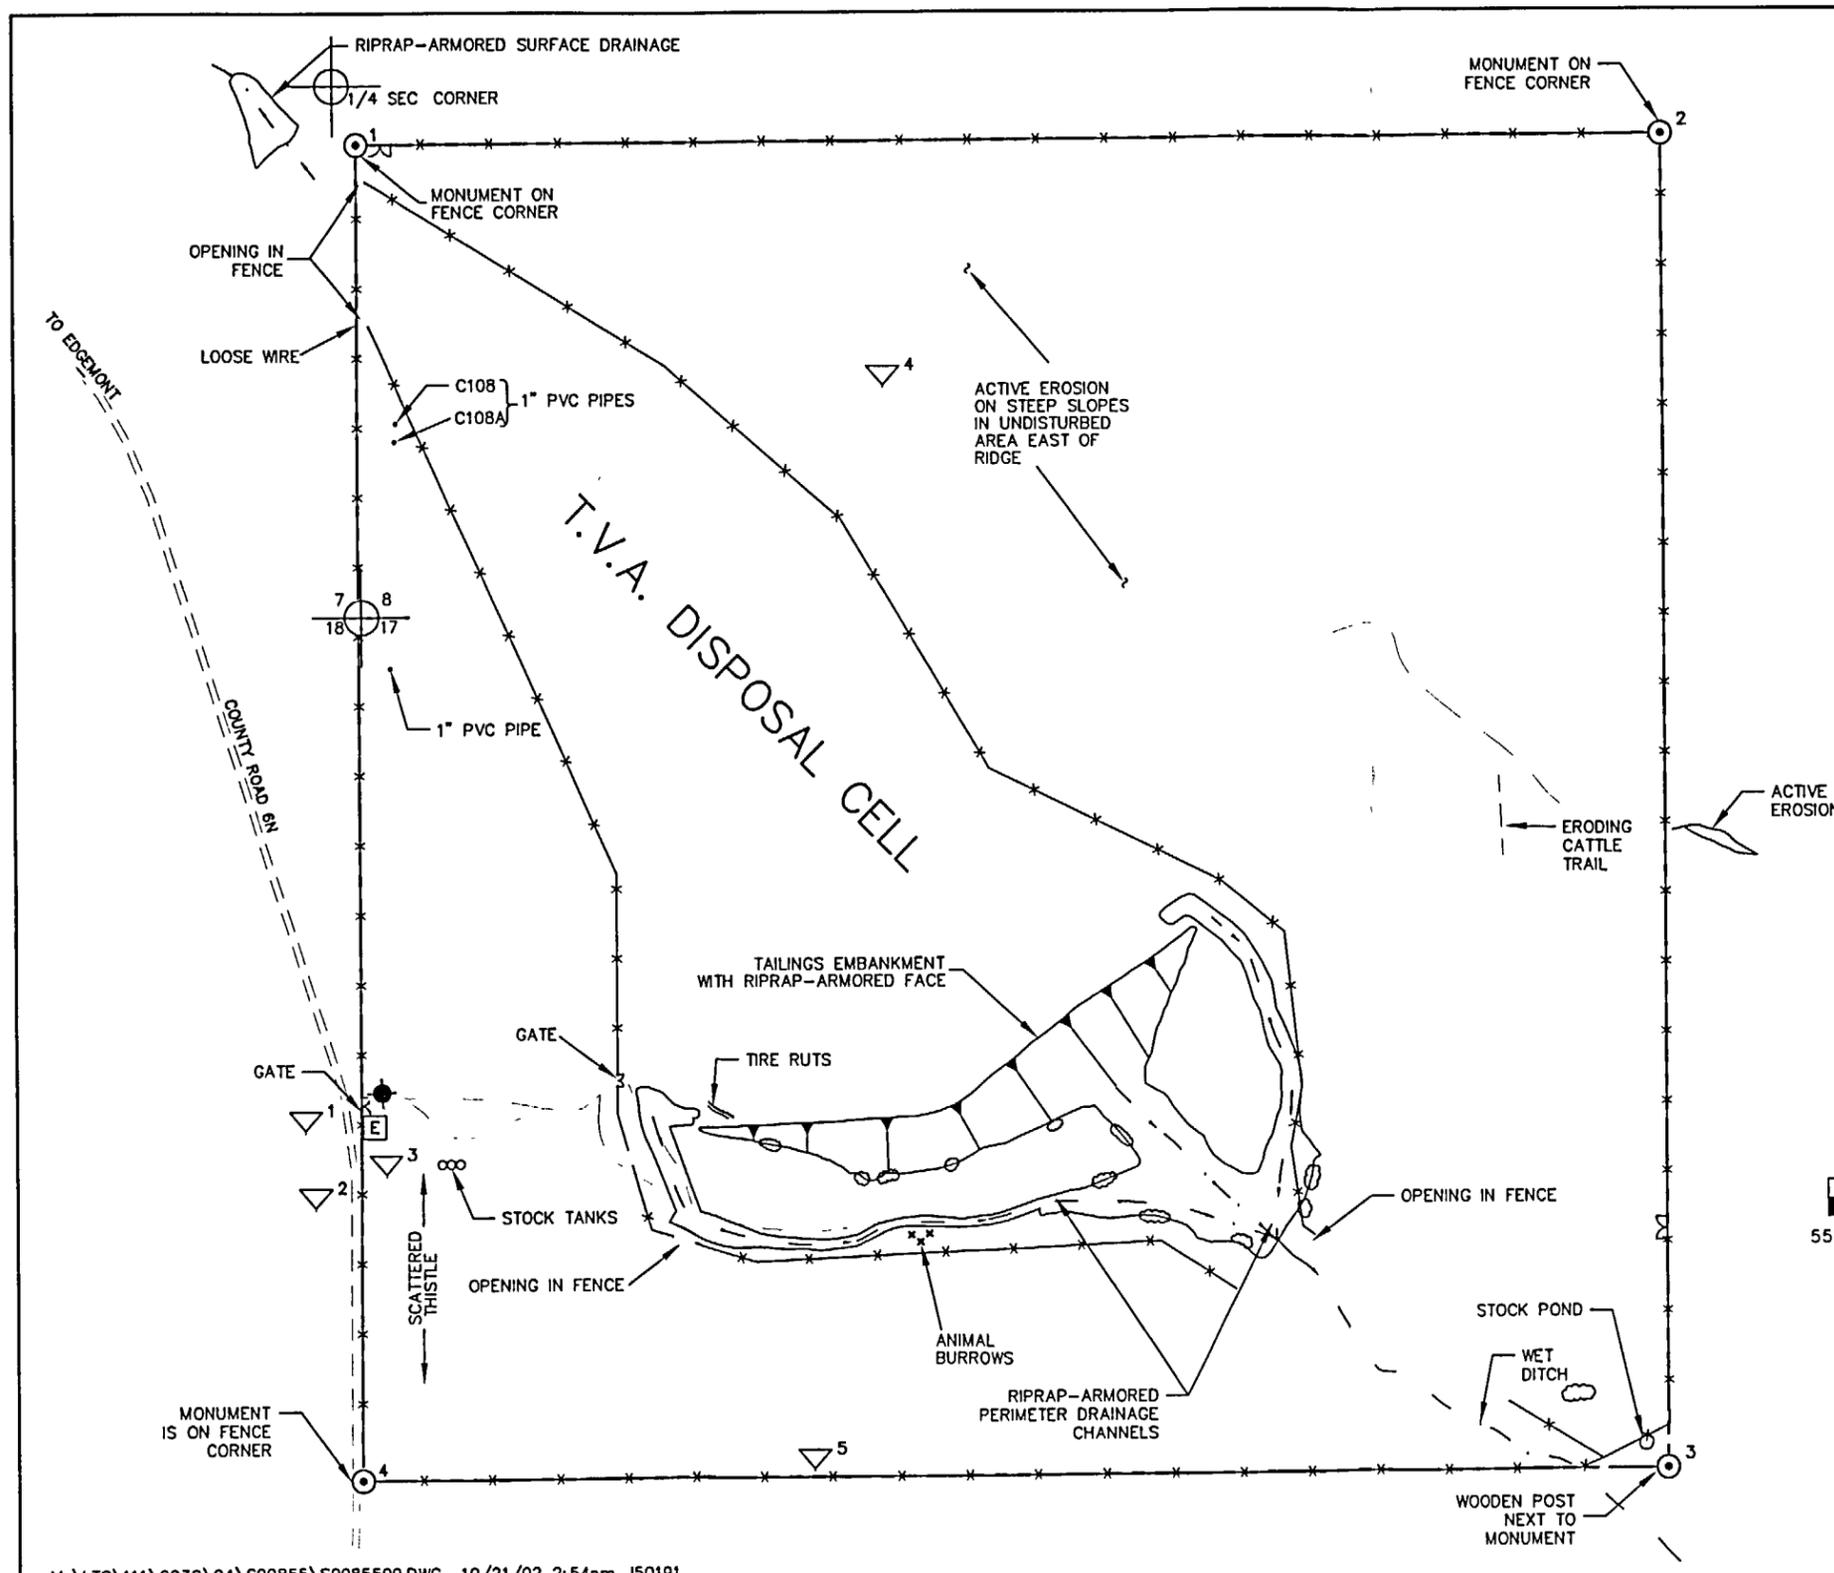
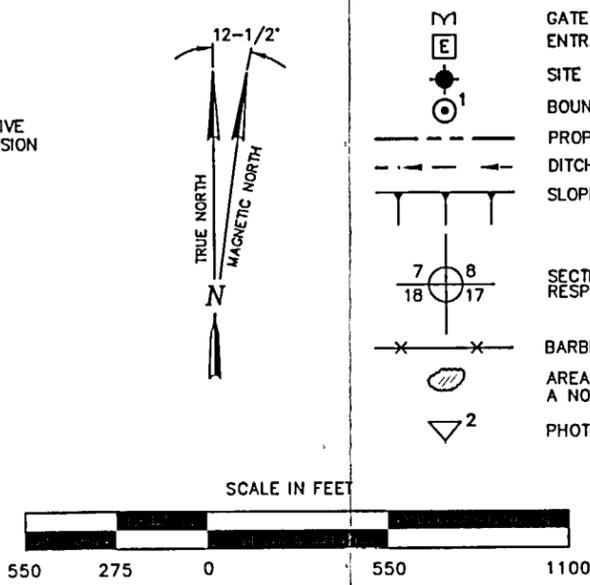
U.S. DEPARTMENT OF ENERGY GRAND JUNCTION OFFICE GRAND JUNCTION, COLORADO	Work Performed by S. M. Stoller Corporation Under DOE Contract No. DE-AC13-02GJ79491
2002 COMPLIANCE REPORT DRAWING EDGEMONT, SOUTH DAKOTA DISPOSAL SITE	
DATE PREPARED OCTOBER 21, 2002	FILENAME S0085500

The tailings dam face is covered with riprap and represents the steepest slope on site. The slope is stable and the riprap shows no signs of degradation. Scattered plants, mostly grass, grow in the riprap (PL-5A, PL-5B, and PL-5C). These plants do not pose an immediate threat to stability or function of this structure. The plant density has not increased over the last few years. Plant density in the riprap dam face will continue to be evaluated during future inspections.

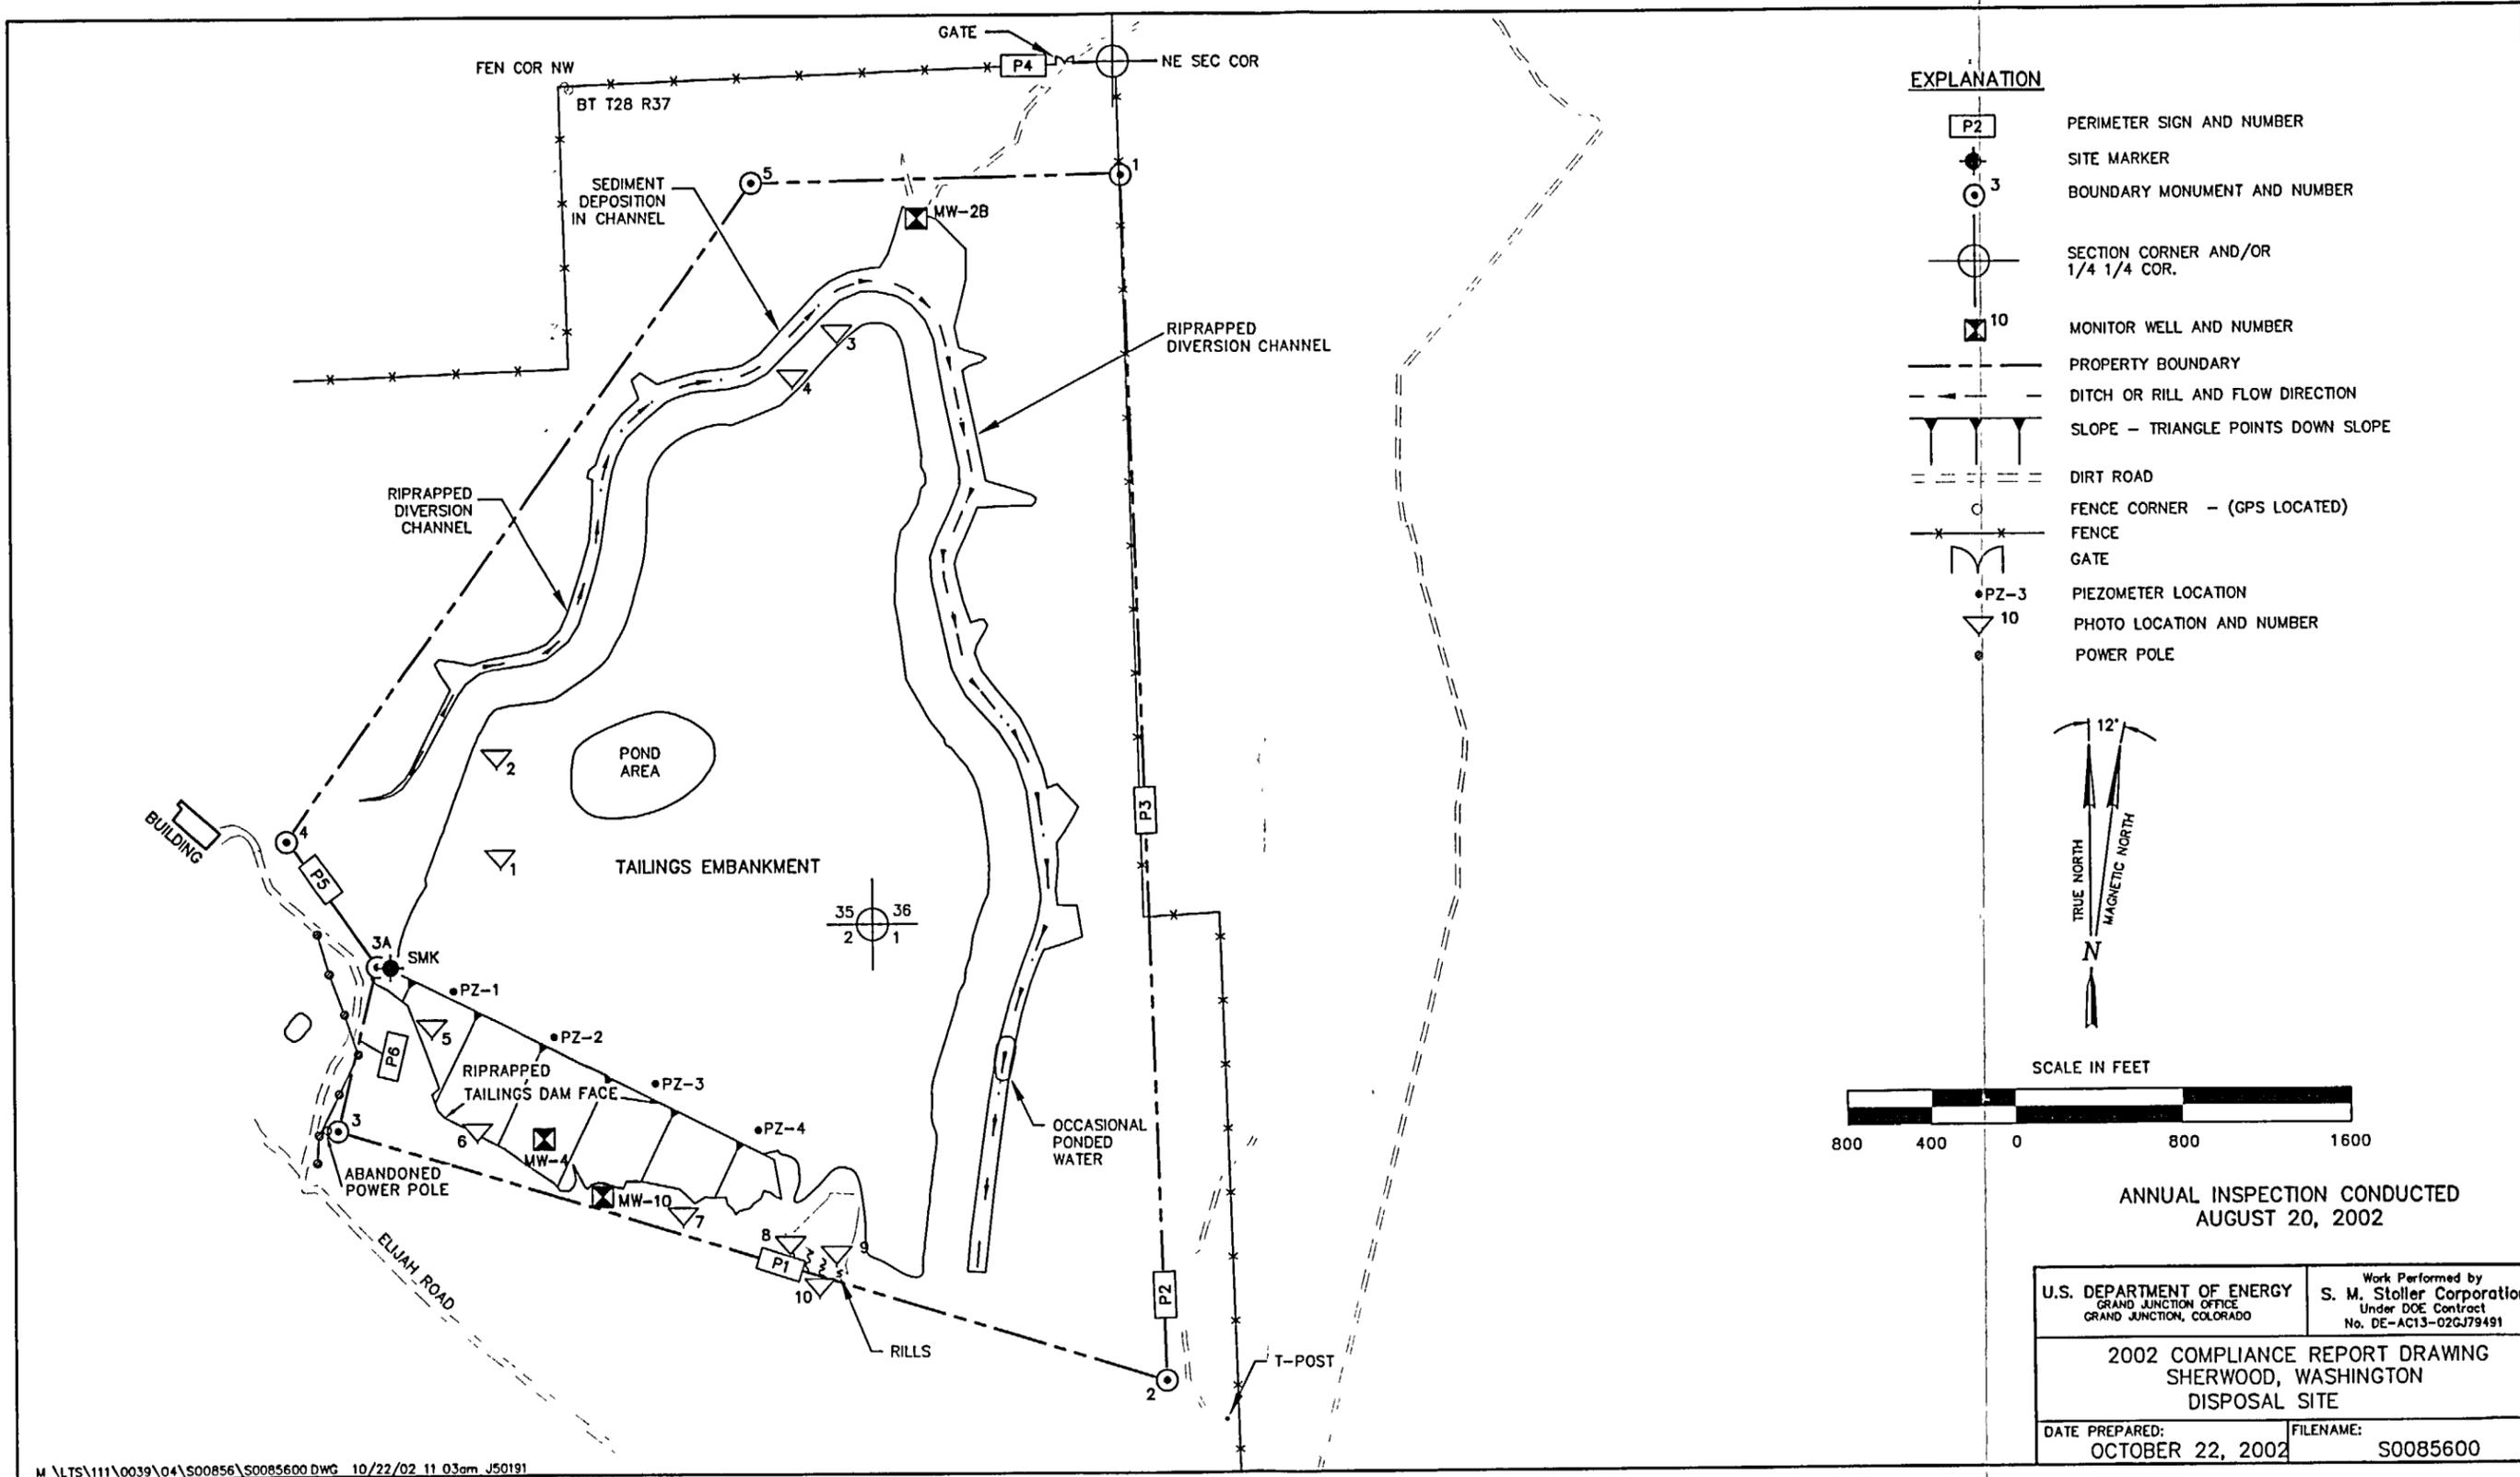
Figure 3-1. Sherwood, Washington, 2002

Inspectors walked the length of the diversion channel. Volunteer plant intrusion within the diversion channel is evident in most areas of the channel; however, this intrusion is not expected to interfere with the channel's design function. Rock condition is good and is the same as observed during earlier inspections. Sediment deposition is evident in places on the west side of the diversion channel (PL-3 and PL-4), but currently does not interfere with the channel's design function. The degree of sediment deposition should be noted during future inspections although it is not expected to increase to the degree that it could become a maintenance issue. At times, standing water has been observed in the channel along the east side of the impoundment (see Figure 3-1); this area was dry during the 2002 inspection.
