**HOLTEC PRESENTATION TO NRC**

**TECHNICAL ISSUES MEETING**

**January 9, 2003**

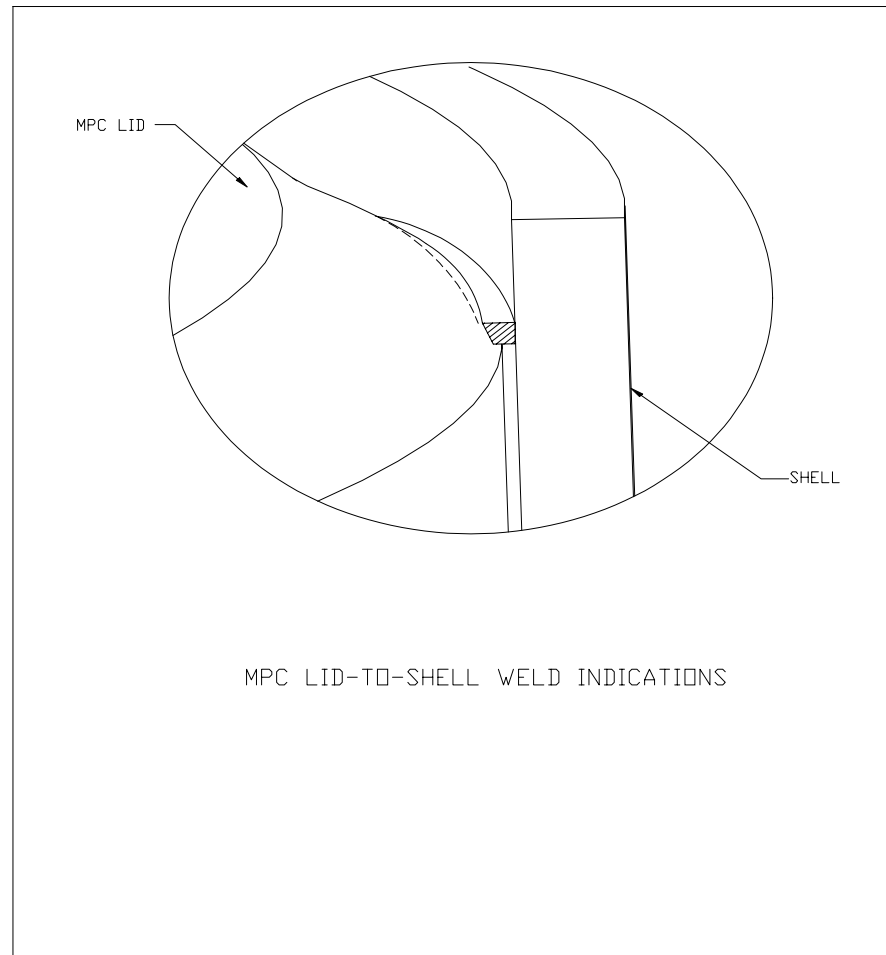
- Summary of Hatch Welding Difficulties
  - Rejectable indications found in MPC lid base metal during liquid penetrant examination of root pass
  - Indications distributed along entire circumference having the appearance of porosity
  - Code weld repairs attempted by grinding and re-welding - similar indications found
  - Changes in welding processes (GTAW, FCAW, SMAW) and welding parameters also unsuccessful

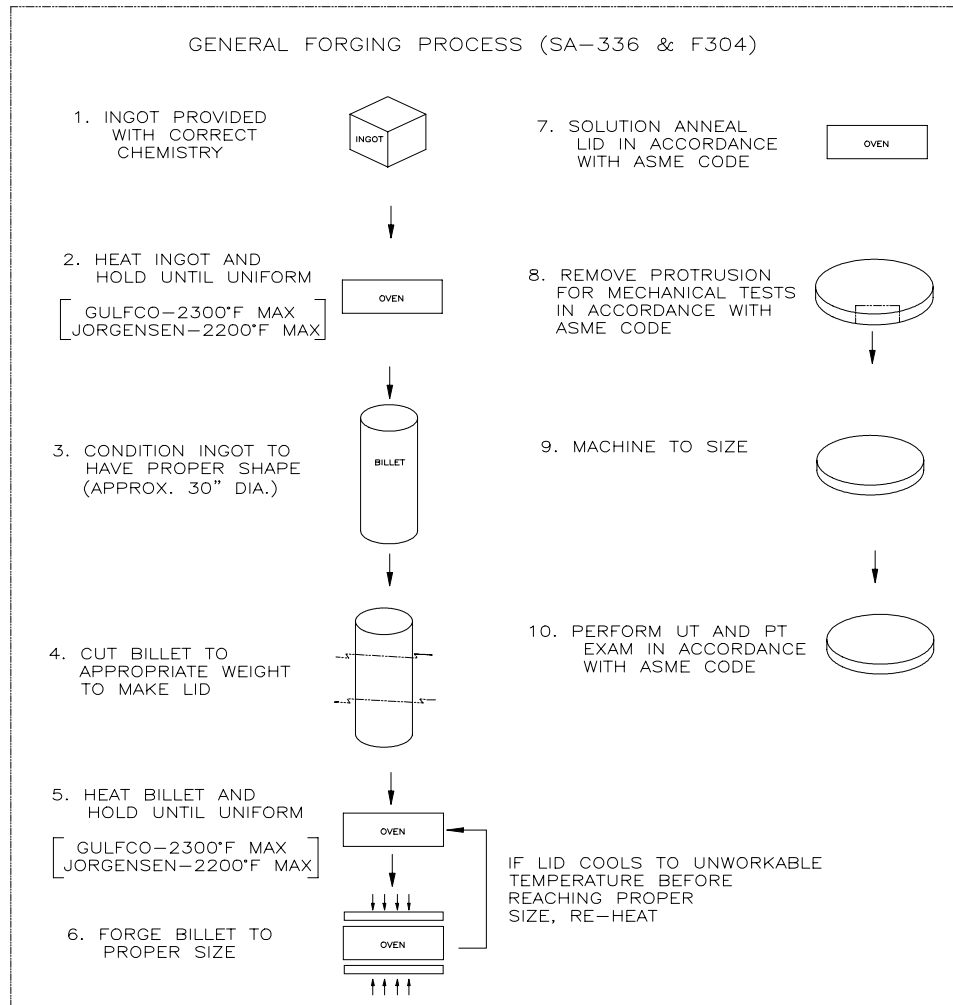
- Large grain size ( $\geq$  "00" ASTM E-112) of lid forgings makes the lid susceptible to liquation cracking (grain boundary cracking in the base metal)
- Subject lids met all ASME requirements for mechanical properties and chemistry
- Lids already in service are unaffected based on satisfactory weld inspection

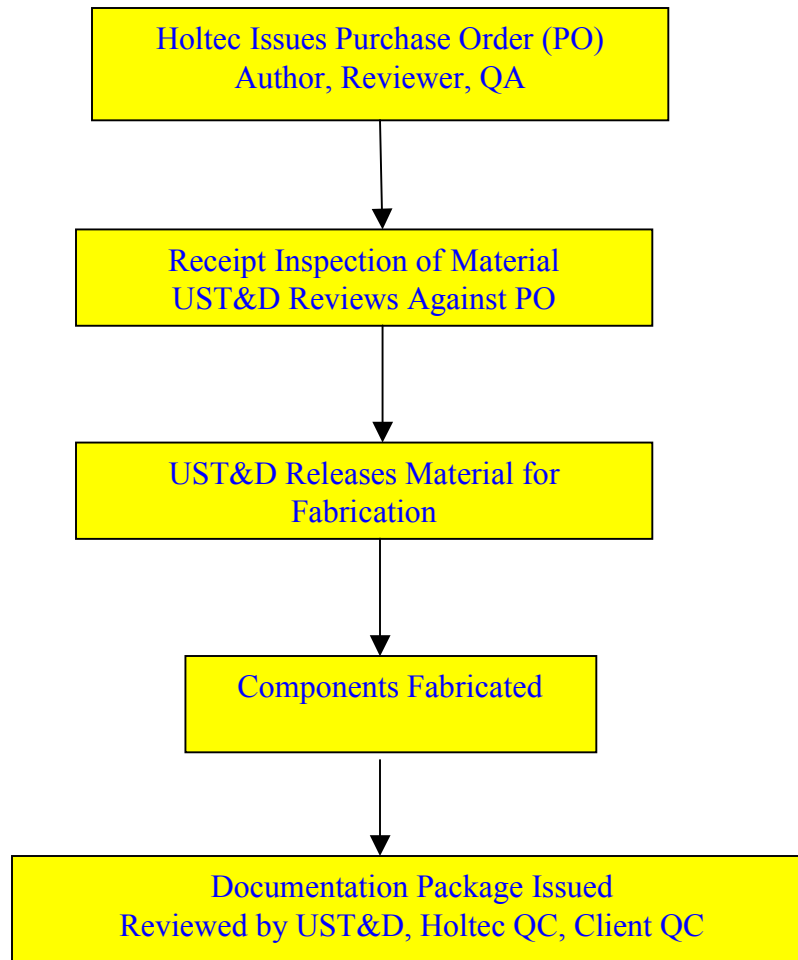
## Material Flow Chart

- Root Cause
  - Inadequate self-checking of procurement documents by author/reviewer
- Contributing Cause
  - Technical and quality information not easily accessible/organized for procurement agent
