Subject: *2002 Annual Site Inspection and Monitoring Report for UMTRCA
Title I Disposal Sites*

2002 Annual Site Inspection and Monitoring Report for Uranium Mill Tailings Radiation Control Act Title I Disposal Sites

GJO-2002-392-TAC
GJO-LREP 6.3.1-5

December 2002

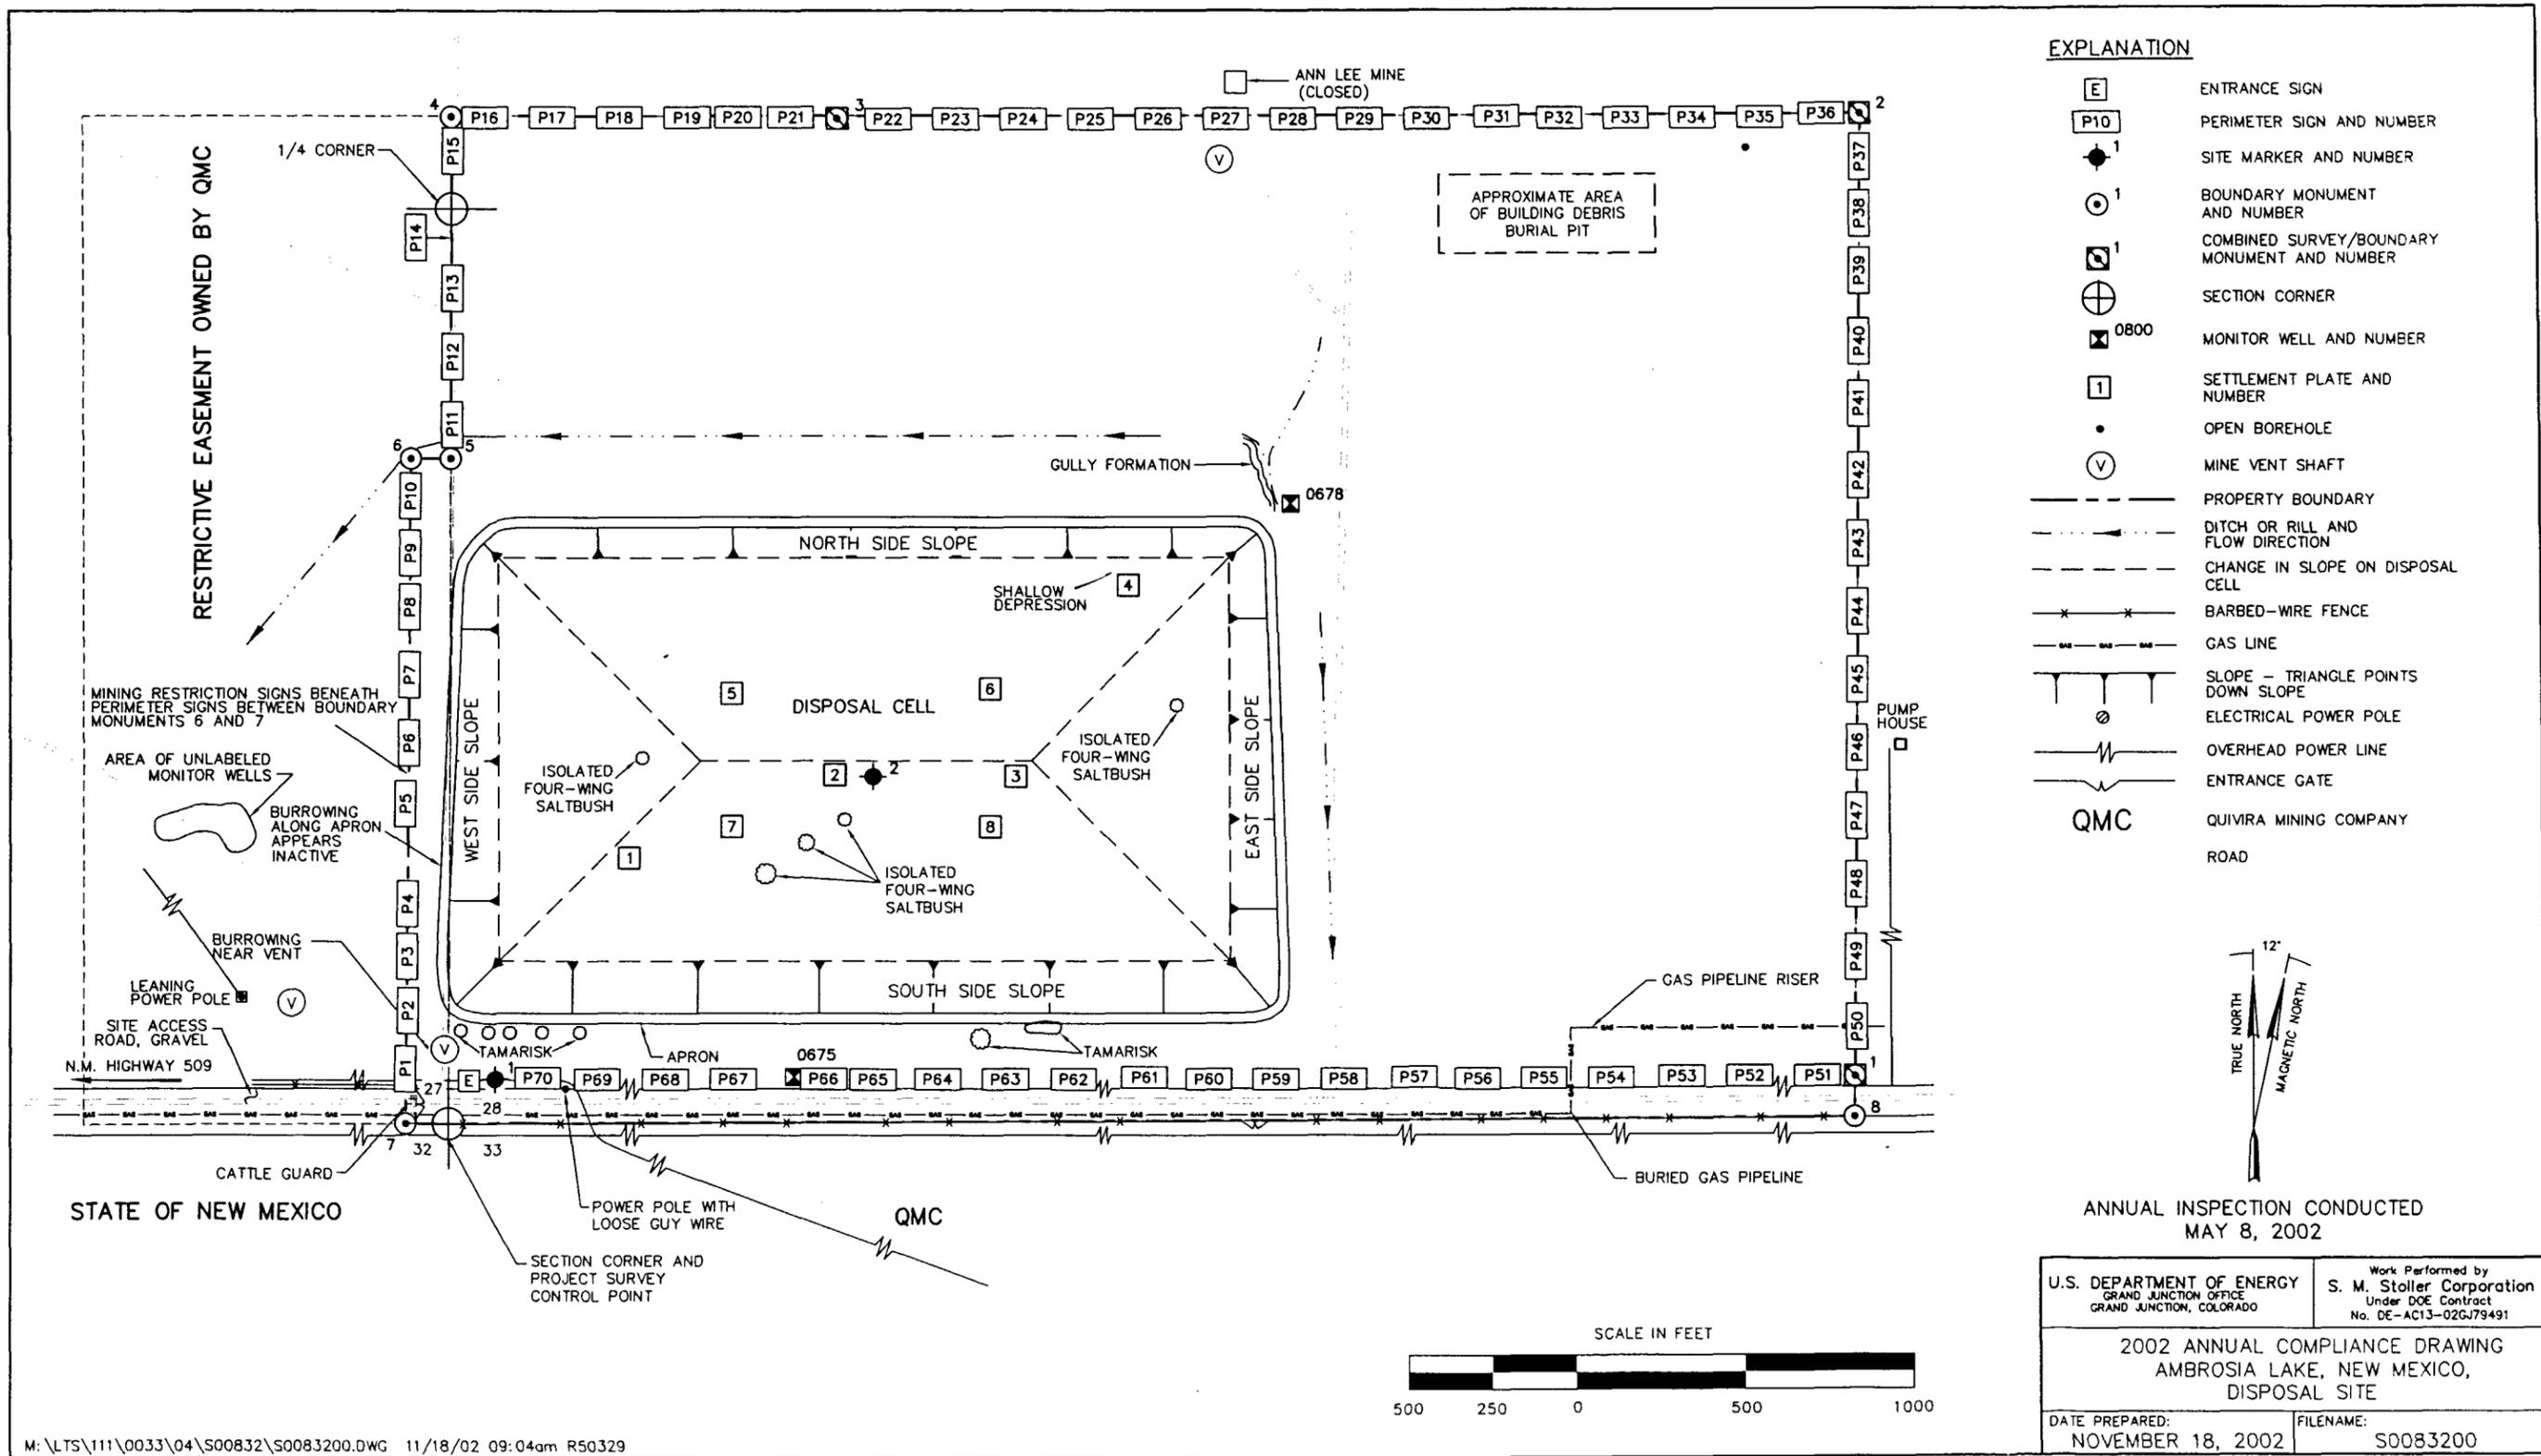
Figure 1-1. 2002 Annual Compliance Drawing for the Ambrosia Lake, New Mexico, Disposal Site

1A **Top of Disposal Cell**—The top of the disposal cell was in excellent condition. With exception of one location there was no evidence of cracking, settling, slumping, or erosion. A shallow depression around settlement plate SP-4 was first noted during the 1997 inspection; however, there has been no visible indication to suggest the depression holds water. At the time of the 2002 annual inspection, the subsidence was estimated to measure approximately 20 feet across and approximately 1 foot in depth. The depression will continue to be monitored to ensure the integrity of the cell cover.

1B Several isolated four-wing saltbush shrubs were observed at various locations on the cell cover. These deep-rooted shrubs growing on the disposal cell will be removed before the next inspection.

1C **Side Slopes and Apron**—The side slopes and apron were in excellent condition and showed no evidence of cracking, settling, slumping, or erosion. Tamarisk was observed growing in several locations along the southern edge of the disposal cell apron and will be removed before the next inspection. No evidence of recent animal burrowing was noted during this year's inspection. No standing water was observed in the apron along the south side slope, as had been noted during previous inspections.

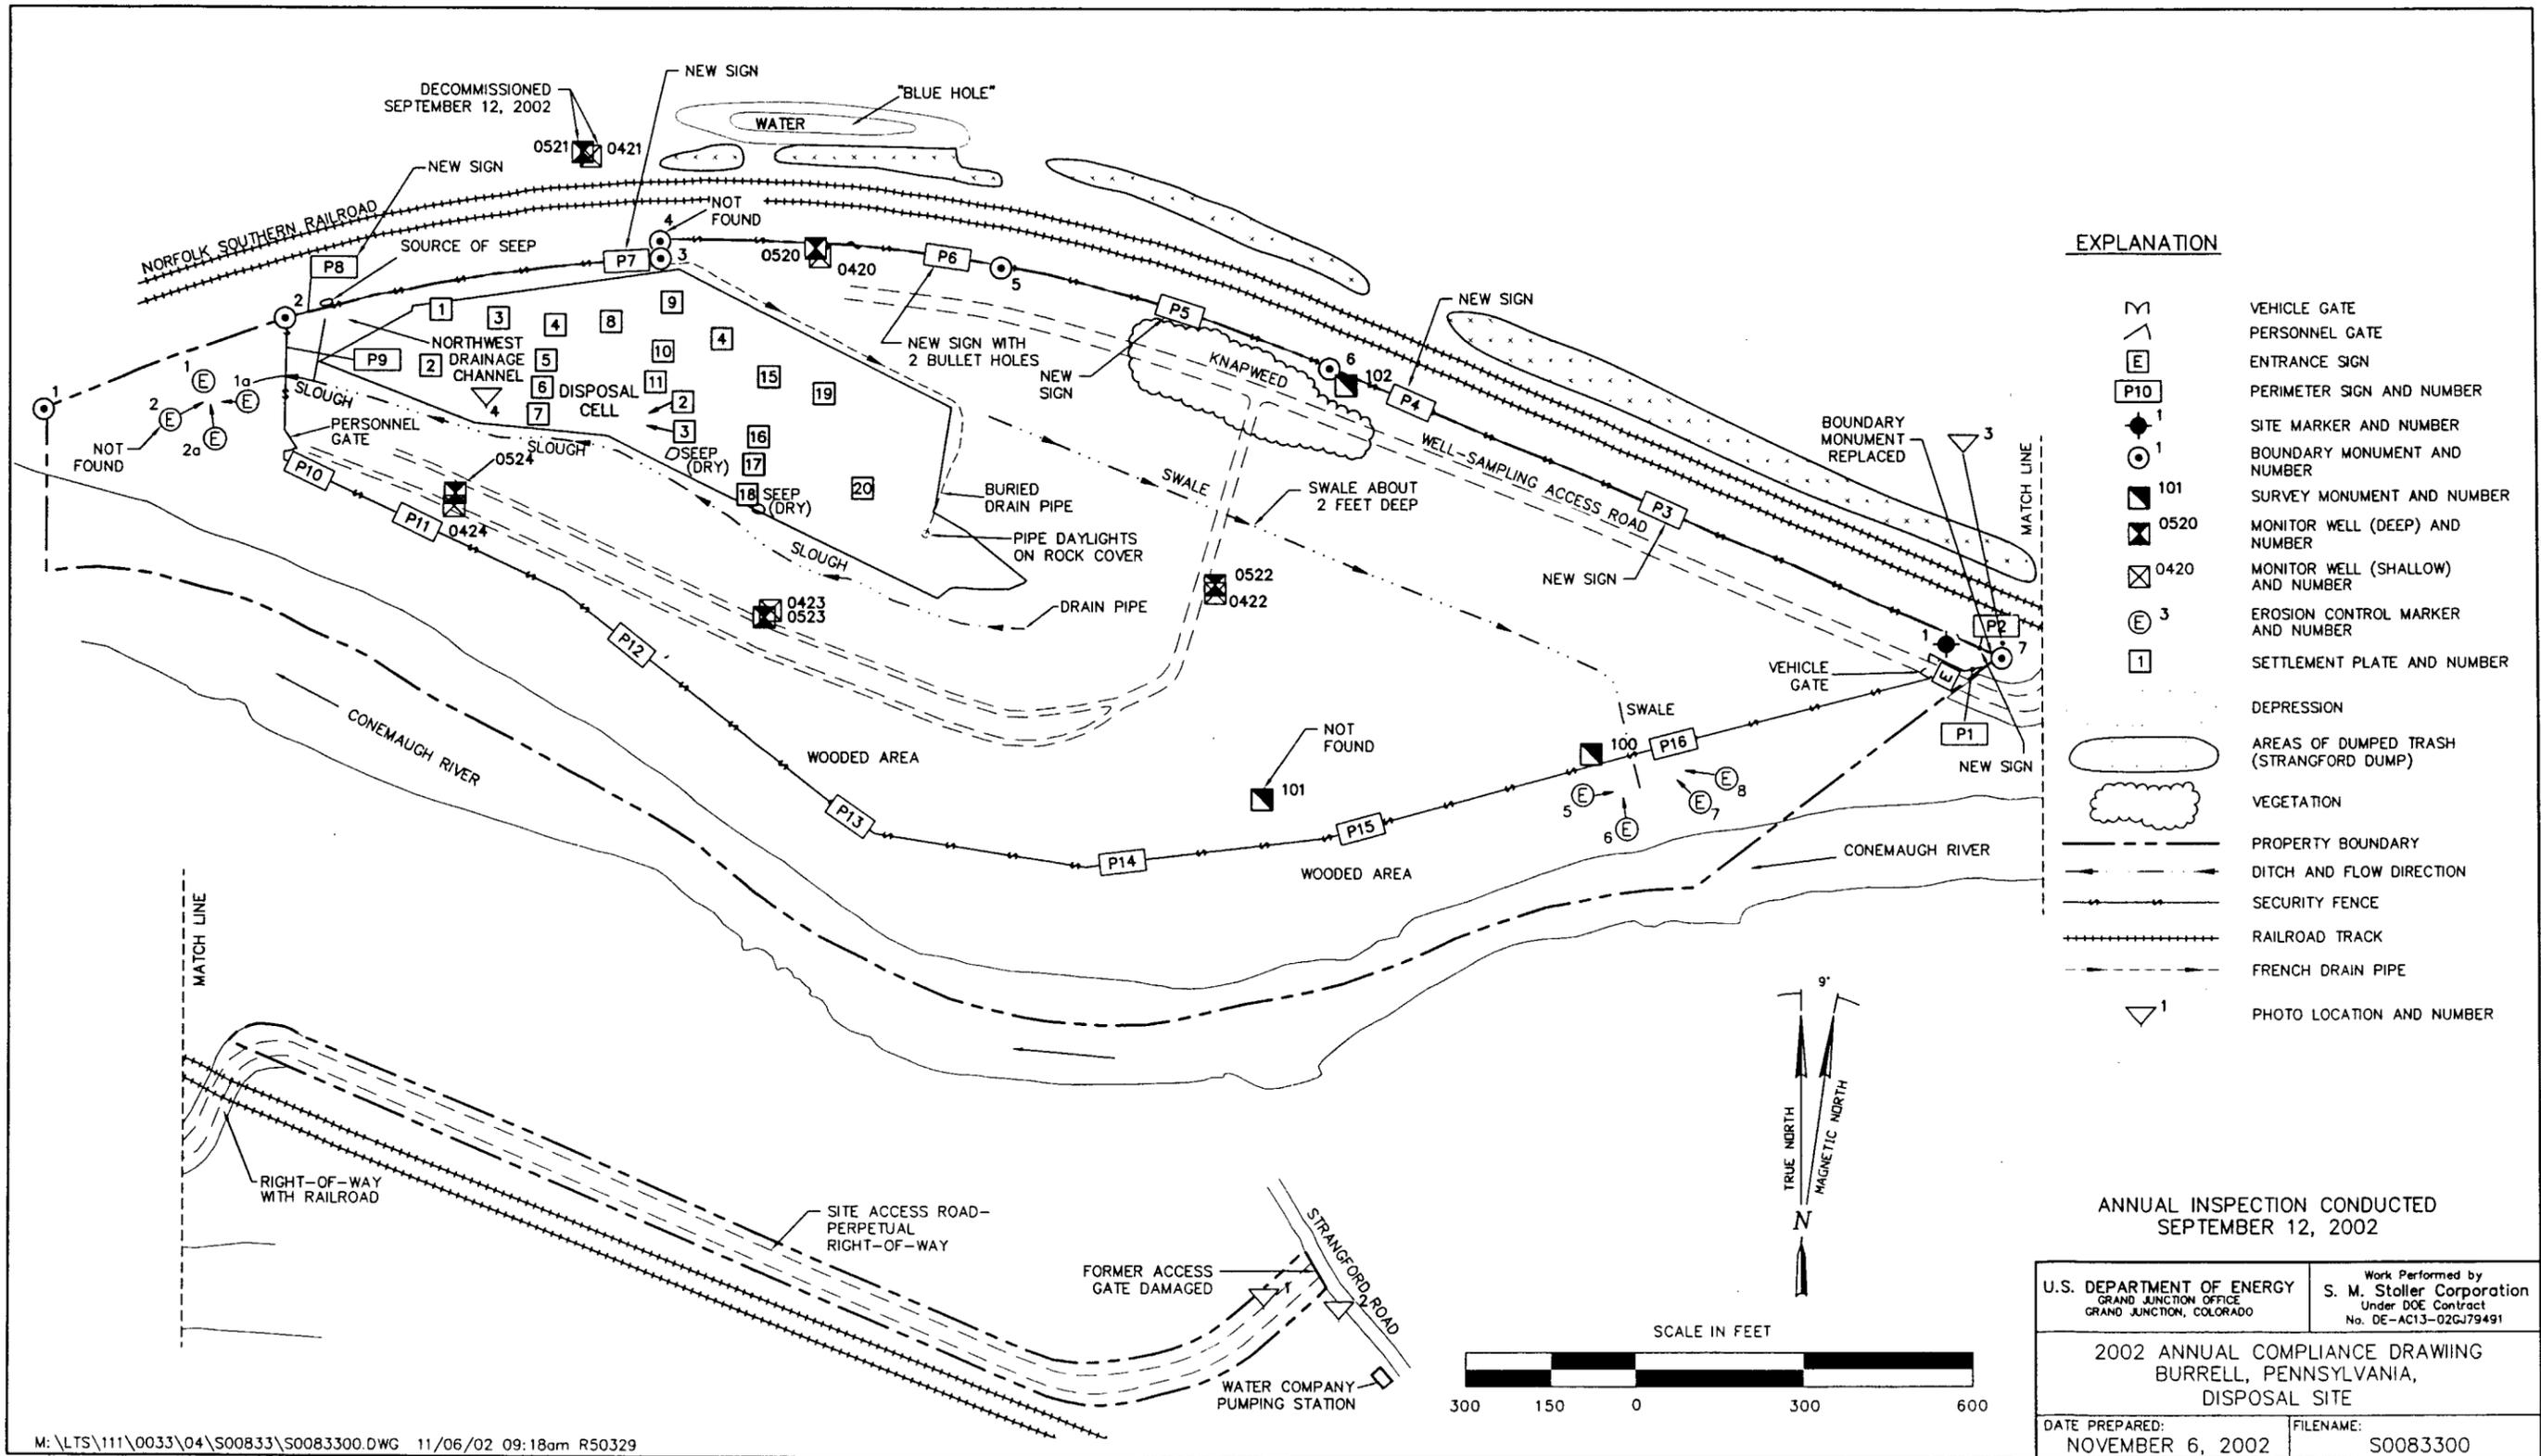
Figure 2-1. 2002 Annual Compliance Drawing for the Burrell, Pennsylvania, Disposal Site

2C The entrance sign and 17 perimeter signs are attached to the security fence. Over the past several years, inspectors noted that perimeter signs along the northern perimeter fence between perimeter sign locations P1 and P8 were progressively more damaged by gunfire to the point where, in 2001, the signs were essentially illegible. DOE replaced the damaged signs in December 2001. Inspectors found the new signs in reasonably good condition, although perimeter sign P6 already had two bullet holes in it. Because access to the other side of the site is more difficult, the remaining perimeter signs were in good condition.

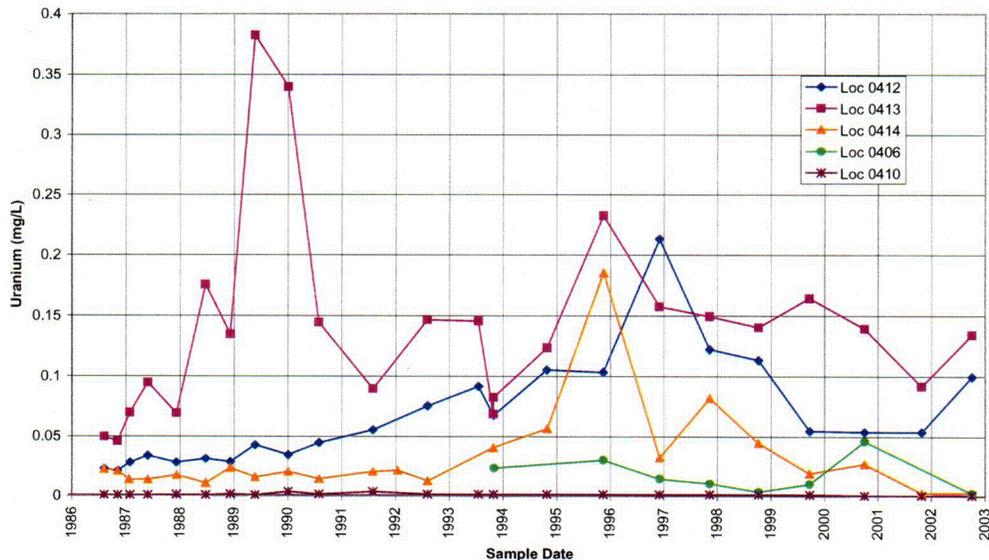
Figure 3-2. Time-Concentration Plot of Uranium in Ground Water at the Canonsburg, Pennsylvania, Disposal Site

Uranium is the analyte of primary concern at this site because of the frequency with which it has exceeded its maximum concentration limit of 0.044 mg/L. Time-concentration plots for uranium in ground water are shown in Figure 3-2 (well 0424 is not shown because concentrations are at or below the detection limit). The plots representing wells 0406 and 0414 include respective data from replacement wells 0406A and 0414A. Uranium concentrations exceeded the standard at two of the four downgradient wells (0412 and 0413) in 2002. Historically (before 1992), uranium concentrations at well 0414 were consistently elevated above levels observed at upgradient well 0410 but still below the maximum concentration limit. Uranium concentrations at well 0414 increased between 1993 and 1995, and decreased until the well was replaced. Uranium concentrations observed in replacement wells 0406A and 0414A have been near the laboratory detection limit since they were installed, perhaps due to lithological or hydrological differences in the unconfined aquifer between them and the wells they replaced. Uranium concentrations were below the laboratory detection limit at all sampling locations in Chartiers Creek.

The elevated concentration of uranium at some wells, and the wide fluctuations in uranium at these wells over the years, are probably unrelated to disposal cell performance for the following reasons: (1) there is remnant contamination outside the disposal cell; (2) the geochemistry of ground water in the unconsolidated materials beneath the disposal cell apparently is favorable for the mobilization of uranium; and (3) high levels of uranium existed in ground water before construction of the disposal cell.

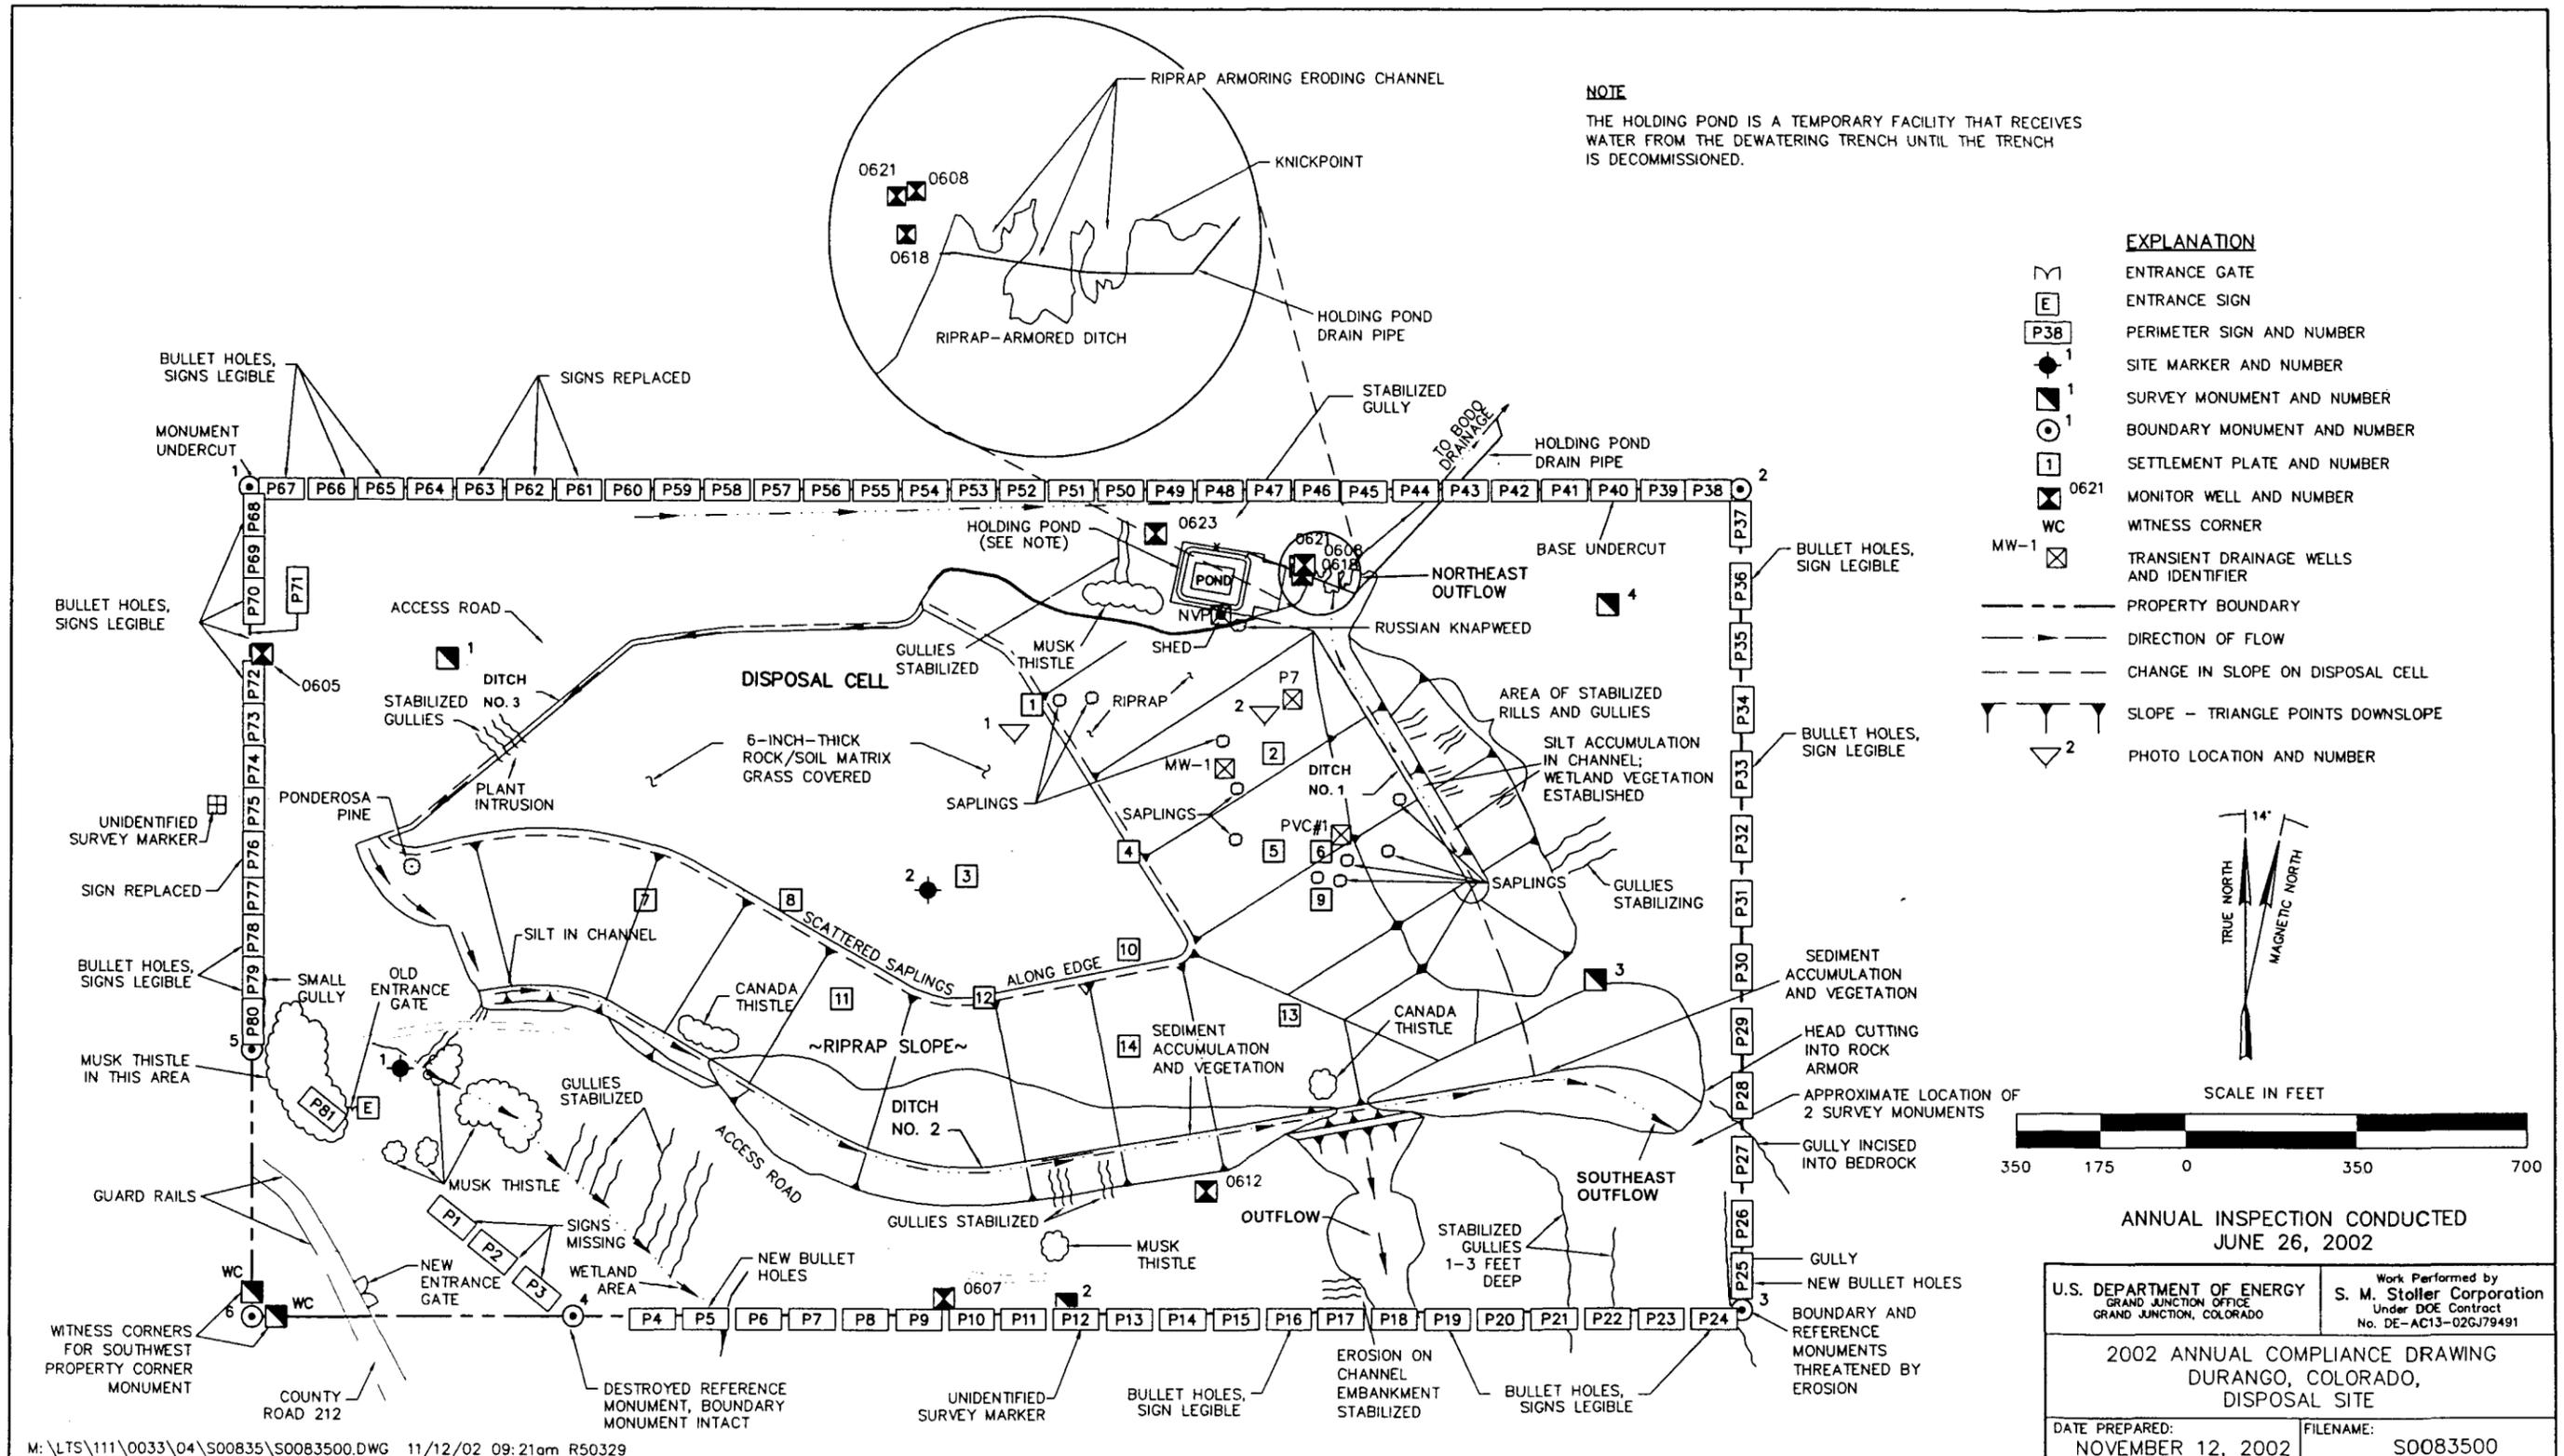
Figure 4-1. 2002 Annual Compliance Drawing for the Durango, Colorado, Disposal Site

4B At the time of the 2002 inspection, vegetation on top of the cell was dry and stressed due to drought conditions. The vegetation consists of seeded grasses and several volunteer species including deep-rooted shrubs and trees (PL-1), and musk thistle. In accordance with the Long-Term Surveillance Plan, the deep-rooted plants were cut and herbicide was applied to their stalks.

4C Musk thistle needs to be controlled as recommended by La Plata County. DOE initiated biological control of this weed in 2002 by releasing the Thistle Defoliating Beetle at thistle locations. This beetle has been used by the state to control the thistle in the area around the disposal site. The effectiveness of this biological control effort will be evaluated during future inspections.

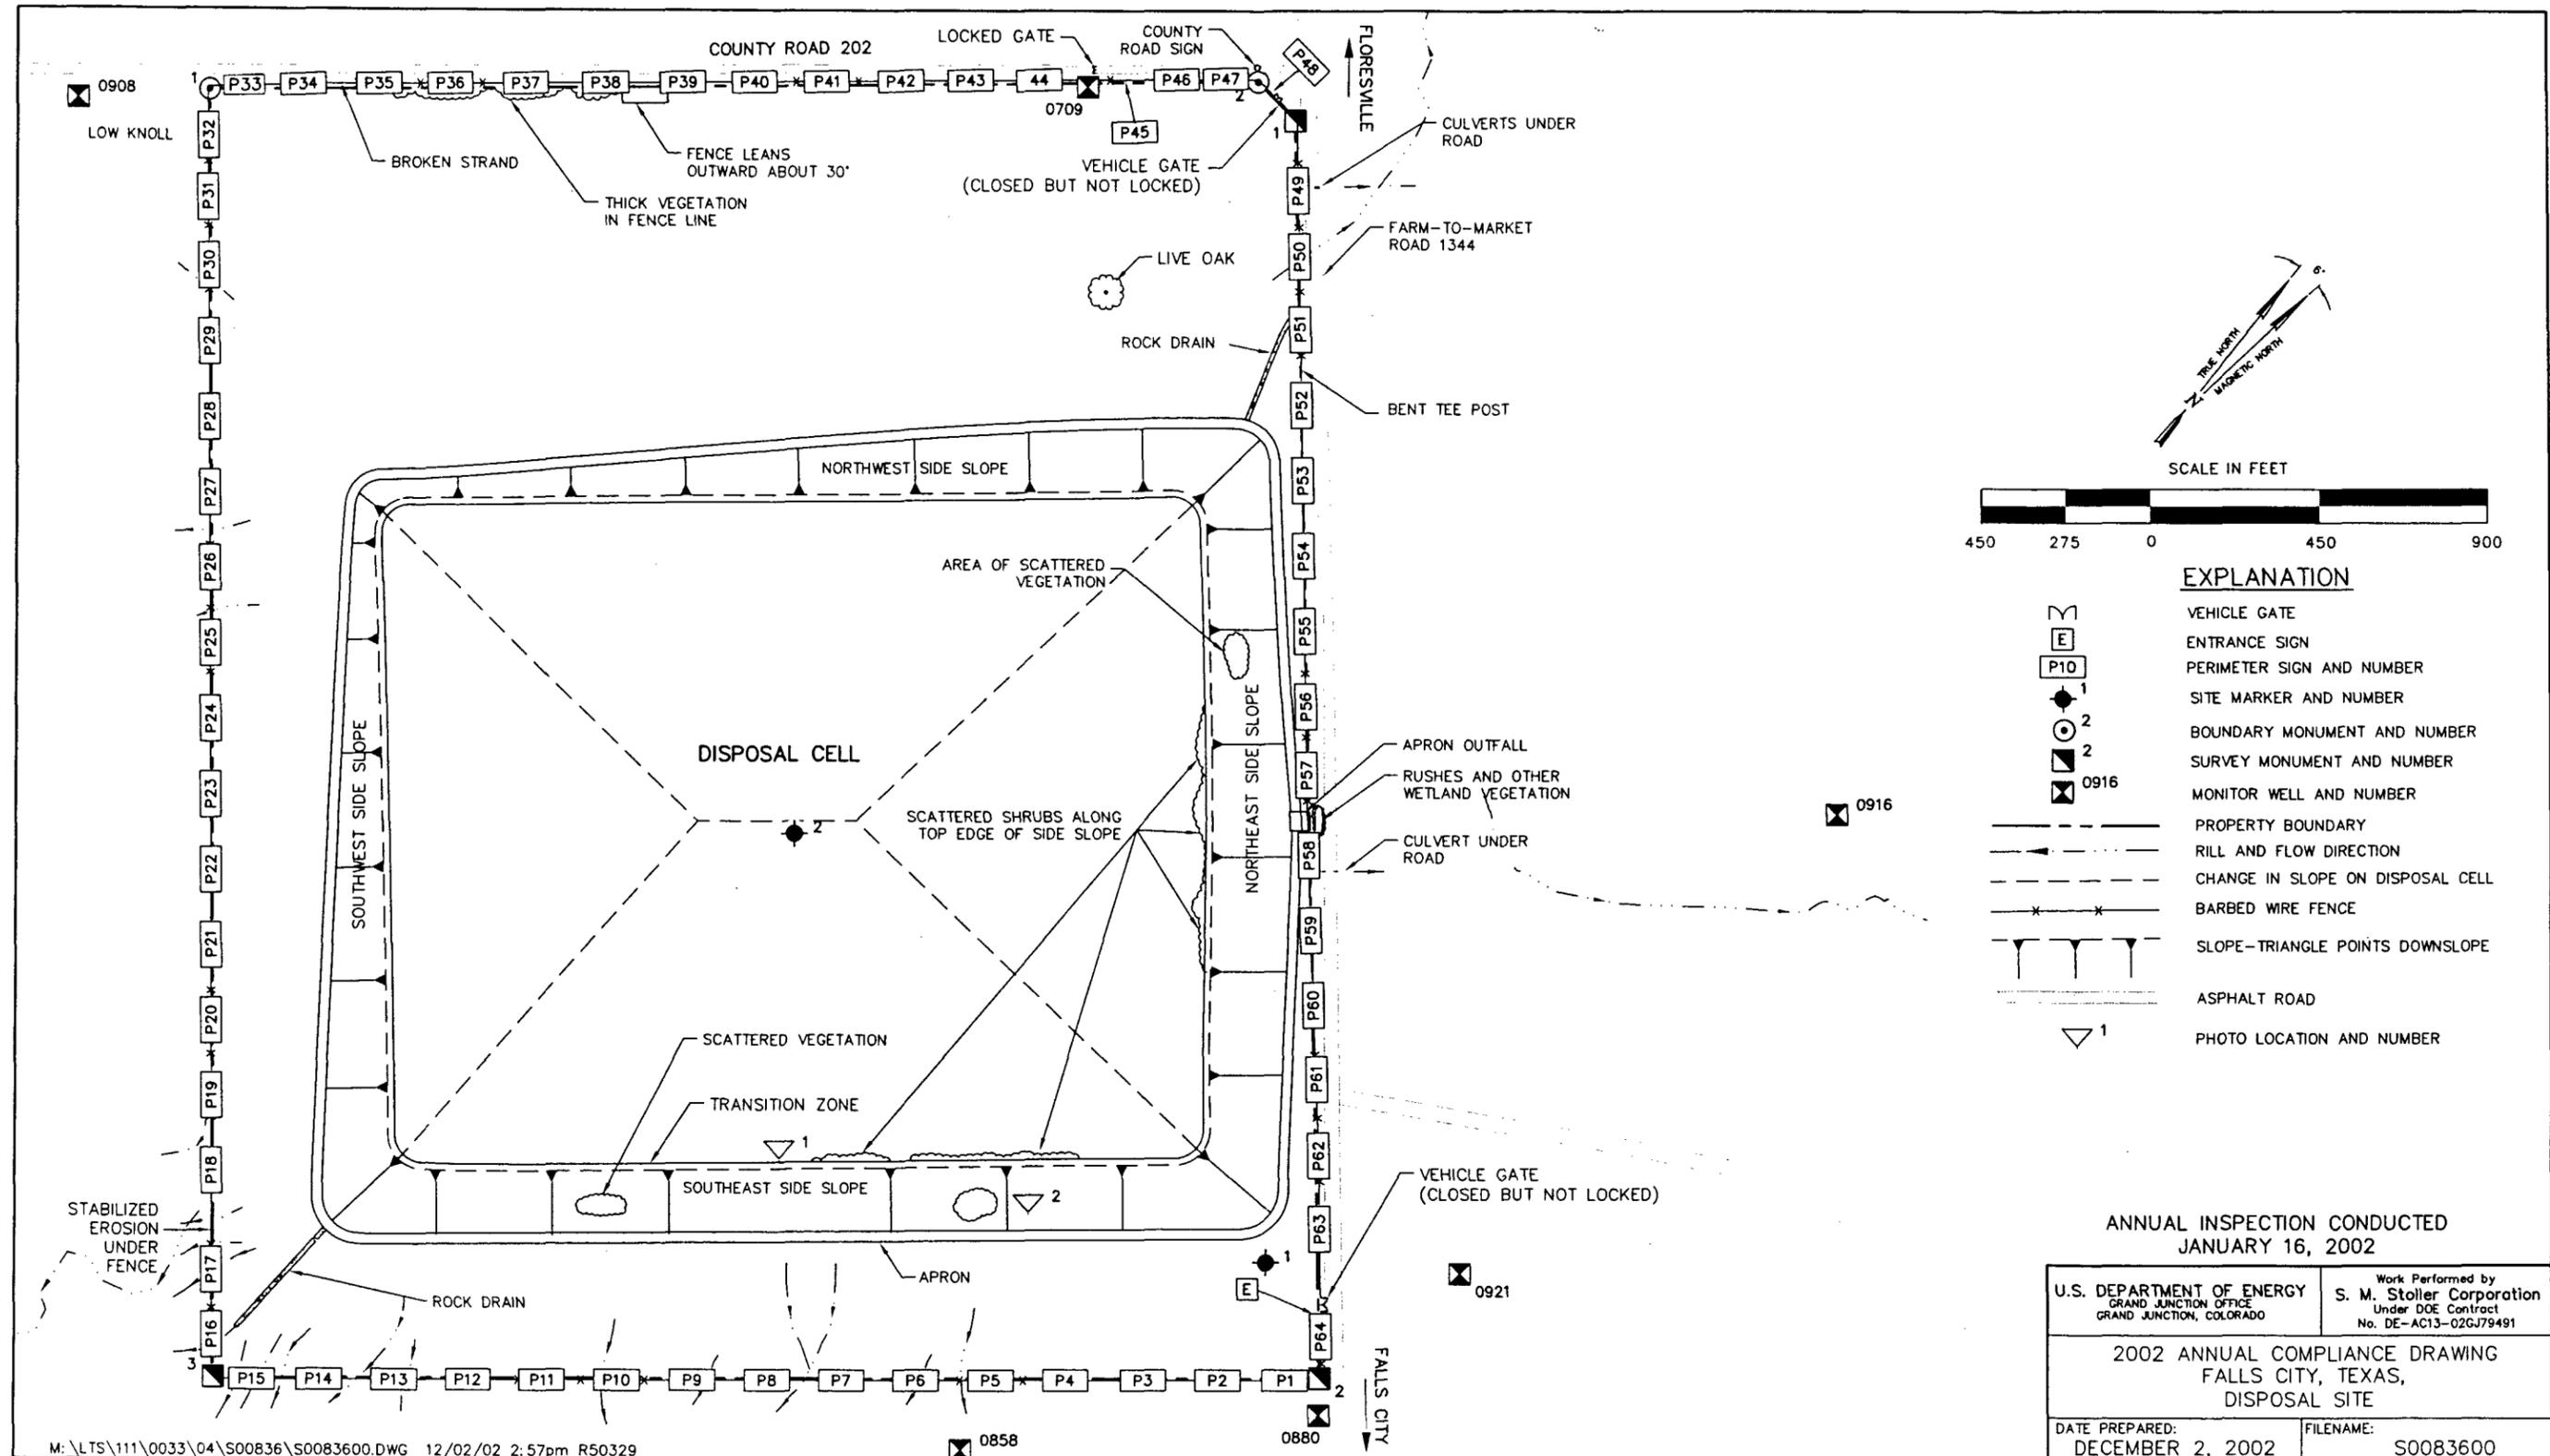
Figure 5-1. 2002 Annual Compliance Drawing for the Falls City, Texas, Disposal Site

Small amounts of fractured riprap were observed along the side slopes, as also noted during previous inspections. It has not been determined if the fractured riprap is an artifact of quarrying and placement or an indication of rock degradation. If subsequent inspections indicate that rock degradation may be occurring, implementation of a formal monitoring program will be evaluated.

Small scattered trees and bushes that had established on the side slopes were mostly absent. Inspectors sprayed the plants with herbicide in previous years and a local farmer was contracted to eradicate the perennial plants. Greasewood and similar species are concerns because they are deep-rooted. Most vegetation was dead including annual plants and most woody species; however, new growth on some previously treated plants was observed (PL-2). Vegetation control will continue on the side slopes.

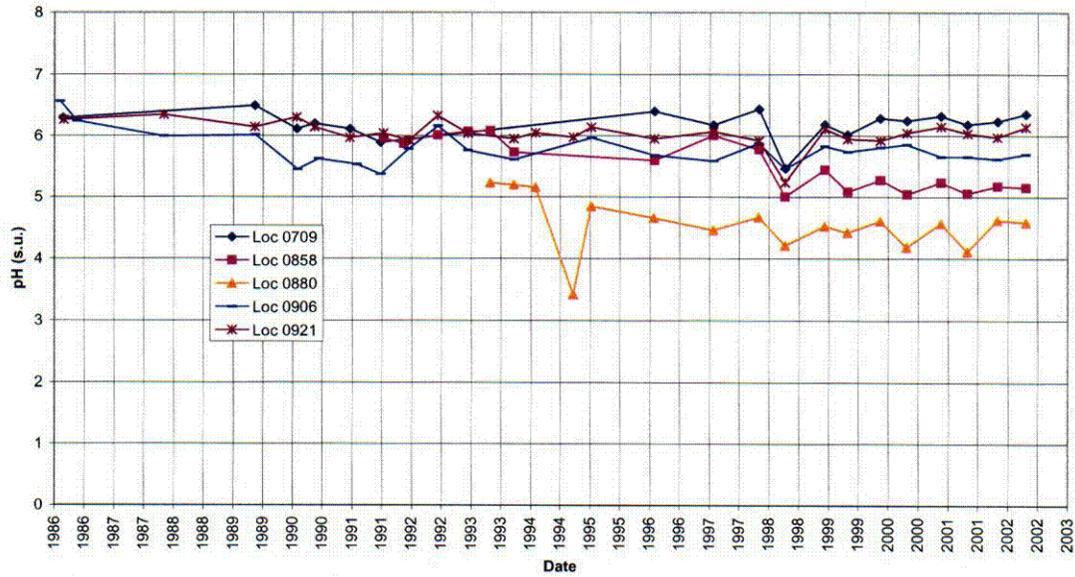
Figure 5-3. Plots of Ground Water pH at Cell Performance Monitor Well Locations at the Falls City, Texas, Disposal Site

The Long-Term Surveillance Plan identifies pH as the indicator parameter for cell performance monitoring on the basis of tailings pore-fluid chemistry. However, legacy plumes typified by low pH exist beneath the cell in a ground water mound created by infiltration from historical tailings impoundments and mill effluent discharges. These plumes would be expected to spread outward as the ground water seeks an equilibrium level; however, buffering mechanisms caused by interaction of low pH waters and formation materials are expected to limit plume extent. The pH of the ground water samples collected in 2001 and 2002 was essentially unchanged and consistent with previous results for all wells (Figure 5-3).

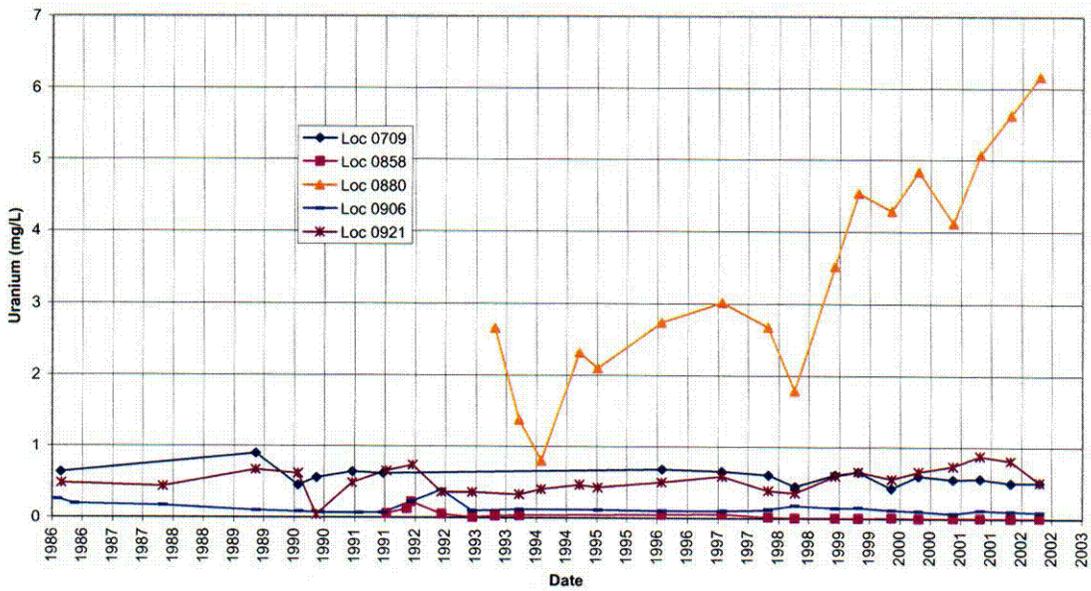
Figure 5-4. Time-Concentration Plots of Uranium in Ground Water at Cell Performance Monitor Well Locations at the Falls City, Texas, Disposal Site

Analytical results from 2002 are consistent with previous results and what would be expected of ground water contaminated by uranium mineralization. Of the 10 analytes, concentrations of arsenic, cadmium, selenium, and uranium, and activities of radium and gross alpha, continue to exceed their respective standards in several wells. Uranium concentrations, though near or below the standard in most wells, continue to increase well above the standard in monitor well 0880 (Figure 5-4). This increase in concentration may be an indication of a legacy plume spreading outward as expected.

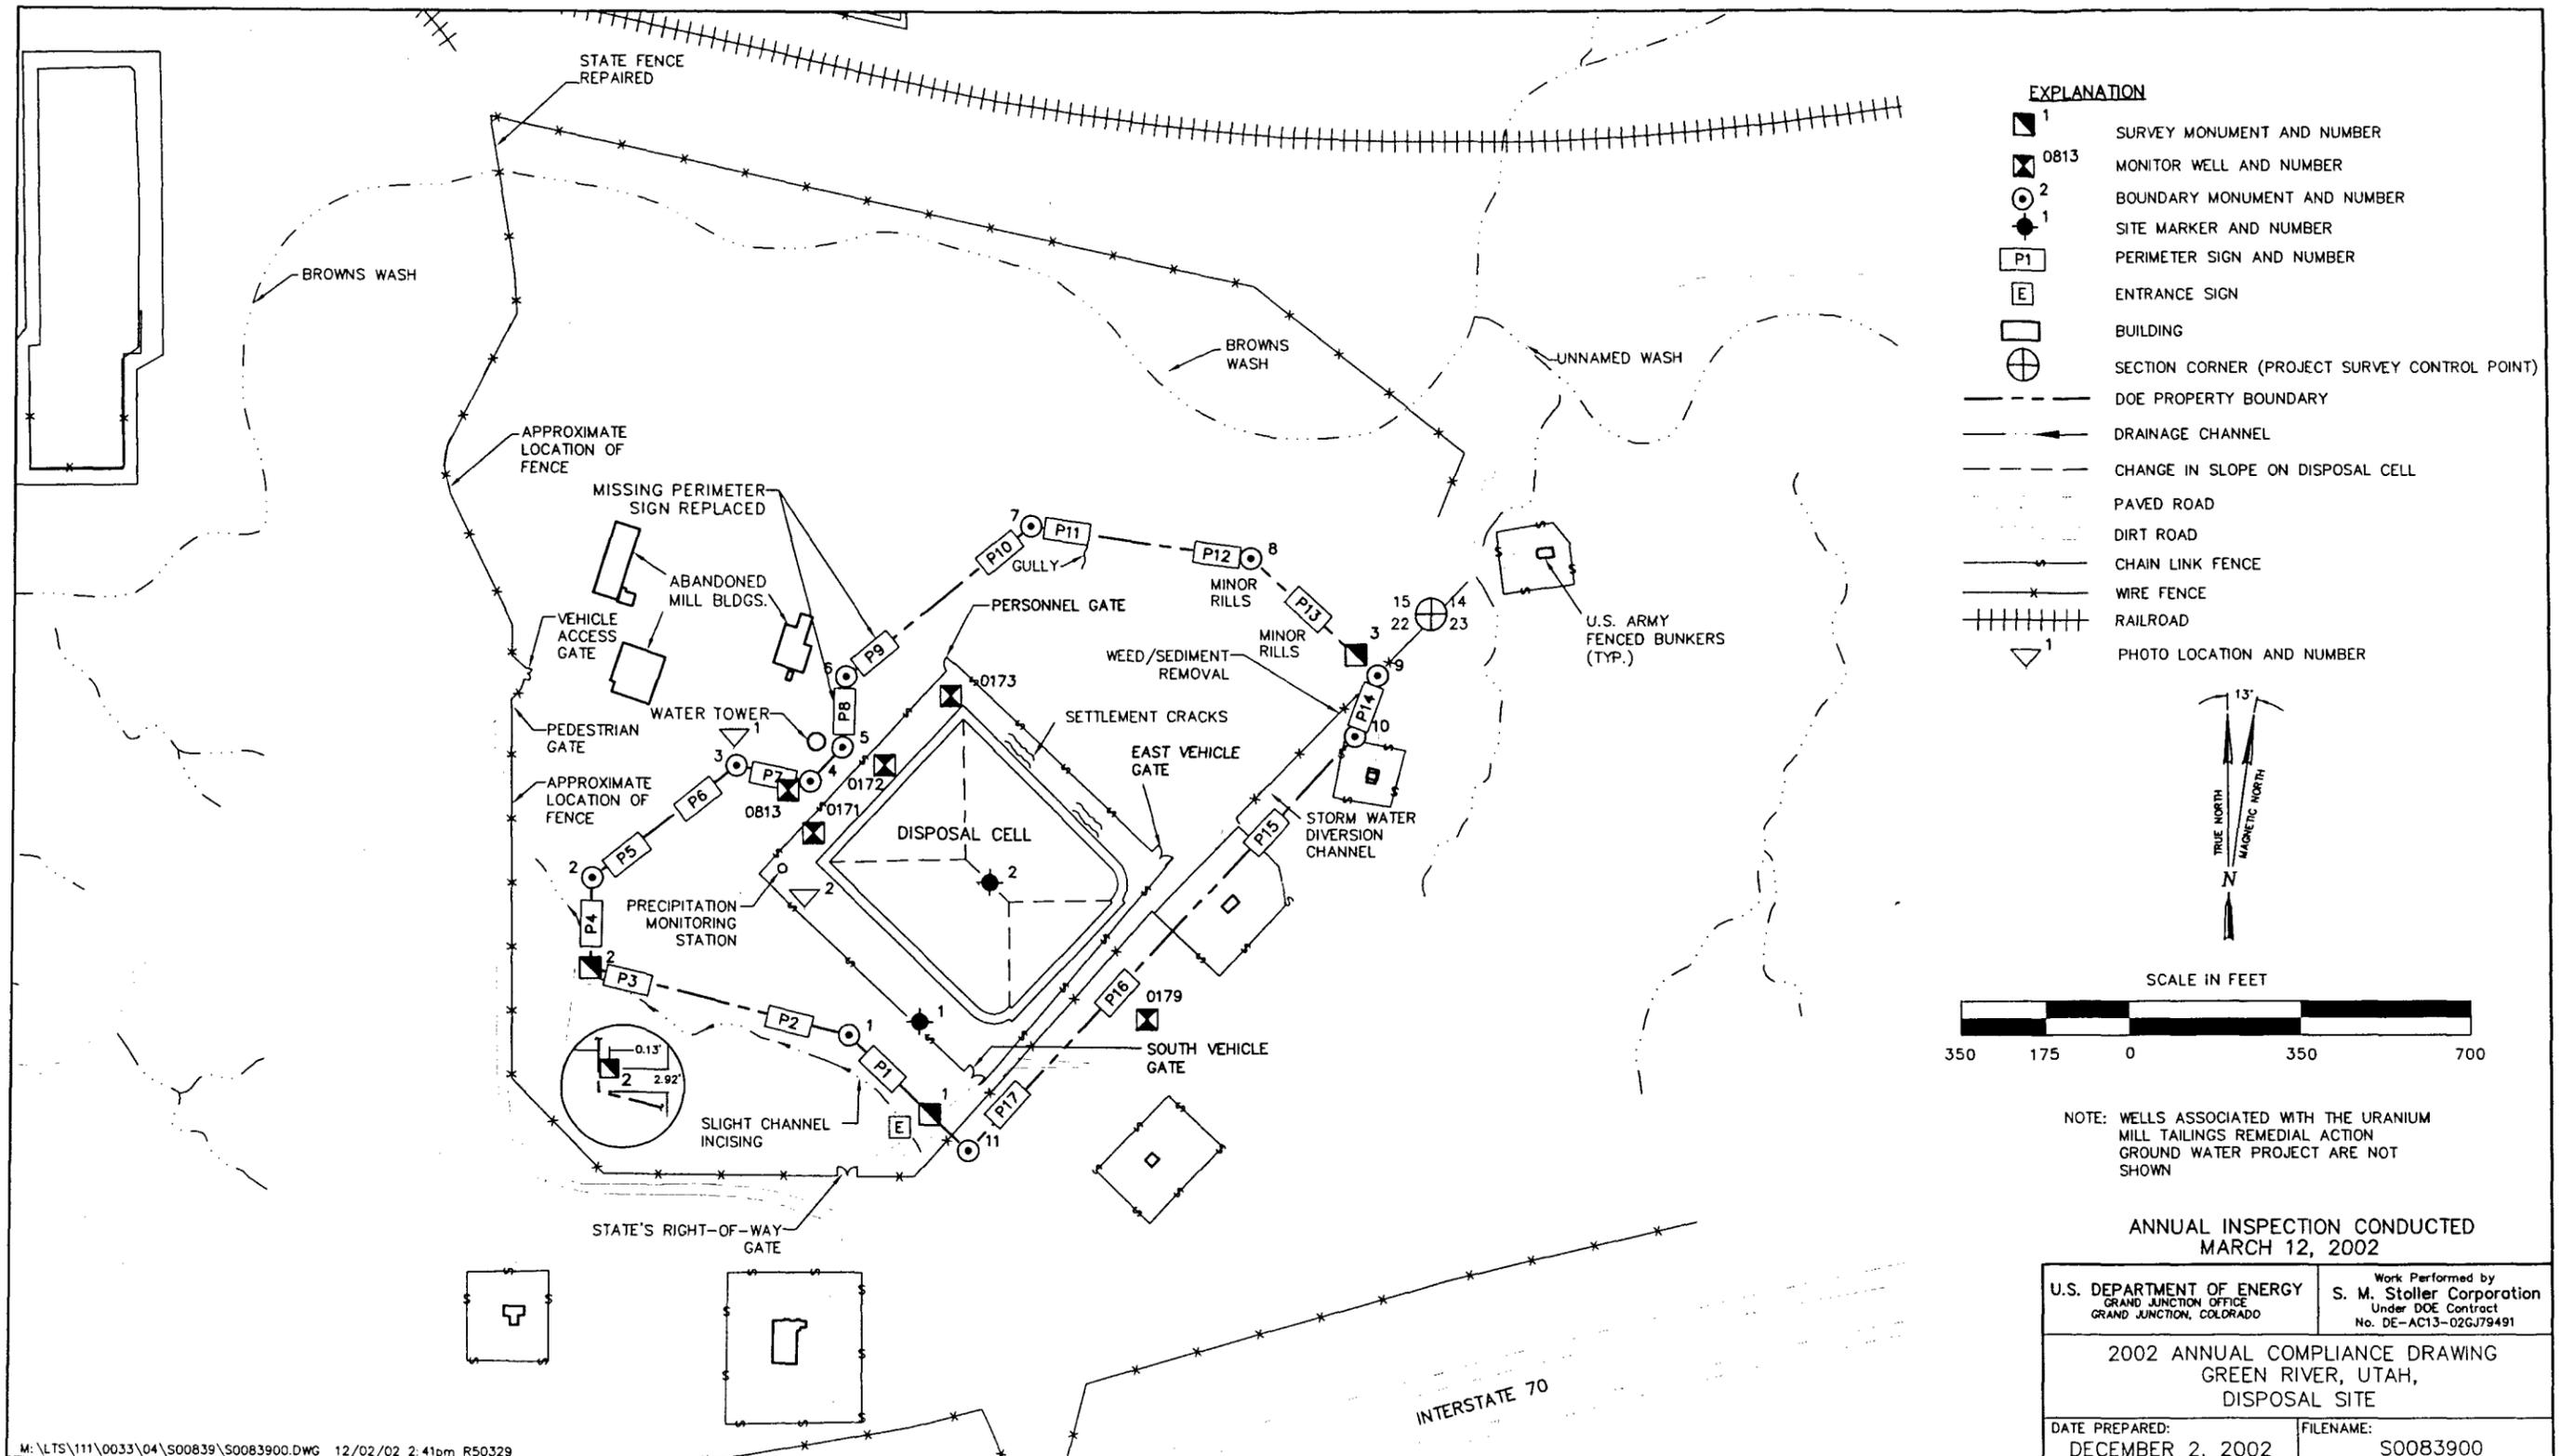
Figure 7-1. 2002 Annual Compliance Drawing for the Green River, Utah, Disposal Site

The diversion channel along the base of the disposal cell on all sides was in excellent condition. As noted in previous inspections, the small-scale rill erosion at the southwest corner of the disposal cell was inspected and found to be unchanged from last year. This erosional feature is not considered to be a threat to the disposal cell and no further action is required at this time.

Inspectors noted the series of linear cracks running parallel to the northeastern edge of disposal cell, which were first observed in 2000. The cracks are located approximately 25 feet from the edge of the riprap, vary in length, and were approximately 6 to 10 inches deep. Wind blown sediments are filling the cracks, and the cracks do not pose a threat to the integrity of the disposal cell, nor do they warrant any maintenance action. The cracks are believed to be attributable to the settling of the soils that were backfilled against the cell apron.
