Subject: *2002 Annual Site Inspection and Monitoring Report for UMTRCA
Title I Disposal Sites*

2002 Annual Site Inspection and Monitoring Report for Uranium Mill Tailings Radiation Control Act Title I Disposal Sites

GJO-2002-392-TAC
GJO-LREP 6.3.1-5

December 2002

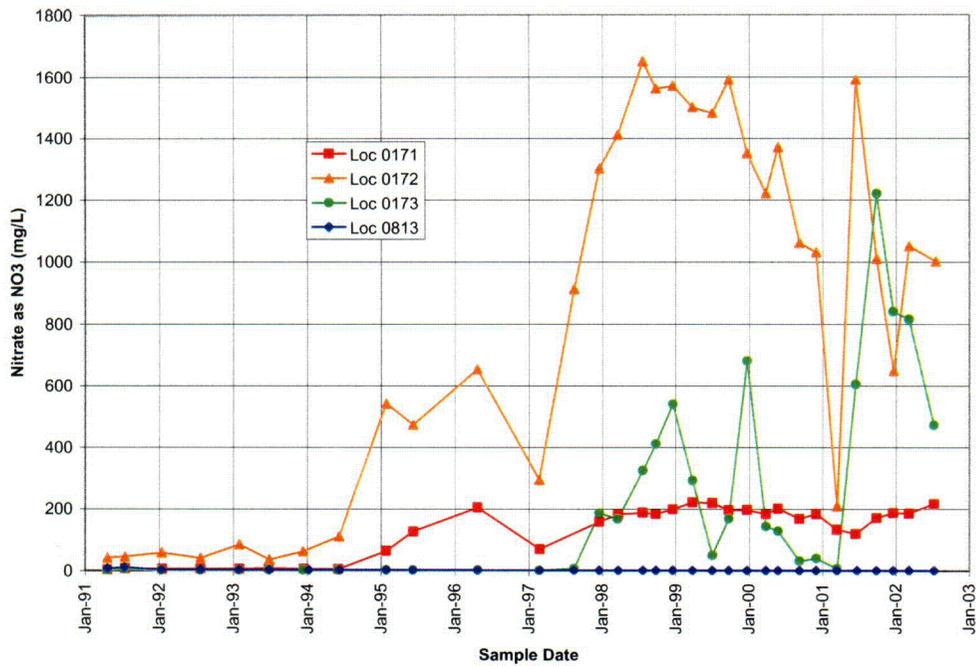
Figure 7-2. Time-Concentration Plots of Nitrate (as NO₃) in Ground Water at the Green River, Utah, Disposal Site

Ground Water Quality Monitoring—Concentrations of nitrate in ground water continued above the proposed concentration limits except in well 0813, where values were very near the laboratory detection limit (Figure 7-2). Nitrate concentrations fluctuated slightly in well 0171, but there was considerable variation in the values for wells 0172 and 0173.

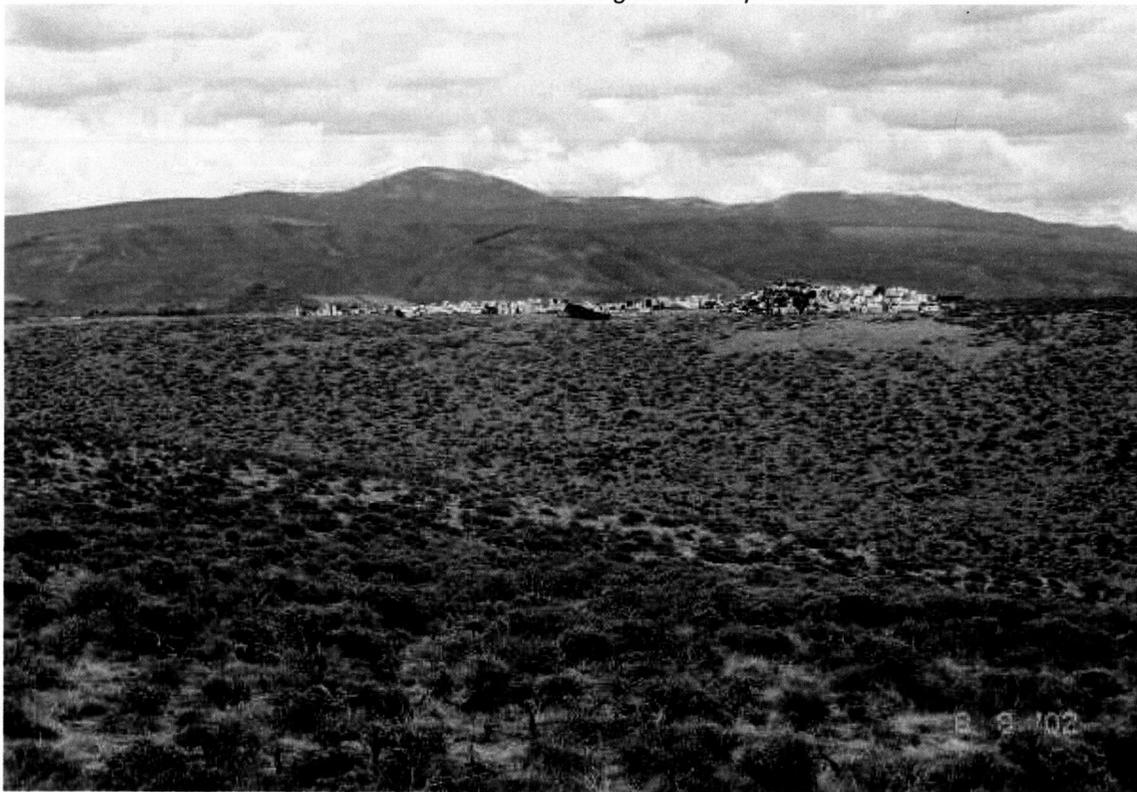
PL-2. View of appliance scrap/disposal area at Gunnison County landfill.

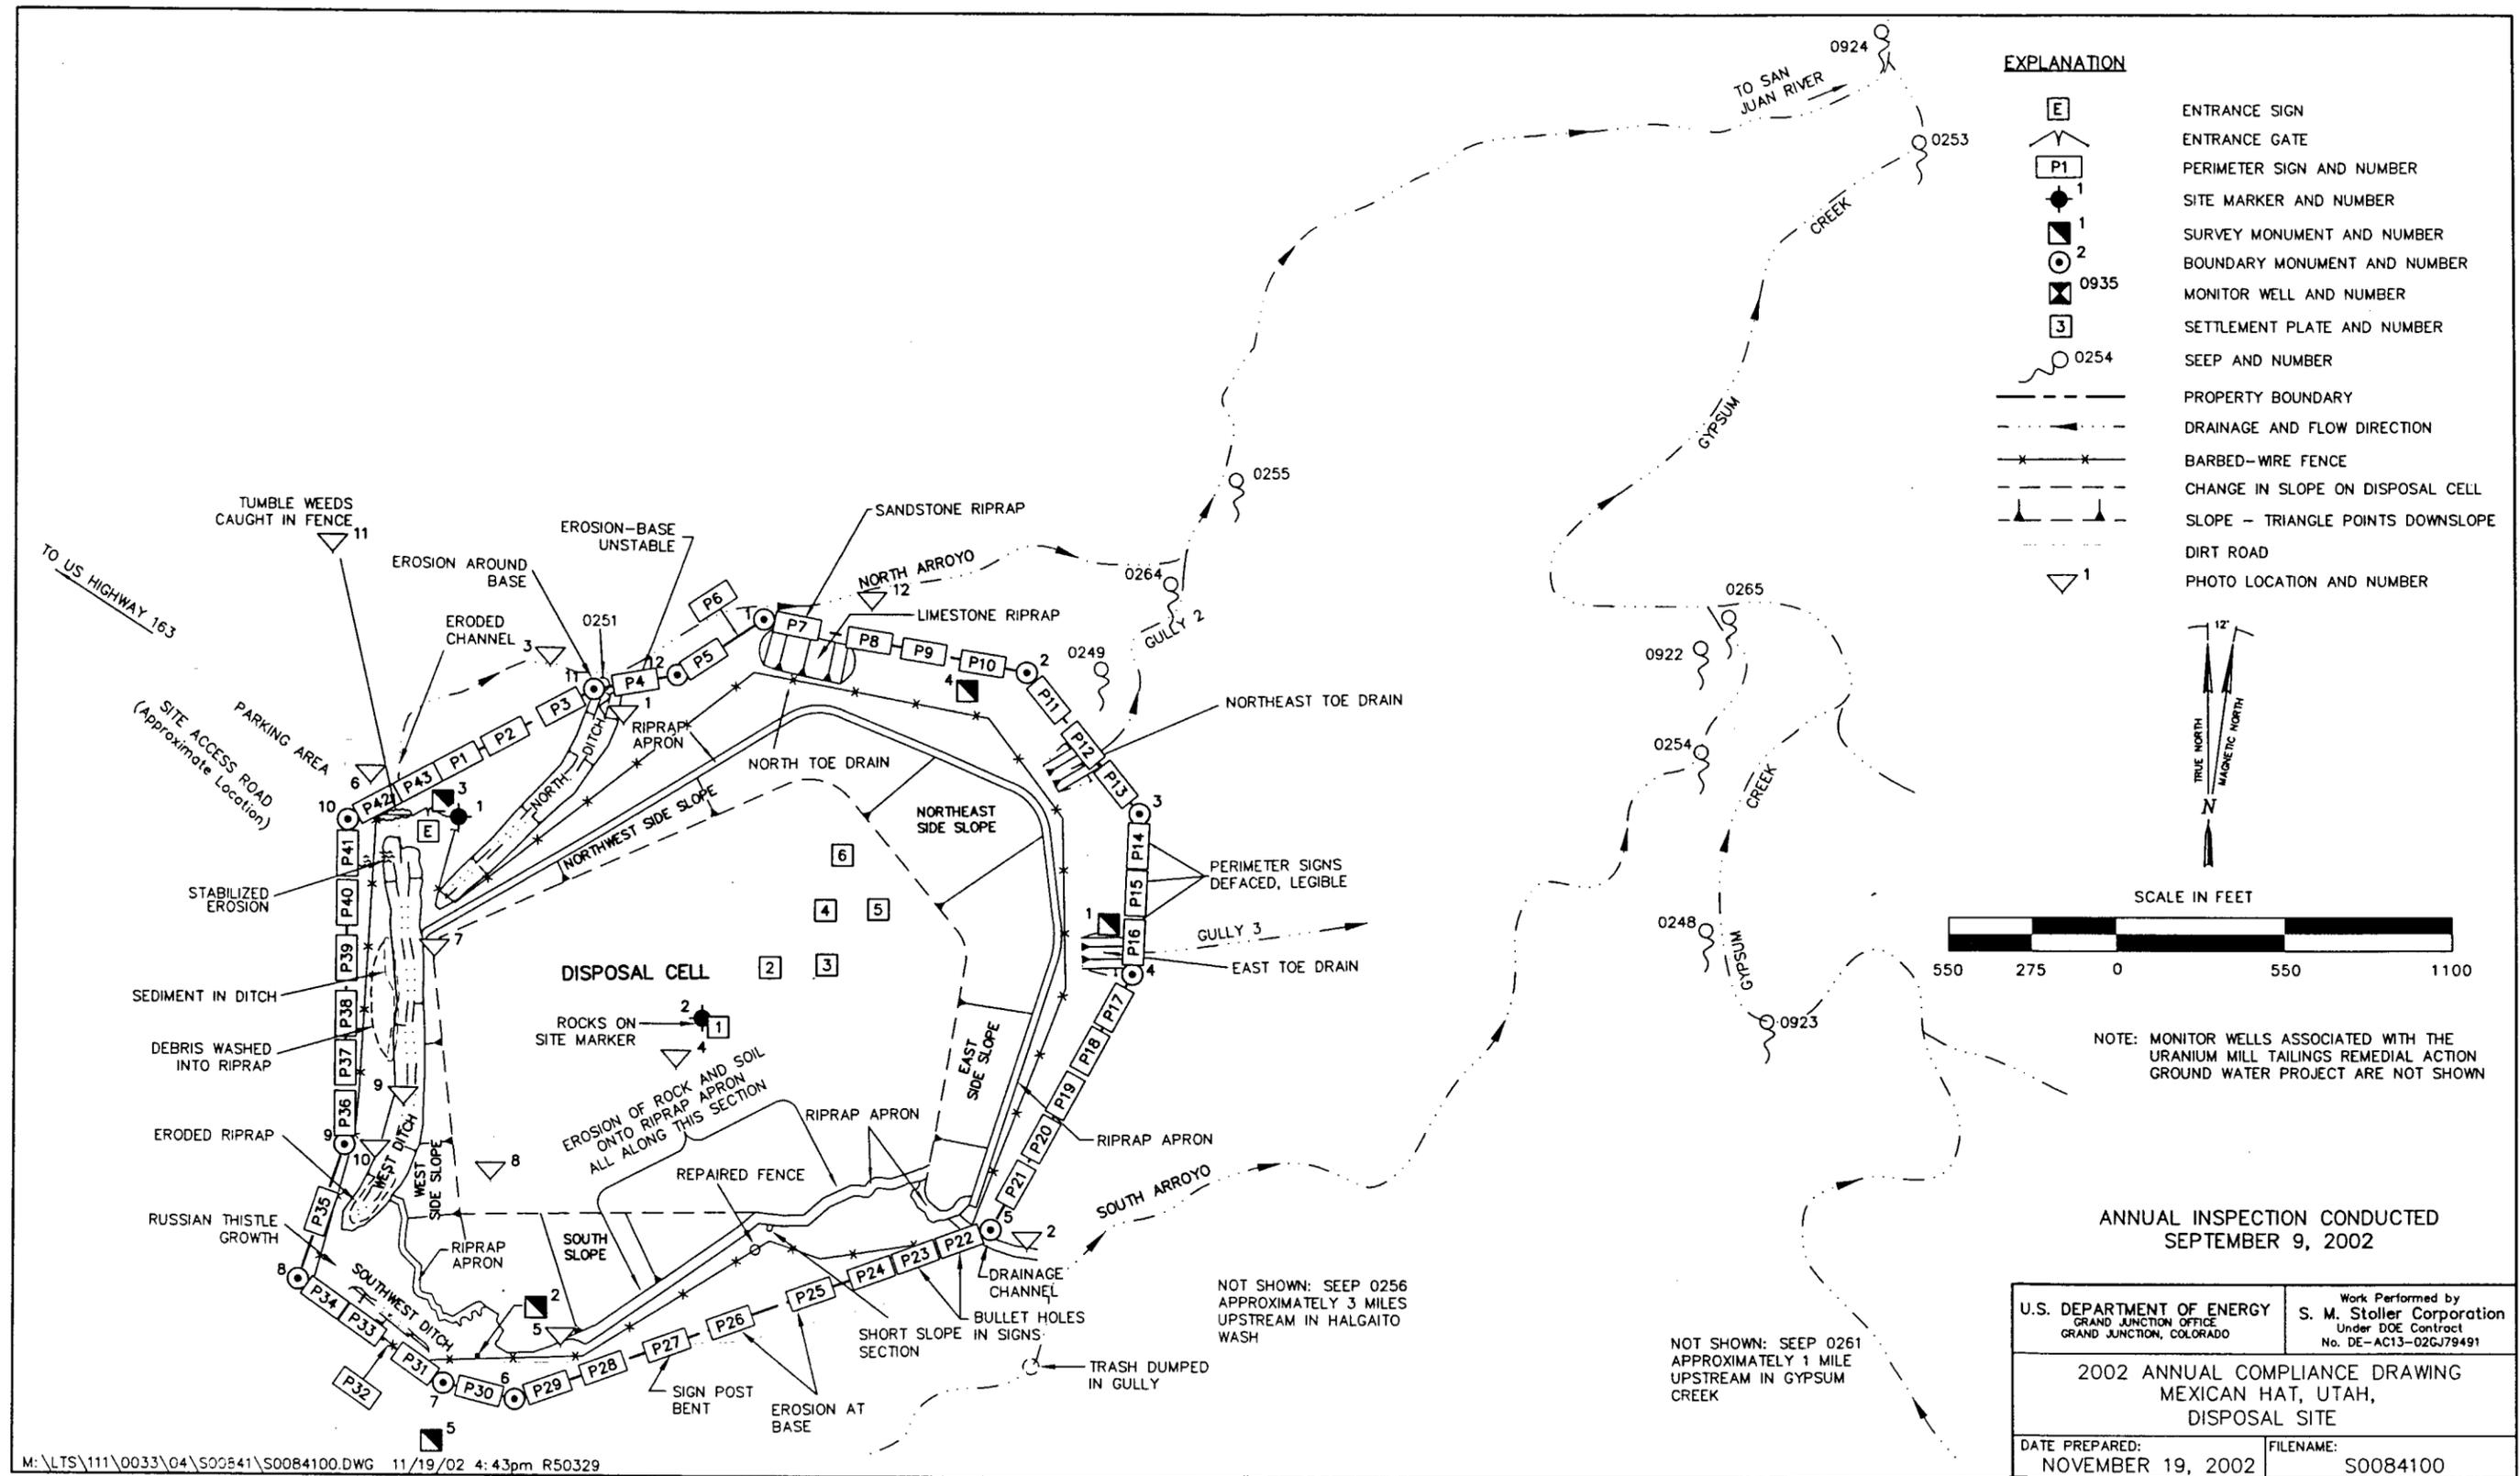
Figure 12-1. 2002 Annual Compliance Drawing for the Mexican Hat, Utah, Disposal Site

12A A severe storm passed through the Mexican Hat area on September 8, 2002, causing water from impervious areas south and west of the disposal cell to flow into the west diversion ditch. Municipal trash, tumbleweeds, and sediment were carried onto the site and became lodged in the security fence and diversion ditch riprap. Water depths in the ditch reached about 3 feet as indicated by the high water mark on the ditch sides. A 40-foot long by 3-foot wide section of

riprap at the south end of the ditch slumped to the bottom of the slope (PL-4). Erosion also occurred in the soft bedrock where the west ditch exits into the north arroyo. Inspectors saw no other evidence of creep, settling, erosion, burrowing, or other degradation in this transect.

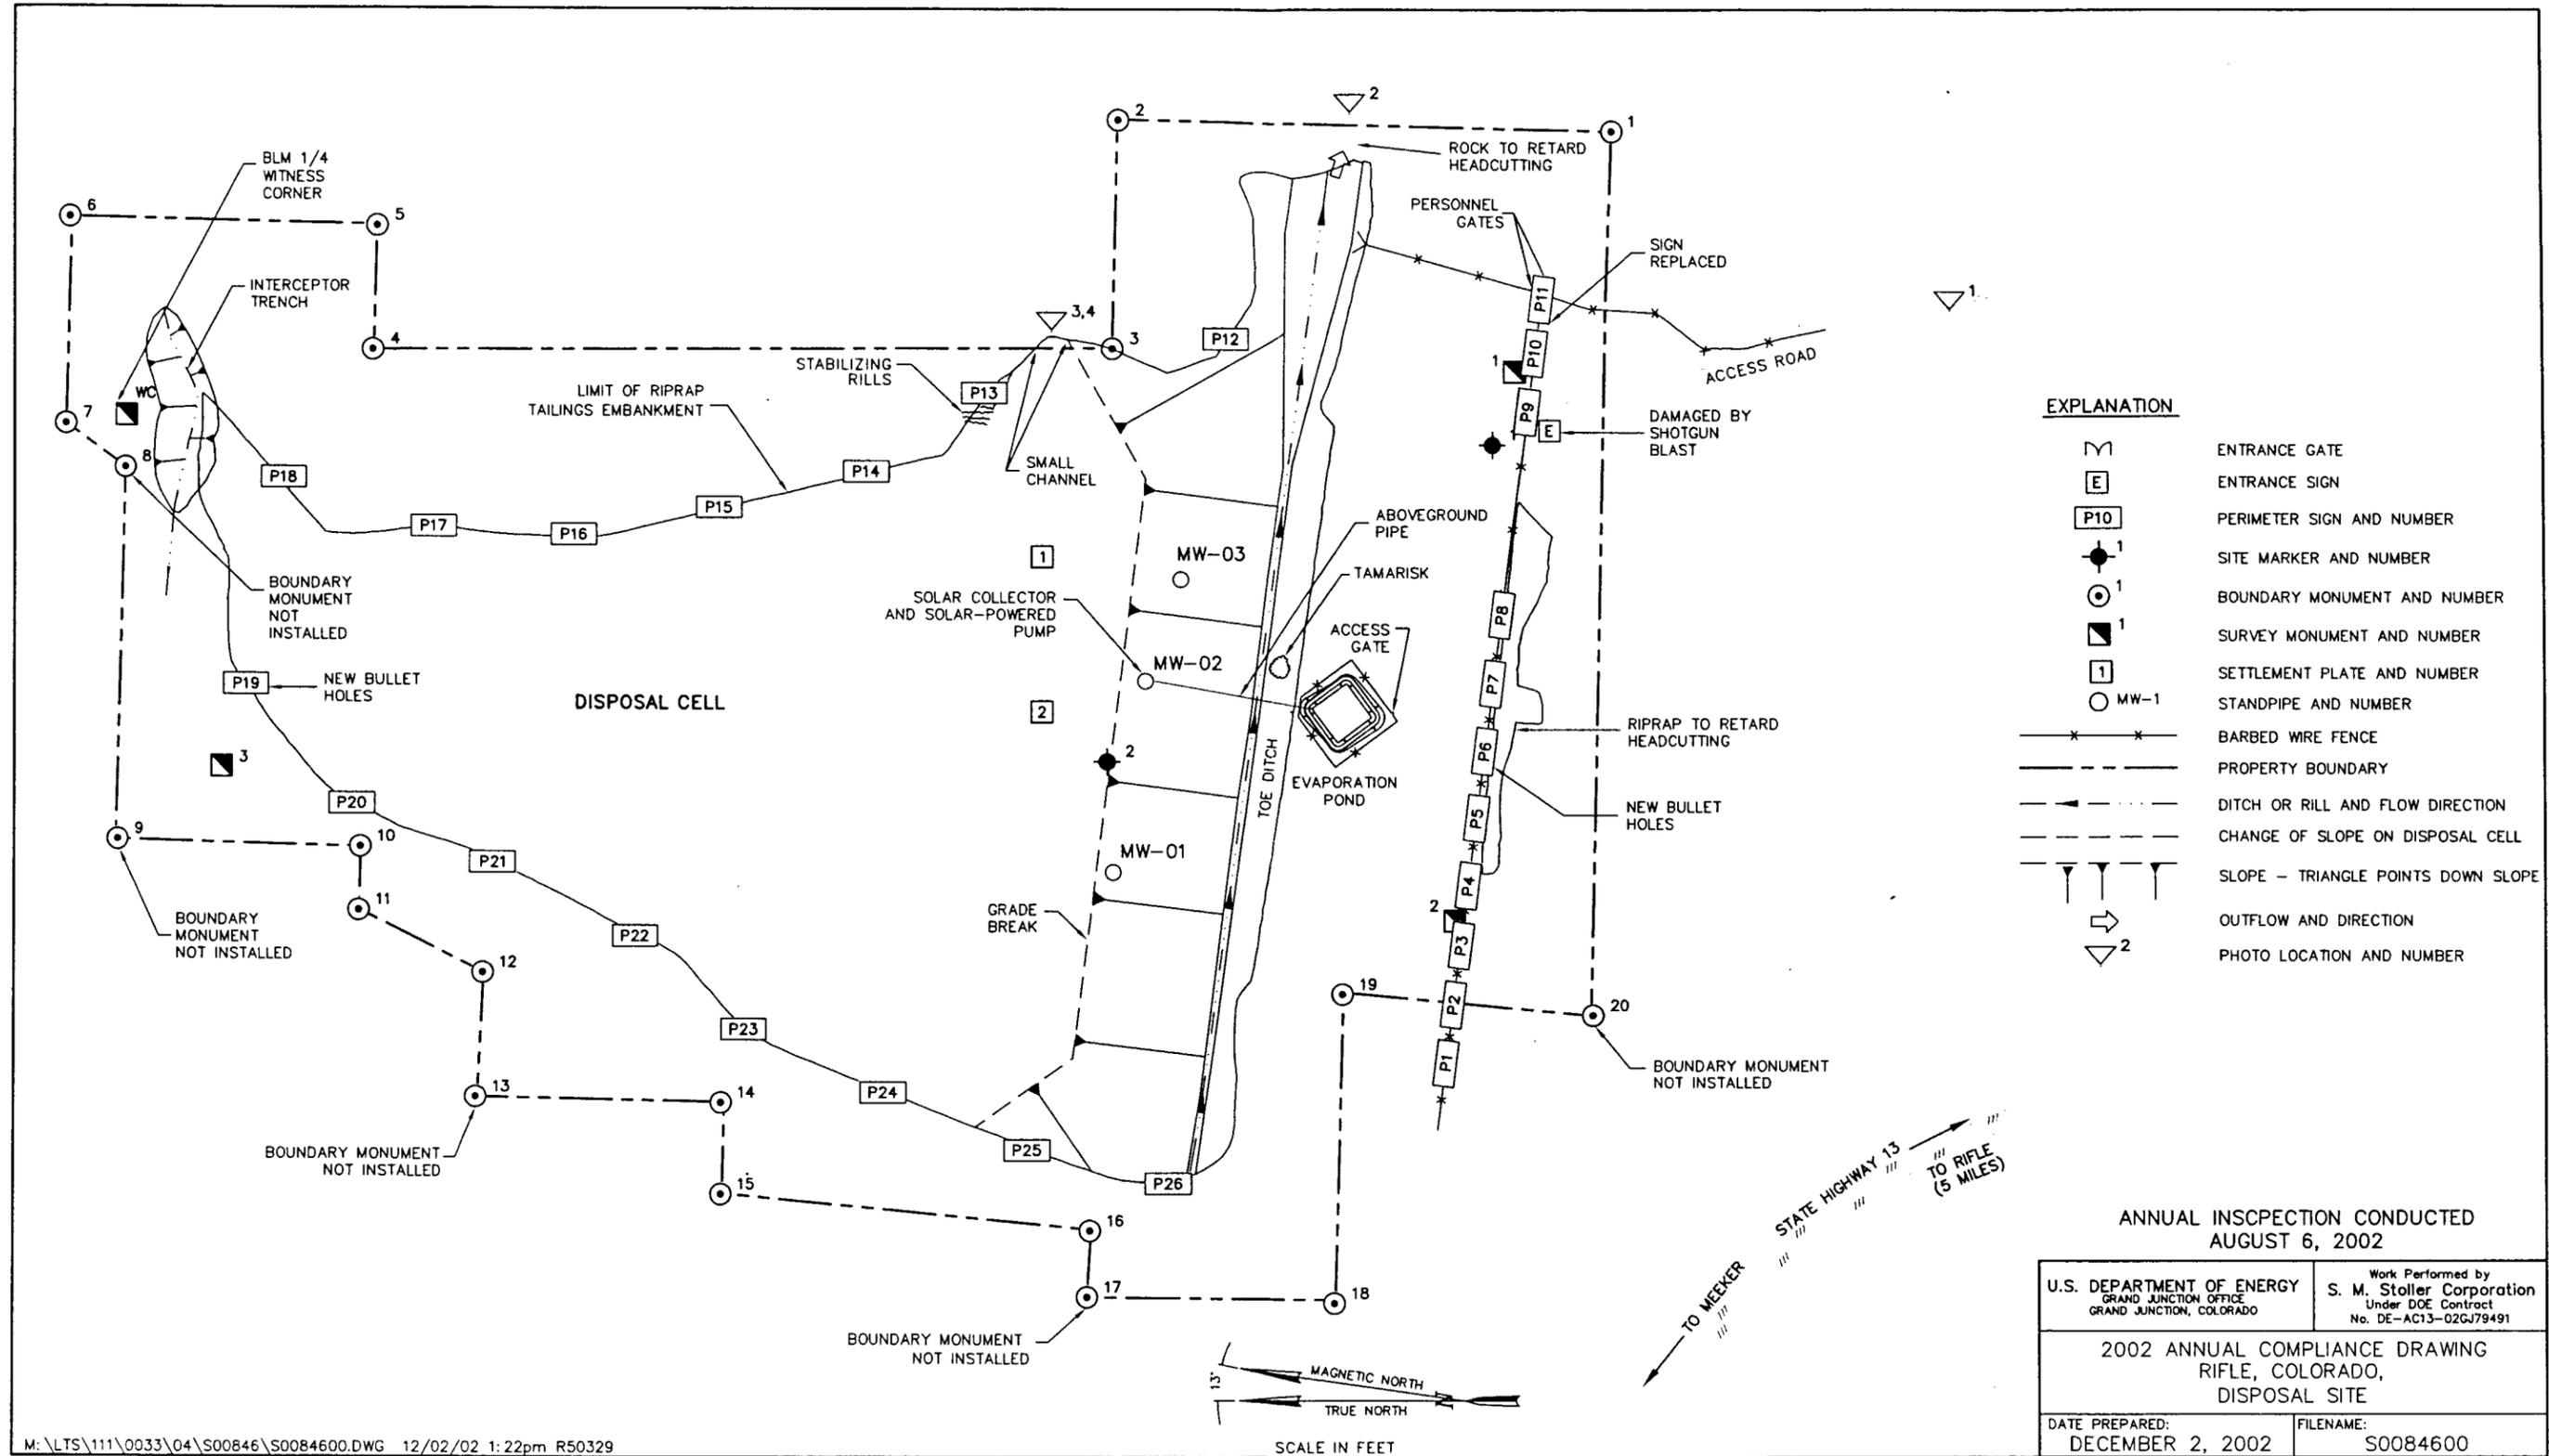
Figure 14-1. 2002 Annual Compliance Drawing for the Rifle, Colorado, Disposal Site

14B A solar-powered pump was installed in MW-02 in 2001 to lower the water level in the cell as specified by the Long-Term Surveillance Plan. Due to damage by freezing, the wellhead was insulated and repairs were made to the discharge pipe in January 2002. The solar collector was in excellent condition at the time of the inspection; however, the pump was not operating properly. Repairs were made to the pump the day after the site inspection.

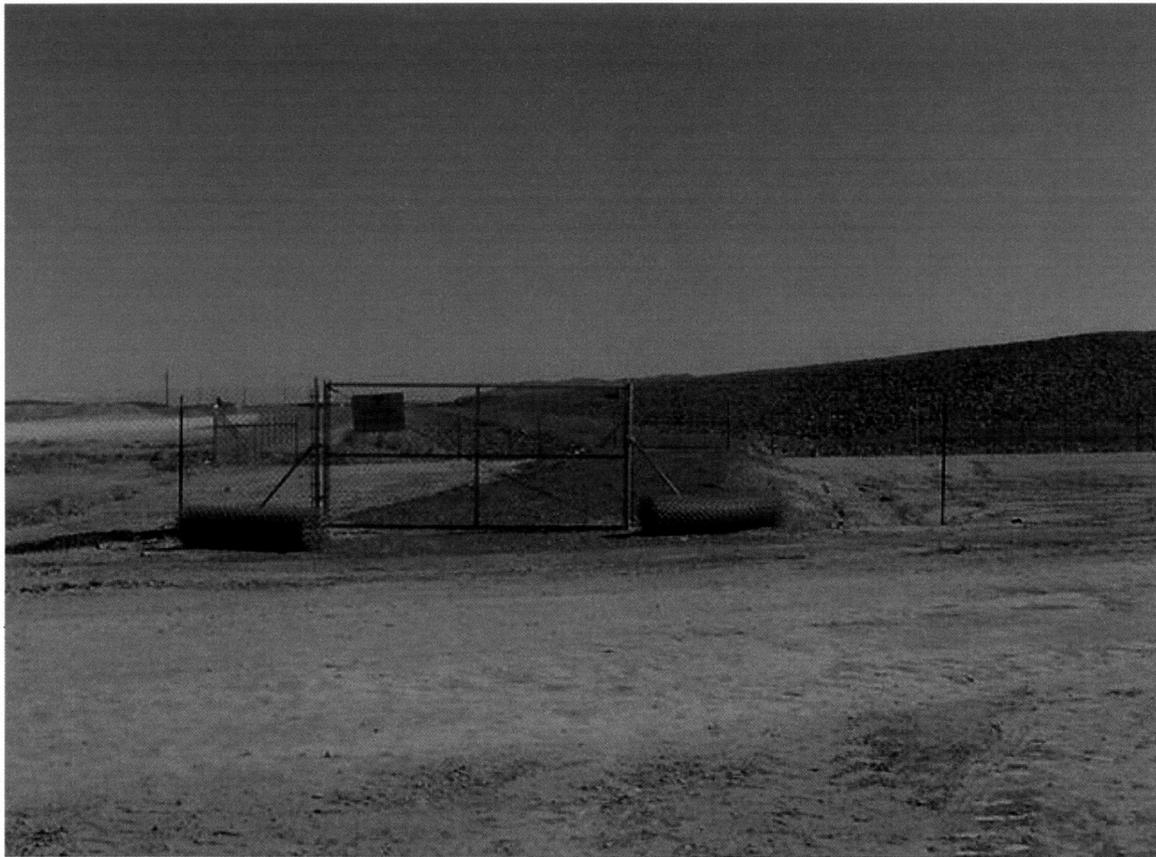
PL-1. New entrance gate and entrance sign on Envirocare's south fence.

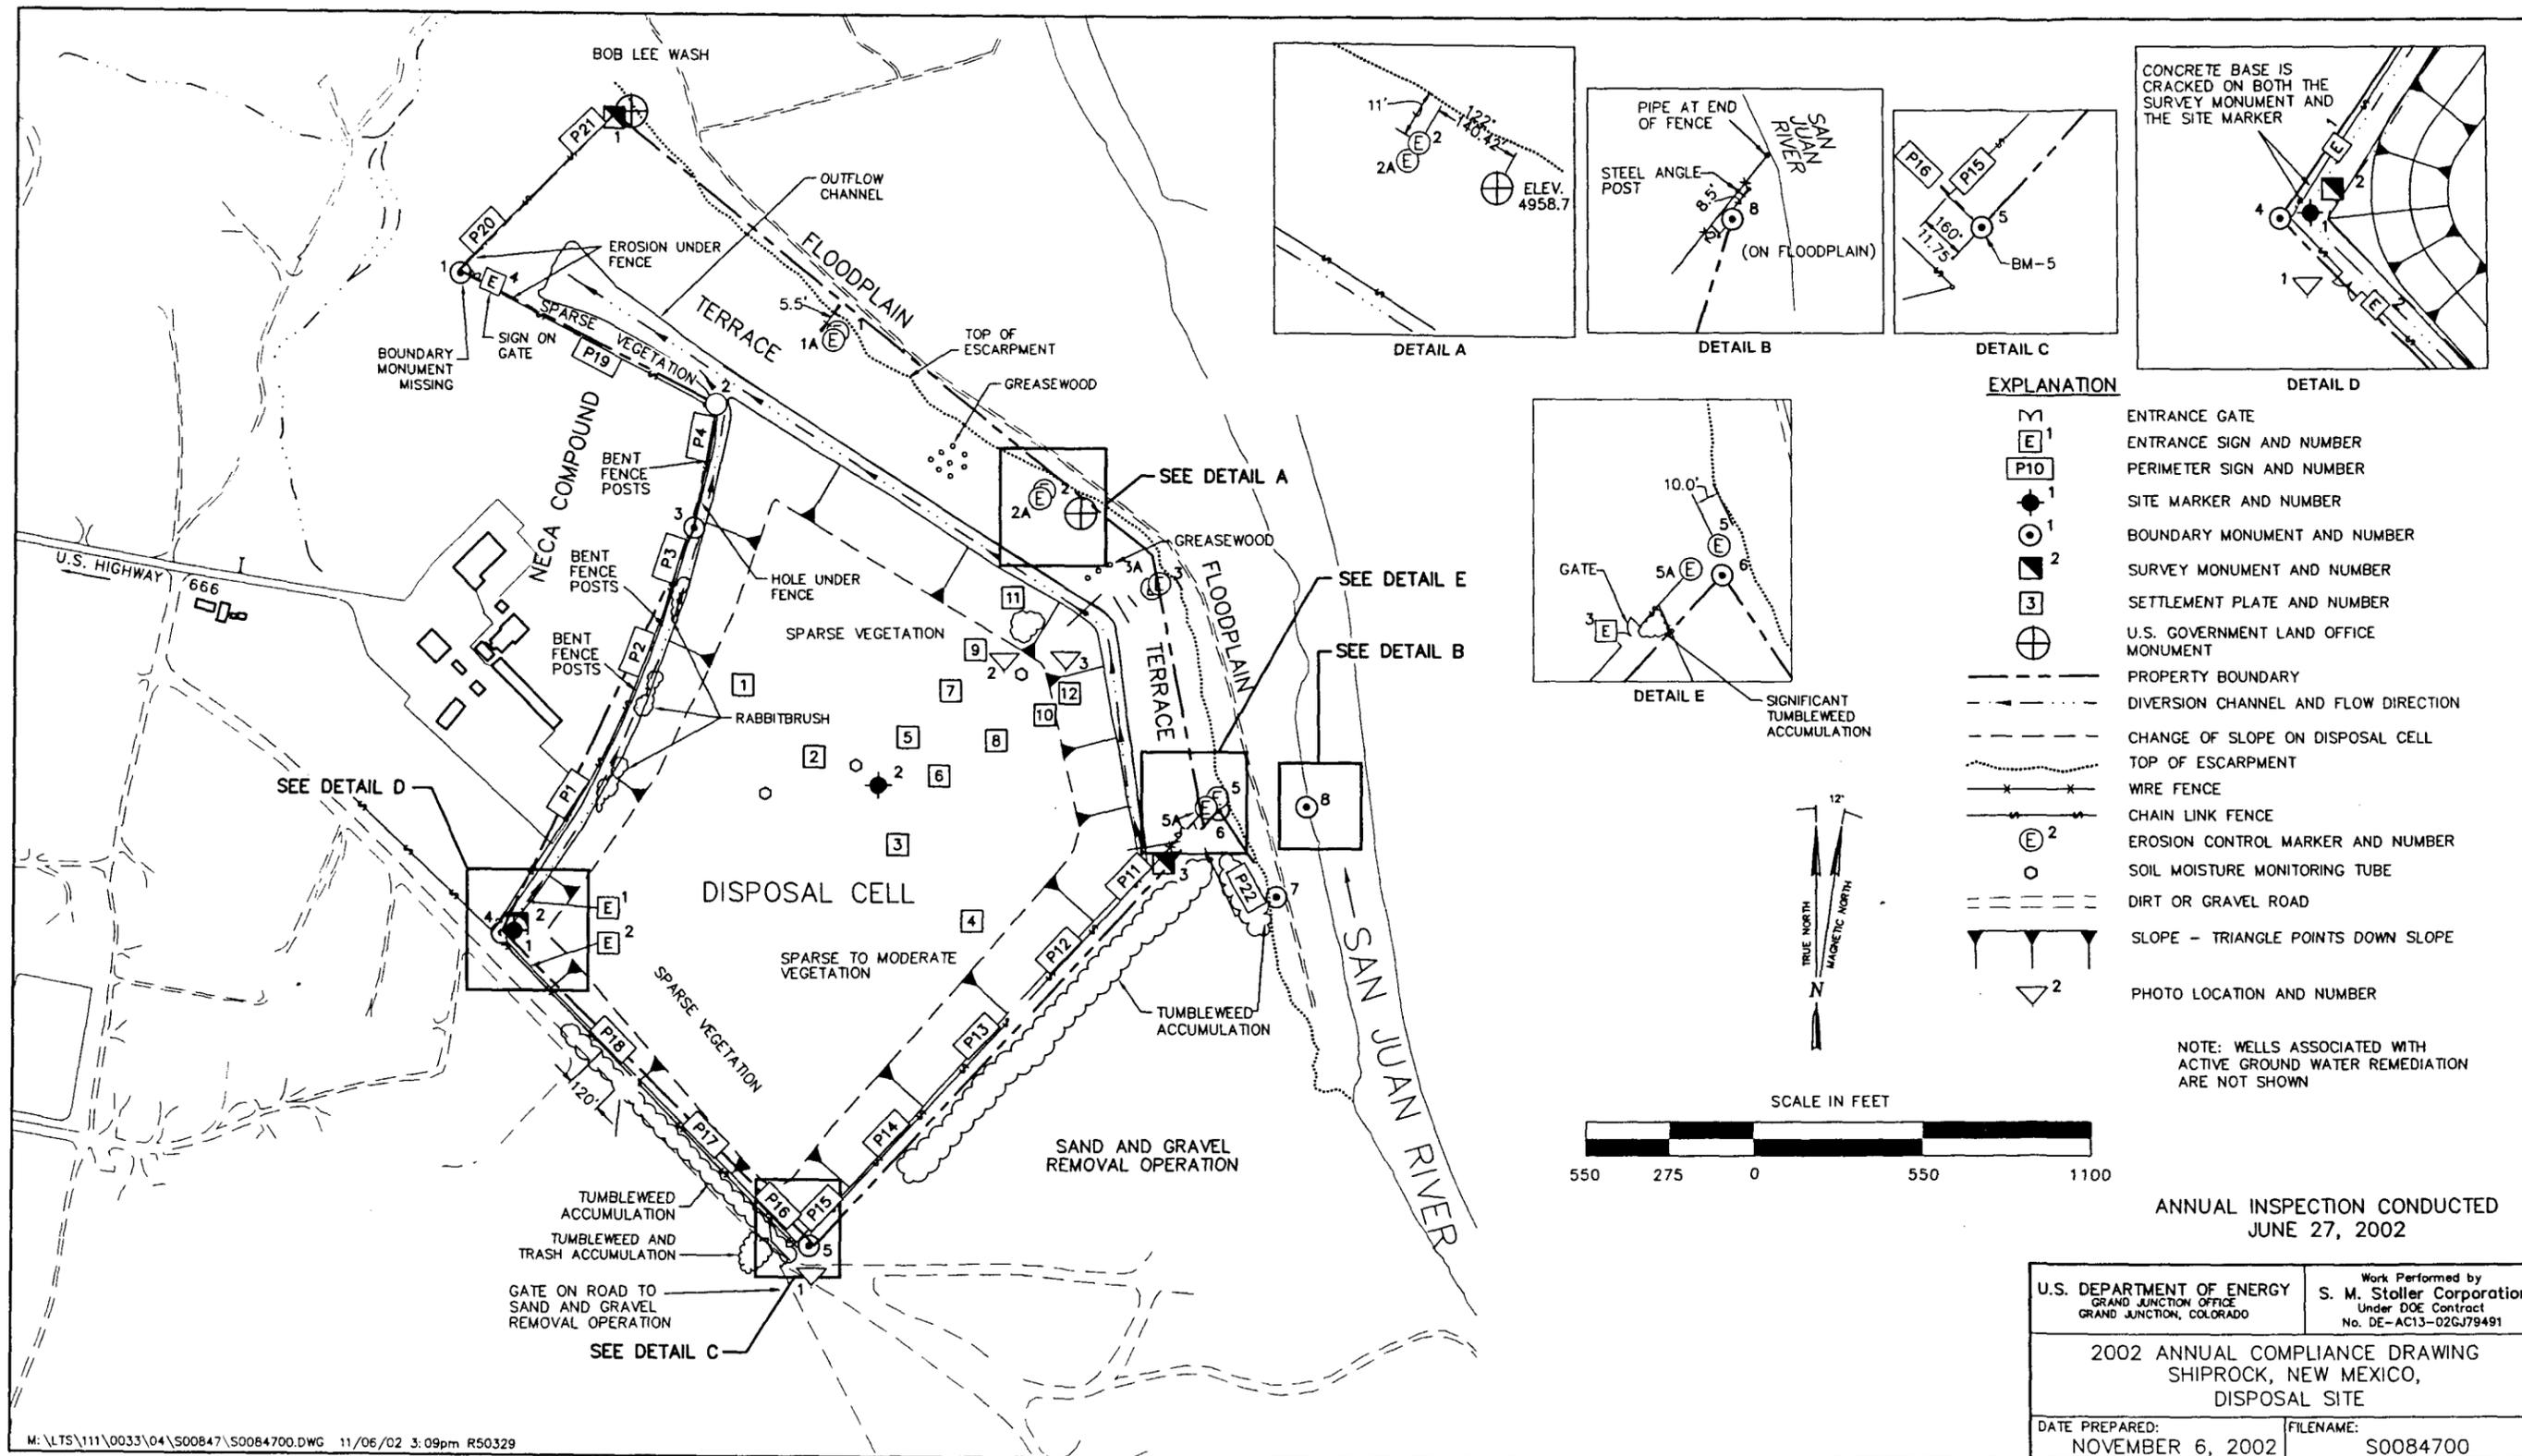
Figure 16-1. 2002 Annual Compliance Drawing for the Shiprock, New Mexico, Disposal Site

16B Erosion resulting from the July 2001 storm washed away boundary monument BM-1. DOE will replace the missing monument when the erosion damage is repaired. All other boundary monuments were located and found to be in good condition.

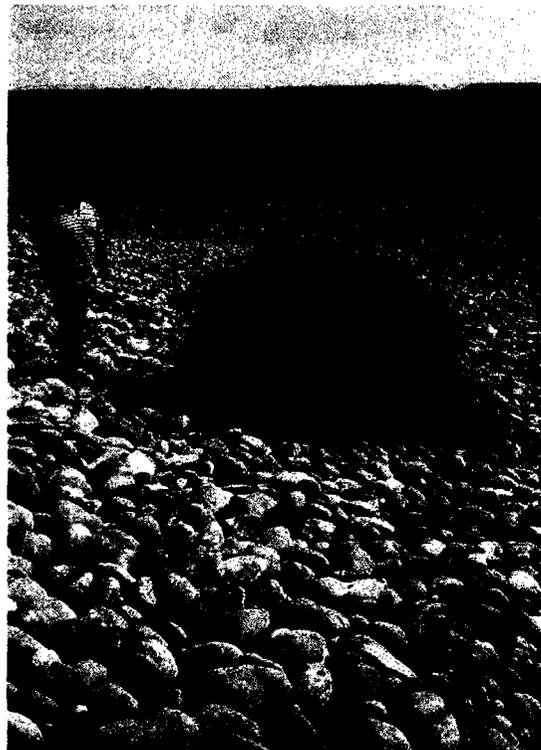
PL-3. Rabbitbrush growing on NE side slope.

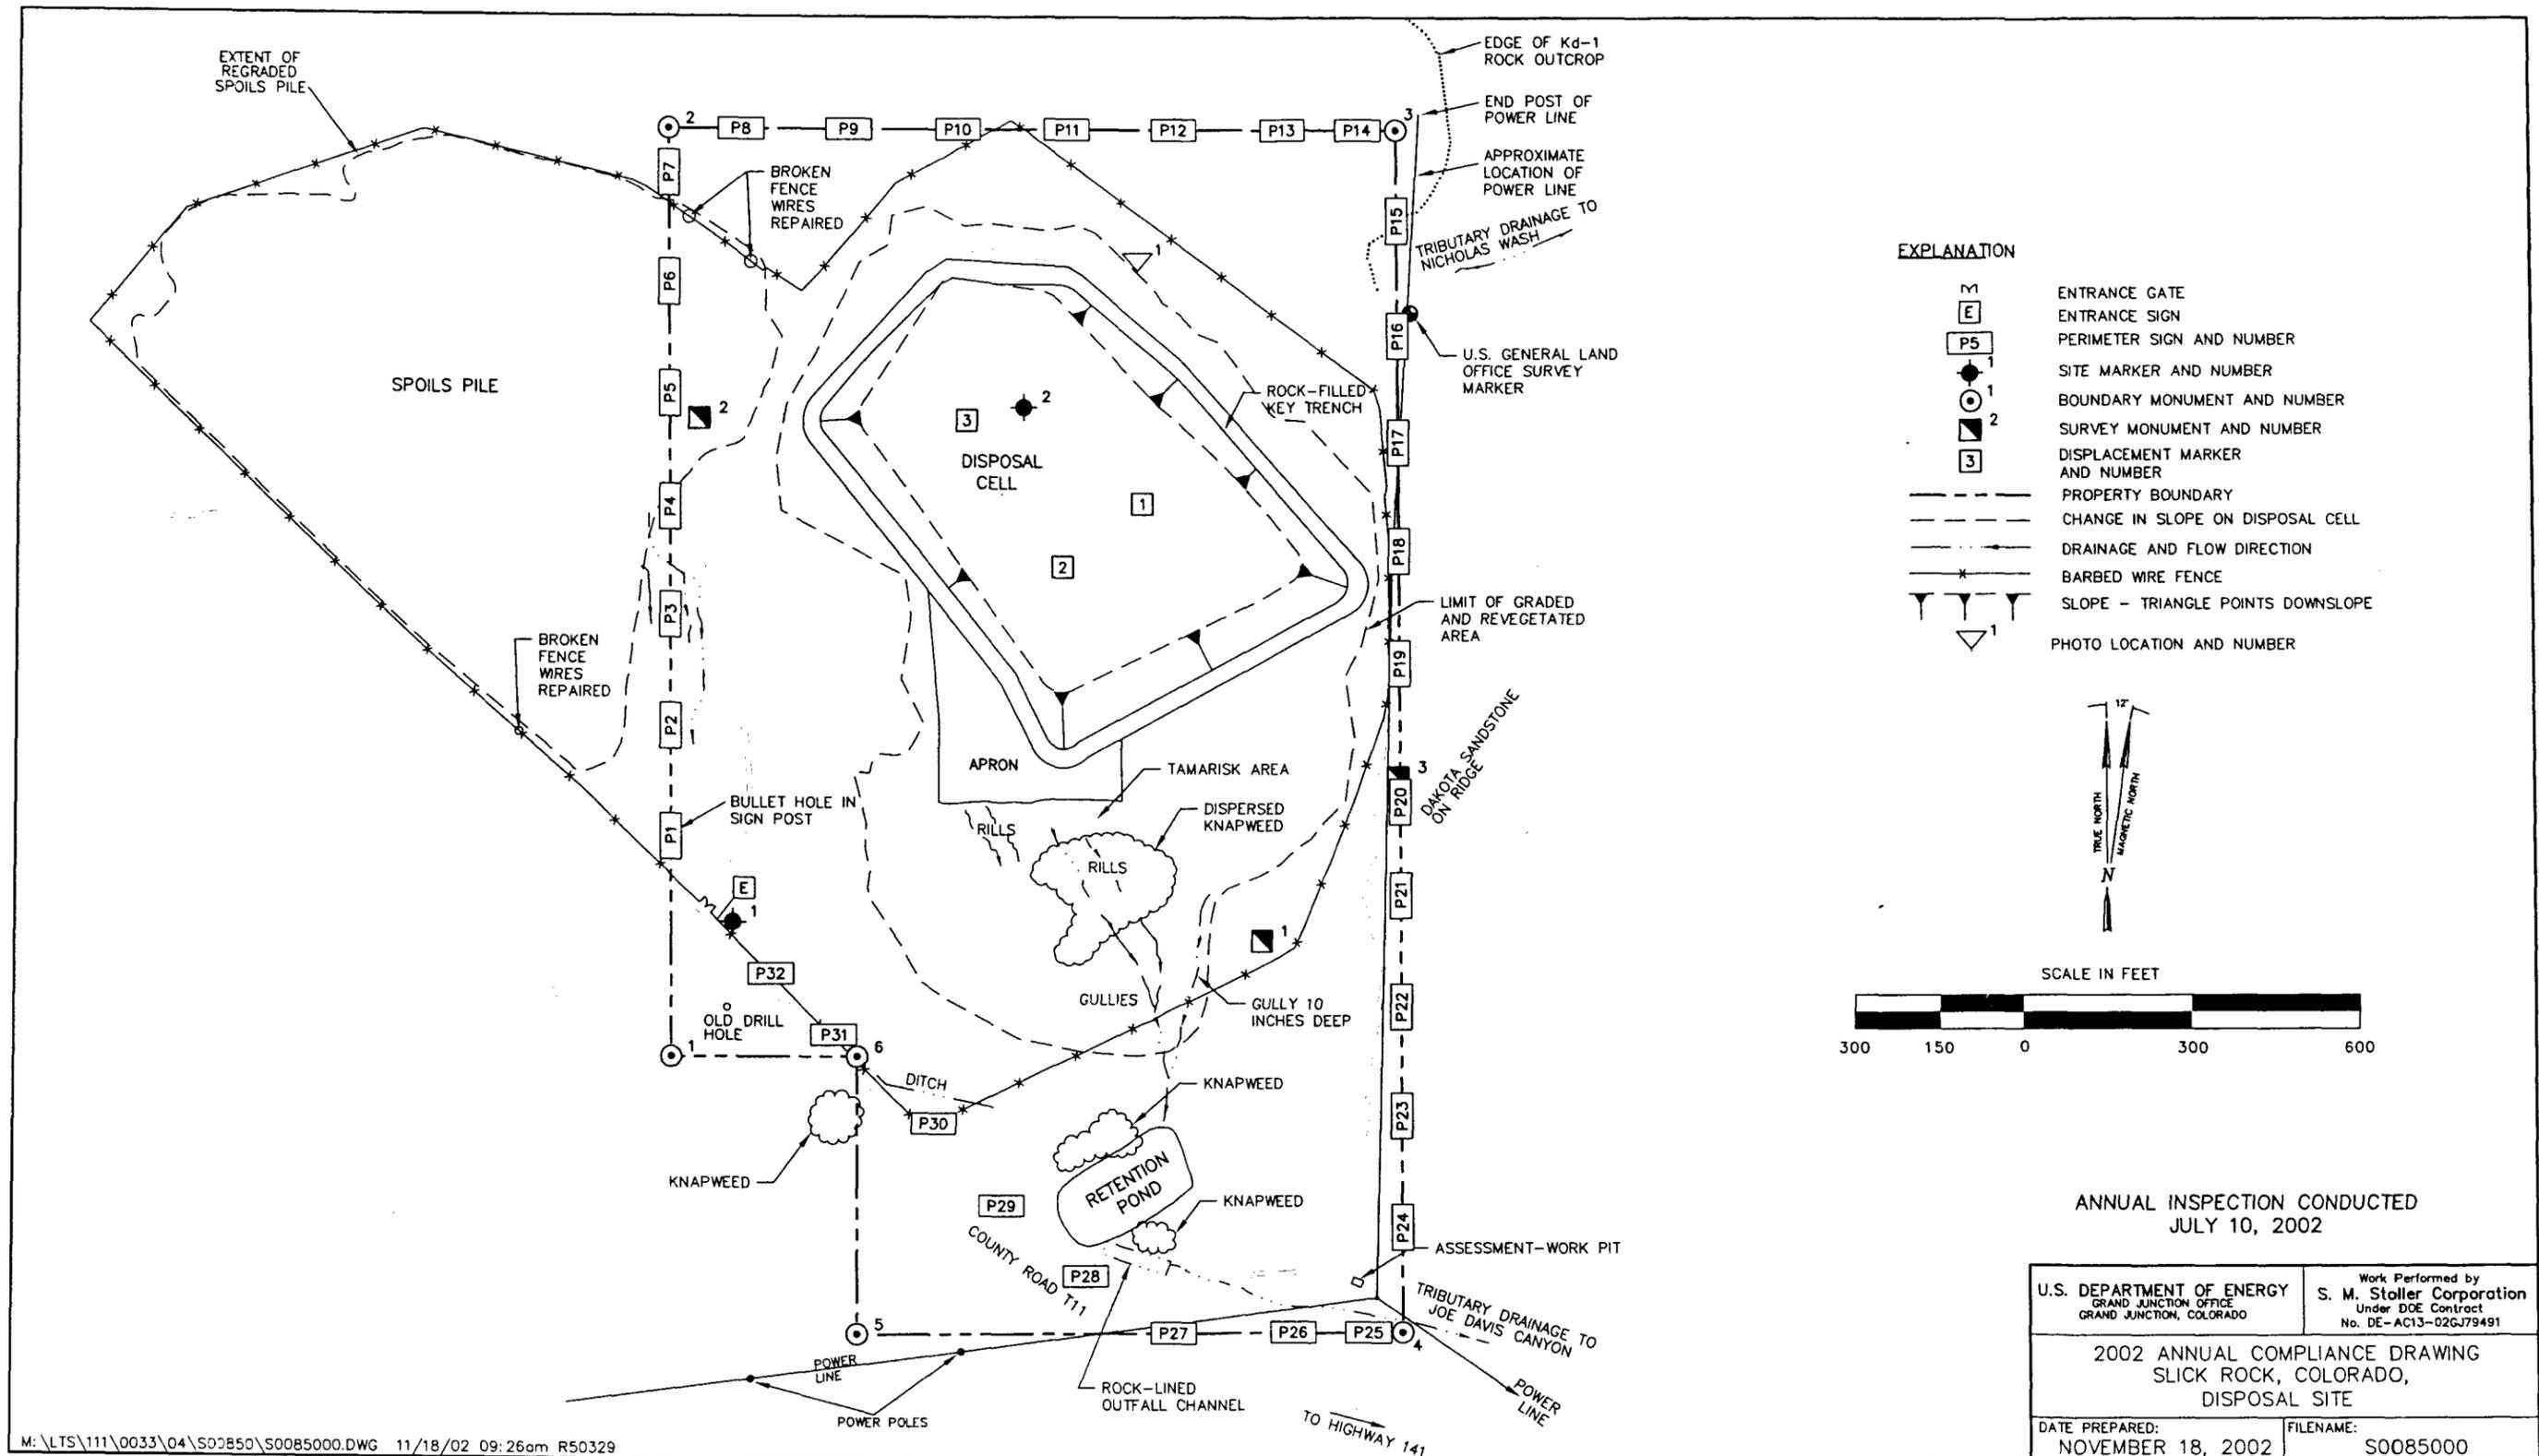
Figure 17-1. 2002 Annual Compliance Drawing for the Slick Rock, Colorado, Disposal Site

Disposal Cell—The disposal cell, side slopes, key trench, and apron are armored with rounded cobble- and pebble-sized rock. The rock was in excellent condition. No evidence of settling, slumping, or erosion was observed on any of the rock-covered surfaces of the disposal cell.

Area Between the Disposal Cell and the Site Boundary—The area around the disposal cell includes the retention pond and the graded and reseeded areas. Surface drainage from the disposal cell flows south into the retention pond, which is constructed in a channel tributary to Joe Davis Canyon. An outflow channel below the pond is lined with rounded cobblestones for a short distance. The pond, which was dry at the time of the inspection, and outflow channel were in excellent condition.

As noted during previous inspections, rills and a few gullies are present downslope from the disposal cell apron (between the apron and retention pond) and along the western boundary between perimeter signs P2 and P4. The rills appear to be healing slowly, as indicated by the rounded edges and establishment of vegetation in the bottom of the rills. These erosional features should continue to be monitored.

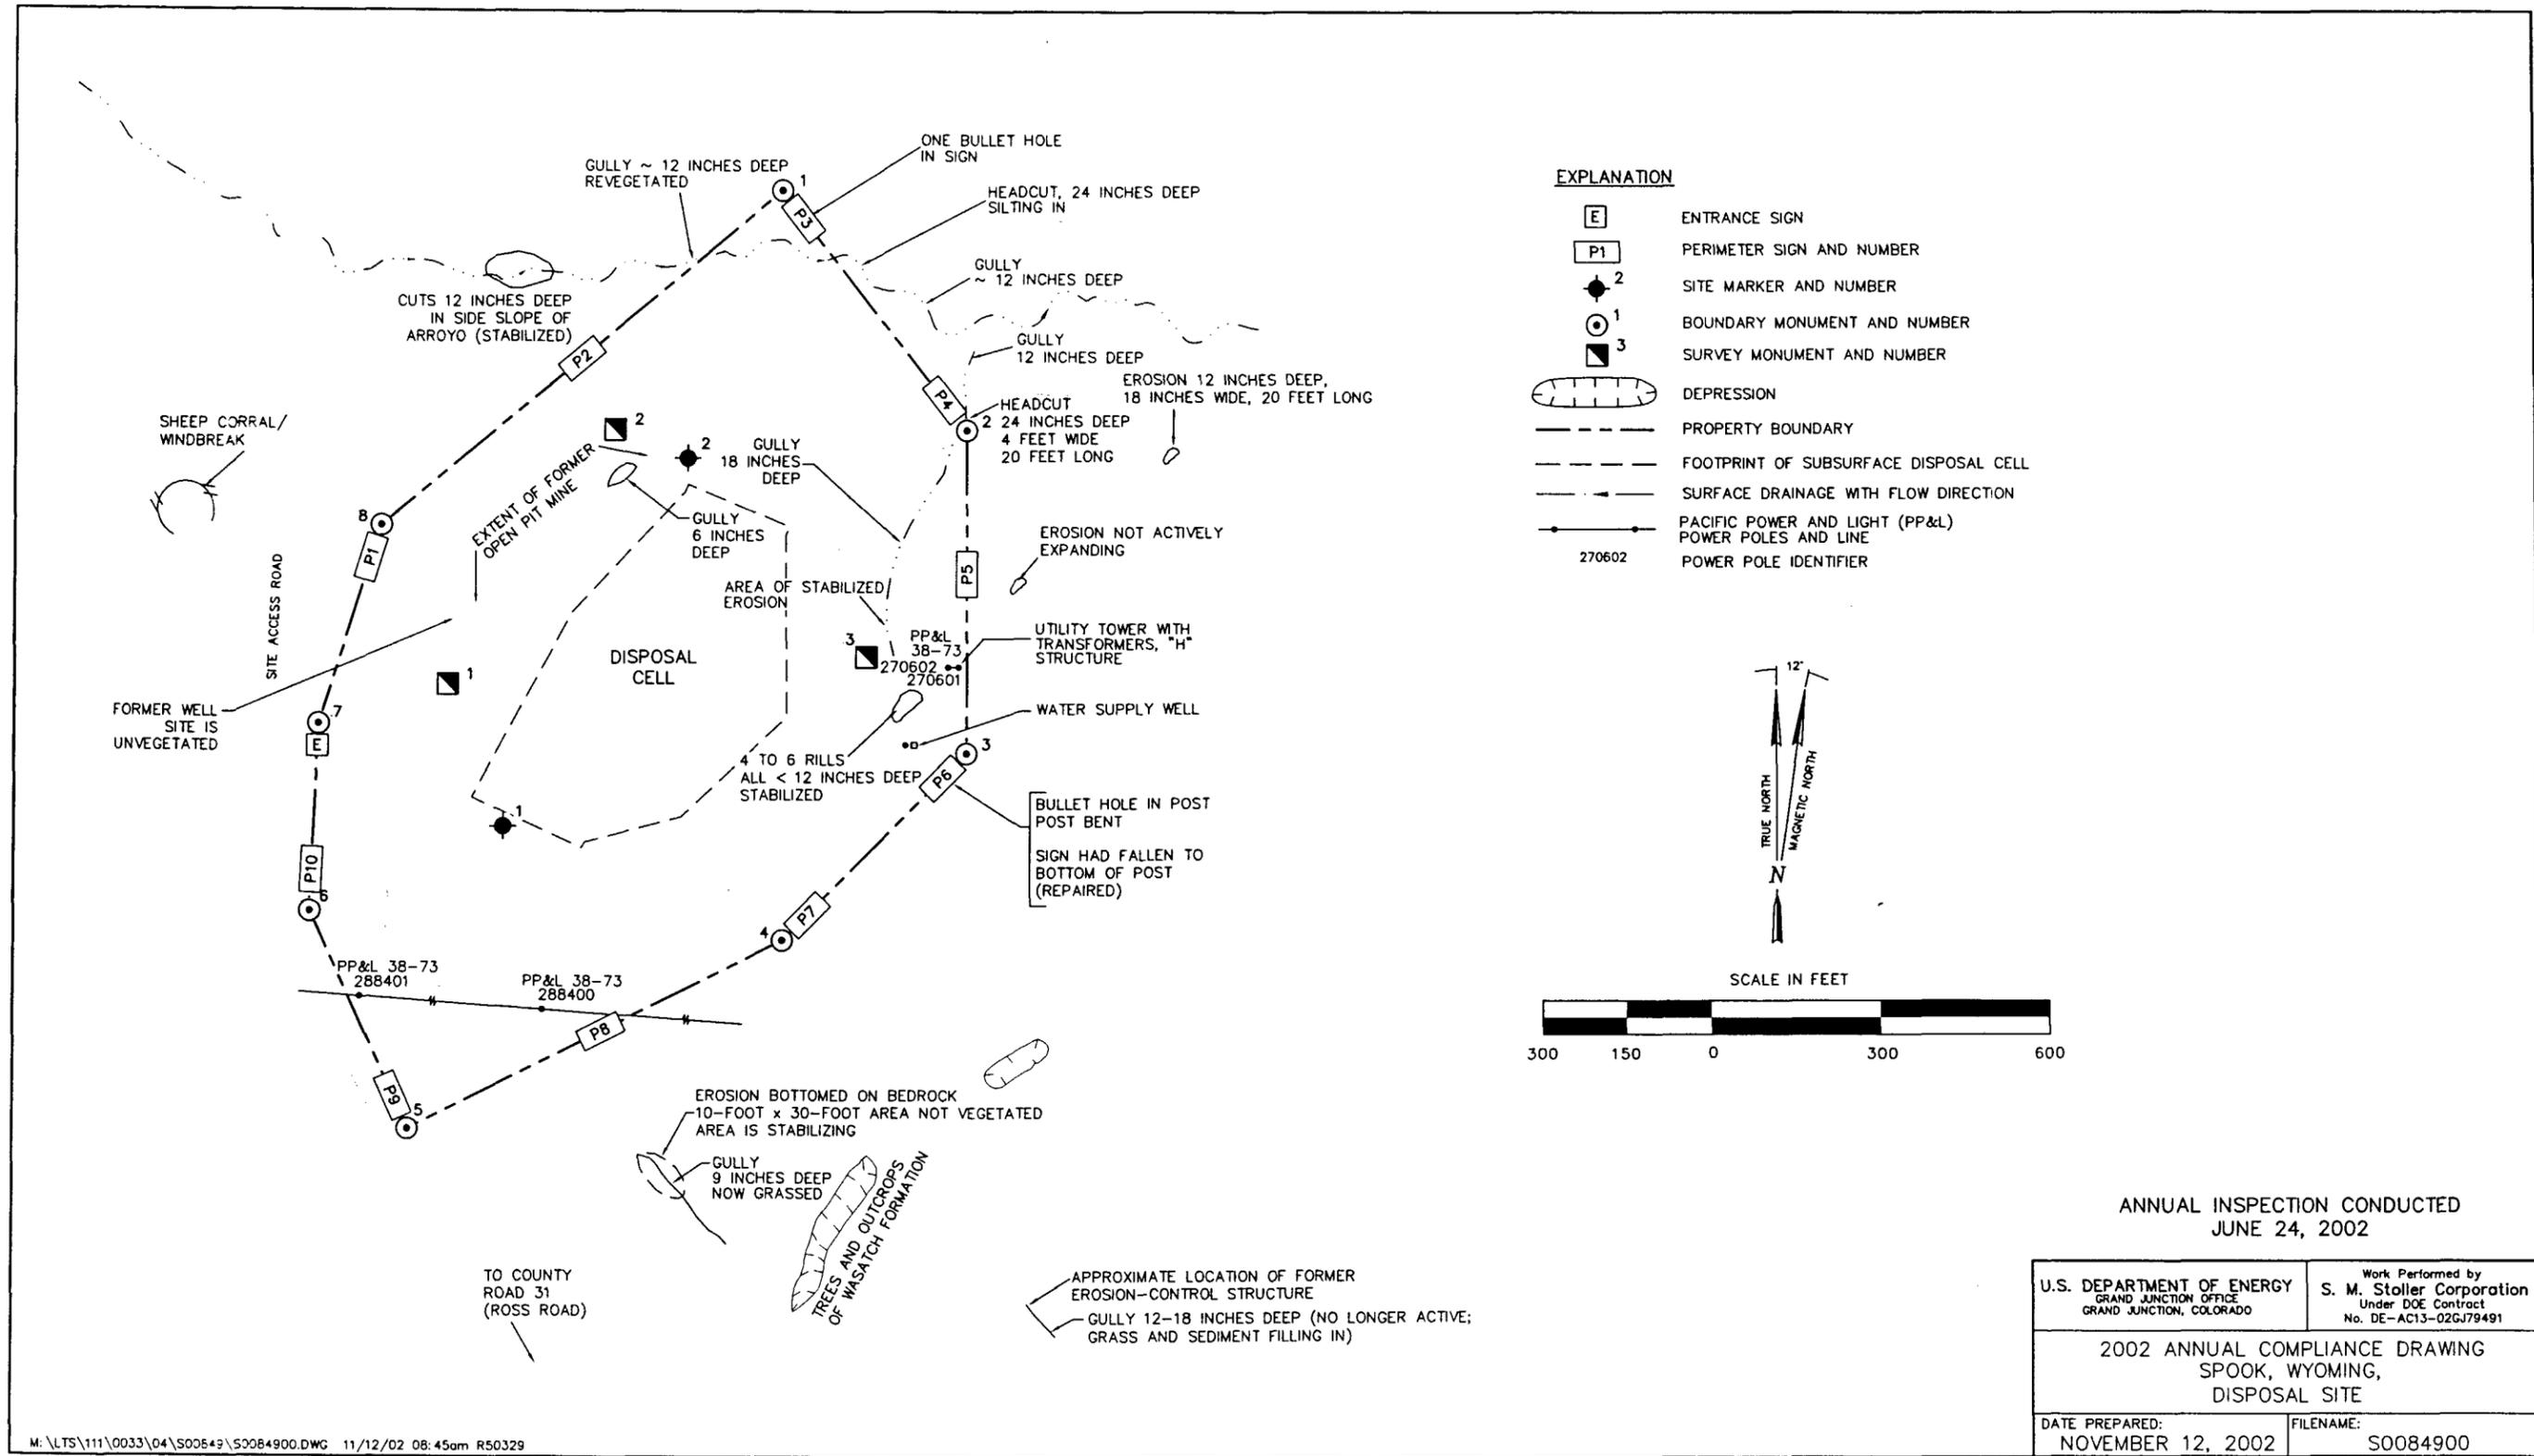
Figure 18-1. 2002 Annual Compliance Drawing for the Spook, Wyoming, Disposal Site

A water supply well remains at the site on DOE property. The well and the ground water it intercepts belong to DOE, but the adjacent landowner, Hornbuckle Ranch, historically has used the well for irrigation and for watering livestock. The well has not been used recently as

18A indicated by the removal of the electricity meter. DOE executed an agreement establishing DOE ownership of the well and providing Hornbuckle Ranch access to the well and use of the ground water at no cost or liability to DOE.
