Subject: *2002 Annual Site Inspection and Monitoring Report for UMTRCA
Title I Disposal Sites*

2002 Annual Site Inspection and Monitoring Report for Uranium Mill Tailings Radiation Control Act Title I Disposal Sites

GJO-2002-392-TAC
GJO-LREP 6.3.1-5

December 2002

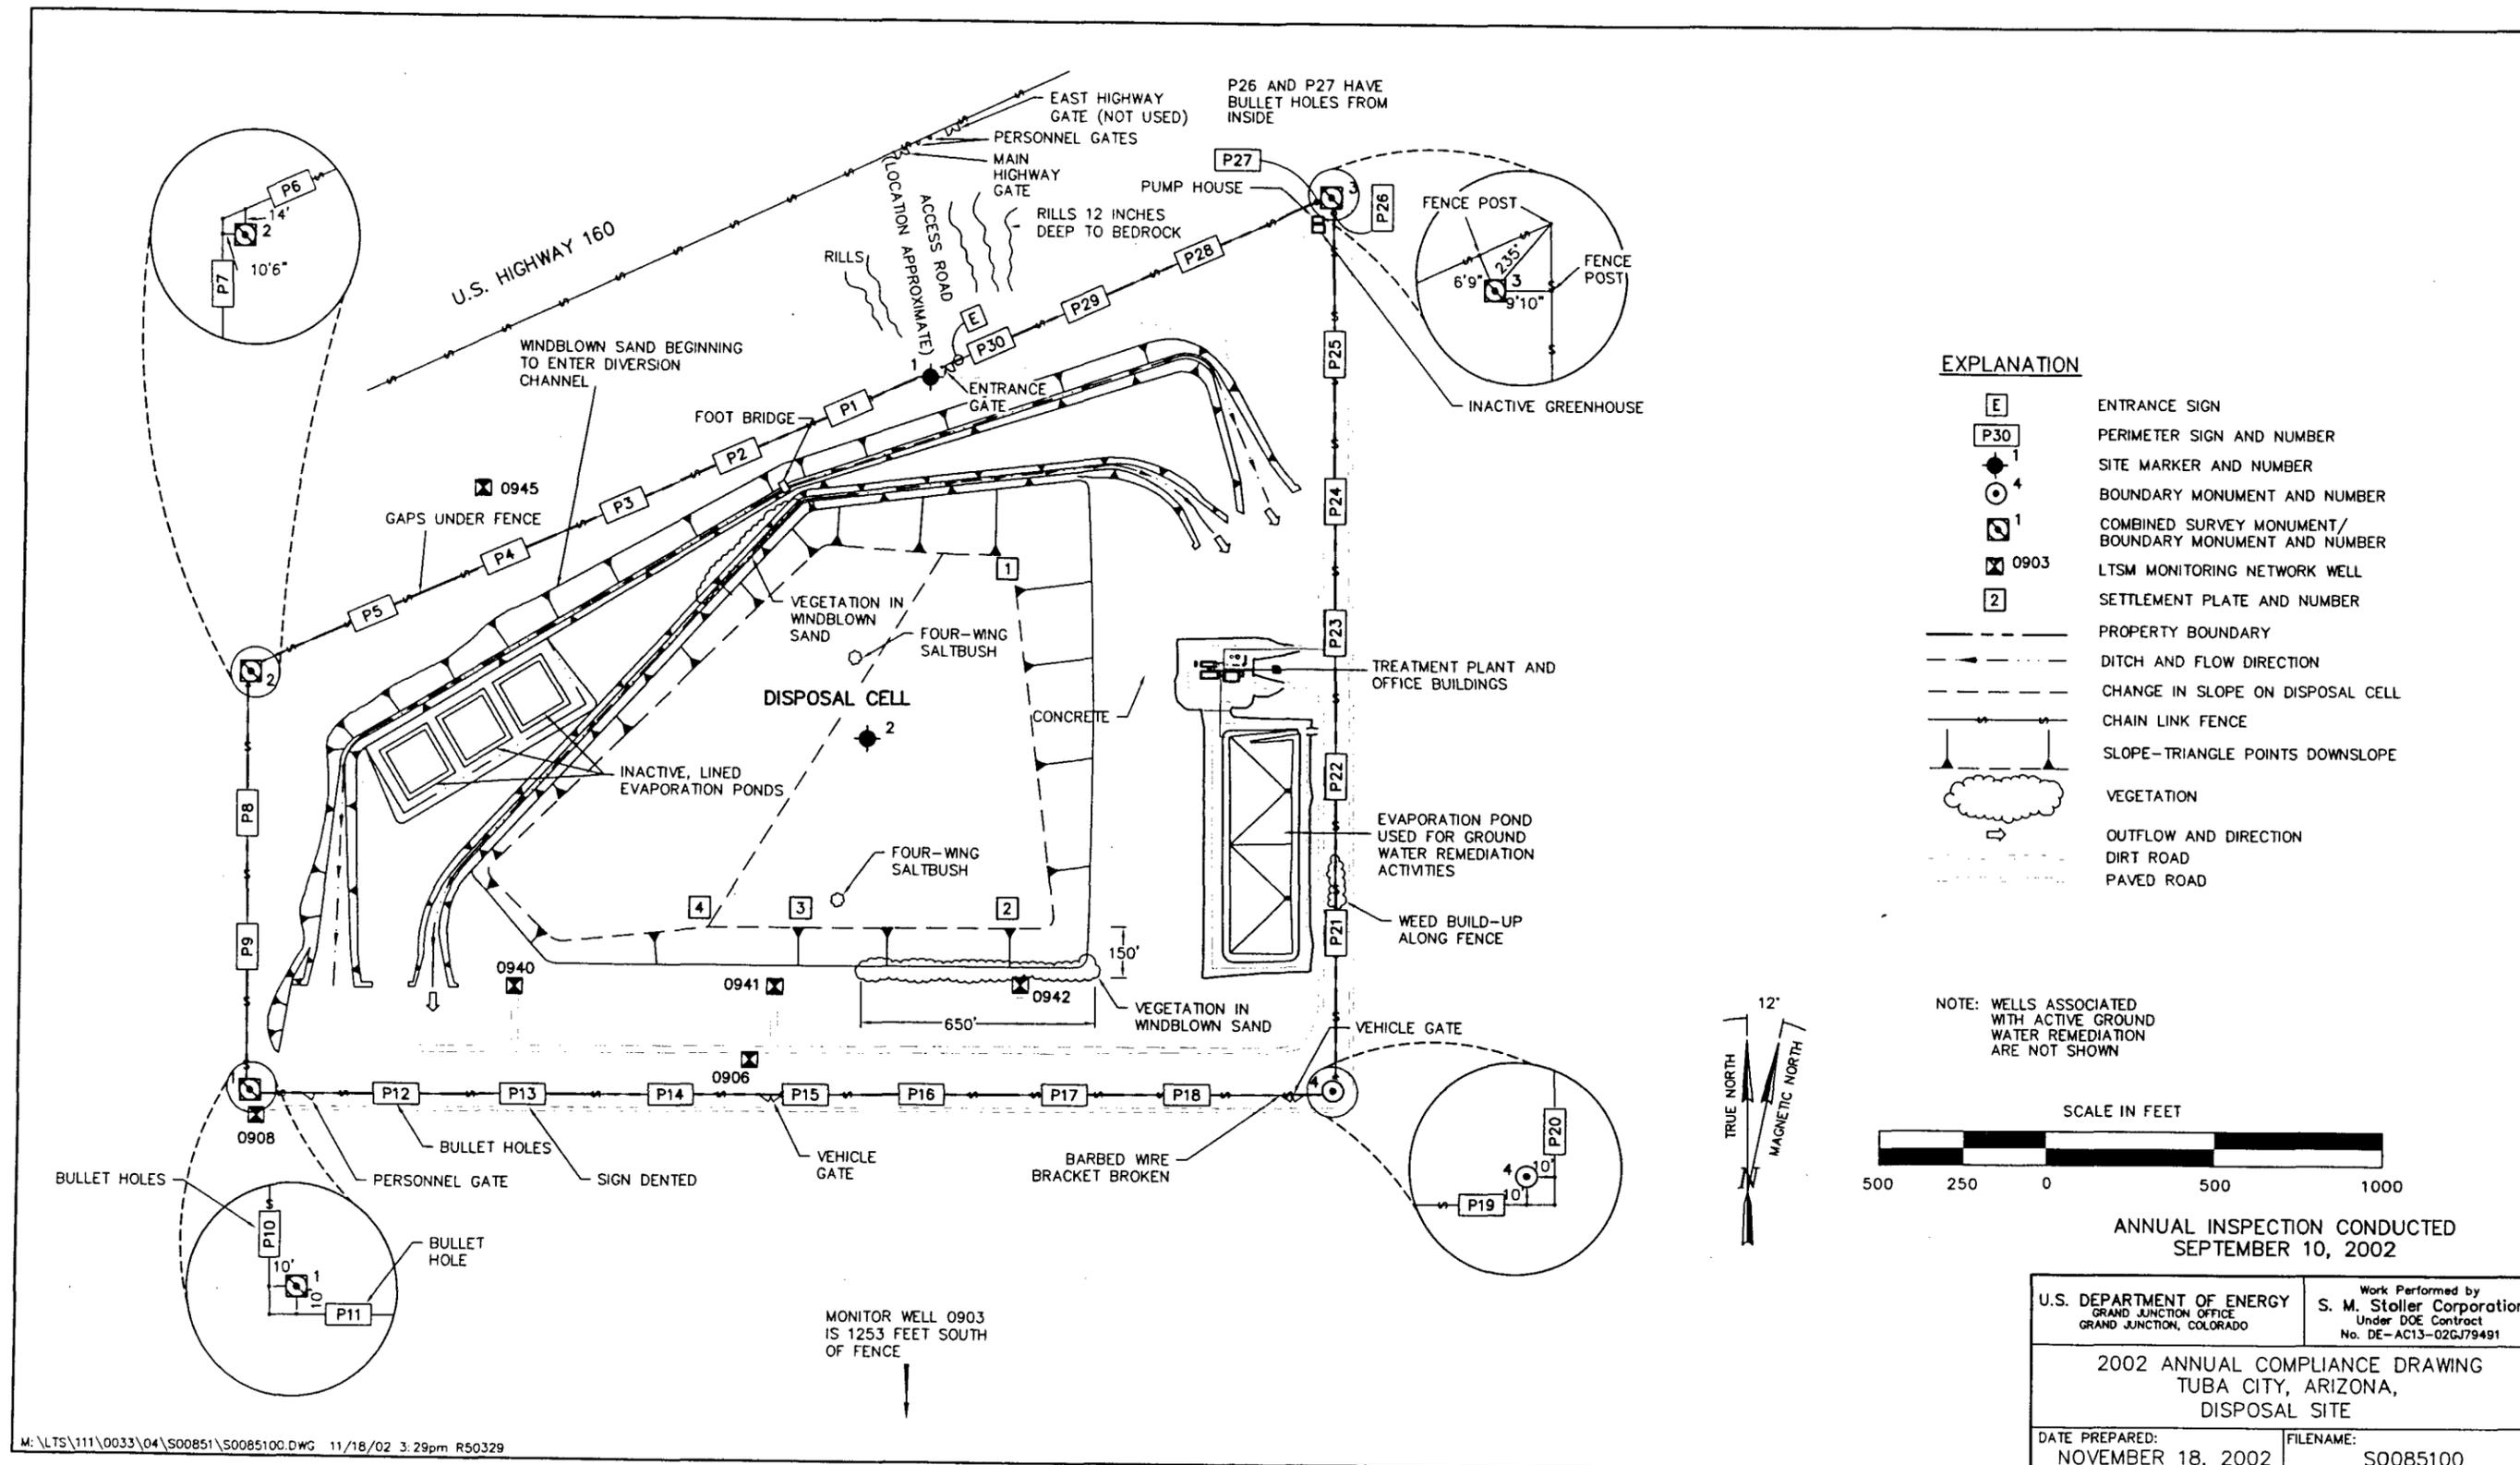
Figure 19-1. 2002 Annual Compliance Drawing for the Tuba City, Arizona, Disposal Site

Disposal Cell—The disposal cell is covered with riprap for erosion protection. The rock was in excellent condition. Inspectors discovered no evidence of slumping, settling, or instability on the top or side slopes of the disposal cell.

Patches of dead kochia and Russian thistle were seen on the south side slope and top slope of the cell. A few patches of these weeds were present on the west and north side slopes. The reduced quantity of annual weeds when compared with previous years was likely due to drought conditions during the 2002 growing season. Inspectors continue to monitor changes in plant cover with photographs, which are taken from selected vantage points on an annual basis.

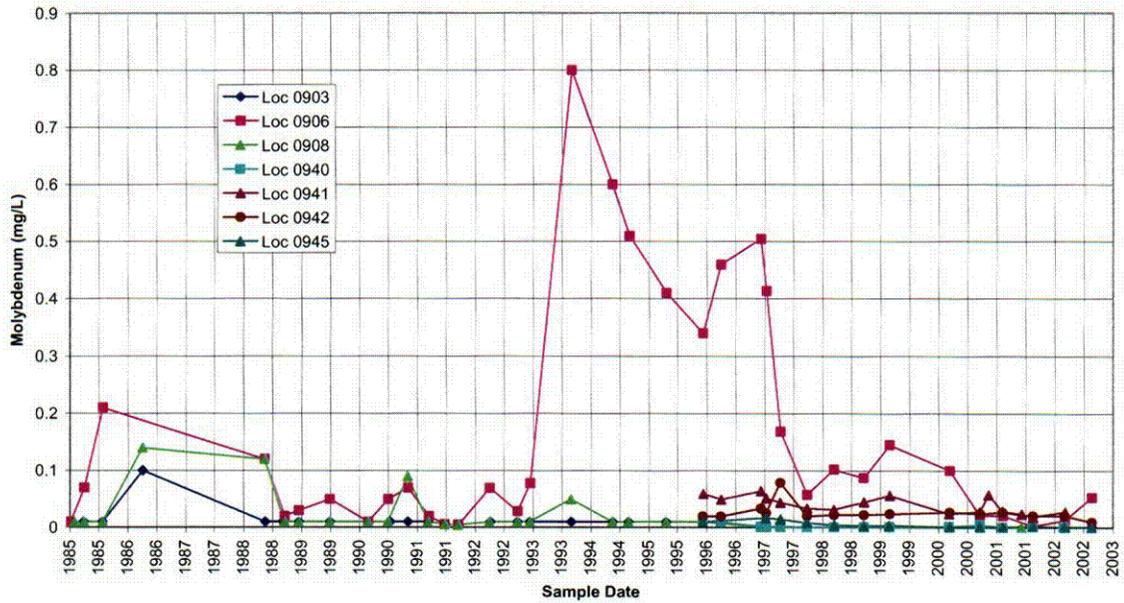
Figure 19-2. Time-Concentration Plots of Molybdenum in Ground Water at the Tuba City, Arizona, Disposal Site

Molybdenum concentrations did not exceed the 0.1 milligram per liter (mg/L) standard in samples from any well in 2002. Except at well 0906, molybdenum concentrations have not varied significantly in the last 15 years (Figure 19–2). Samples from well 0906 typically have had higher and more variable molybdenum concentrations than samples from other wells.

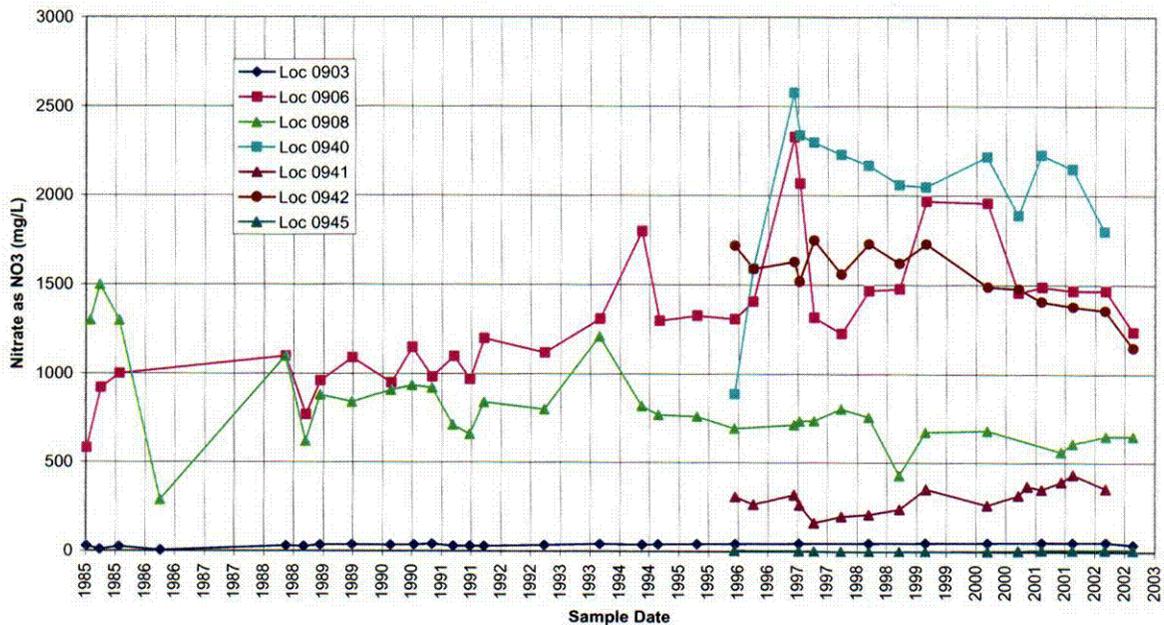
Figure 19-3. Time-Concentration Plots of Nitrate (as NO₃) in Ground Water at the Tuba City, Arizona, Disposal Site

In 2002, the concentration of nitrate (as NO₃) exceeded the 44 mg/L standard in samples from all monitor wells except well 0945, the background well. Between 2001 and 2002, no significant increases or decreases in concentrations were observed in samples from any well, although concentrations varied considerably—by more than two orders of magnitude—from well to well (Figure 19–3).

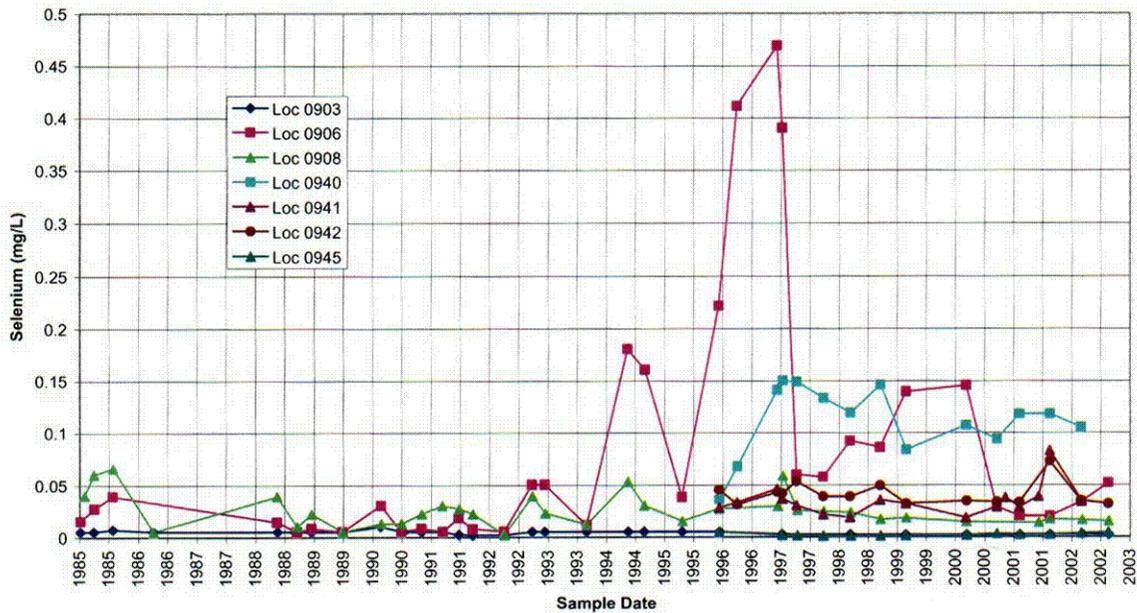
Figure 19-4. Time-Concentration Plots of Selenium in Ground Water at the Tuba City, Arizona, Disposal Site

Consistent with historical data, selenium concentrations exceeded the 0.01 mg/L standard in 2002 in samples from all wells except background well 0945 and off-site, downgradient well 0903. Selenium values have remained fairly consistent in samples from all wells except 0906 and 0940 (Figure 19-4).

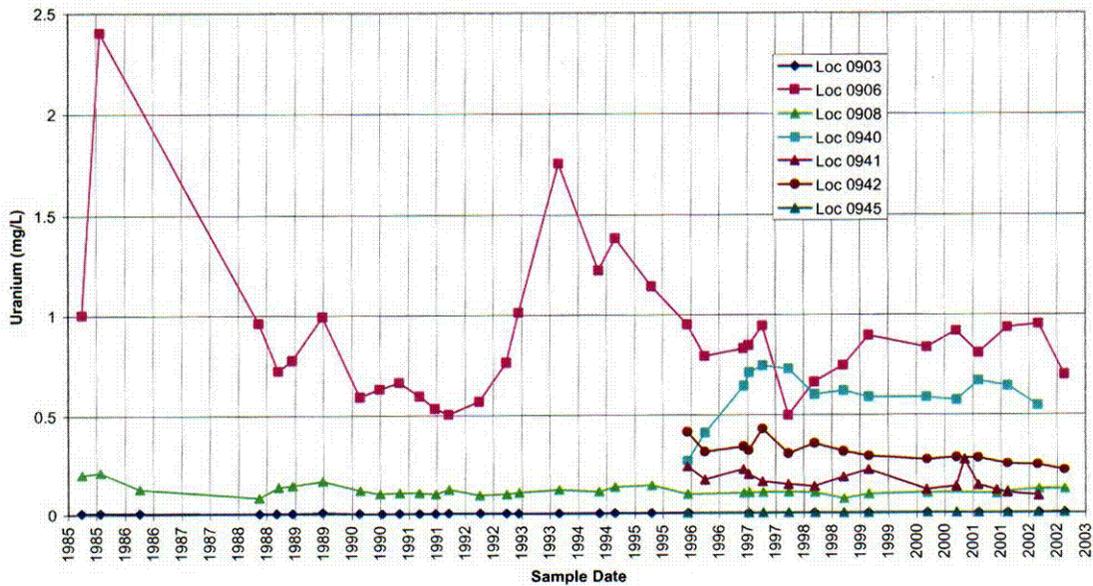
Figure 19-5. Time-Concentration Plots of Uranium in Ground Water at the Tuba City, Arizona, Disposal Site

Uranium concentrations exceeded the 0.044 mg/L standard in 2002 samples from all wells except background well 0945 and off-site, downgradient well 0903. Concentrations have remained fairly constant over time in samples from all wells except 0906 and 0940 (Figure 19-5).
