**SG-SGDA-02-43-NP
Comanche Peak Steam Electric Station
1RF09 Outage Condition Monitoring Report and
Preliminary Cycle 10 Operational Assessment**

SG-SGDA-02-43-NP

October 2002

Westinghouse Electric Company LLC

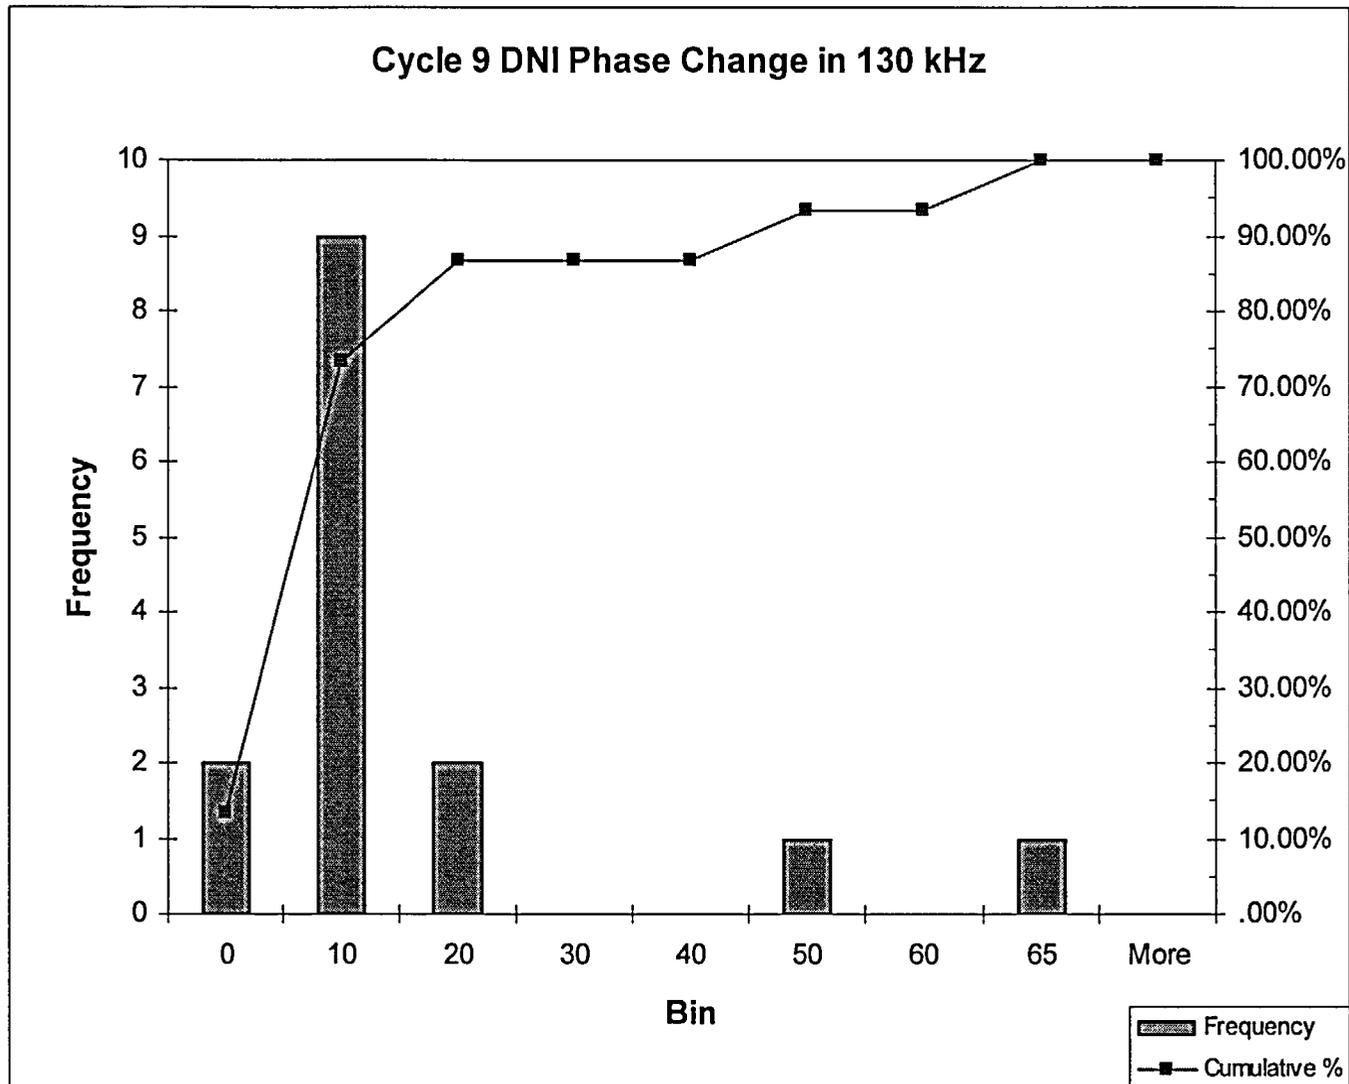
population can be seen in Figure 10. Figure 10 plots the 130 kHz phase change for all reported ding flaws comparing the 2002 and 2001 130 kHz phase responses. Figure 10 shows that only 2 indications had a 130 kHz bobbin phase change of greater than 20°. These two indications are represented by R41 C71 and another indication. The other indication was reported in a <1 volt ding. Once ODSCC initiated in this ding, the limited ding influence would result in significant phase change. The other dings were located in dings up to 6.2 volts, and therefore would result in lesser amounts of phase change due to the combination of the ding and flaw vectors. Since the ding amplitude of R41 C71 was estimated at 1.7 volts, the amount of phase change for this tube is significantly different from the rest of the 1RF09 ding ODSCC population, and significantly different from the ding flaws reported at other plants.
